CHAPTER 6

REPORT ON THE 1986 EXCAVATIONS CHAPEL 556

Site supervisor: B.J. Kemp

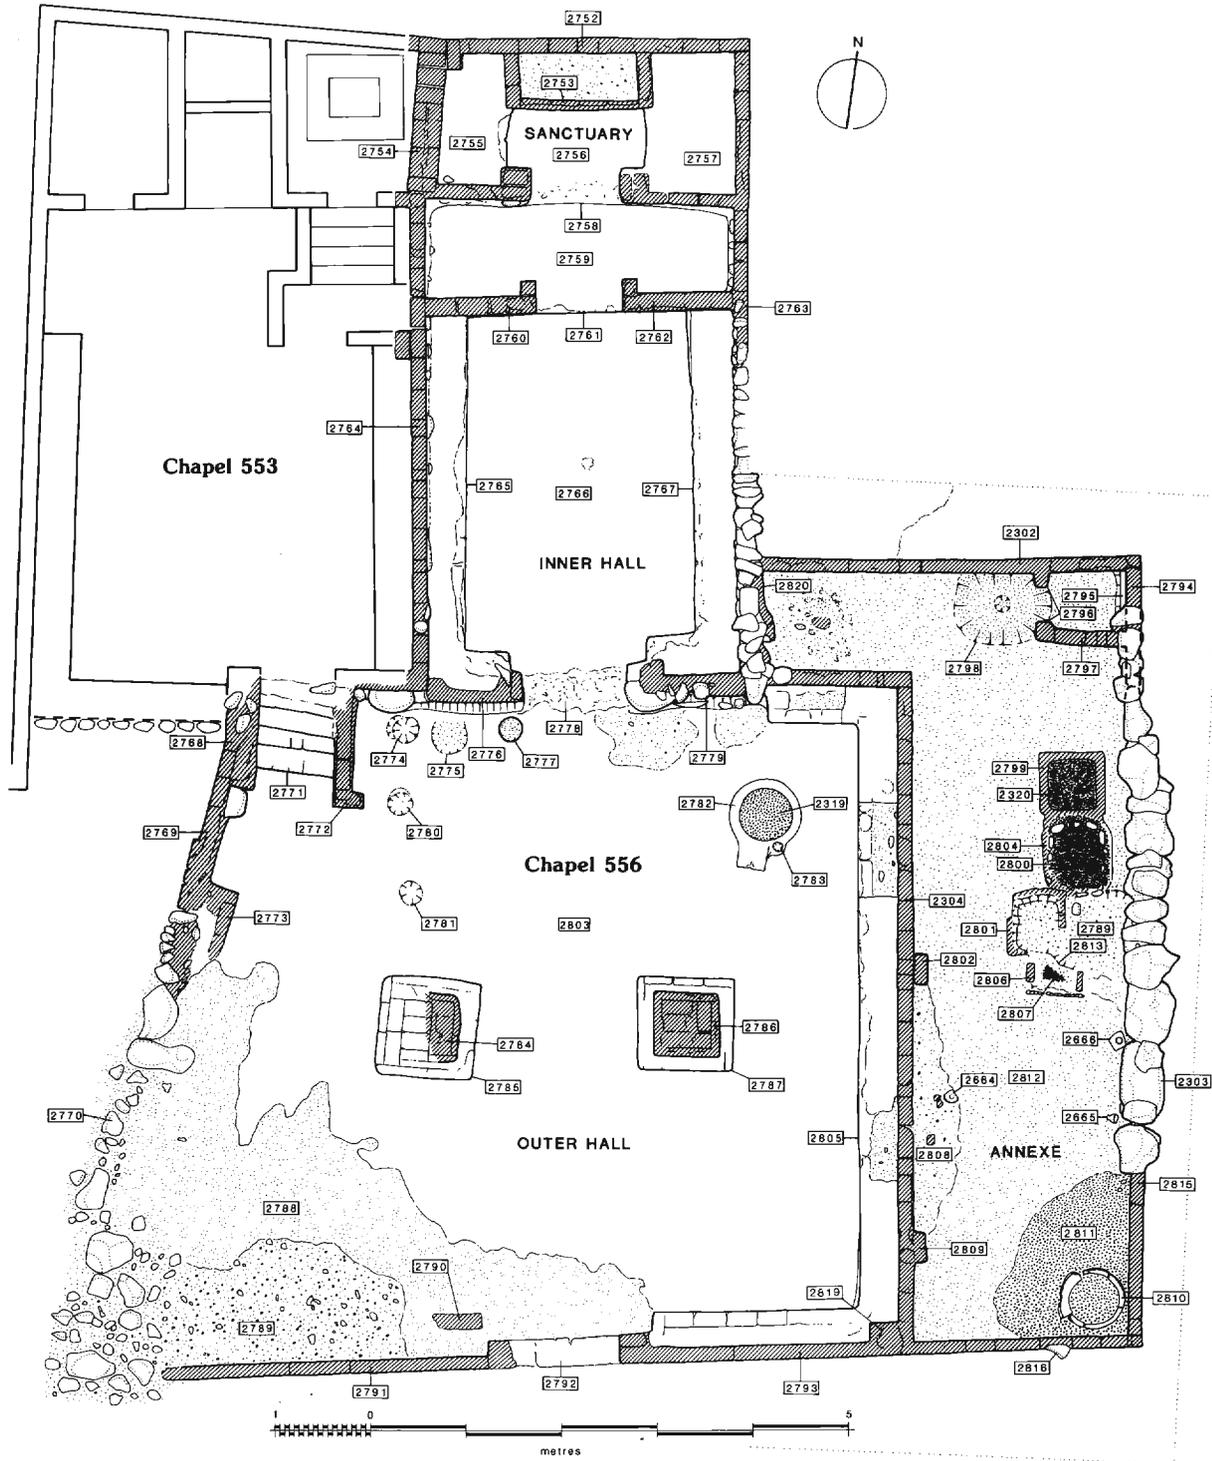
Figure 6.1. General plan of Chapel 556 at the end of excavation (original by B. Kemp). The outline plan of Chapel 553 is taken from *COA I*: Plate XXV.

The results were not quite as expected. The stone wall turned out to be the side to an annexe for a substantial part of Chapel 556 which had never been excavated. This led to the complete excavation of the building, including the re-clearing of the part dug in 1922 (Figures 6.1, 6.2). By the end, however, little real light had been shed on the enigmatic pathway and enclosures, although it had been established that the stone wall was itself a post-Amarna Period replacement of an earlier brick wall.

An interesting feature of the chapel as a whole is the staircase in the north-west corner of the Outer Hall, which led up to Chapel 553. Its position shows that the Outer Hall was shared communally by both chapels. Chapel 553 was not re-excavated by the expedition; the outline plan in Figure 6.1 is taken from *COA I: Plate XXV*, with corrections imposed by the different alignment of the rear wall visible from clearance of the north-west corner of Chapel 556.

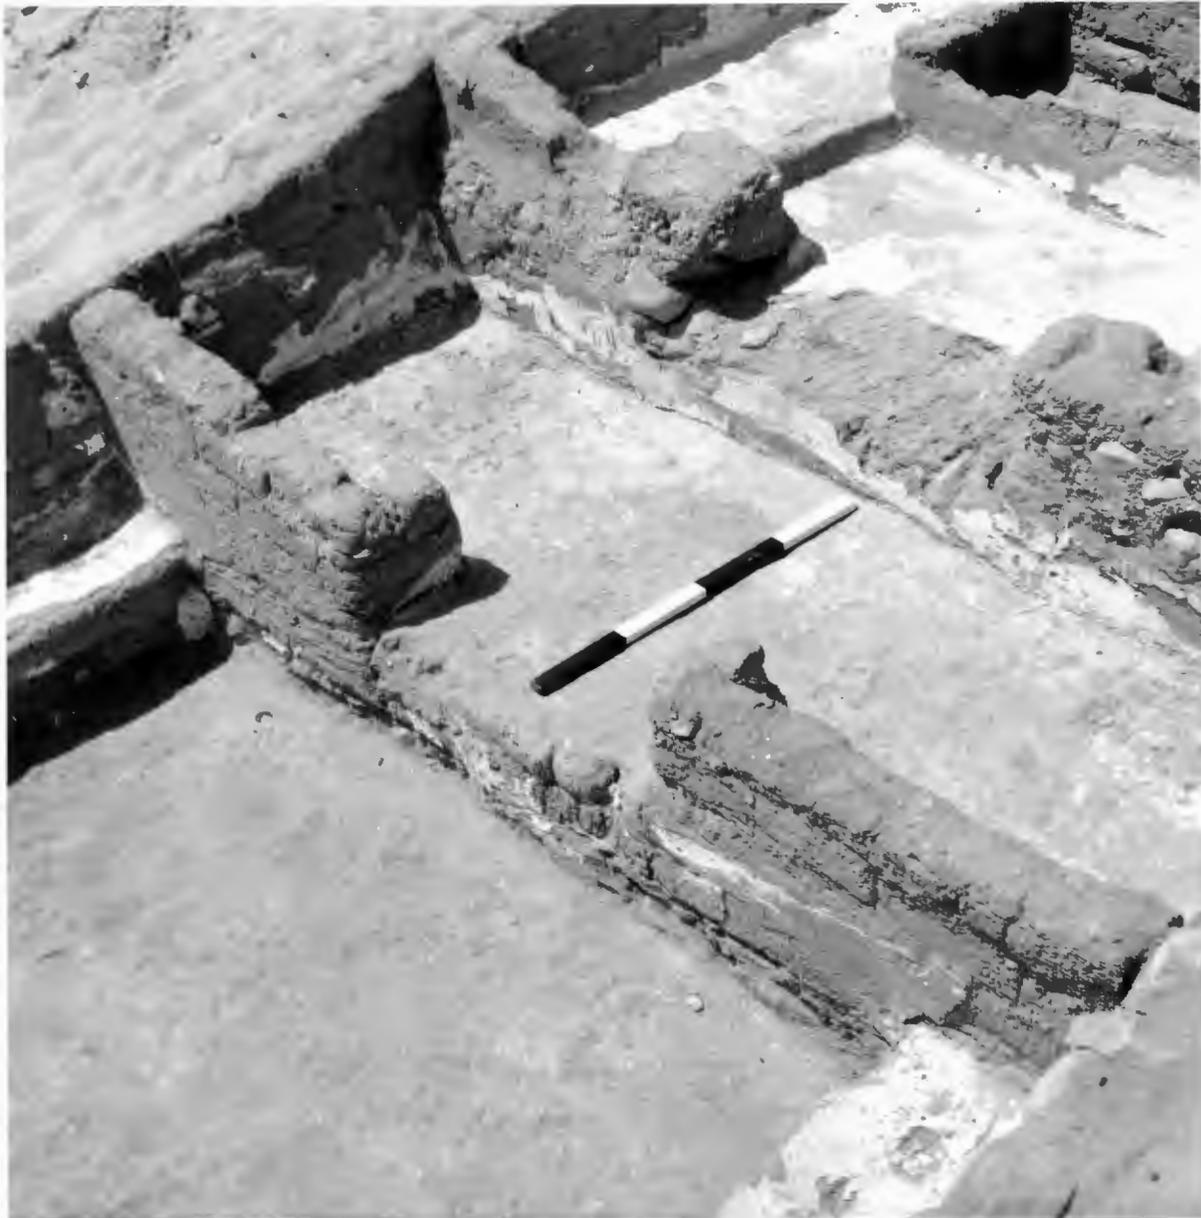
Figure 6.2. View of the rear part of Chapel 556, including the Sanctuary, looking north-west.

The *COA I* plan (Plate XXV) covers only the Inner Hall and Sanctuary, which conform to the stereotyped design of Workmen's Village chapels (Figure 6.2). A bench-like altar [2753] filled about half of the rear wall of the Sanctuary room, the eastern and western parts of which had raised floors [2755, 2757]. During or after Woolley's excavation the fill of the altar had been cleared out leaving only the surrounding wall. The whole was separated from the Inner Hall by a transverse corridor with plastered floor [2759]. Within each door was a step [2758, 2761], corresponding to the steep natural slope of the hillside. When the Inner Hall was cleared it was found that the old excavations had not reached floor level, and had, in fact, only skimmed off a layer of surface sand, leaving the rubble fill [2298] untouched. Although much of the structure of this unit had been lost through compaction and weathering, its colouration showed it to be more than half composed of alluvial Nile mud. This fact, together with a small number of actual Nile mud roofing fragments with pole and beam impressions, identifies the rubble as the remains of a fallen roof which had completely spanned the Inner Hall, so adding usefully to the evidence for the original roofing of the chapels. The lifting of this layer revealed a pair of benches [2765, 2767] against the walls, separated by a plastered floor [2766] virtually unmarked.

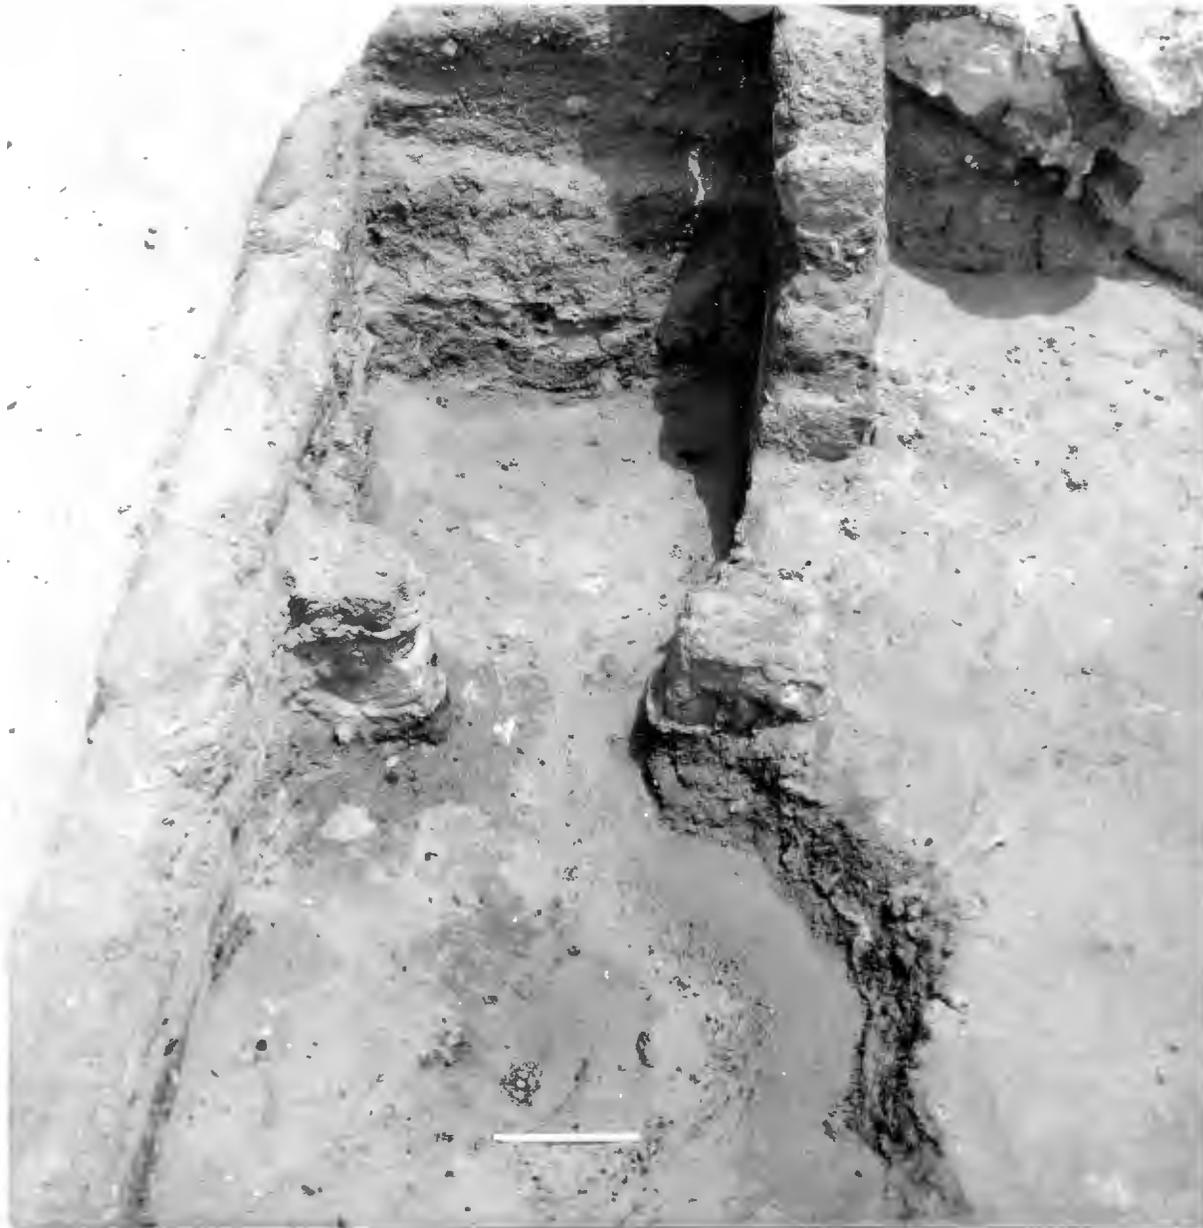
Figure 6.4. Box oven in the north-east corner of Chapel 556, with contents removed, looking east. Note the ash pit in front of the oven door. The scale is 15 cm.

A **box oven**, in the north-east corner (Figure 6.4), made by walling-off the north-east corner

[2794] to create an almost rectangular space measuring 66/64 x 75 cms. A narrow step or ledge [2795] had been formed at the east end. The western end had been left largely open as a doorway [2796], and in front lay a circular pit [2798] filled with ash (part of [2317]). A layer of ash [2321] also covered the oven floor. The chapel had been abandoned around the time when the oven was being used. As a result a full set of bread moulds had been left in position (Figures 6.5, 6.6). These had later been somewhat disturbed, but not sufficiently to obscure their original configuration. Two kinds of pottery mould had been used: one of them narrow and cylindrical, the other hemispherical and with a foot (Figure 6.7). The former had been stacked vertically in probably three rows of ten, resting against the back wall. At least thirty-four of the latter kind had then been placed in the remaining space in front, probably in two tiers. In the subsequent disturbance (which was ancient) the outer moulds and the west wall of the oven had been kicked or pushed, spilling the moulds outside the confines of the oven. A small lump of basalt had also been thrown in, smashing one of them (no. 68237).

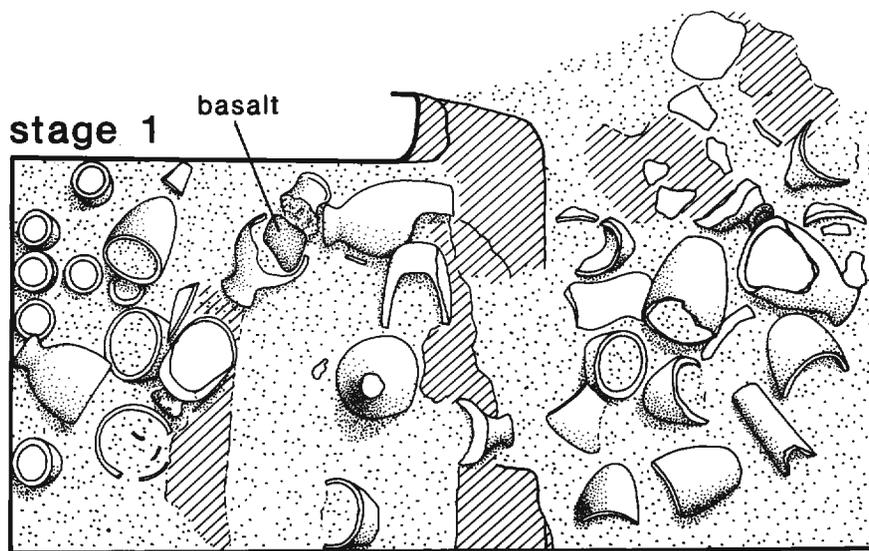
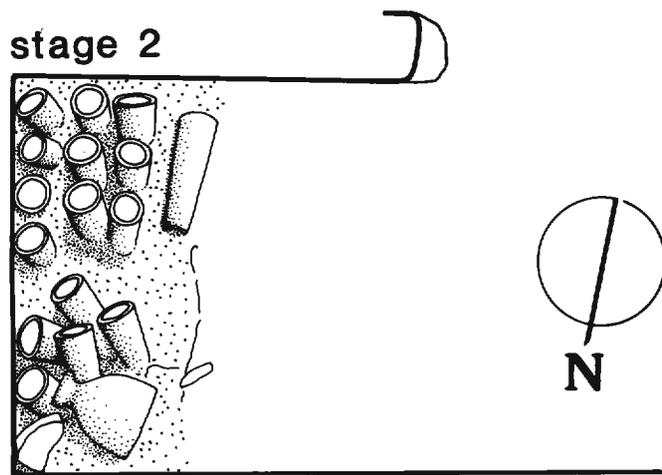
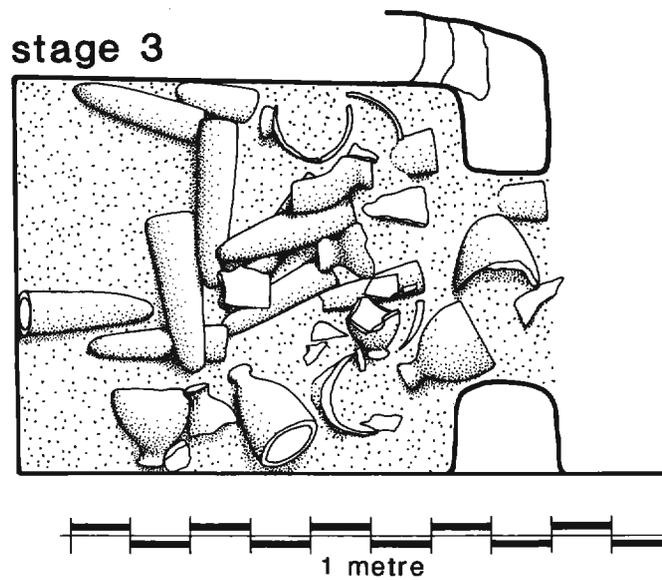
Figure 6.5. Plans of the box oven in the north-east corner of Chapel 556 at three successive stages of excavation, showing the bread moulds (original by B. Kemp).

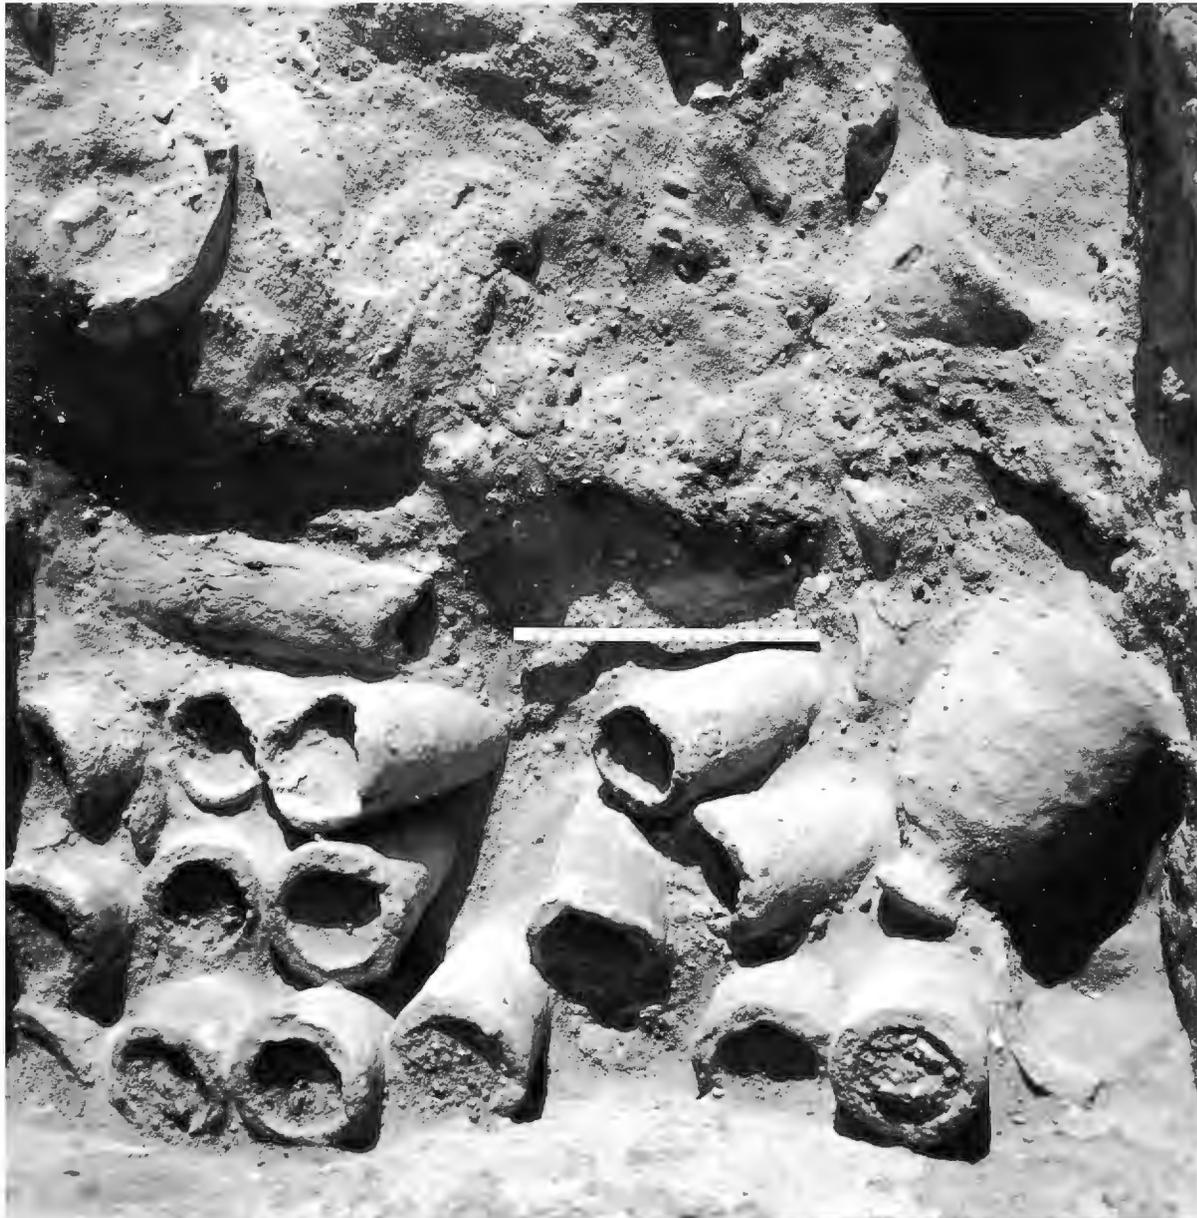
Figure 6.6. Bread moulds *in situ* in the box oven of Chapel 556. The scale is 15 cms. The photograph corresponds to Stage 2 in Figure 6.5.

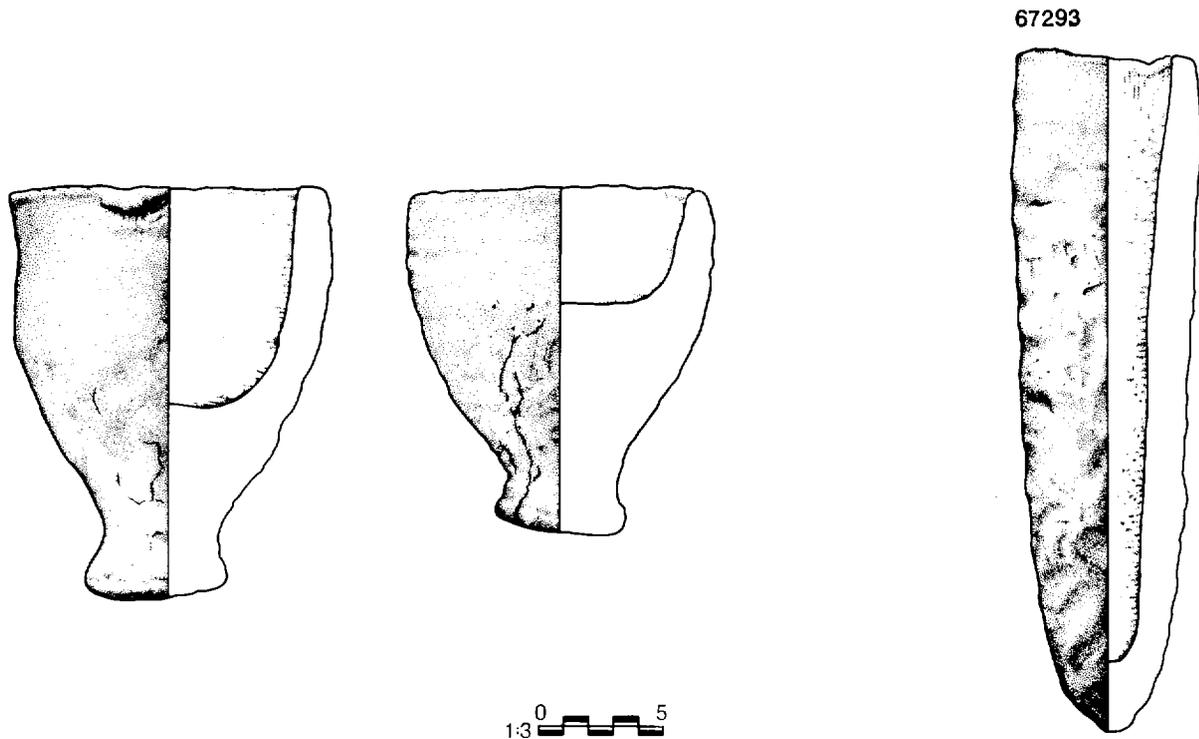
Figure 6.7. Sample of bread moulds from Chapel 556 box oven (drawings by A. Boyce at one-third scale).

Of the 64 vessels, 30 were long, tapering cylindrical moulds with rounded bases, a type which is well-known in the New Kingdom (Figures 6.7, 6.8; see Jacquet-Gordon 1981: 18-21, Type D). There is little variation in the dimensions of these moulds; the mouth aperture ranges from 5.1 to 5.4 cms. in diameter, and the internal depth from 19.5 to 24.2 cms.; in over half the cases the depth falls between 23 and 24 cms.

The remaining 34 vessels are of a type which has not previously been noted at Amarna, or, as far as I can tell, at any other site of this period (Figures 6.7, 6.8). Their most conspicuous feature is the knob on the base of the vessel which, both from its size in relation to that of the complete mould, and from its curved underside, is unsuitable as a support for the vessel. Only about half the height of the mould is taken up with the cavity in which dough was placed. This cavity has straight sides which curve into a flat bottom. The rim shape is usually squared, but sometimes, where the wall is overly thin, it tapers towards the inner face. The variation in the wall thickness around the vessel diameter, whereby one half can be over twice as thick as the other, and the smoothness of the internal cavity, suggest that the interior was itself shaped by means of a mould which was either pressed into a lump of clay, or over which clay was pressed. The knob could

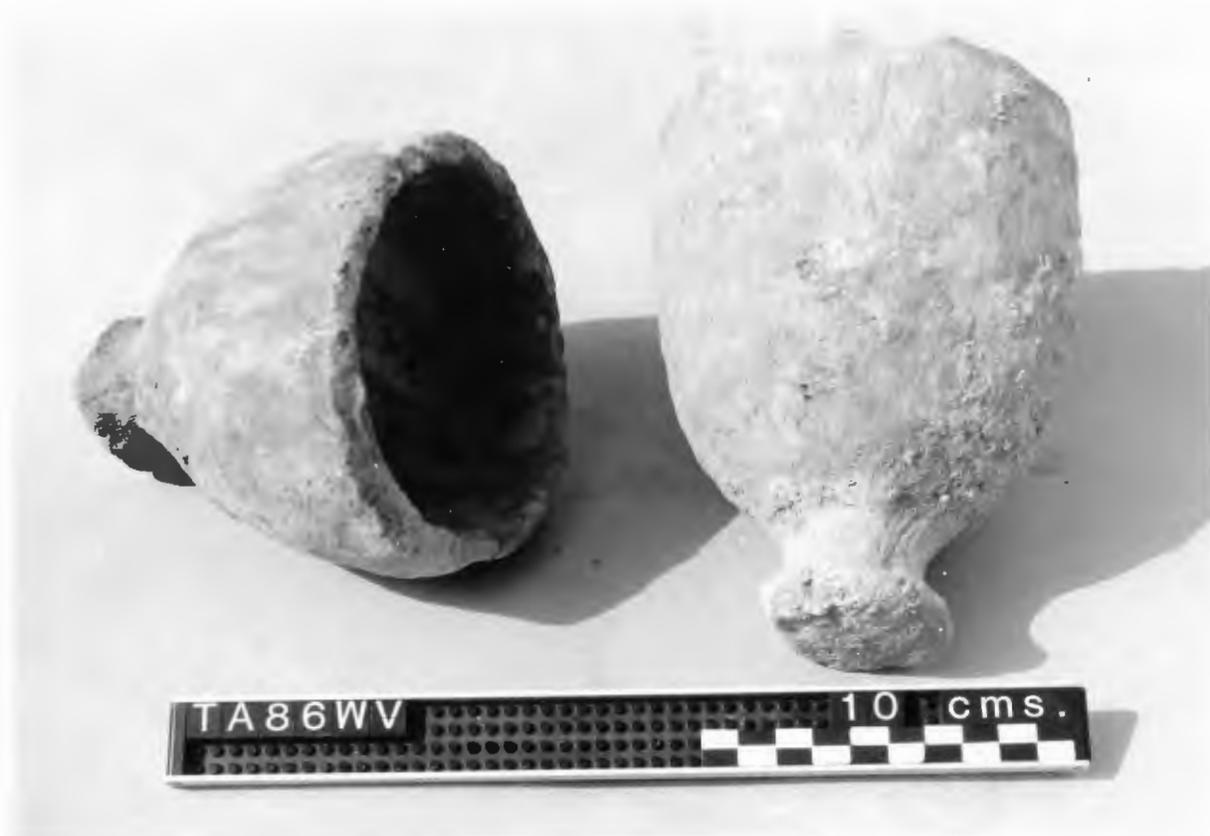
Figure 6.8. Sample of bread moulds from Chapel 556.

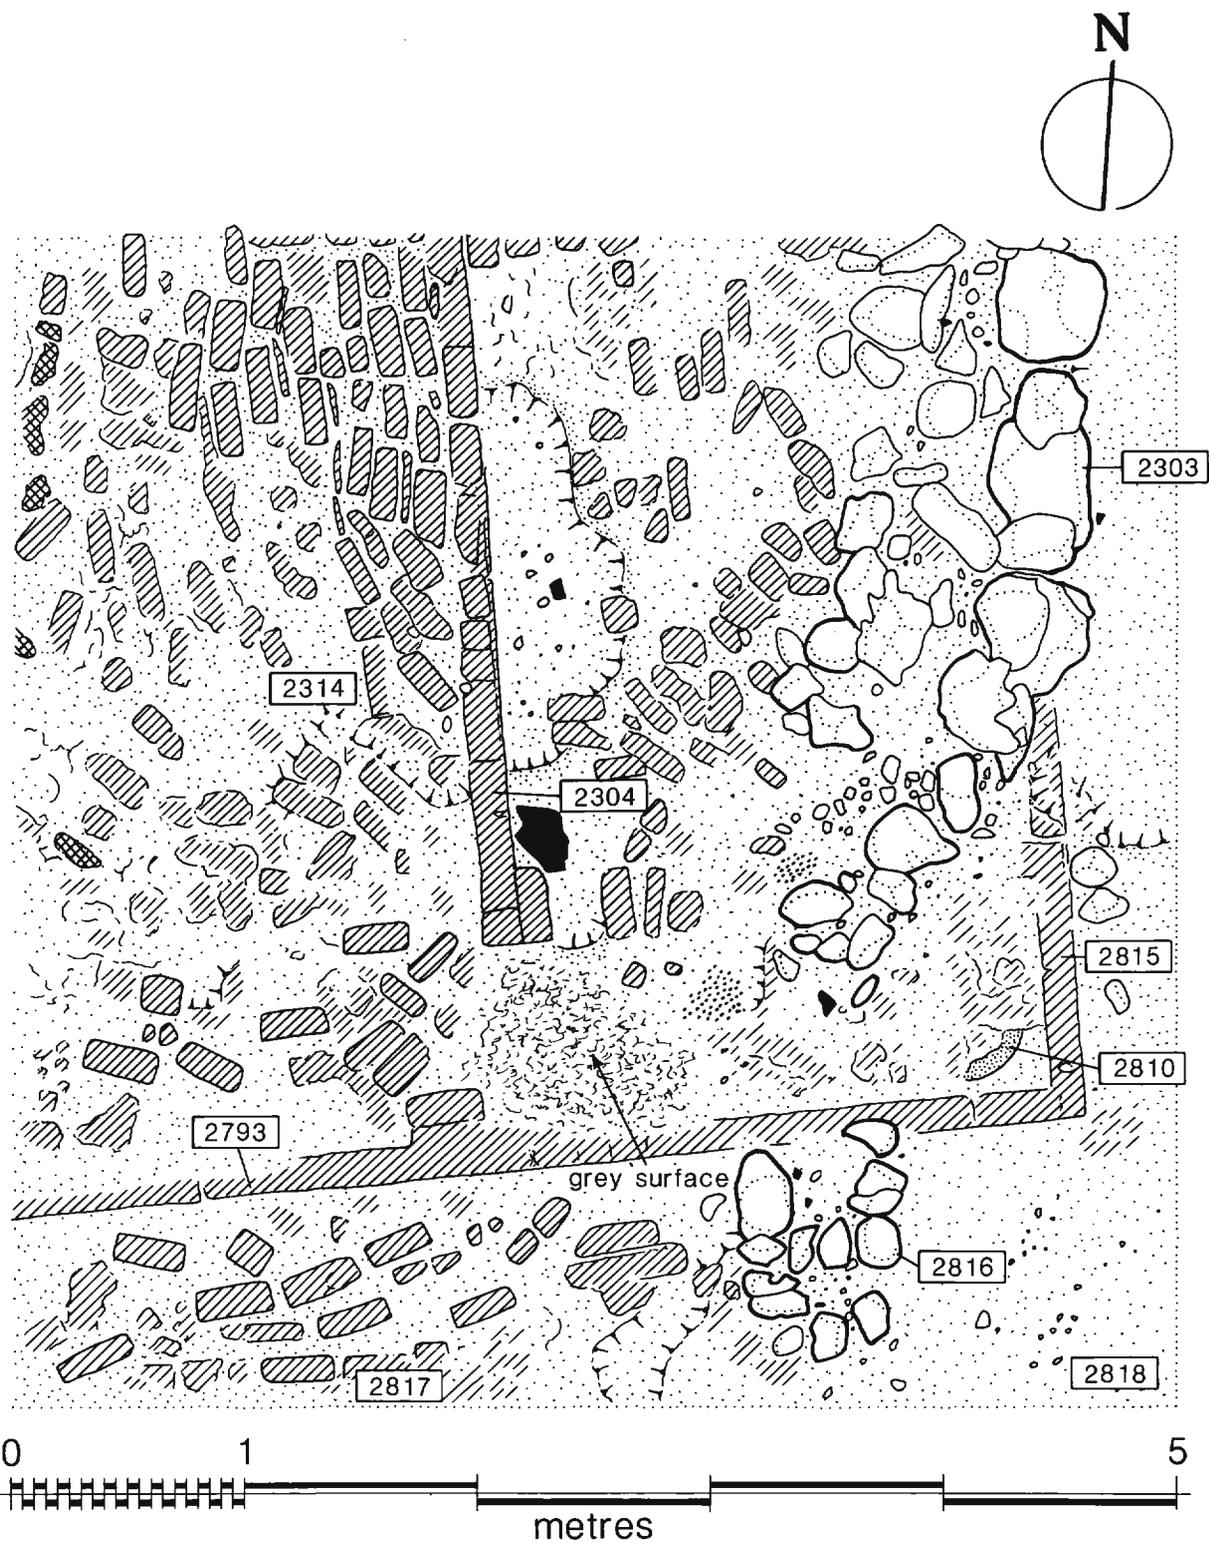
Figure 6.9. Plan of the south-east corner of Chapel 556 at the end of the first stage of excavation, showing the later stone wall [2303] curving across the south-east corner, leaving a gap, and then continued by the stonework [2816] (original by B. Kemp).

There is a reason for emphasising the absence of modern disturbance. The east wall [2303] of the annexe had been reconstructed. The material used was large stones, and at both ends these stones had been set up over the original brick wall [2794, 2815]. Moreover, as they were set up the garden plots seem to have been dug into, leaving the irregular cut [2813] which had destroyed plot [2801]. This by itself is of small interest, but at its south end the stone wall curved around westwards, departing from the line of the original brick wall, and passed across ground made up of decayed brick rubble (part of [2314]; see Figure 6.9). Then beyond a narrow break, a pile of stones [2816] seems to mark its southern limit, standing just outside the southern wall of the chapel, and above the level of the rubble which had collapsed outwards from it [2817]. The evidence together, therefore, seems to point to a more-than-casual attempt to construct a barrier across the foot of the side valley, making use of the ruined east wall of Chapel 556. This is not the first time that slight traces of later activity have been discovered. The most conspicuous were in the north-east corner of the Main Chapel, excavated in 1983 and 1984 (*AR* III: 110-111), and seemed to belong to an animal pen. A reason for wanting to seal off one of the natural exits from the valley would be to stop animals from straying. But as to the date and background of this period of activity we have no evidence of any real value. It does, however, provide another point of reference for the narrow pathway and linked group of enclosures on the top of the plateau.

An area of sand was cleared halfway down the side valley on the line of the pathway to see if it survived beneath the sand, but this turned out not to be the case. However, if the line of the path were continued it would strike the line of wall [2303] roughly in the middle or, if it were to follow the base of the hill round to the south and so continue into the main valley, it would cross the line of wall [2303] roughly where the break does occur. The stone pile [2616] would have marked the other side of the entrance, and it is possible that the wall continued for a short distance further to the south, although this was not tested by excavation. If the pathway took this line it would explain the appearance of the southern end of wall [2304], where it joins the south wall of the chapel [2793] at the buttress [2819]. When the surface sand was first removed a gap appeared to exist in the wall. In its place was part of a larger powdery grey patch representing the top of weathered organic material. Yet when this layer was excavated it was found that no

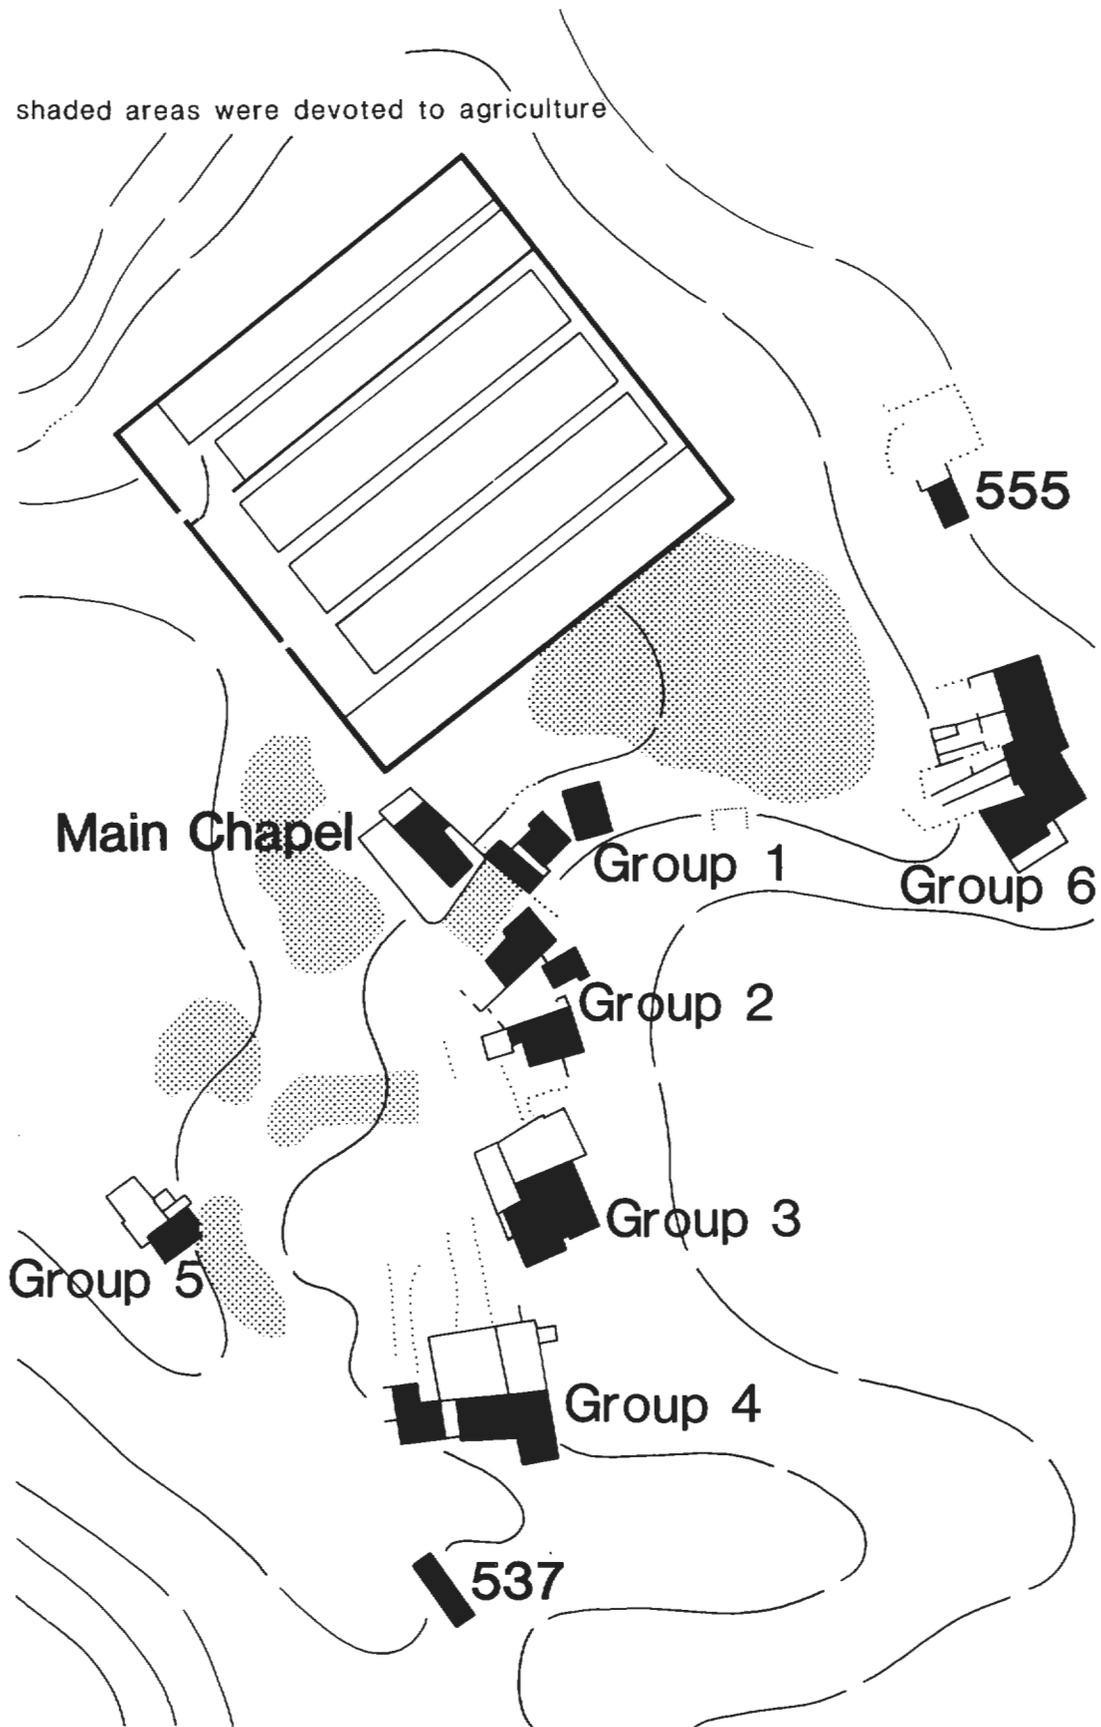
Figure 6.10. Outline plan of the Workmen's Village showing grouping of chapels.

It is very apparent from the site map (Figure 6.10) that many of the chapels form groups, not only through general proximity and common alignment, but sometimes in the sharing of walls and of ancillary elements. In Table 6.1 and Figure 6.11 the chapels are arranged into six groups, leaving three isolated cases (one of them the Main Chapel). Groups 1 and 2 are separated by the intervening Building 523 and also have the weakest degree of physical linkage. Only two excavated chapels belong to Group 1, but adjacent to no. 521 is the one definite unexcavated chapel that has been located and which should probably form part of this group.

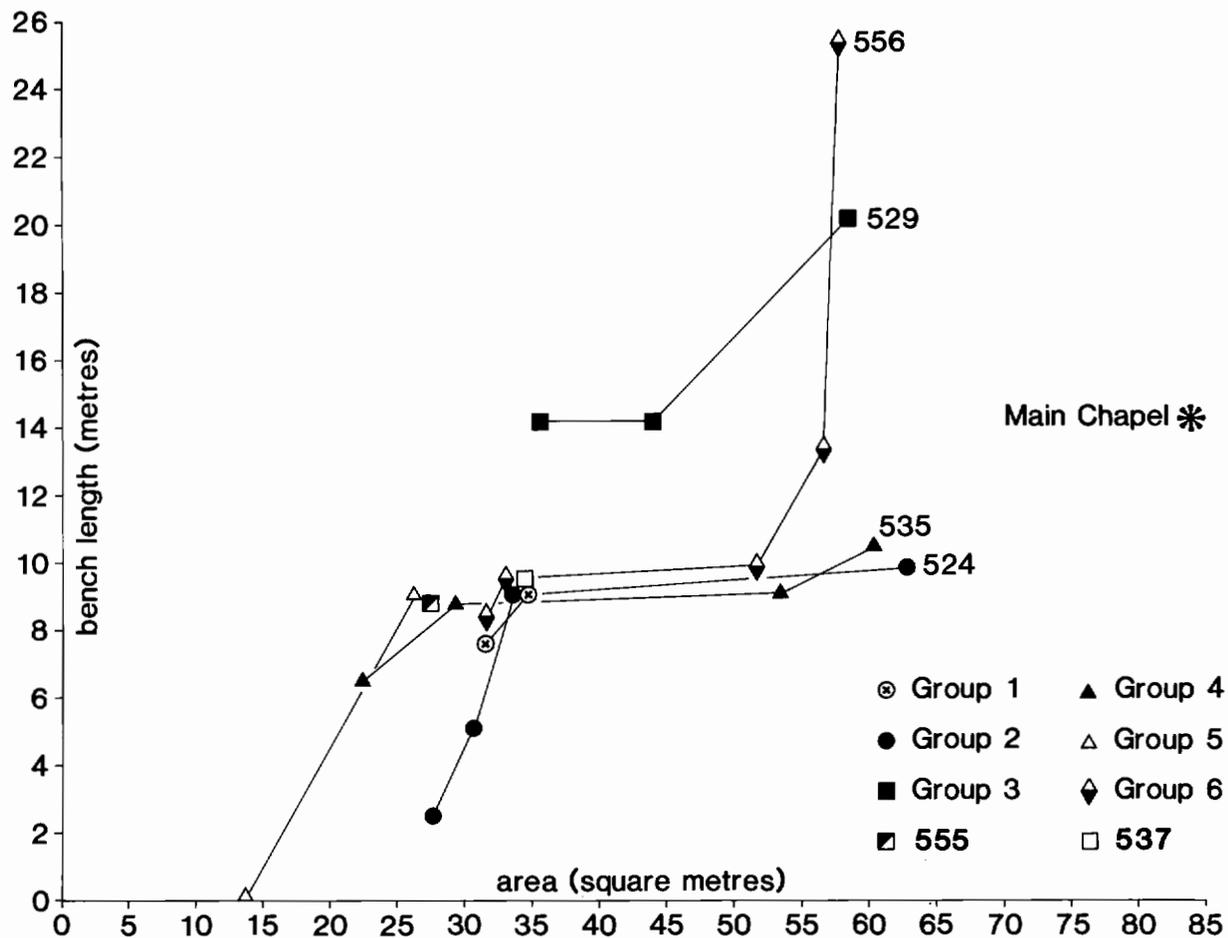
Figure 6.11. All Workmen's Village chapels, plotted according to area of roofed portion and length of wall benches.

In Figure 6.11 we can readily pick out a general progressing relationship between both measured elements, as well as the "average" chapel, covering between 25 and 35 square metres, and with bench length between 6 and 10 metres. There is, too, a general cut-off point in floor area before 65 square metres, only the Main Chapel exceeding this at 84. In bench length, on the other hand, 5 chapels (in addition to the Main Chapel) noticeably exceed the norm, equalling or surpassing the provision of the Main Chapel. All three members of Group 3 do this, as does Chapel 556 when the newly discovered part is included. Group 3, it will be recalled, is the one which possesses the distinctive ceremonial forecourt, no. 528.
