CHAPTER 4

REPORT ON THE 1986 EXCAVATIONS
BUILDING 200: ANIMAL PENS AND PLANT BEDS

Site supervisor: Ann Bomann

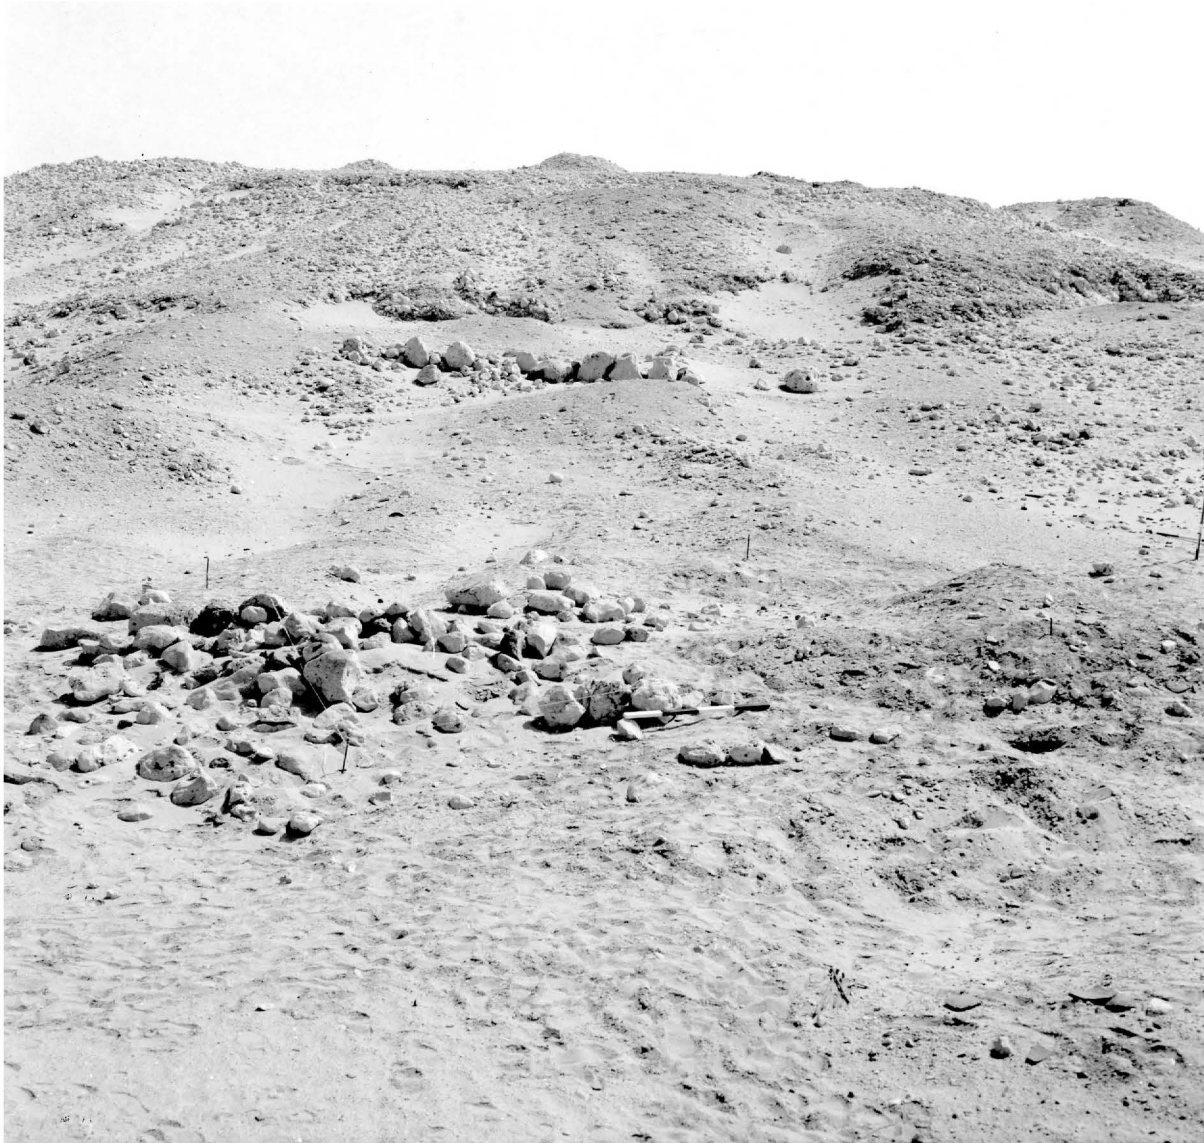
Figure 4.1. View of the site before excavation, looking east. Most of the boulders lie in square T28. On the hillside above the line of stones probably marks a court in front of a tomb entrance (no. 557).

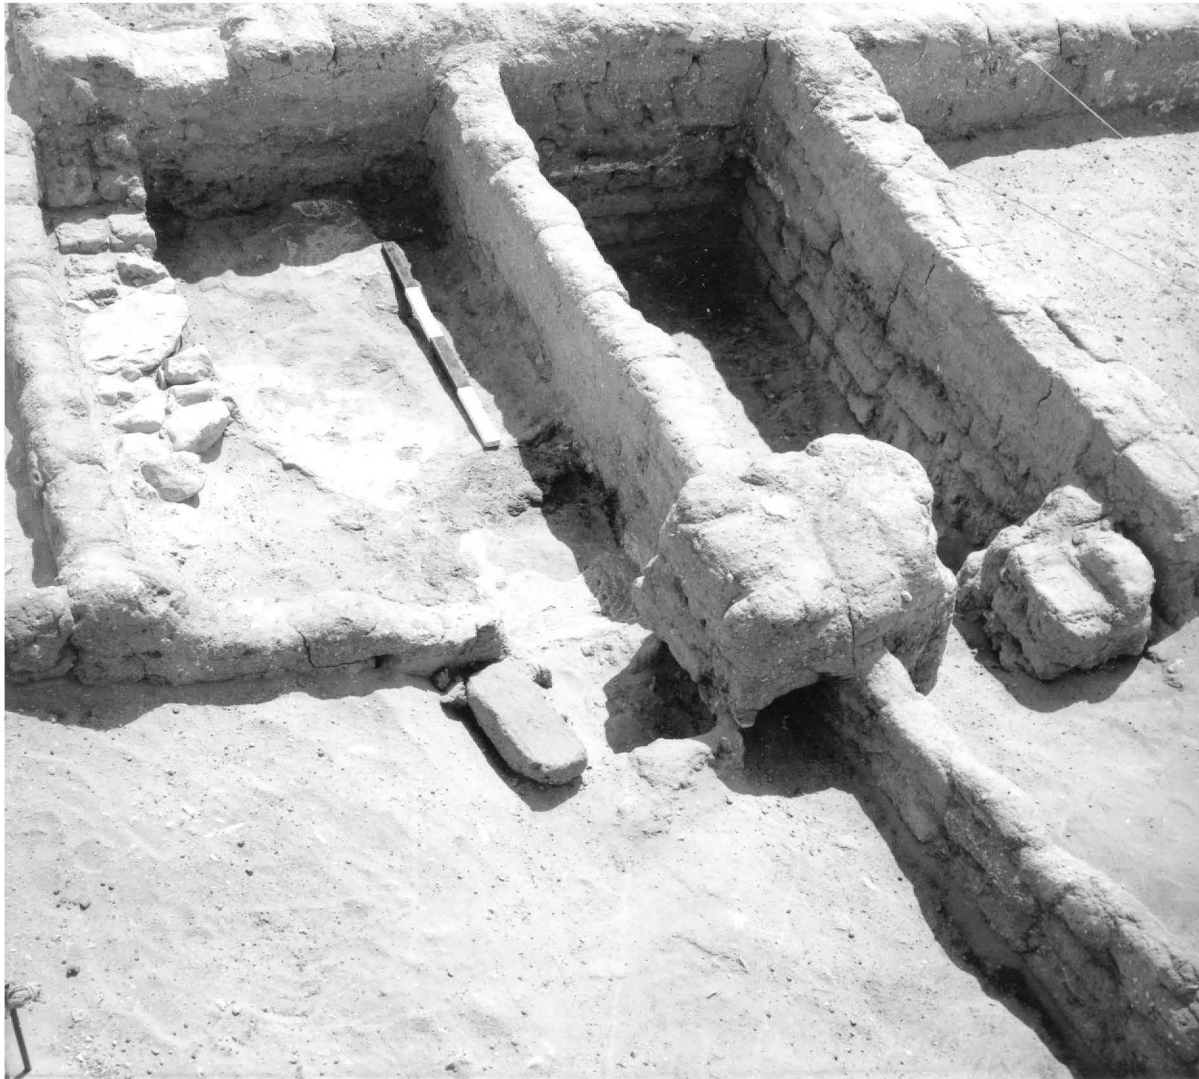
Figure 4.3. Areas ii and iii, looking south.

As in Building 250 excavated last year (*AR III*: Chapter 2), the passage of time brought changes in layout. Area iii was enlarged to the east by rebuilding the east wall on a new line, and now of a single brick in thickness only [2350]. No attempt was made, however, to remake the gypsum-plastered floor. This sideways enlargement was probably accompanied by a similar enlargement of the space in front, Area vi. Indeed, it would make good sense to relate this activity to the subdivision of Areas v and vi, and the cutting of the second doorway in wall [2089]. With a further lapse of time an organic floor deposit built up, hiding the original carefully made floors, and accompanied by a simplification of plan. Areas i and iv were merged by the removal of the intervening wall [2734]; the same happened with Areas v and vi, for by the time

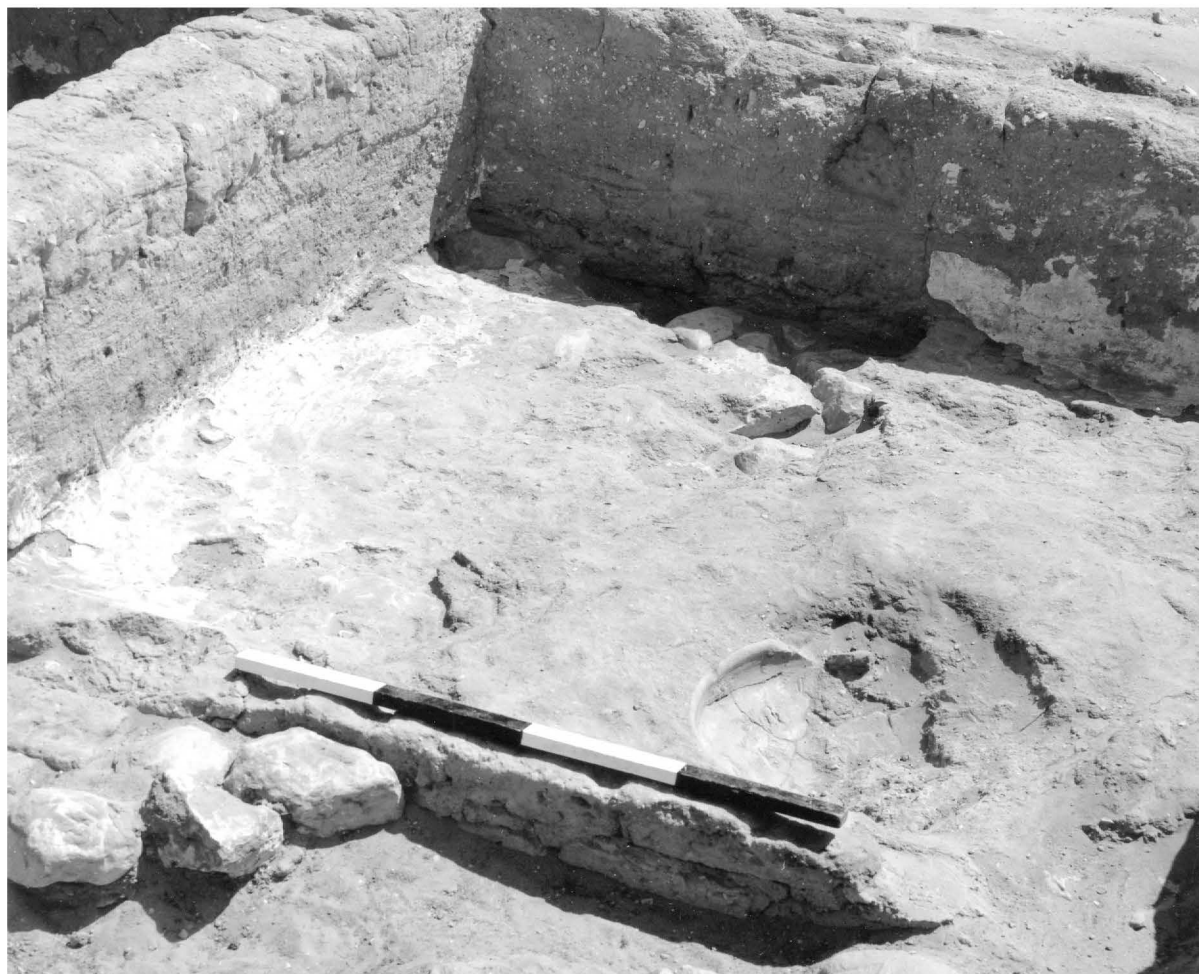
Figure 4.4. Area i, looking south-east. Note the gypsum floor and sunken pottery bowl.

On the west lay two almost square courts, **Areas i and iv**, measuring 2.10 x 1.90, and 2.20 x 1.80 metres respectively. The dividing wall [2734] had later been knocked down to convert the two courts into a single open space, but the original entrance could be inferred from the stones and bricks set into the floor of **Area iv** at the east end, for use as a step. The marl plaster floor [2722] and wall surfaces had been coated with gypsum [2725]. A hard-packed organic deposit [2723] lay on the floor of the northern half, where a large pottery bowl [2724] had been let into the floor to serve as a trough (Figure 4.4). **Area iv** had seen some modern pitting of the floor. The surviving parts were of marl plaster [2722] with an organic cover [2723], without trace of gypsum or of a trough. The remaining part of the core building, in the north-east, was an open space subdivided into two unequal parts, **Areas v and vi**, by a thin wall [2090]. This looks as though it was an addition to the original layout, and necessitated cutting a separate entrance at the eastern end of wall [2089], with small buttress [2541]. Neither area had a proper floor, the

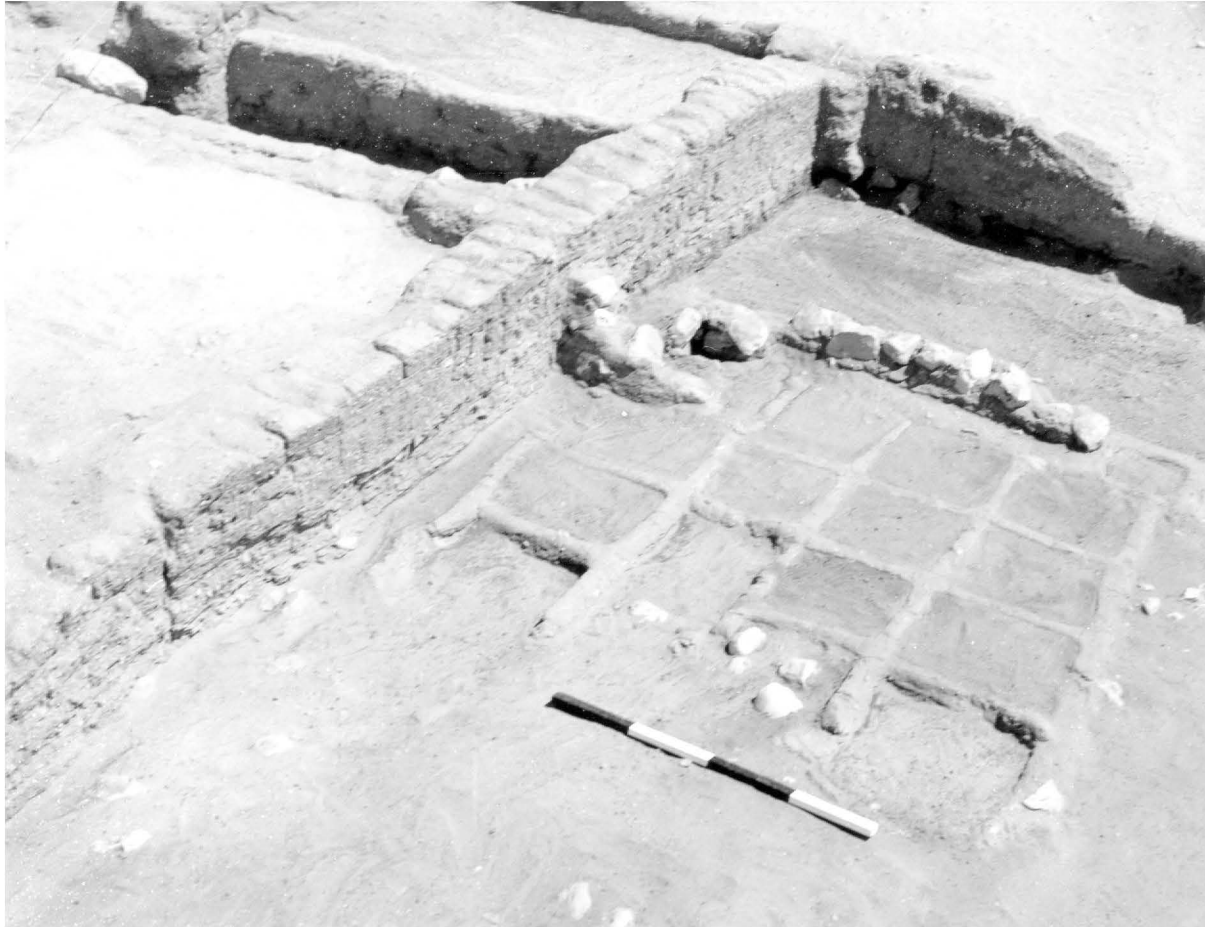
Figure 4.5. View of the garden plots at an early stage of excavation, looking east. Note the rough stone wall [2347] running along the back of the plots.

soil. Some irregular additions had been made on the east, which had subsequently been covered by a low stone wall [2347] (not shown in Figure 4.2, but visible in Figure 4.5). On the west, modern disturbance has exposed the outline of an original low enclosure wall [2537]. This shows that originally twenty of these plots were laid out, in five rows of four (ignoring in the count the double-sized plot in the middle).
