## REPORT ON THE 1986 AMARNA SURVEY

Surveyor: Salvatore Garfi

**8.2 The Sanctuary of the Great Aten Temple by Barry J. Kemp**

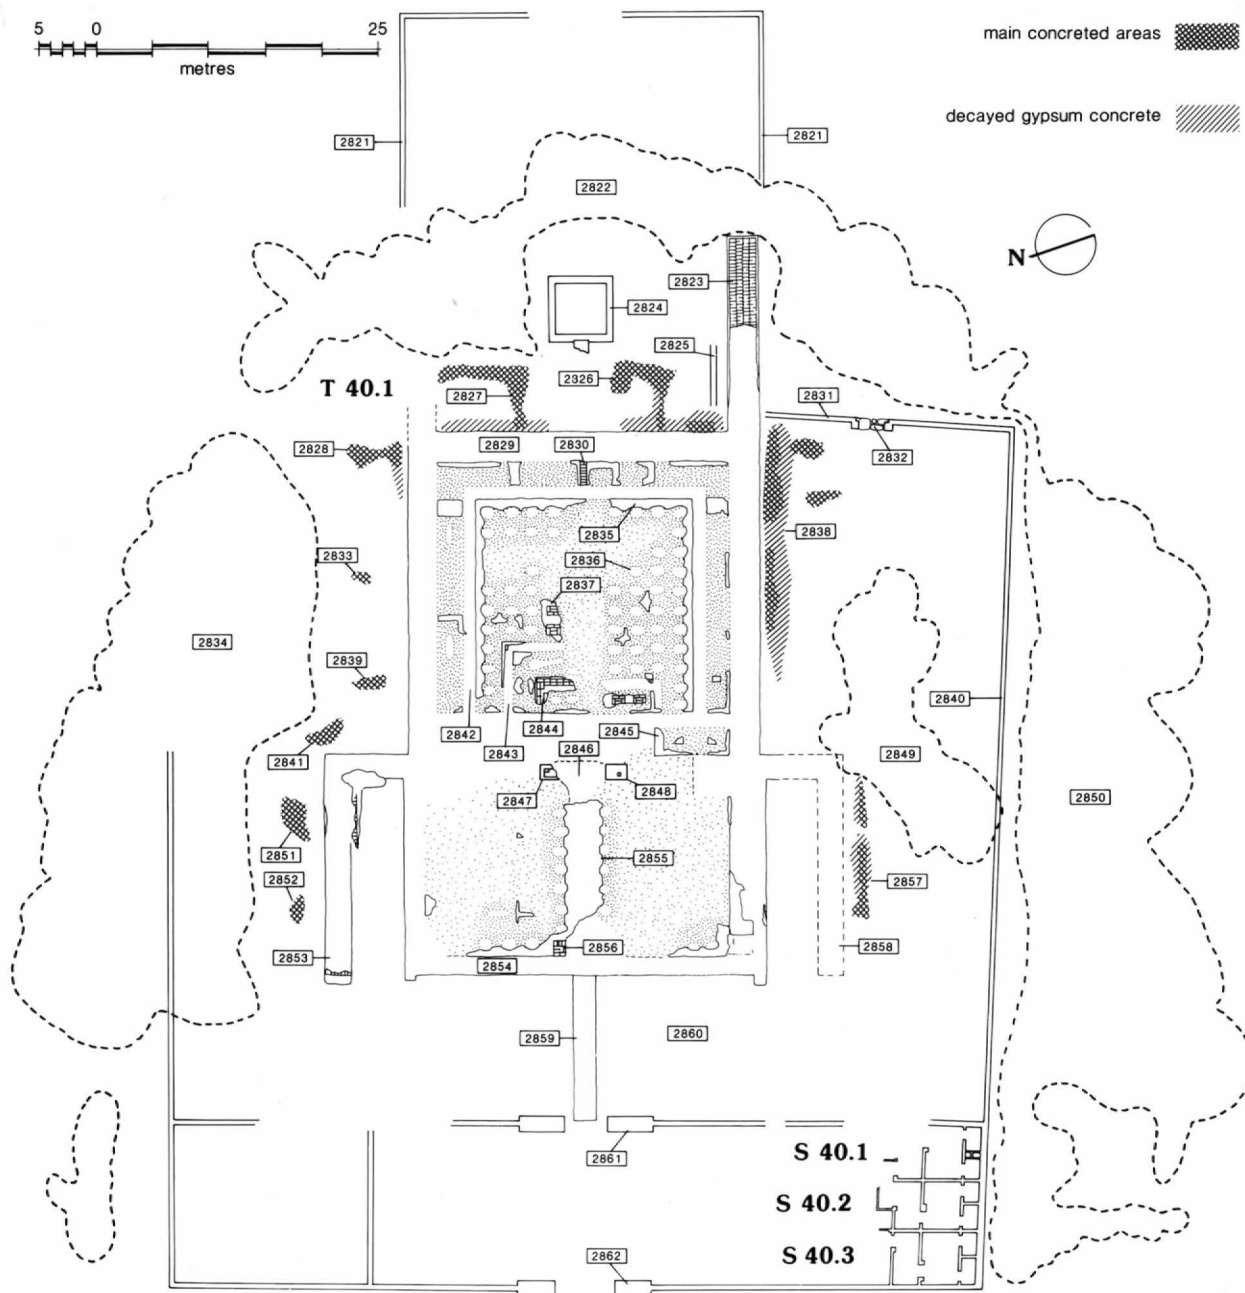
Figure 8.1. Plan of the Sanctuary of the Great Aten Temple, after Lavers, with additions and corrections from the 1986 Amarna Survey.

The Lavers' plan shows the remains of foundations from a stone building lying within an enclosure of mud brick. Herein lies the first correction. Not all of the brick walls are necessarily contemporary with the stone building, nor are they quite so regularly aligned as they appear on Lavers' plan. Moreover, in the south-east corner the Lavers' plan does not express the

relationship correctly. Not only does the brick wall [2831] containing the doorway [2832] not follow the same alignment as the stone structure, the stone wall trench [2823] actually cuts through it showing that it is later. What effect this has on the overall interpretation of the Sanctuary's history is hard to assess without re-clearance. Lavers assumed that the wall fragment [2825] was part of the rear brick enclosure [2821], but this is not the case, and so the connection between the rear brick enclosure and the brick walls on the south [2831, 2840] is severed. Since these were also built on a different alignment we have to consider if, when the stone Sanctuary was erected, this part was demolished and removed from view. If this applied all the way along the network of brick walls it would also remove from this phase the two pairs of small brick

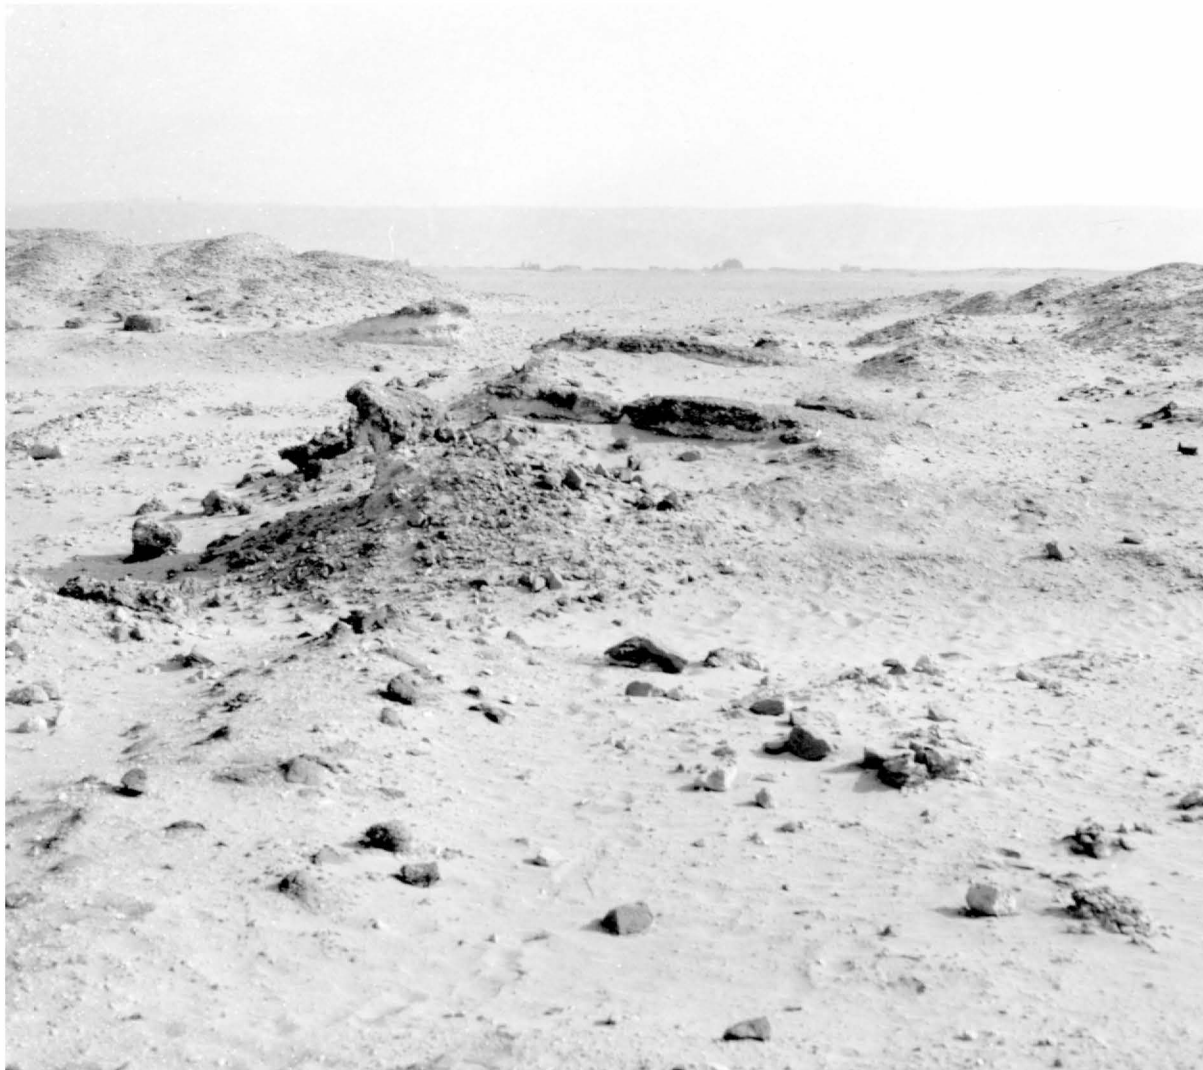
Figure 8.2. Remains of the embankment along the rear of the Sanctuary, looking north.

Much more important, however, is the omission from Lavers' plan of a conspicuous embankment of gypsum concrete which seems originally to have surrounded the Sanctuary on three sides. It is best preserved now on the south and east sides, running along the outer edge of the main outer foundation trench, and is well portrayed in some of the photographs of Pendlebury's excavations published in *COA III*: Plate XXVI.1, 2, and 4. Figures 8.2 to 8.5 show its present condition. On the plan, Figure 8.1, each main part is designated by a separate unit number. On the north side much less of it survives, but several definite patches with northward slope downwards can be identified, units [2828, 2833, 2839, 2841, 2851, 2852]. The last two run beside the trench of the north wing-wall [2853].

For several of the portions of embankment direct measurements can be given for its width, angle of slope and height above the ground outside the sanctuary proper. These are summarised in Table 8.1. In general we can say that the embankment was originally around one metre in height and six wide. Its inner faces run along the edges of the foundation trenches for the main Sanctuary wall [2829]. Since these have been almost totally robbed of their stonework in antiquity the effect is to make the embankment seem taller on this side than it really was. There is, in fact, a very clear stratigraphic break between the desert and rubble which marks the sides of the foundation trench and the almost white colouring of the embankment lying above. This shows up very clearly in the *COA III* photographs.

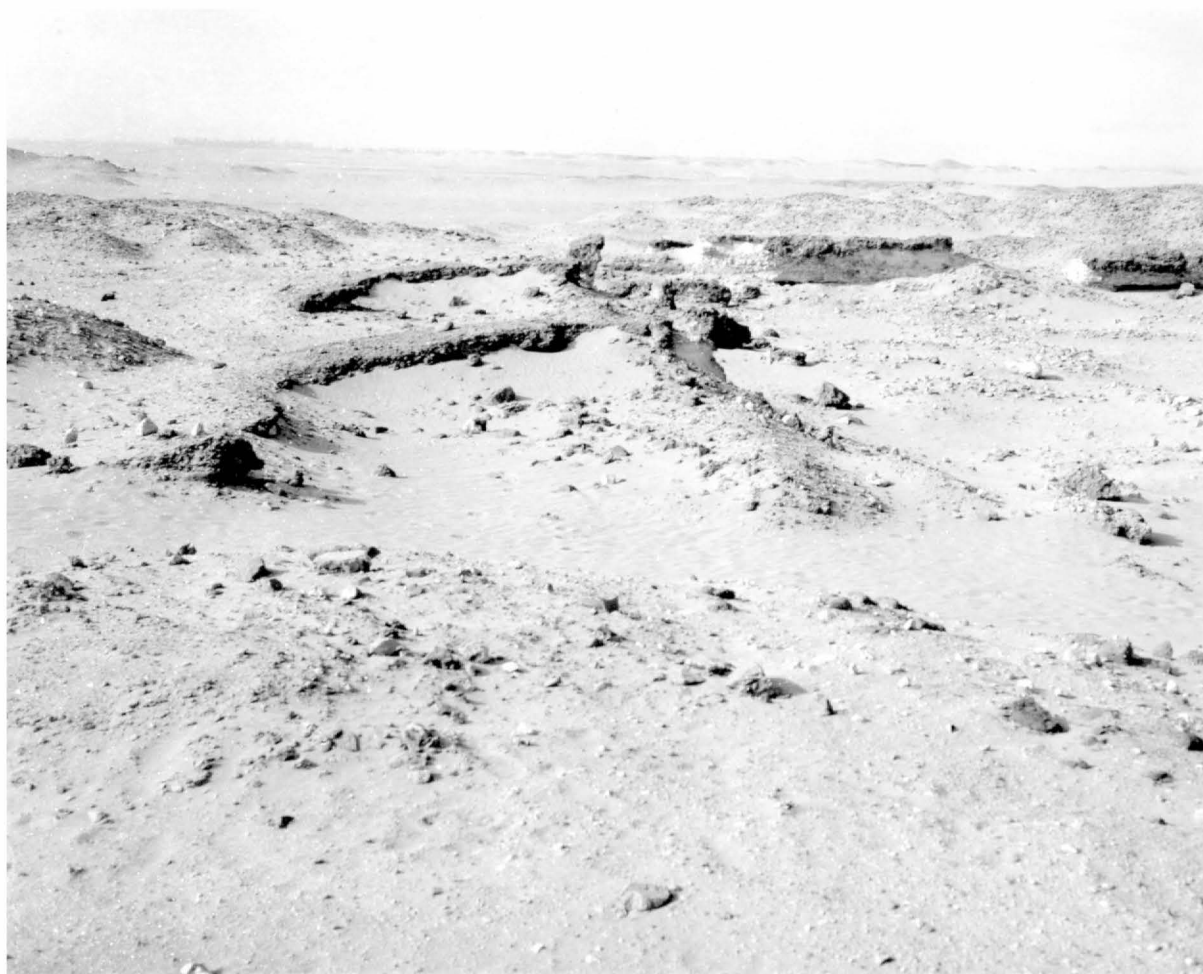
Figure 8.3. Remains of the embankment along the rear of the Sanctuary, looking south.

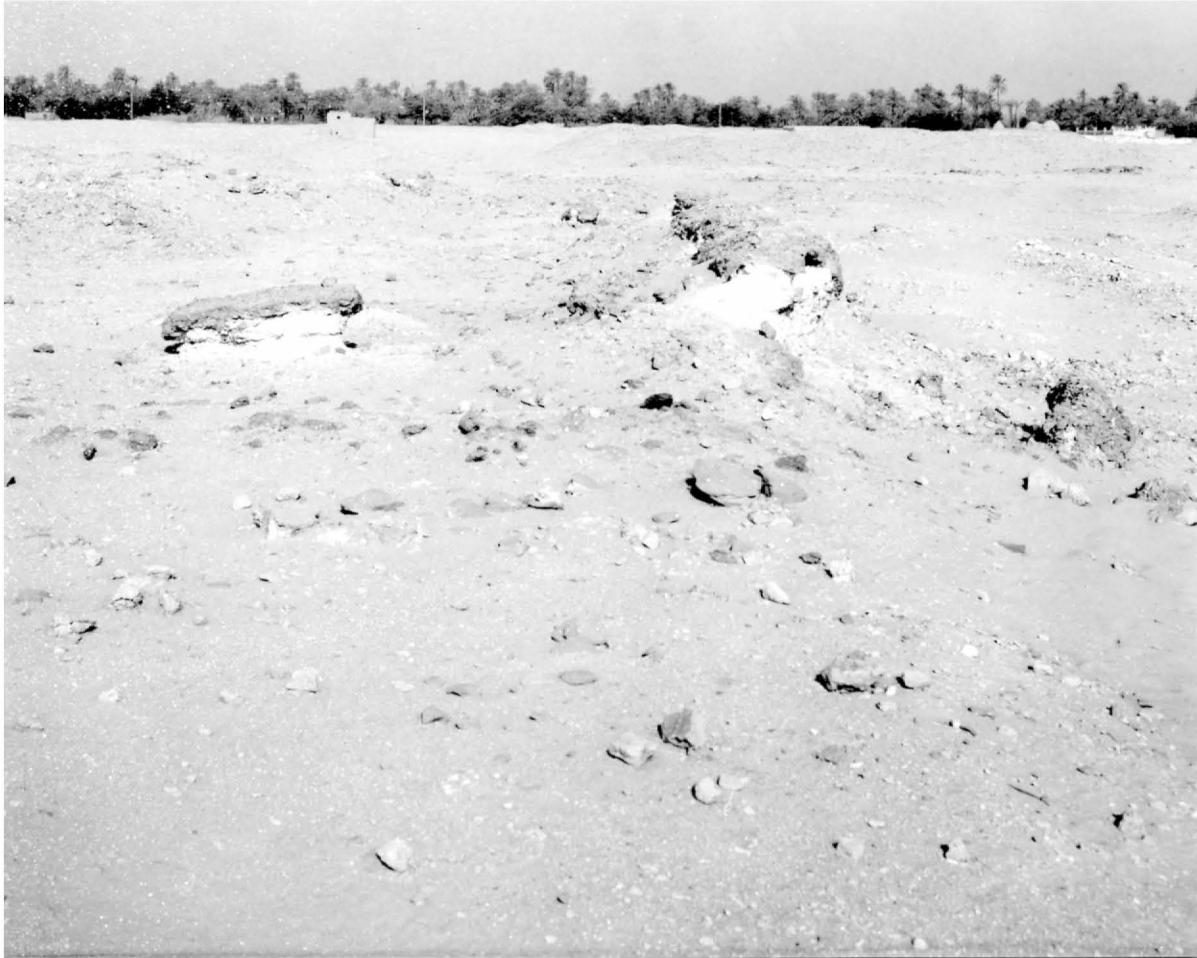
Figure 8.4. Remains of the embankment along the south side of the Sanctuary, looking west.

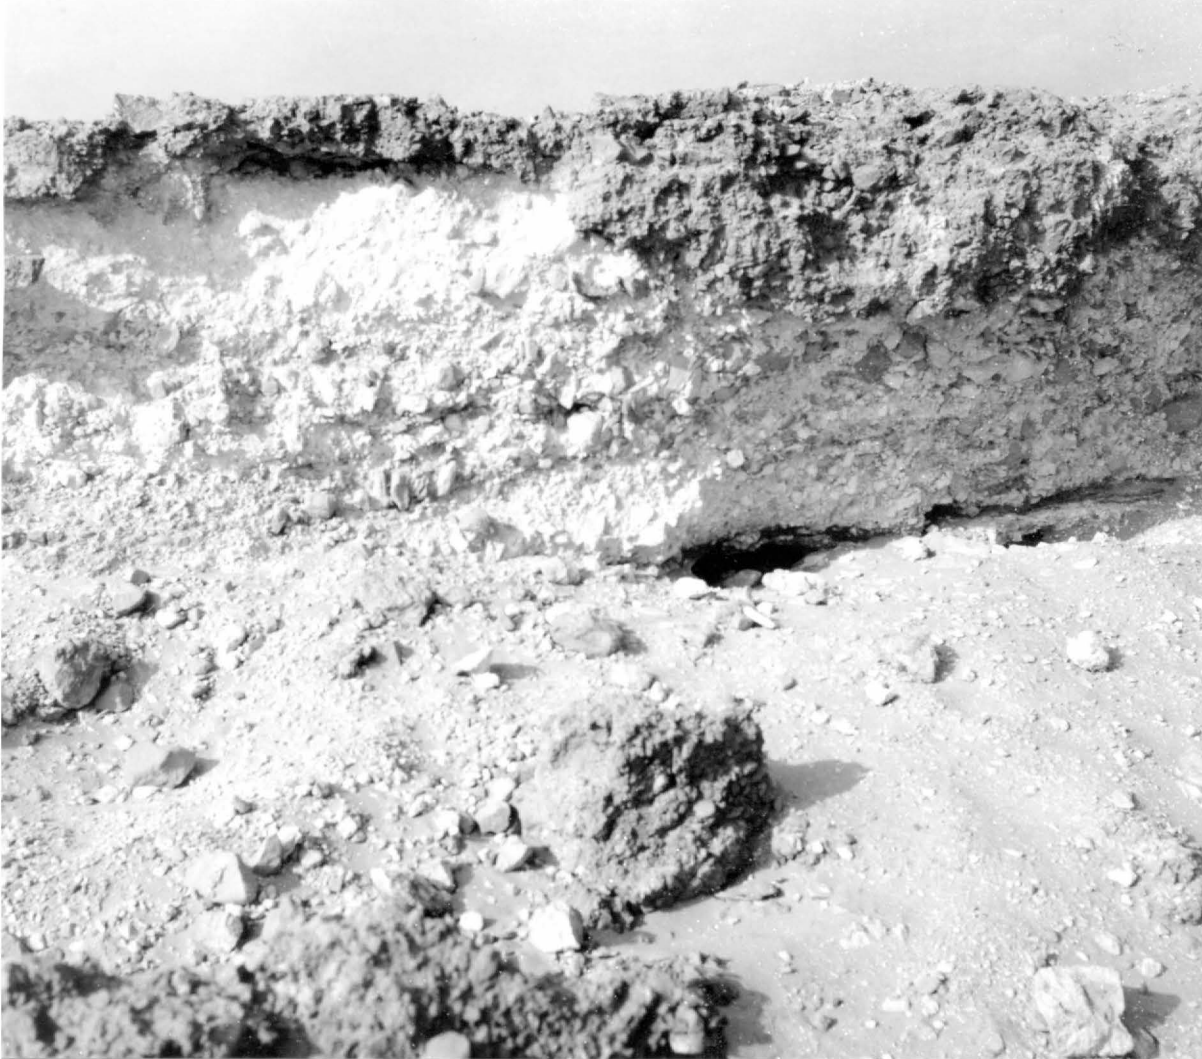
Figure 8.5. Detail of the embankment on the south side, showing the darkened weathering crust that has formed on the top of the gypsum concrete, and the horizontal division lower down between the base of the concrete and the top of the natural desert.

The material of the embankment is one that is very common on sites of stone buildings at Amarna: a concrete made from chips of limestone and some sandstone mixed with gypsum. Over a long period of time it weathers from white to brown, and exposed surfaces appear to take on an added hardness, so that the result is fairly durable. The embankment was perhaps mistaken in Pendlebury's time for rubble deriving from the destruction of the stonework of the Sanctuary, but if so this was wrong. Wherever portions are at all well preserved they display a constant and even slope downwards away from the walls of the Sanctuary, and, as the *COA III* photographs show, when viewed laterally it has an impressive evenness of thickness and disposition in relation to the underlying ground. It has to be accepted that it is part of the original building.

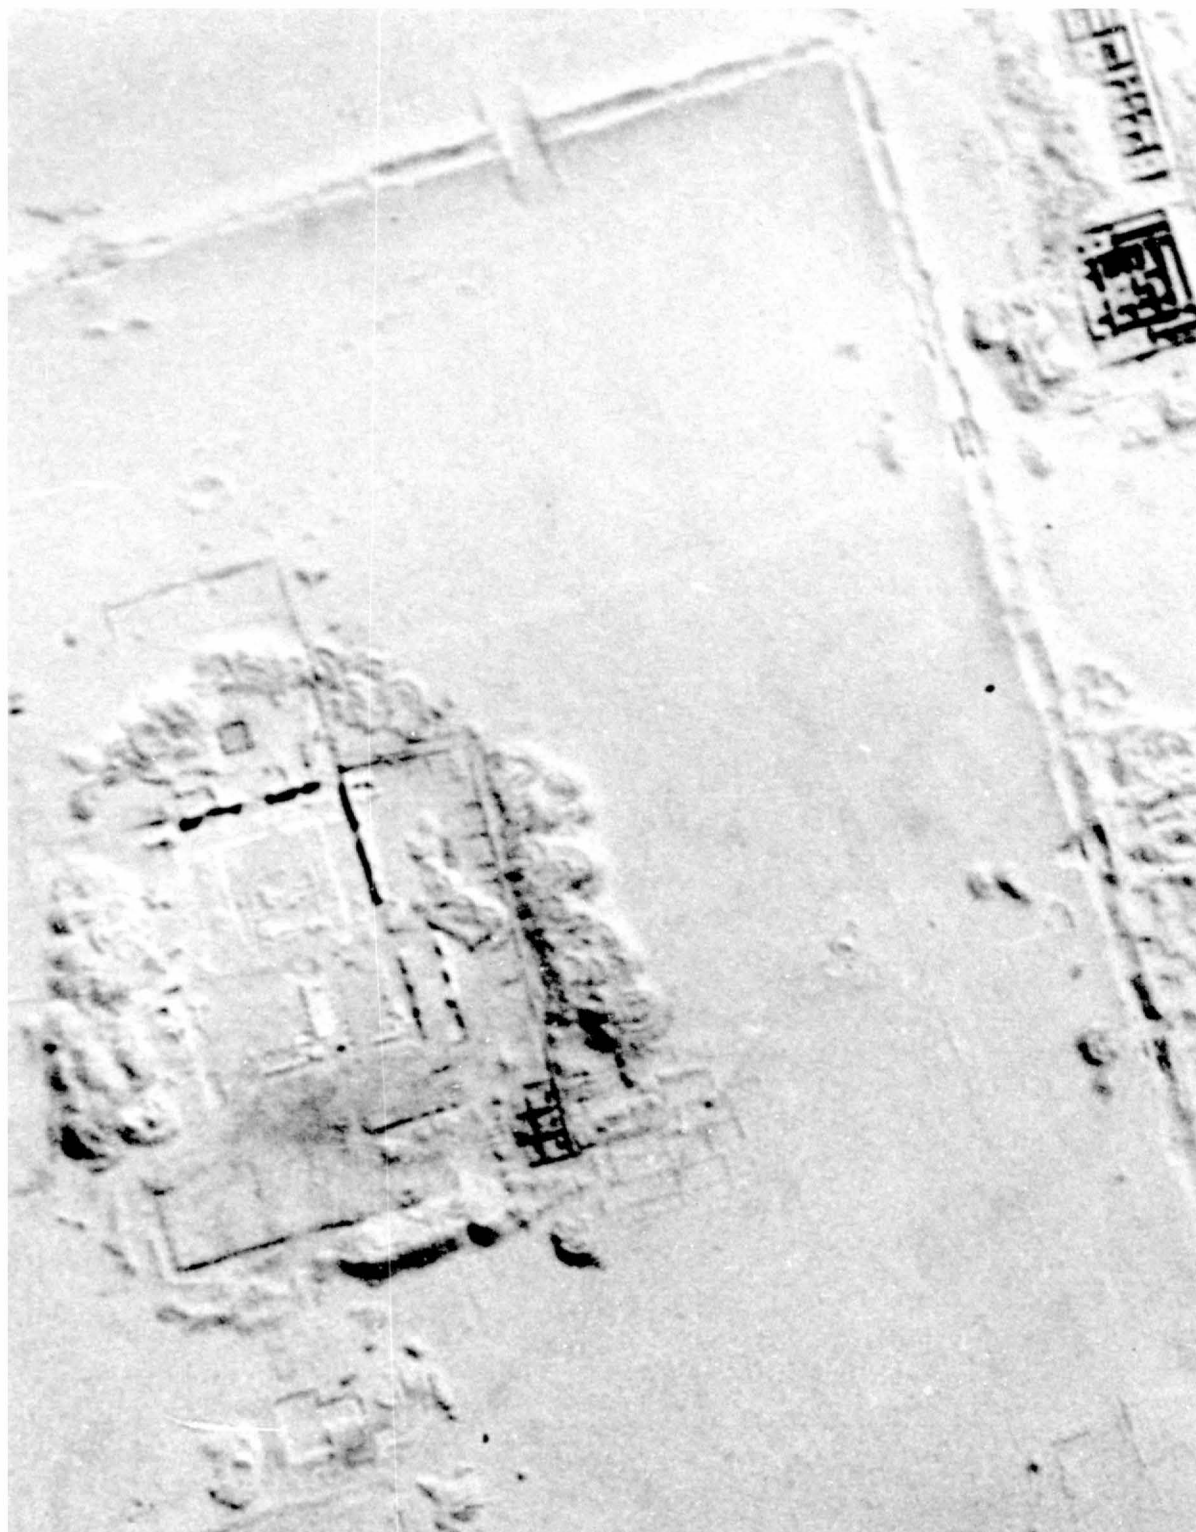
Figure 8.6. Aerial photograph of the Sanctuary of the Great Aten Temple taken in 1935 after the completion of Pendlebury's excavations in 1934.

The Sanctuary was excavated under Pendlebury's direction in 1933-4. The written account and illustrations, which include the plan of the remains made by Lavers, form part of *City of Akhenaten* III (5-10, Plates VII-IX, XXV-XXVI; also Pendlebury 1934: 129-133, Plates XIV-XVI). Pendlebury stripped off the loose covering of rubble to expose the lowest level of foundations, and these have since been reduced by weathering. Nevertheless, one major feature survives which has passed without comment, despite the fact that it is the most conspicuous one of all. This omission was first noticed during the first phase of the Amarna Survey in 1978. With the second phase now covering the same ground the opportunity was taken to look again at the Sanctuary and to add to a copy of Lavers' plan the necessary corrections and additions (Figure 8.1). These include a series of spot heights, related to one of the Amarna Survey's bench marks of 49.05 metres a.s.l. on the concrete base of the nearest electricity pylon (no. 68). Use was also made of a fine low-level aerial photograph taken in 1935, a small portion of which is reproduced here (Figure 8.6).

Petrie was the first archaeologist to work at the Sanctuary. He entrusted the task to Howard Carter, and the aim seems to have been simply to search for sculpture: "The site of the temple, or shrine, which was entirely excavated by Mr. Carter, is marked by heaps of broken pieces of mortar and stone; and the cores of the walls consisting of mortar and chips still remain to shew the position. Mr. Carter turned over nearly all of this without finding anything more than two or three blocks of the great stele" (Petrie 1894: 18). By the end of Pendlebury's work, whatever was left of the concrete foundations, except the embankment, had been removed. There is, however, a possible discrepancy in the history of the site to be accounted for. An aerial photograph taken in 1922 shows the site of the Sanctuary as, presumably, Carter and Petrie had left it. The photograph is not as sharp as one would like, but one can see the site covered with a low mound of pale debris pitted with holes. There is, however, no sign of a dump to one side. This appearance is consistent with the "turning over" which Petrie mentions and which was a common practice of his. Pendlebury includes a photograph of the site before his excavations in *COA* III: Plate XXVI.1. It is taken from the rear, just east of the piece of concrete ramp labelled [2827] in Figure 8.1. It shows a thin cover of chippings, reduced to almost nothing on the south side where some of the plaster flooring is already visible. On the left of the picture the line of the embankment on the south side appears. Furthermore, behind the photographer there must have been a tall heap of debris which is casting a long shadow. This is the dump which Pendlebury ascribed to Petrie and which is marked as such on Lavers' plan.<sup>5</sup> These features are not evident on the 1922 photograph, which, in particular, reveals no trace of "Petrie's dump". One cannot be absolutely certain, but there must be a strong suspicion that between 1922 and 1933 the Sanctuary was illicitly dug in a very thorough manner. Pendlebury himself noted recent interest on the part of the villagers of el-Till: "A feature of the site used to be the quantity of cut and carved stone on the south side. This was removed by the villagers in the summer of 1933. From a previous, admittedly superficial, examination, however, nothing of importance has disappeared" (*ibid.*, 6, note 2; cf. Pendlebury 1934: 129, note 1; 133). The villagers's removal of pieces may have extended to an excavation which threw up an extensive spoil heap on east and north. Even so, Pendlebury's pre-dig photograph seems to show a patch of the gypsum concrete platform, towards the right of the picture, well within the confines of the Sanctuary walls.

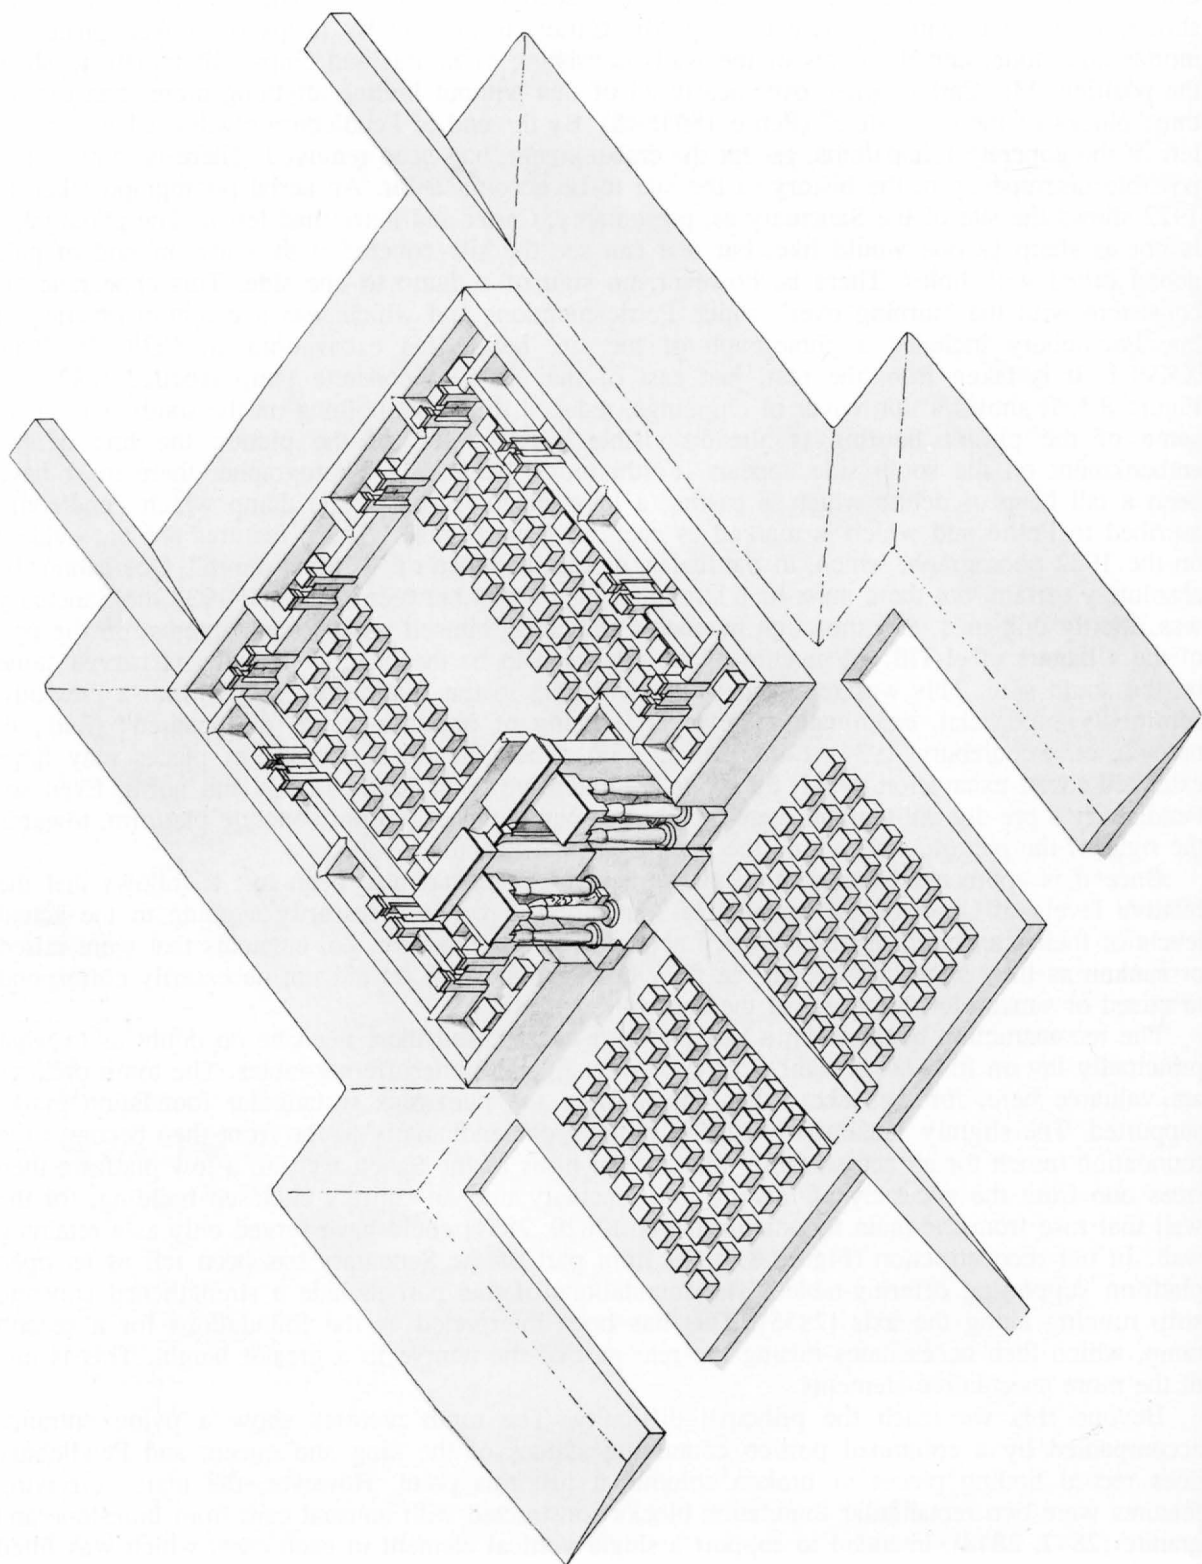
Figure 8.7. Reconstruction of the Sanctuary of the Great Aten Temple (original by B. Kemp).

The reconstruction begins with a low platform overall, and there need be no doubt as to what principally lay on it: a large number of small rectangular stone offering-tables. The tomb pictures are valuable here, for they show that this is what the numerous rectangular foundation marks supported. The slightly sunken strip [2859] running perpendicularly to the front then becomes the foundation trench for an access ramp. Making the basis of the Sanctuary into a low platform then frees one from the necessity of making the Sanctuary into an entirely enclosed building, for the wall that rose from the main foundation trench [2829, 2854] could have served only as a retaining wall. In our reconstruction (Figure 8.7) the front part of the Sanctuary has been left as an open platform supporting offering-tables. The foundations of this part include a strengthened concrete strip running along the axis [2855]. This has been interpreted as the foundations for a second ramp, which then necessitates raising the rear part of the temple to a greater height. This is one of the more speculative elements.

The correctness or otherwise of some of the elements in the reconstruction of Figure 8.7 is probably not very important. The overall design, however, becomes part of the basic material by which we form our impressions of Akhenaten's style of rule. In the Lavers' reconstruction, although the temples were open to the sky, they retained the traditional atmosphere of seclusion by being entirely surrounded by high walls which would, for most of the day, have kept the interiors in shadow. In the new reconstruction a good part of the temple is entirely open, and elevated, making the king's entry into an extension of the semi-public drama of the king's progress that seems to underlie the tomb pictures. If we keep the walls of the rear part reasonably low we also remove the principal source of internal shadow and make the whole more fitting to the worship of the sun's disk. It would also better convey the air of openness to view which the tomb pictures suggest.
