**CHAPTER 4**  
**THE SOUTH PYLON**

by  
**Susan Cole**

## Kom el-Nana excavations

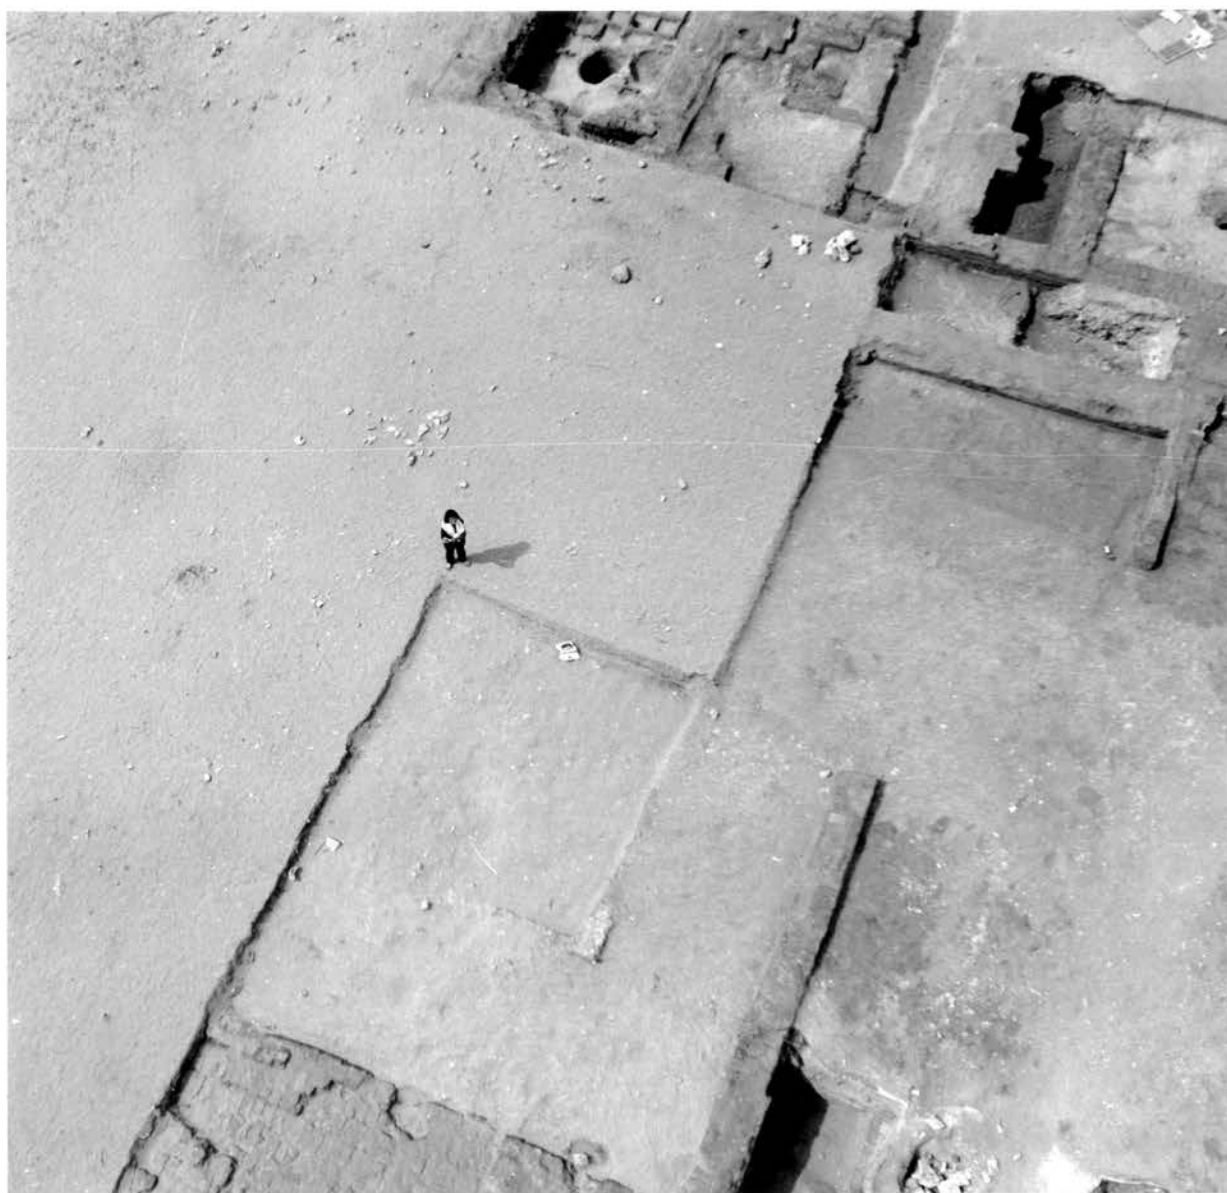
**Figure 4.1.** Aerial photograph showing (in the bottom part) the north-west corner of the South Pylon, the western wing wall of the north ramp leading up to it, and (in the upper part) the South House.

Along the southern edge of Kom el-Nana a low ridge runs intermittently which, even before excavation began, could be recognised as the line of an enclosure wall. Opposite the site of the Central Platform its line was interrupted by two features: a patch of stone and gypsum chippings, and, immediately to the east, a tall, steep-sided mound apparently composed largely of mud-brick rubble. As part of the investigation of the ceremonial area a grid of five-metre squares was laid out to cross the line of the enclosure wall in continuation of those south of the Central Platform. By the end of the season a block of nine five-metre squares had been excavated in this part: AA10–12, AB10–12, and AC10–12. They joined up with excavation squares in which lay the South House (Figure 4.1).

The western wing wall for the northern ramp [6208] was excavated along its complete length of 7.25 m (Figure 4.1). It had a width of 60–65 cm, and along part of its eastern face still bore its original surface of mud plaster coated with white, which continued very patchily on to the adjacent mud floor [6203]. The mud floor [6203] to the west of this wall had an average

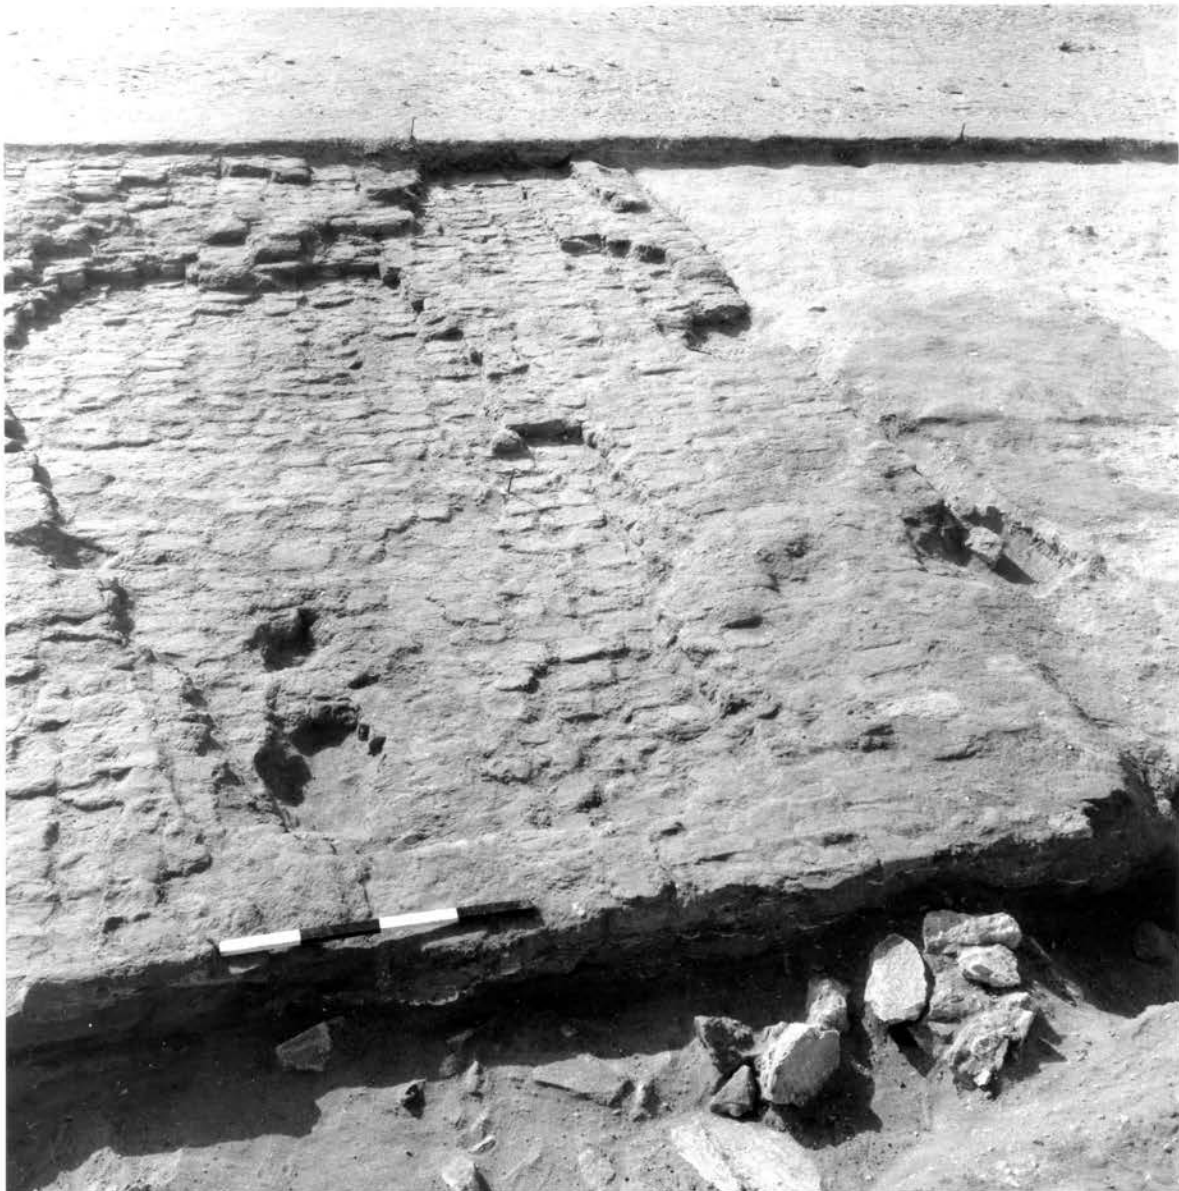
**Figure 4.2.** Western tower of the South Pylon, viewed to the north-west. In the foreground lie pieces of broken gypsum-concrete foundation platform brought to the surface by modern pitting. The exploratory trench was subsequently dug along this line.

Across the western half of the excavation the removal of a superficial deposit of sand [6151] followed by decayed brick rubble ([6157], [6159]) revealed the base of a pylon tower built of mud brick [6170] (Figures 3.1, 4.2). How far it extends to the west is not yet known, but in width it was 6 m, making it a structure of monumental scale (the pylon widths at the Small Aten Temple are: 8.40, 6.40, and 6.80 m). The brickwork survived to a very modest height above the ancient ground level inside the enclosure, being virtually flush with it in some places. Very little rubble surrounded it, too, yet the dimensions of the pylon base imply that it rose to a height of many metres. The lack of a greater quantity of rubble and the absence of more brickwork *in situ* can only be explained by substantial removal of bricks in later times, as happened with the second and third pylons at the Small Aten Temple. The foundations are very deep, however. This was exposed towards the end of the season in the trench dug along the east face of the pylon (see section 4.4 below) which eventually exposed 1.15 m of brickwork, most of which lay below the ancient ground level.

The excavation of the trench began with the removal of the filling of several pits which had been dug in probably fairly recent times (Figure 4.2). What was left — the bulk of the debris over the area of the trench — was material which had been sealed beneath the trampled surface [6168]/[6355], thus a record of what had accumulated prior to late Roman times. As the excavation proceeded many pieces of broken gypsum-concrete floor and fragments of limestone were recovered, until, over most of the area, the surface of the *gebel* lay exposed. This established, really for the first time in terms of unambiguous stratigraphy, that the destruction meted out to the gypsum-concrete foundation layers was ancient and not modern. The basic stratigraphic sequence is recorded in the right-hand part of a section drawn of the northern half of the east face of the trench (Figure 4.4). Below the trampled mud surface is half a metre or more of dusty sand devoid of bedding planes but containing numerous nodules of gypsum plaster with brown weathered surfaces. Below this is a dense layer of limestone and concrete lumps and fragments which lies on a layer, 25–50 cm deep, of unbedded coarse sand and gravel which rests in turn on *gebel*. Why there should be so much sand and gravel beneath the wreckage of the foundation layer is not clear, for one might have expected the destruction to have left the broken pieces very close to their original level; more evidence may yet be forthcoming from the large area of fill within the pylon entrance which remains unexcavated. The dusty layer above almost certainly represents the slow accumulation of debris blowing and trickling into the pit, which was left open following the removal of the stone platform within the gateway and the ensuing destruction of the foundation layer.

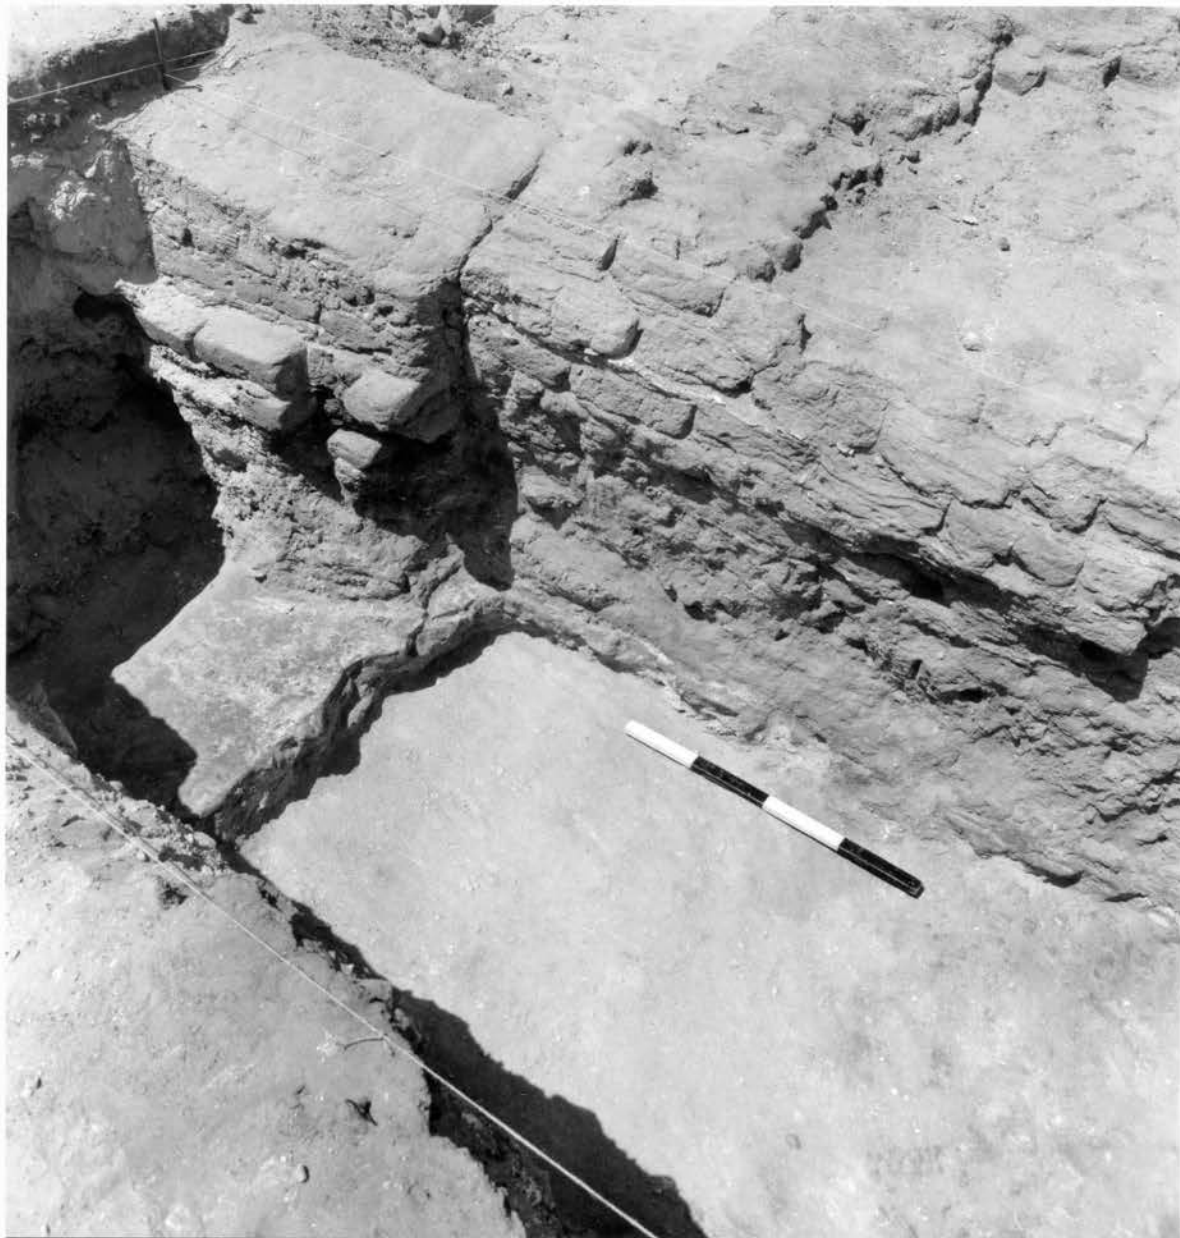
**Figure 4.3.** Southern end of the trench in the pylon gateway, viewed to the south-west

More of the history of decay, as well as of details of the original construction, can be seen in the west face of the trench, which is, for the most part, occupied by the elevation of the side of the brick pylon (Figures 4.3 and 4.4). The concrete foundation platform had been laid down in a pit which was probably about 35 cm deep, if we take as the original desert surface the mud-

The short section of the south wing wall [6354] exposed in the excavation (Figure 4.3) shows roughly laid brickwork which juts out beyond the true line of the wall rising to a higher level than is the case with the north wing wall, probably a sign that the dumping of the fill between the wing walls on this side proceeded simultaneously with the building of them.

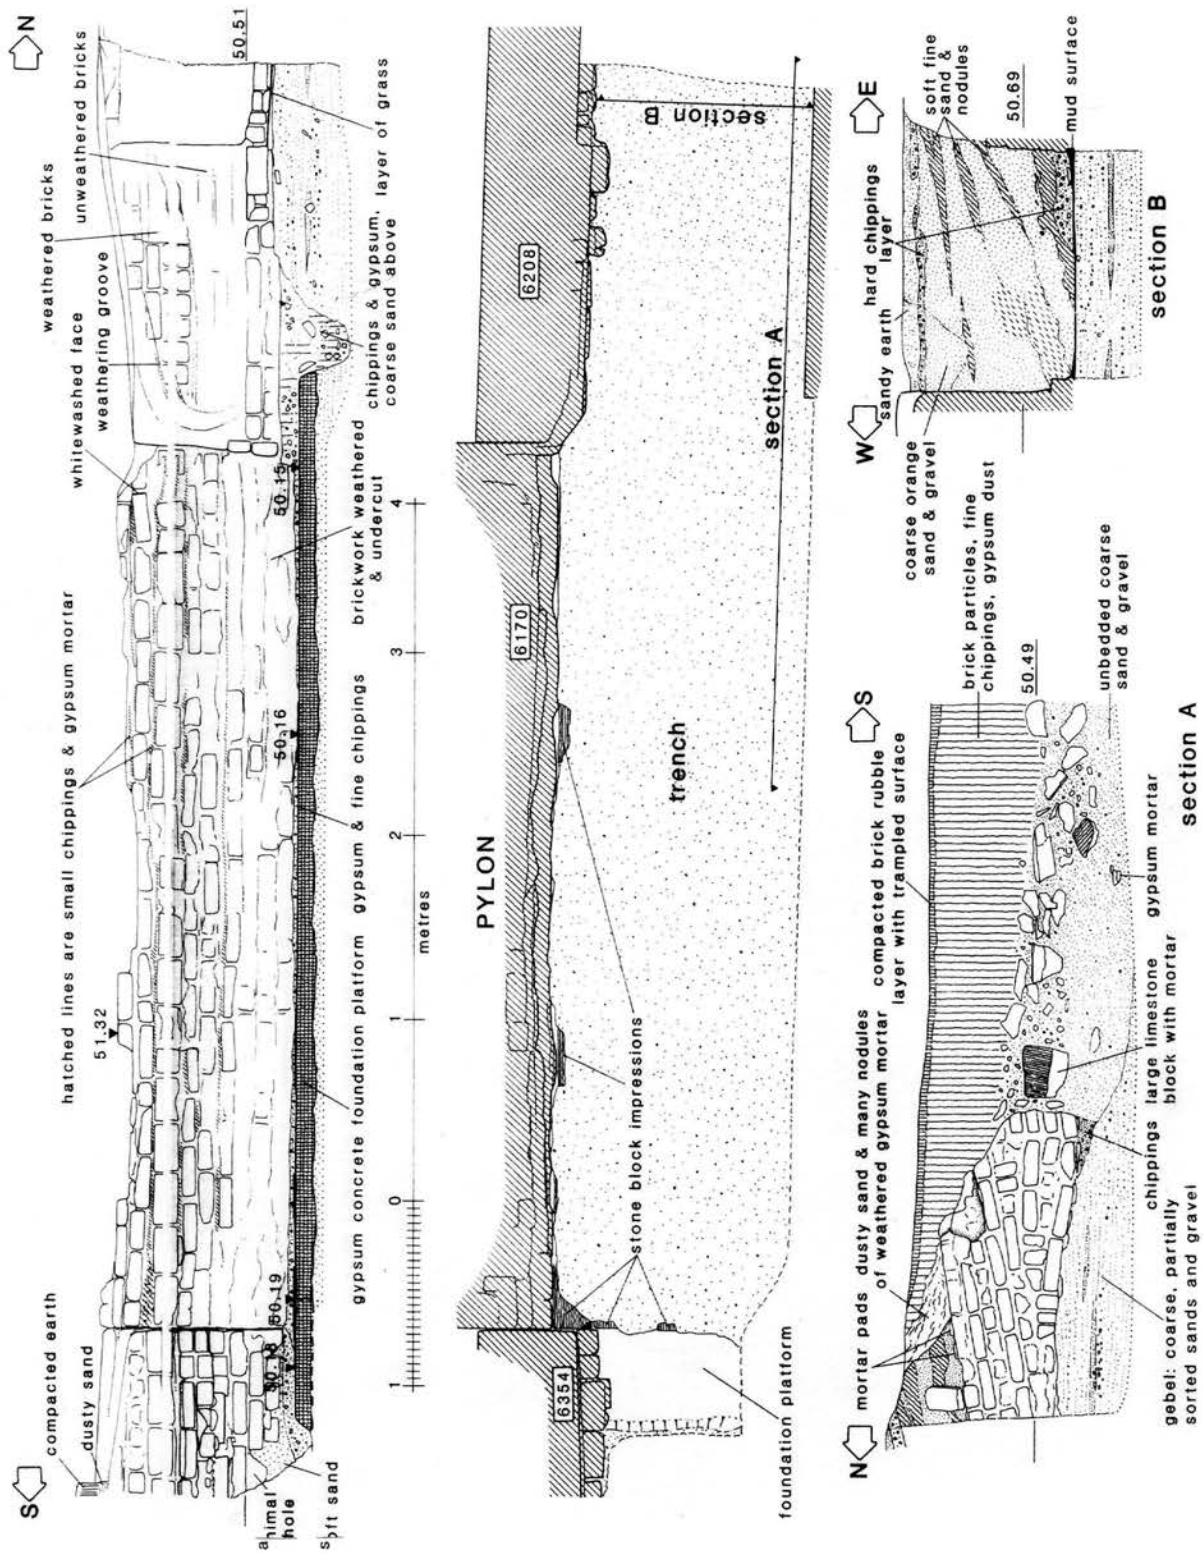
Figure 4.4. Elevation, plan, and sections of the trench in the pylon gateway.

The northern ramp possessed a substructure. This has so far only been revealed in the side of the trench dug along the east side of the pylon tower (see the next section), and is in the form of a brick wall with sloping top which was intended to remain completely buried and unseen (Figures 4.4 and 4.5). In its final stage the top surface of the ramp lay about 55 cm above the top

At the end of the season a north-south trench of a nominal 1.5 m width was excavated along the side of the south pylon tower, down as far as the natural *gebel* (Figure 4.4). On the east side (Figure 4.5) the level from which the trench was started was the trampled mud surface [6168]/[6355] which underlay the collapsed brickwork mixed with late Roman pottery and which may well have been the ground level of the late Roman period (see section 4.5 below); whilst on the north the top of the trench was the top of the surviving Amama Period fill which was here sloping upwards slightly as part of the ramp as it approached the gateway through the pylon.

covered surface which runs from the base of the brick pylon wings and is clearly visible in the north section (Figure 4.4). The brickwork of the pylon tower [6170] was built afterwards and overlapped it slightly so that, although the later destruction was very thorough, the very edge was continuously preserved beneath the pylon brickwork, whilst at the south end a strip which represents the southern edge of the platform was left intact and runs the width of the trench. Most of the upper surface of this strip is smooth and blank, having lain outside the area covered with limestone blocks. That limestone blocks had filled most of the gateway between the pylon towers is evident from two observations. One is of patches which represent the edge of a bed of gypsum mortar into which the lowest layer of blocks was set: the outlines of the edges of individual blocks have been preserved in several places and imply a more or less complete coverage of the gateway floor. The second observation is of many places on the face of the brickwork of the pylon itself where small limestone chippings and gypsum mortar have become mixed with the

The size of the bricks is the same as that commonly used on the site in the Amarna Period. As already noted, however, the wall had collapsed on to a layer of sand rich in late-Roman sherds which in turn lay over a surface of hard-packed mud which, as the stratigraphy exposed in the trench reveals (Figure 4.4), had formed long after the destruction of the pylon gateway. Excavation of the ground to the east should clarify what has happened here, but for the present one can surmise that the steep mound, which seems to be composed of loose brick rubble, is the remains of the fill of a platform constructed in late Roman times and retained by walls built from bricks taken from the adjacent Amarna Period constructions. The packed mud surface [6168]/[6355] is a contemporary late-Roman floor. If much of the line of the pylon and enclosure wall had survived into late-Roman times, perhaps as a ridge of rubble, the space between the pylons could have still been utilised as a gateway.

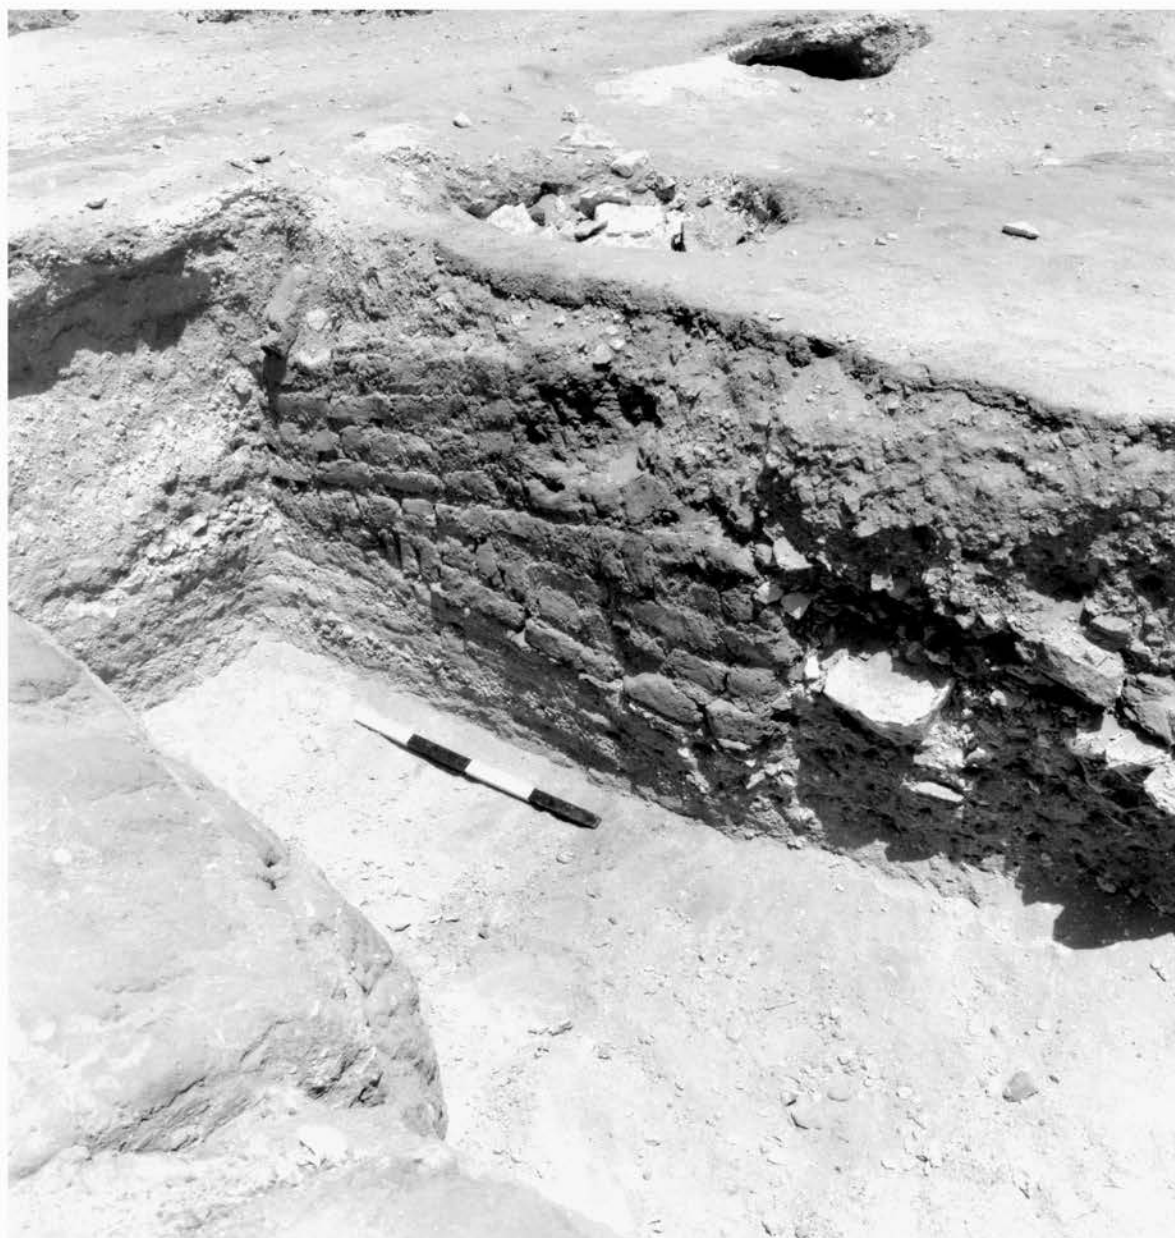
**Figure 4.5.** Northern end of the trench in the pylon gateway, viewed to the north-east. Behind the edge of the trench is a modern robbers' pit.

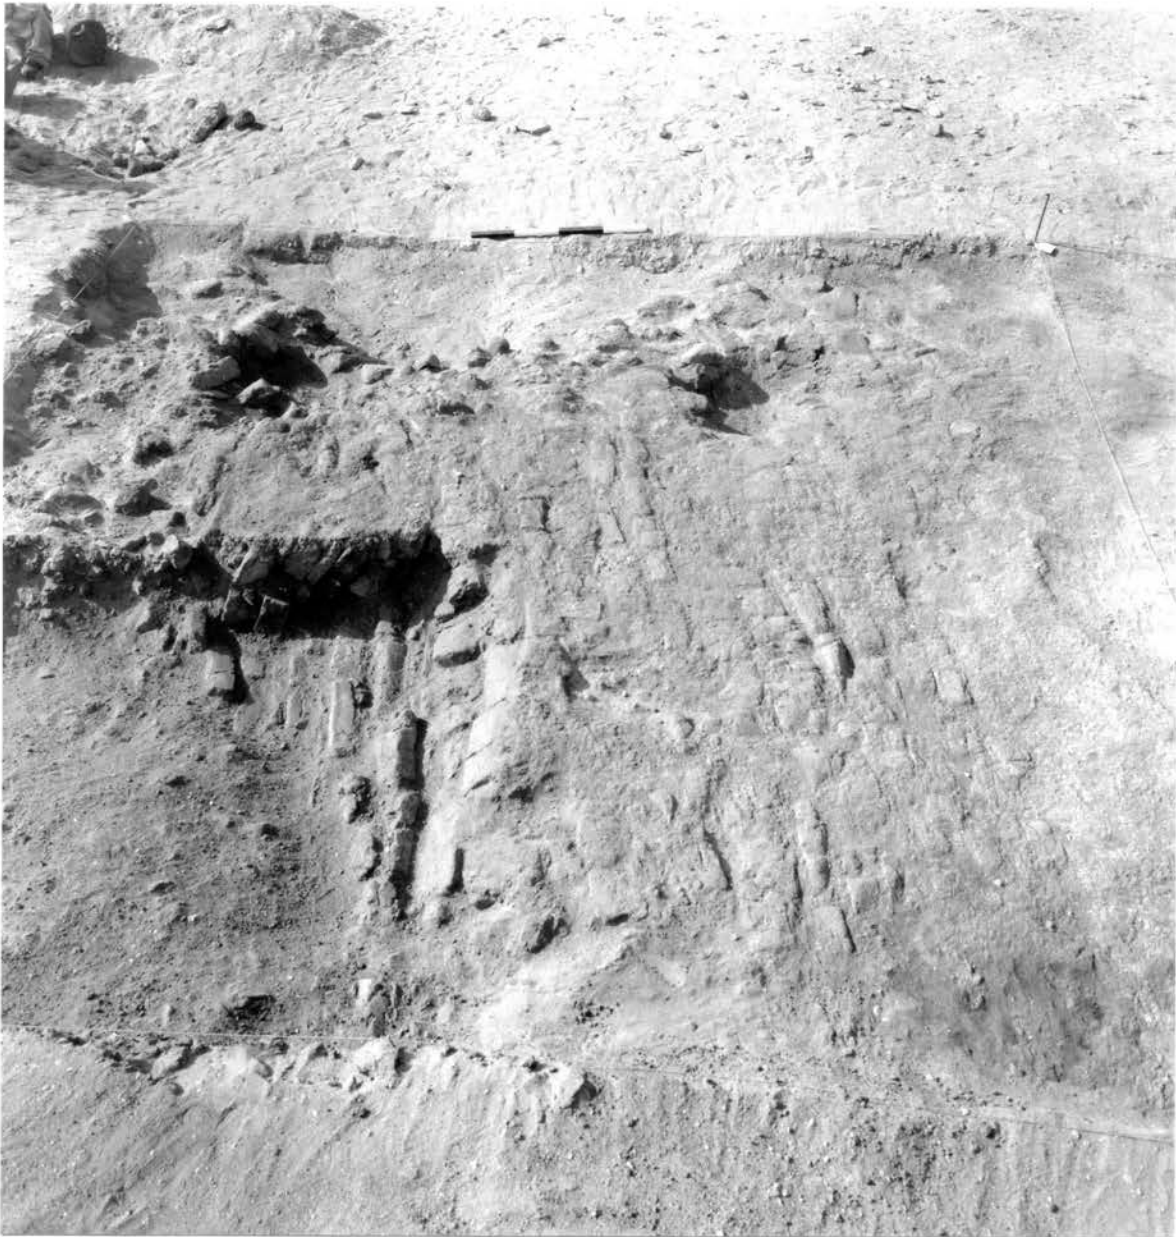
**Figure 4.6.** Surface of the collapsed wall in square AC10, viewed to the south. A small amount of brickwork has been removed to expose a section.

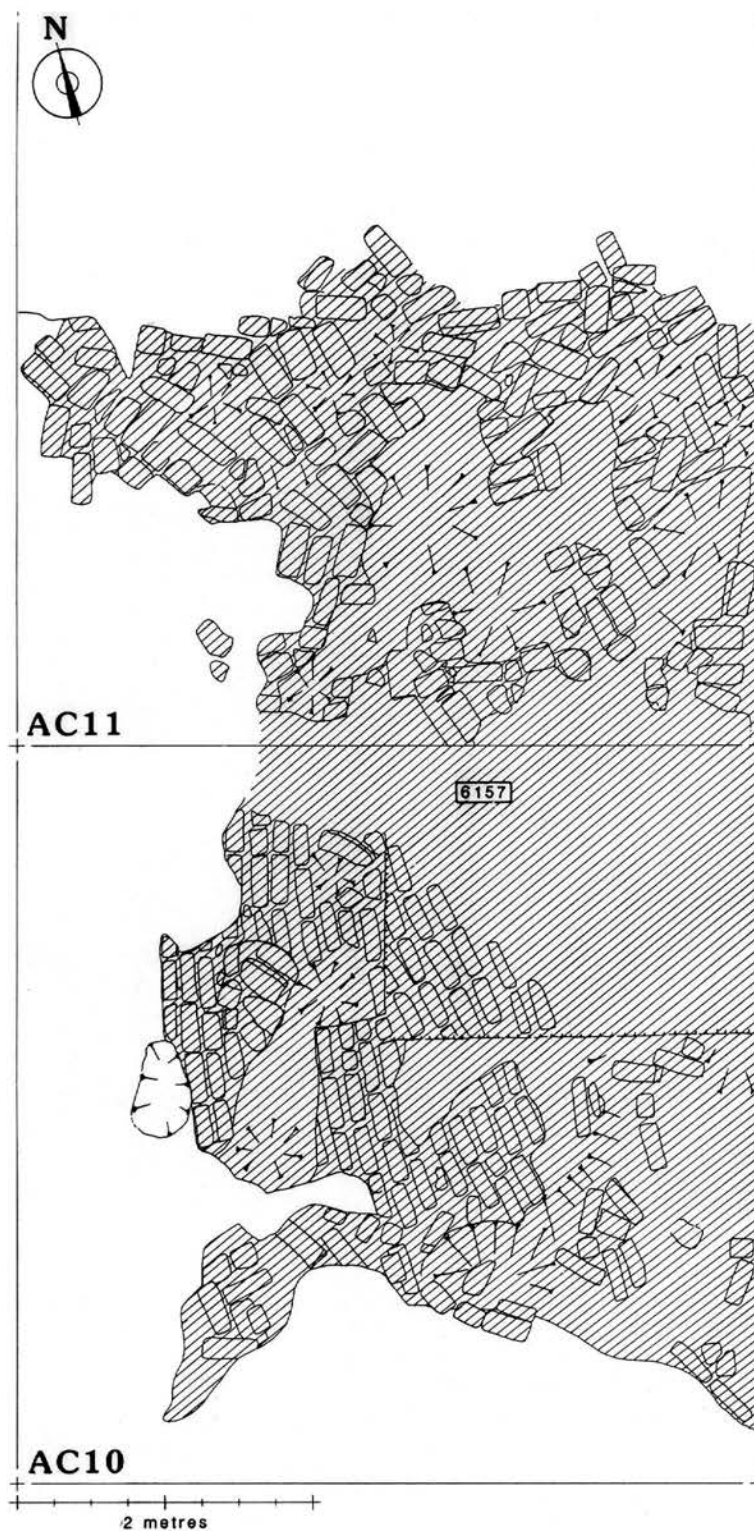
**Figure 4.7.** Plan of the collapsed wall in squares AC10 and AC11 (and see Figure 3.7). Originals by Susan Cole.
