CHAPTER 2

KOM EL-NANA: THE CENTRAL PLATFORM

2.1 Introduction

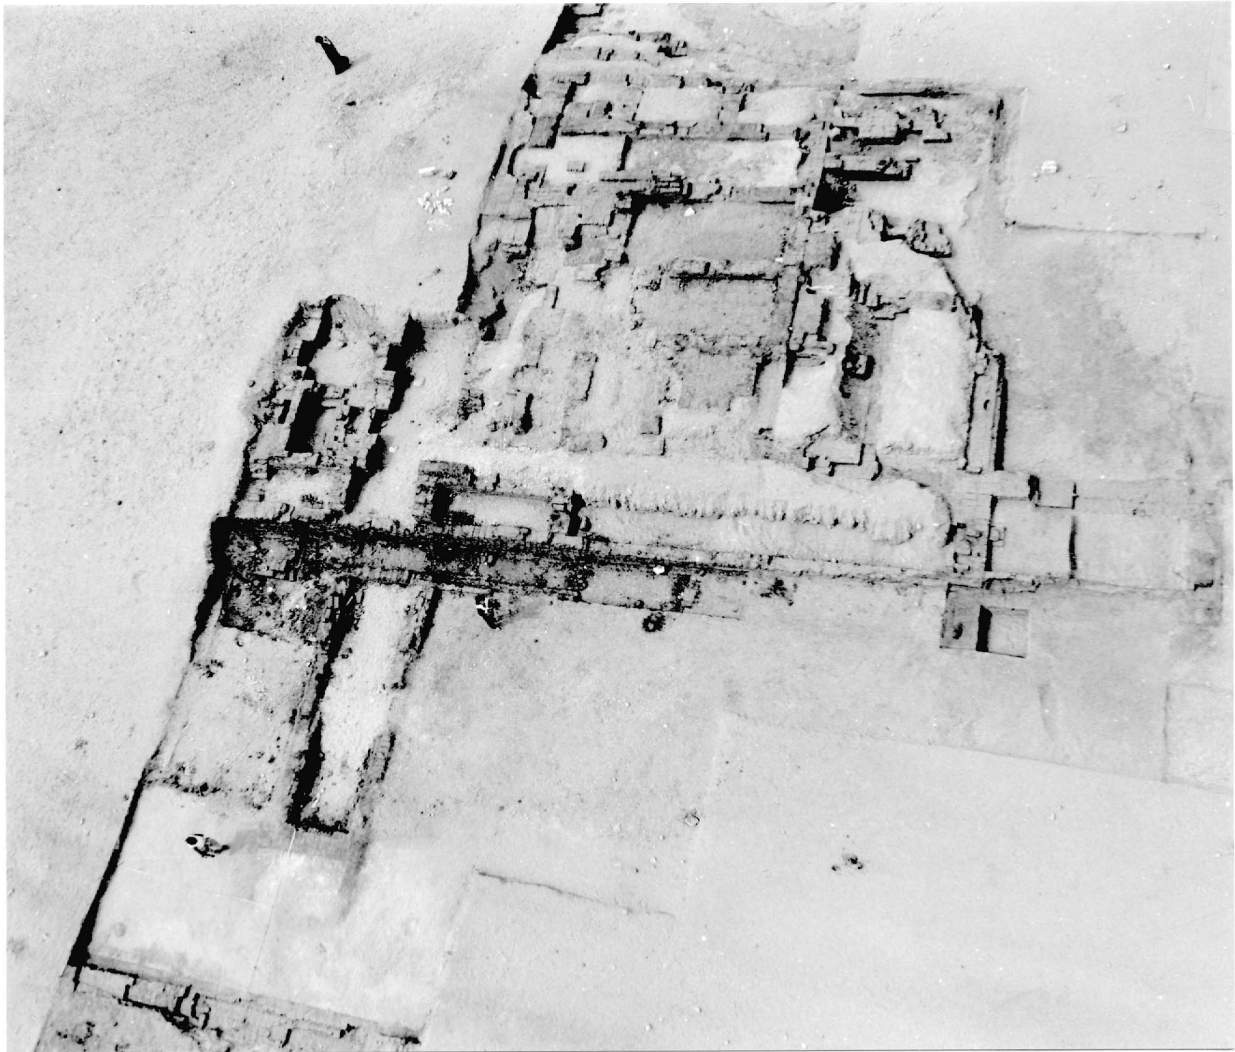
Figure 2.2. Aerial view of the Central Platform at the end of the 1990 excavations.

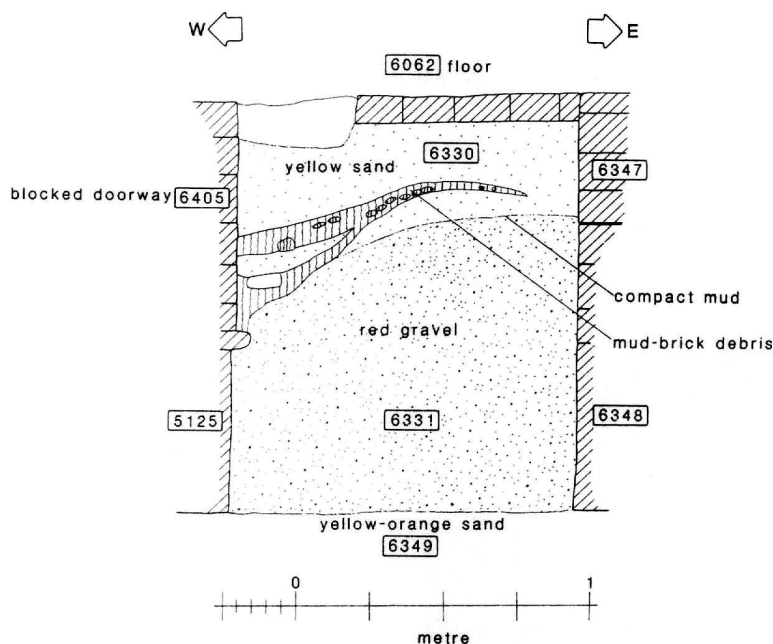
Figure 2.4. Section across brick floor [6062] and walls [5125] (left) and [6347/6348] (right). Original by W. Horton.

The east–west wall [5617] was robbed out to beneath the level of the brick floor [6062] to the south of it, which was one brick thick and overlay yellow sand (*tifla*) [6330]. Mud plaster remained standing on the south side of [5617] and below the level of the floor, implying that an earlier floor existed beneath. Floor [6062] comprised lines of bricks pointing north–south, except

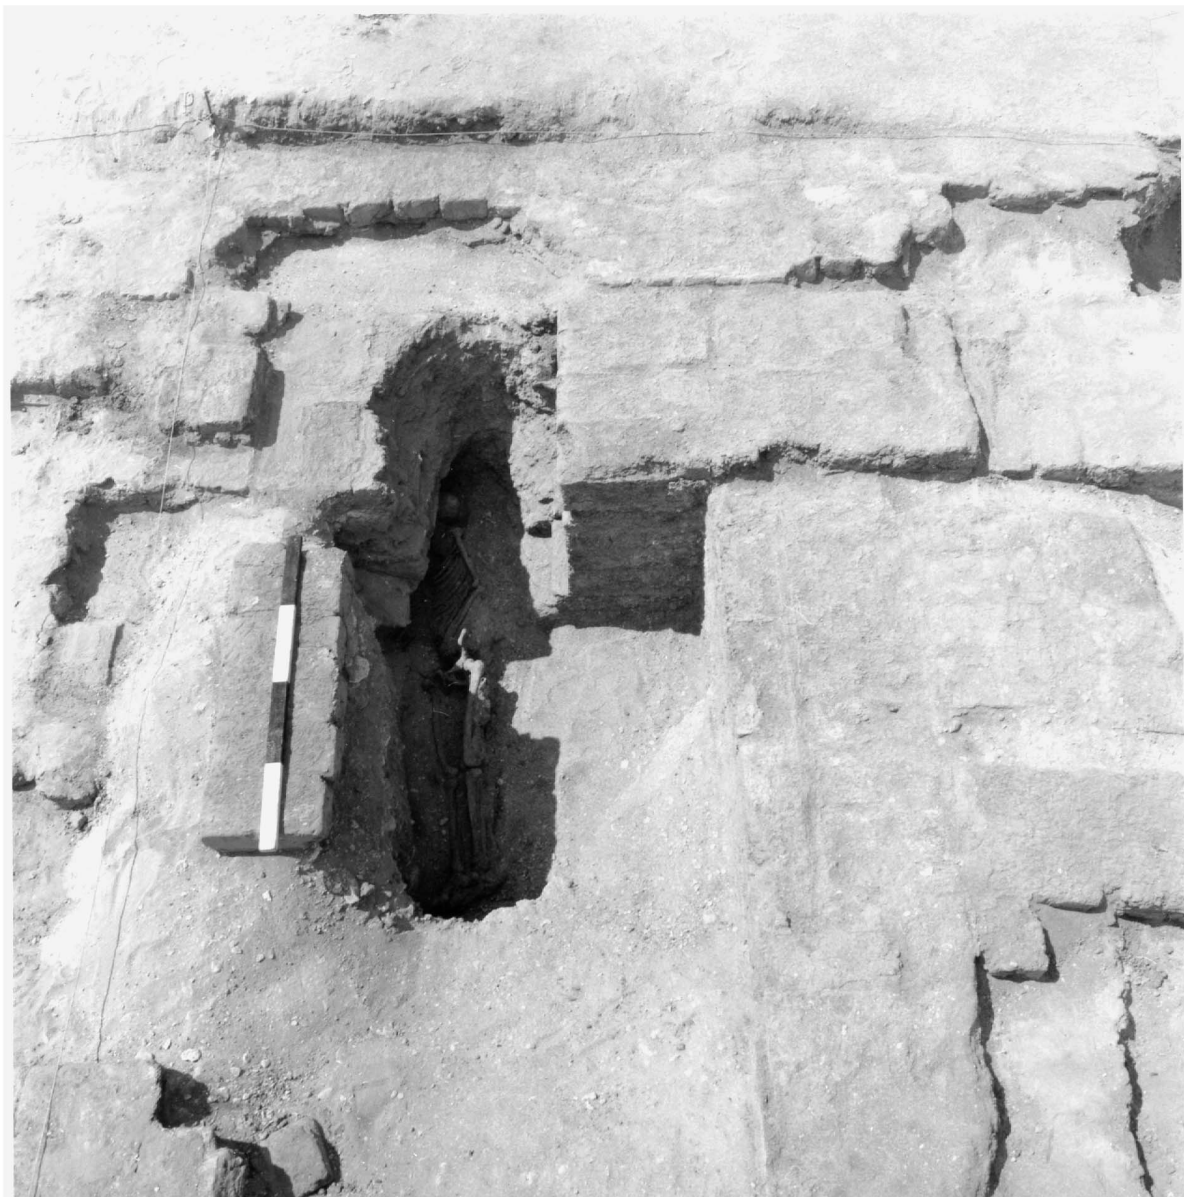
Figure 2.5. View, looking to the west, of the later grave cut into the platform in square AA22.

was excavated to reveal a burial which was very similar to that found last year in square AB21. Like the latter, the skeleton was in an extended position, orientated approximately east–west with the head at the west end and pointing to the south. The right foot crossed the left foot, and the hands and lower arms pointed upwards. The right side of the pelvis was 15 cm higher than the left side, and, like last year's body, it may have originally been interred on its right-hand side, then gradually slipped round. No hair remained on the body, but some skin survived which had been bound by cloth resulting in semi-mummification. The feet were particularly well-preserved, with toe-nails and flesh remaining. A preliminary analysis carried out by Dr. Rosemary Luff showed that this individual was a male, not as tall as last year's (c. 1.6 m), but the bones were heavy and it was definitely an adult, with all the molars erupted and generally well-preserved. The similarities between the two burials imply that they are of similar date.

The deep U-shaped and jagged cut [6083] in doorway-blocking [6422] and the wall below [5125] must represent the edge of the grave. The skull was found 0.9 m down from the top of the wall, under an overhang. The shape of the grave was very clear where it cut through the wall, but

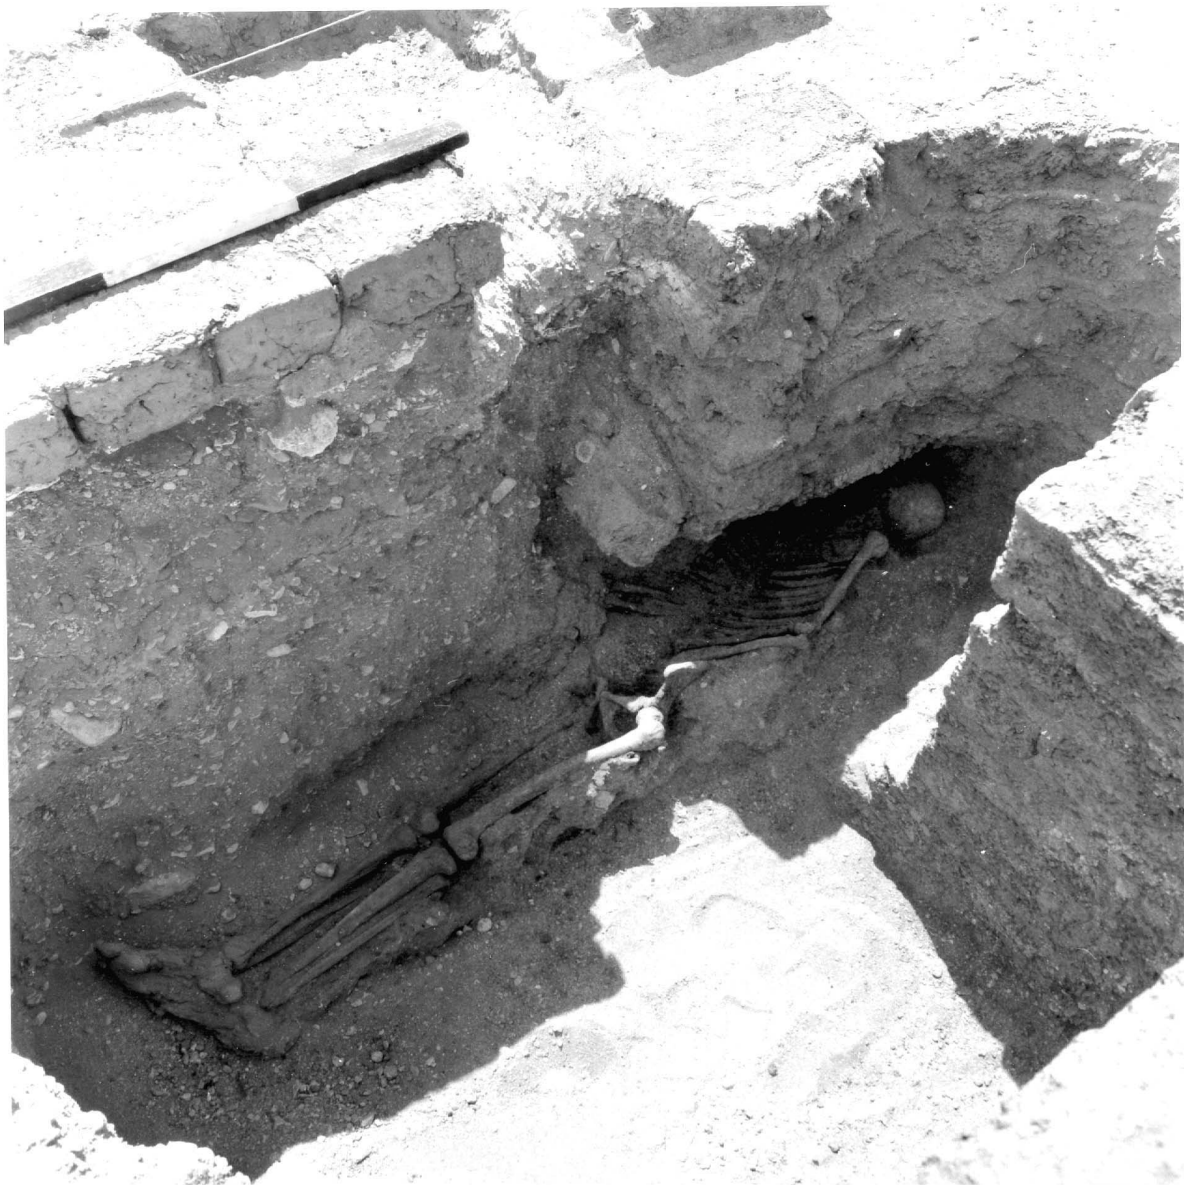
Figure 2.6. The burial in the grave in square AA22, view to the south-west.

elsewhere it had been dug into red gravel [6412] which was almost indistinguishable from the fill [6081] around the skeleton. Thus the outline was not very clear. The burial must post-date the original use of the platform, but seems to pre-date most of the collapse since it appears to have been cut from below the level of the collapse, the fill being almost pure gravel.

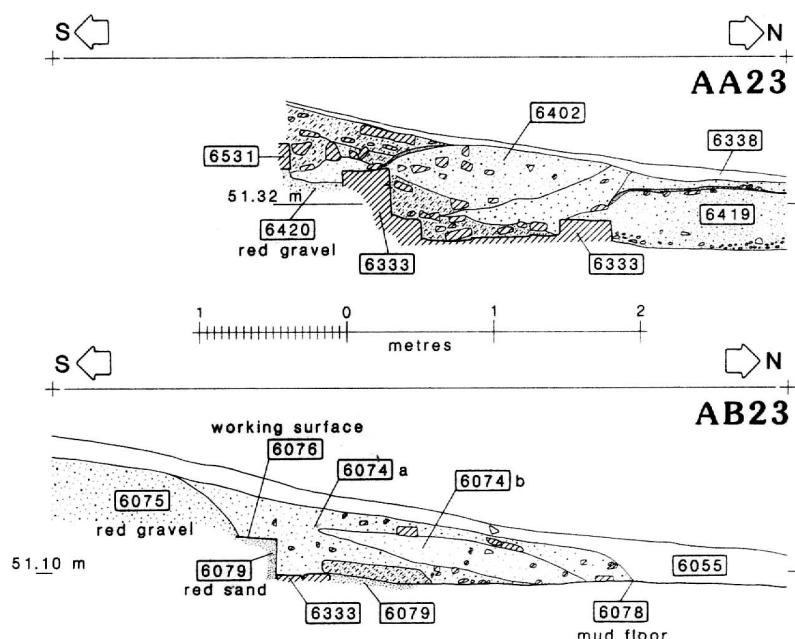
Figure 2.7. Sections along the west sides of squares AA23 and AB23. Originals by W. Horton.

The removal of [6074] revealed an absence of structures (Figures 2.7, 2.8). The red gravel [6075] was found to overlie one of the typical working surfaces [6076], consisting of very black and rough brick fragments. This appeared to be broken away, and below and to the north lay fine red sand [6079]. Also overlying [6079] was the compact mud floor [6078]. The two surfaces, however, did not meet and the working floor was, in any case, 40 cm higher. The fine red sand which underlay everything looked similar to deposits found last year at the south base of the slope, on which the floors and walls were built. The working surface, if it is the same as those found on the south and east sides of the site, should be inside the platform itself and thus the outer wall should lie further to the north. It seemed, therefore, that the northern outer wall had

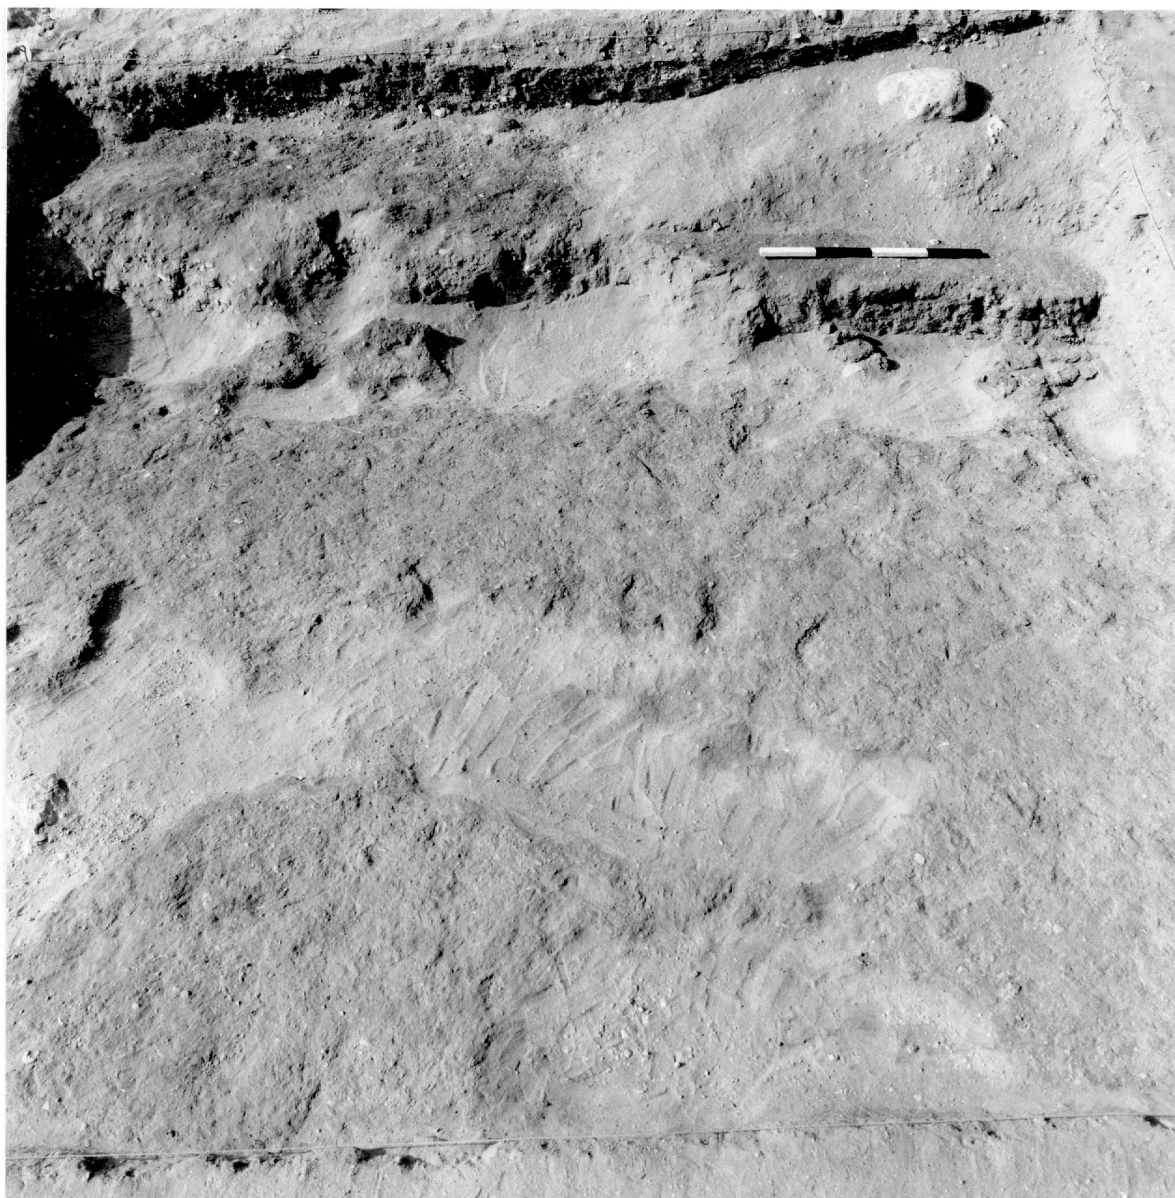
Figure 2.8. Square AB23, viewed to the south, showing the remnants of the north outer wall and the mud floor which subsequently replaced much of it.

been completely removed, that is, until the appearance on the west side of the square of a few pats of mortar, each measuring c. 0.5 x 0.3 m, having a straight south edge which was aligned with, but lower than, the edge of the working floor. It was part of a bottom layer of mortar with impressions of the first course of bricks, and must be the only remaining trace of the outside wall in this square.

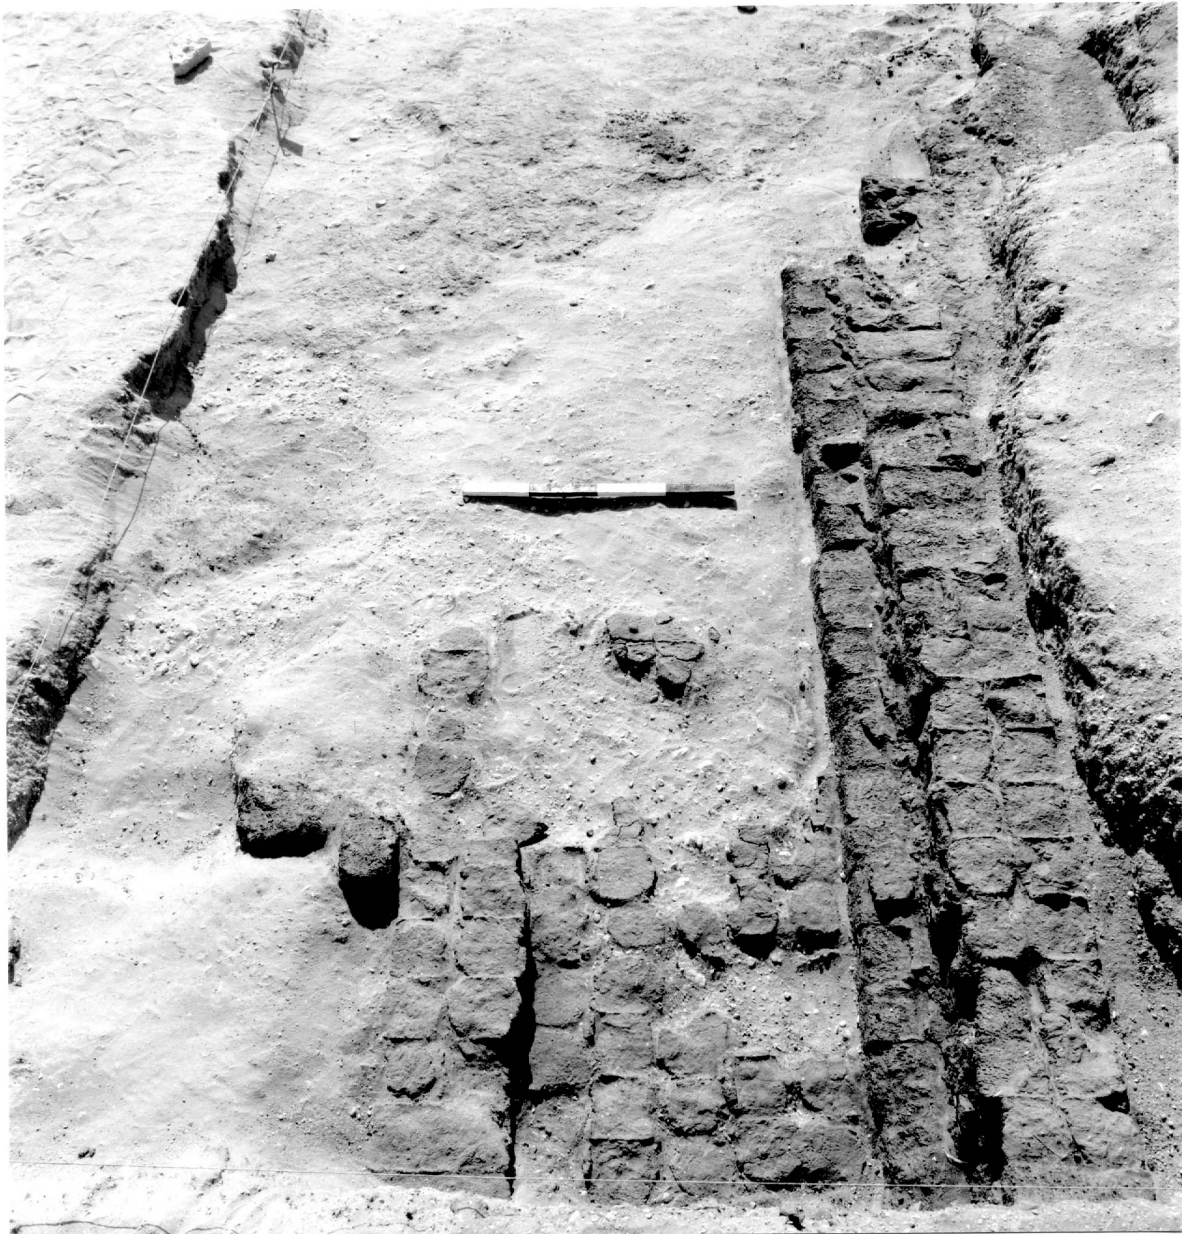
Figure 2.9. Square AA23, viewed to the east, showing the remnants of the north outer wall; the western end of square AB23 is also included.

mortar remained in the centre of the wall, leaving the front, and particularly the back, standing to a higher level. A robber trench over its line appears in the west section of square AA23 (Figure 2.7). A second slightly smaller and possibly later cut lay to the south of it, where the back part of the wall was partially robbed. The bricks which made up the wall were of the first-phase type, dark grey and rough with inclusions of straw, now decomposed. The bottom course had the following sequence from south to north: stretcher–header–header–header–stretcher–header. The course above had headers along each edge. Further to the east only the back half-metre remained, the rest having been completely robbed away.

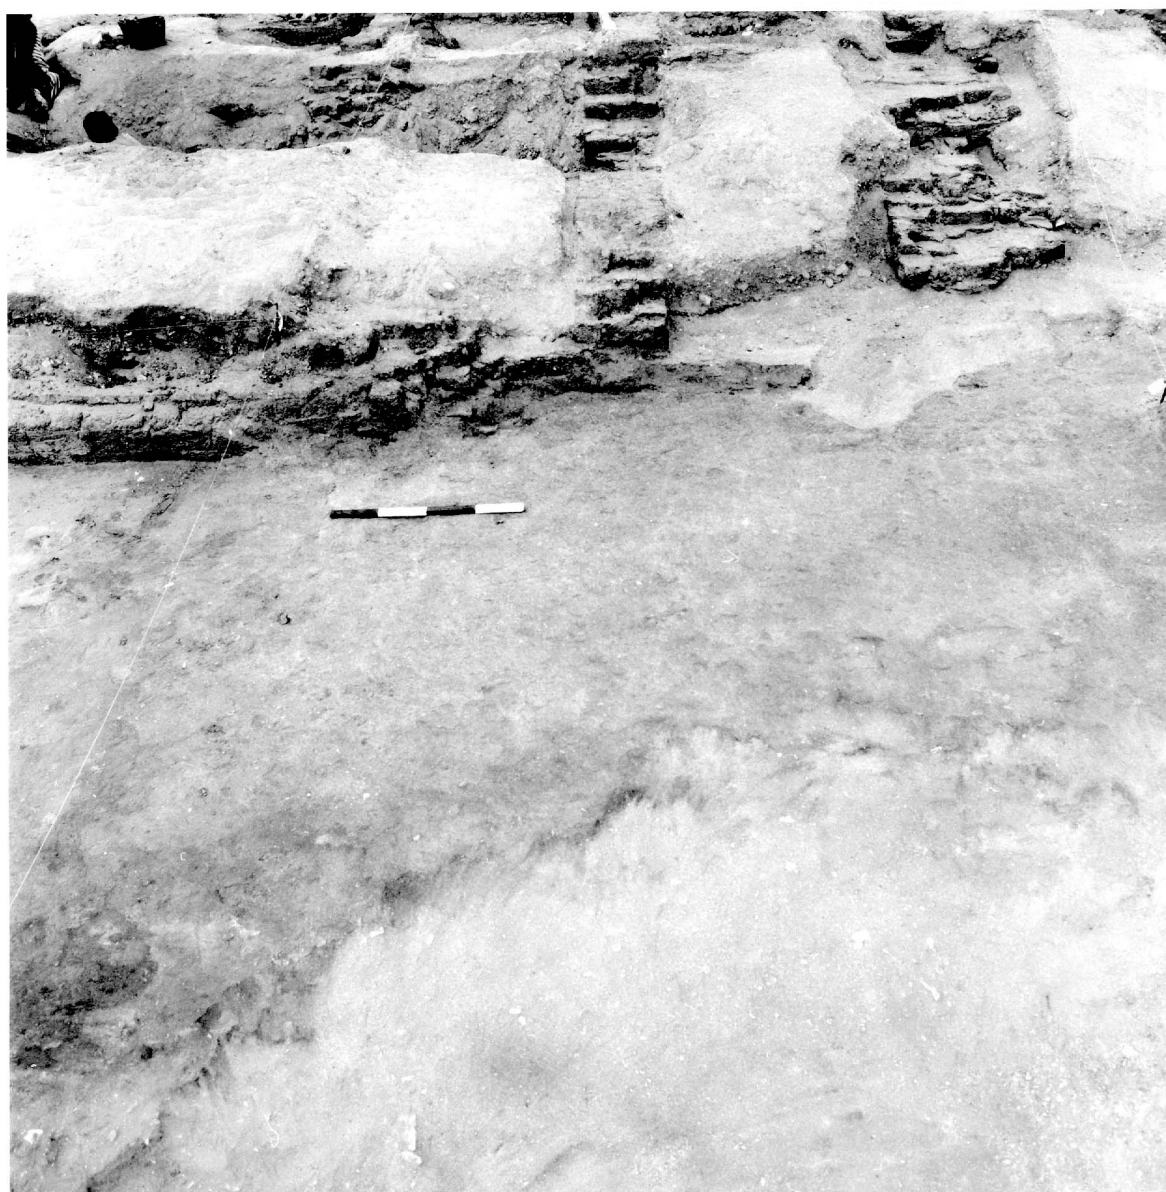
Figure 2.10. The northern end of the east side of the Platform, viewed to the west. In the foreground is the mud floor [6087] which has been carried over the line of the demolished eastern outer wall of the Platform.

connected the latter to wall [5779] (Figure 2.10). At the level of the base of the wall, between 0.75 and 1 m of these features had been cut away. At a higher level it is assumed that the cut stretched back further since it is unlikely to have been vertical. Fine red sand [6524] was exposed beneath the cut, on which the walls, the floor [6087], and the gravel fills were laid. As on the north side of the platform, a repatching was subsequently attempted, with the mud floor [6087] extending over the previous line of the wall and beyond it by at least 40 cm. It is not possible to differentiate between the original floor [6087] and the repatching. In the north-east corner of the square a few brick-joints were visible within the floor, showing that the bottom of the lowest course must have been left. This whole phase of partial demolition and repair, already encountered last season on the south side, is extraordinary because the removal of the wall would have immediately exposed the gravel infills and left them standing without support.

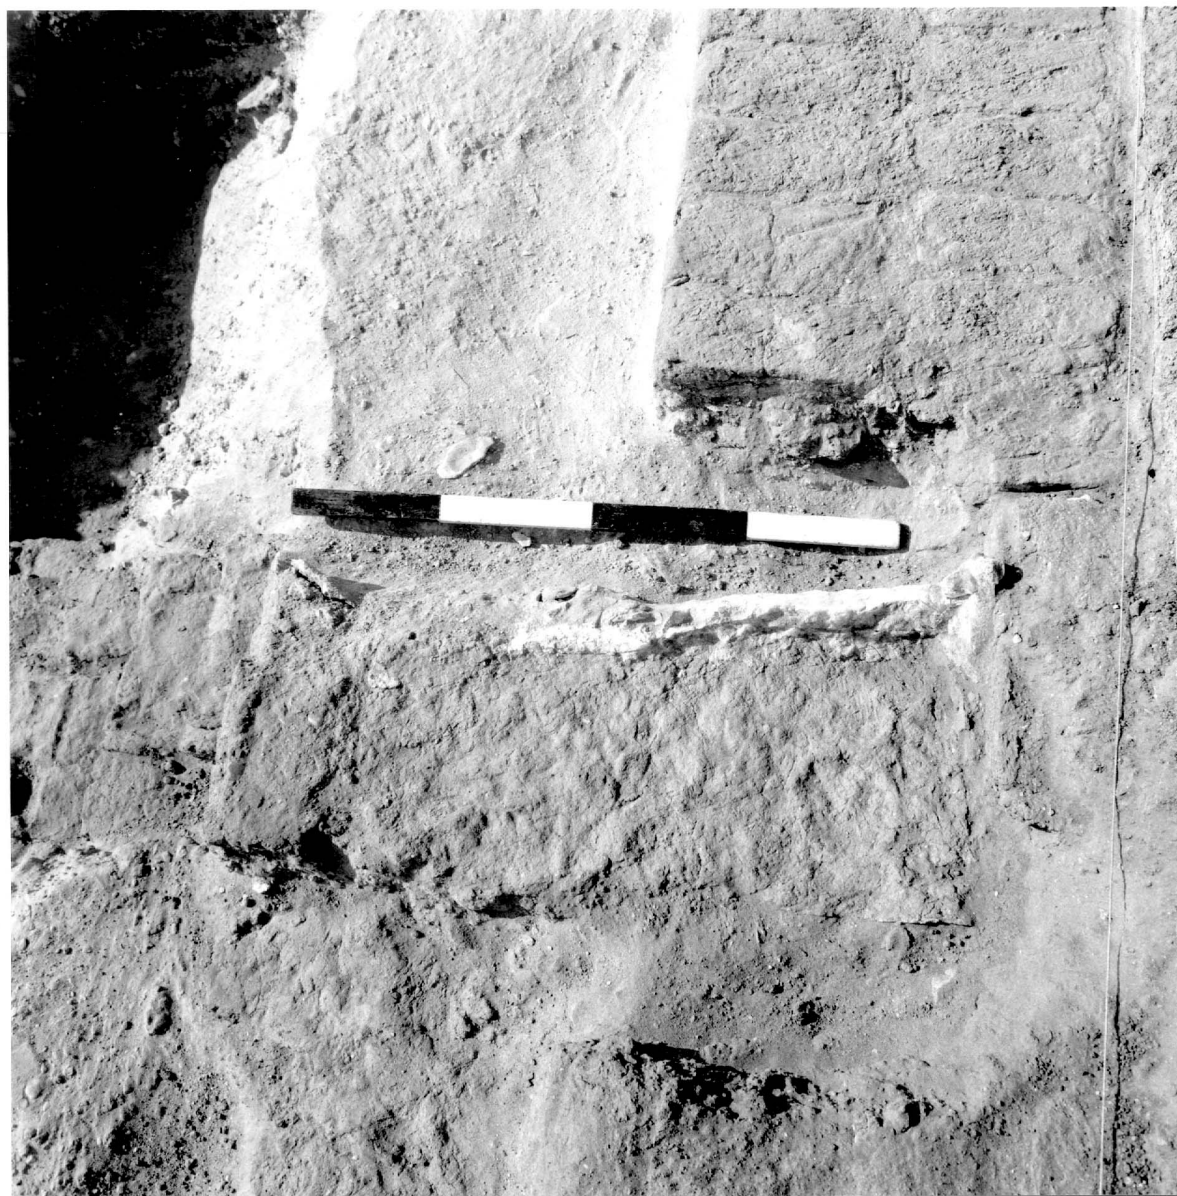
Figure 2.11. Impression in mud mortar of stone door threshold in wall [6514] with line of gypsum mortar, viewed to the south.

At the west end of [6514] were the clearest traces found so far of a door threshold [6513], which was also the only identifiable one in the eastern block of rooms. It had been 1.25 m long and the same width as the wall. What survived was a flat layer of compacted mud containing impressions from a limestone block, 1.25 x 0.4 m, and lined by gypsum/lime plaster which projected 18 cm above the mud, implying that the limestone block must have been at least that thick (Figure 2.11). To the south was a thinner strip of compacted mud, 1.25 x 0.15 m, set c. 20 cm lower, on which another limestone block, possibly laid on edge, would have stood. At first it seemed that the lower section might represent an earlier threshold, but the same gypsum lining curved around both sections to make a single unit. There was also what appeared to be a door jamb jutting out of the north-west corner in the form of a gypsum-lined semi-circle. The threshold was assumed to go with the second phase of construction since it was at the correct level for the paved floors [6520] and [6528]. It was not possible to see if there are late doorway blocking-bricks below since the sides of the wall were not exposed at this point.

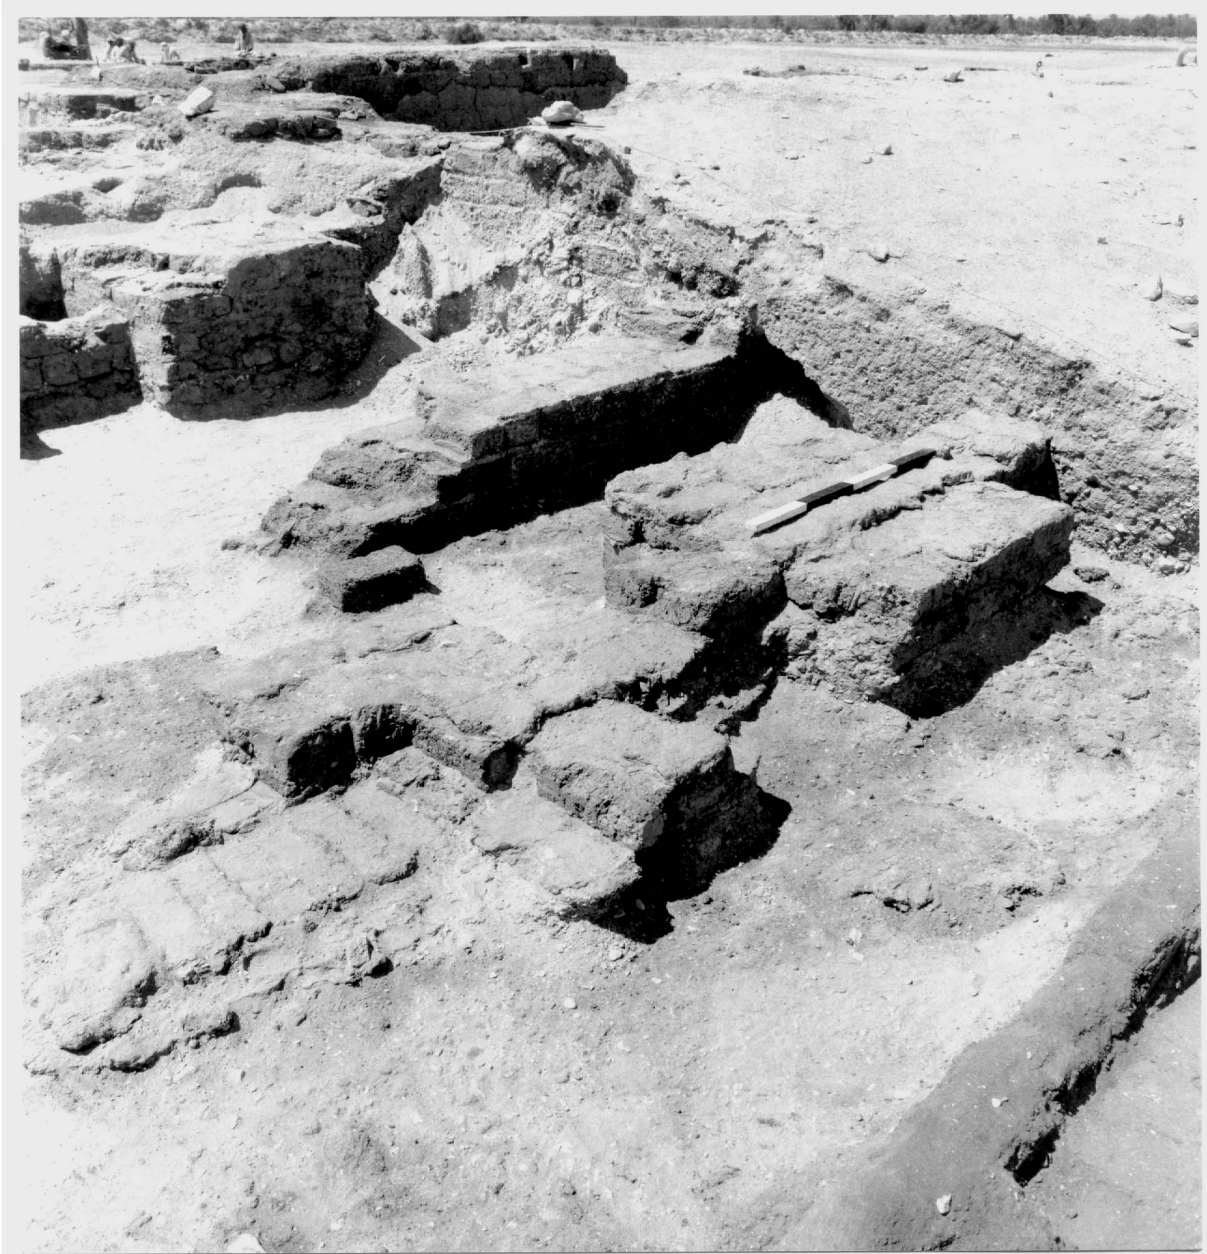
Figure 2.12. Square AC22, viewed to the south-west, showing brick pillar bases in the foreground. The ancient infill has been removed.

The three gravel fills were removed in order to obtain more information on the way the platform was constructed (Figure 2.12). The northern infill [6334] was yellow sand (*tifla*) with a depth of 30–40 cm. It overlay a very rough surface [6342] made up of black compacted mud fragments. It was of the kind already alluded to as a working surface and was similar to [6076] on the north side of the square. The middle fill [6335], of the same material, was about 50 cm deep and came down on to the same working surface, although it was a little more patchy here. The fill running along the south side of the square [6336] was up to 1 m deep, but instead of a working surface lay on the top of a compacted yellow-grey gravel layer. East of wall [6344], where it had been destroyed, the compacted gravel was visible beneath the working surface, which was 5–7 cm thick.

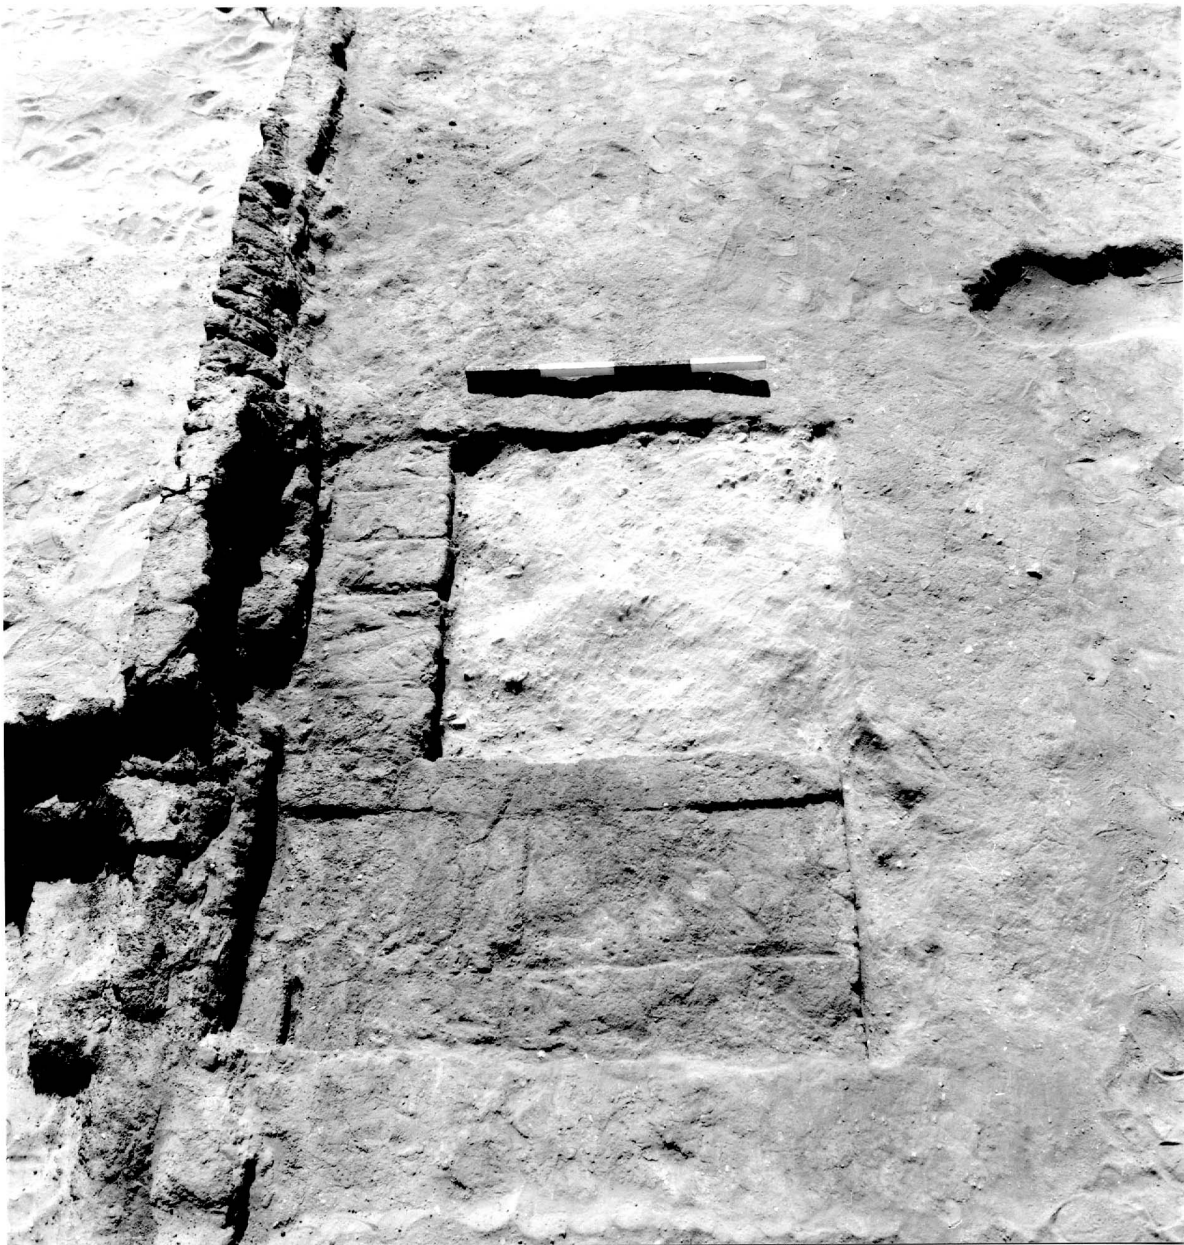
Figure 2.15. The pit dug over the wall junction in square AD19, at an early stage of excavation, and viewed to the east. Note the mud floor [5436] laid over much of the wall and over the gravel infill (cf. Figure 2.14).

An area of floor, 1.6 x 1.9 m, over the suspected original wall junction was removed. This exposed the corner of outside walls [5779] and [5360], and the south wall of the eastern spur [6417] was found to be a separate, narrower wall butting up to the corner (Figures 2.14, 2.15). In construction it was identical to [6090] to its north, namely two bricks (75 cm) wide, and made up of header bricks with a central line between them filled with mortar. The third course from the bottom is made up of bricks on edge. The bricks and mortar were typically of the later phase.
