CHAPTER 3

REPORT ON THE 1983 EXCAVATIONS CHAPELS 570 AND 571

Site supervisor: Christopher Hulin

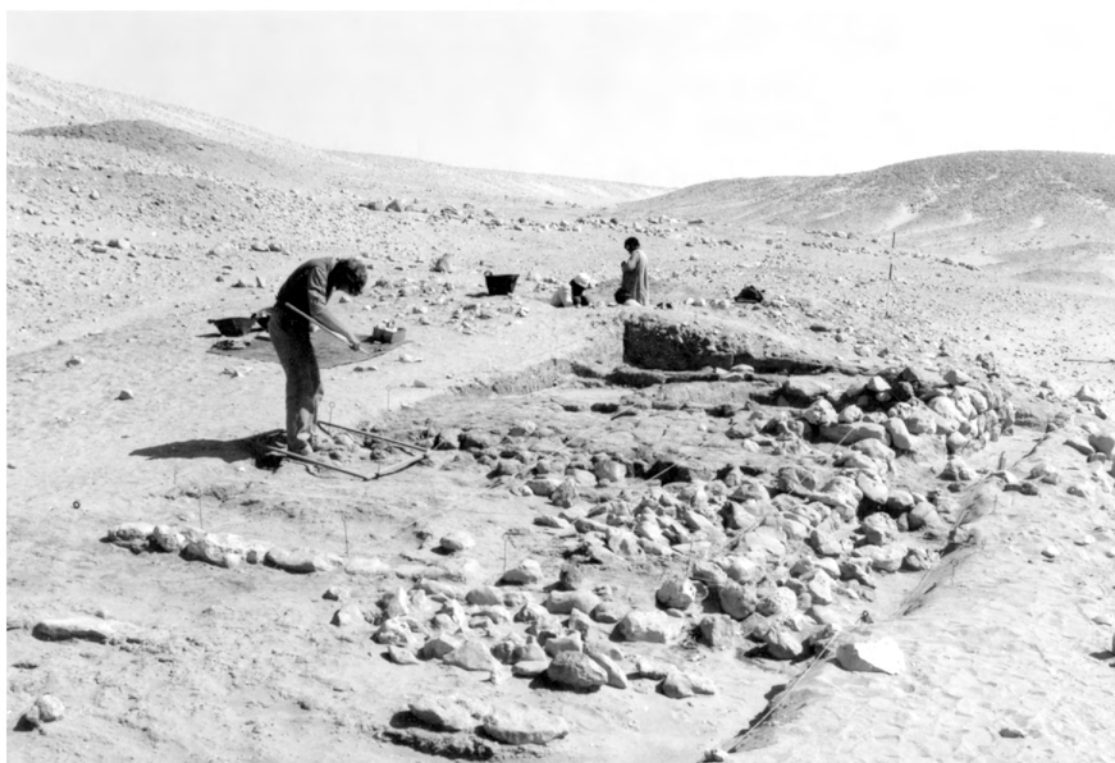
Figure 3.1. Chapel 571 at an early stage of excavation, with top of rubble exposed, looking north-east.

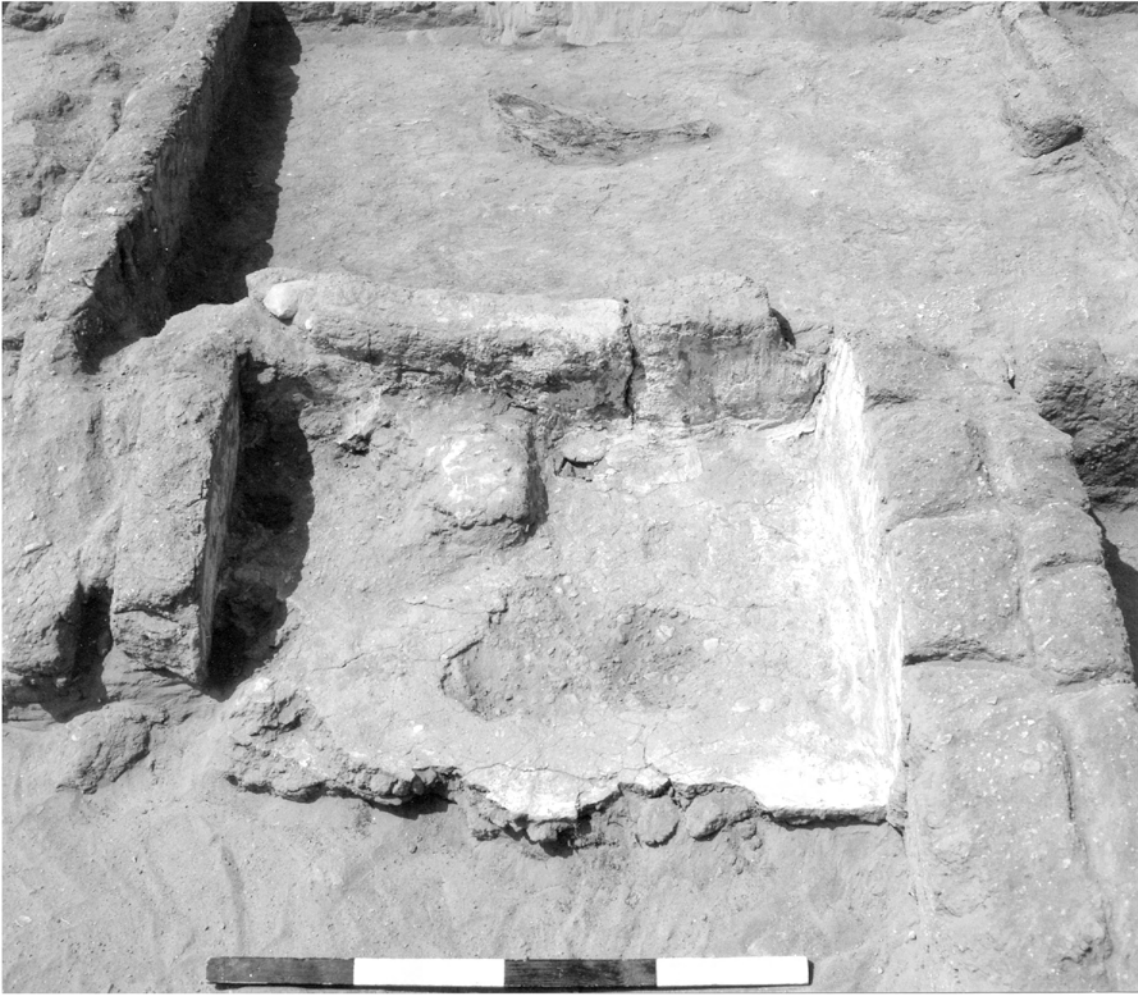
Figure 3.3. Sanctuary of Chapel 570, looking west.

The most interesting part of Chapel 570 is the Sanctuary (Figure 3.3). This was a small square chamber, 1.25 metres across. The eastern half has been destroyed by the modern pit. The northern and southern walls ([694] and [700, 814]) are doubled in thickness. The reason for this was found by an examination of the brick rubble which filled the room. It contained many pieces of flat brick with one broad surface deeply grooved. In a few cases one of the long narrow sides had been plastered to provide a slightly concave surface, which had then been coated with gypsum. These are the distinguishing marks of bricks from a barrel-vault, painted white on the inside (Spencer 1979: 141-142, Plate 53B).

The west wall of the Sanctuary [701] was preserved only to a height of 46 cms. This was just sufficient, however, to preserve a small patch of gypsum on the upper surface revealing that a window had been let into the wall. Immediately below the window, on the inside, stood a pedestal-like projection, also coated with gypsum, as were the walls and floor [807]. The Sanctuary had thus been a little vaulted room, completely white on the inside, communicating with the Hall by means of a window. It must have extended back for only about half the length of this part of the chapel, for the break in the floor on

the east corresponds with a neat vertical break in the gypsum plaster on the adjacent north wall. The robbers must have removed a cross wall here. How the chamber was used must remain for the present a matter of surmise. One possibility is that a tall pottery cult stand, such as was found in the neighbouring Chapel 571 and is discussed in Chapter 12, stood there.
