## CHAPTER 6

REPORT ON THE 1987 EXCAVATIONS  
INVESTIGATION OF THE SMALL ATEN TEMPLE

Michael Mallinson<sup>1</sup>**6.1 Introduction**

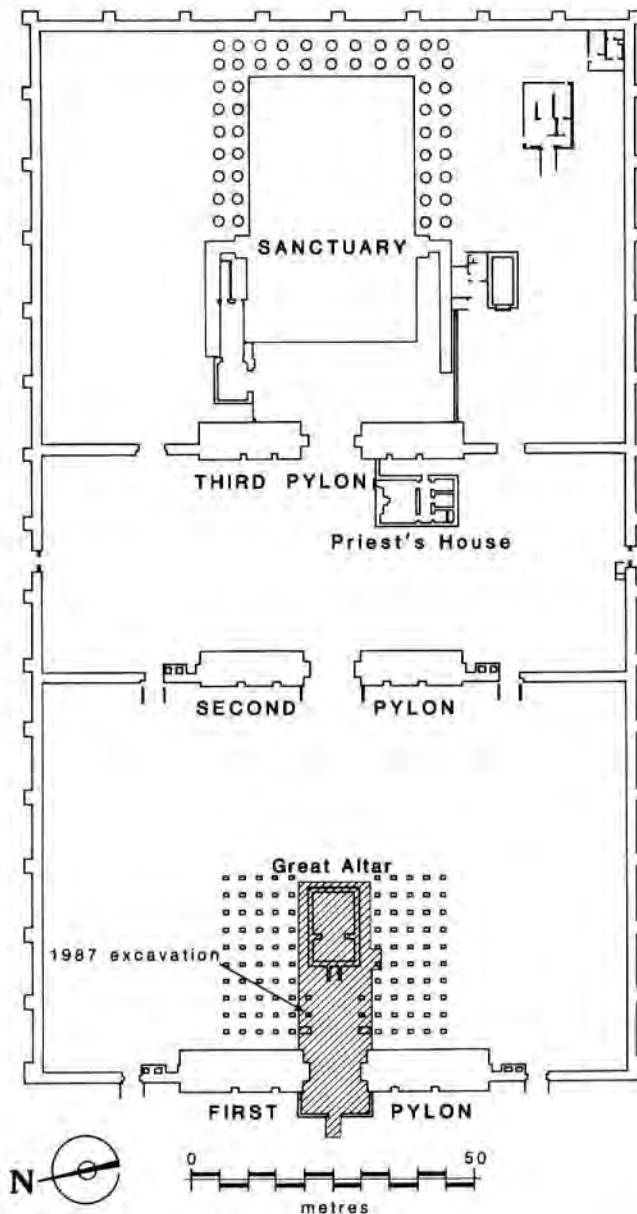
Figure 6.1. Outline plan of the Small Aten Temple, showing area excavated in 1987.

The area chosen for first examination was the main entrance to the temple situated at the western end of the enclosure between the towers of the First Pylon, which, like the Second and Third, were constructed of mud brick (Figure 6.1). It was here that a substantial area of gypsum foundation plaster had been discovered (*COA* III: 92–93, Fig. 17; Pendlebury 1932: 145–146). On removal of the sand it was discovered that this plaster floor was still intact, and the masons' marks noted then were still well preserved. This is a rare and fortunate survival from the exposures of the older excavations of the gypsum foundation layers beneath stone constructions that typify Akhenaten's buildings at Amarna (the system is explained in *COA* III: 6–7). Having been left open to the elements (and the passage of humans and animals) they have generally broken up and lost much of their original surfaces, but here the brick pylon towers trapped sand, and a protective covering had quickly formed. Lavers had made a separate and larger-scale plan of these foundations, published in *COA* III: 93, Fig. 17, but comparison with the original revealed that even this omitted much detail, enough to warrant re-planning. The decision to do this necessarily disposed of much of the time available, to the extent that further clearance was limited to the area immediately behind, i.e. to the east of the gateway, which exposed for detailed planning the foundations of the large brick altar in the temple forecourt, and to cutting a deeper exploratory trench from east to west across the area excavated, which brought to light a valuable and unsuspected stratigraphic sequence.

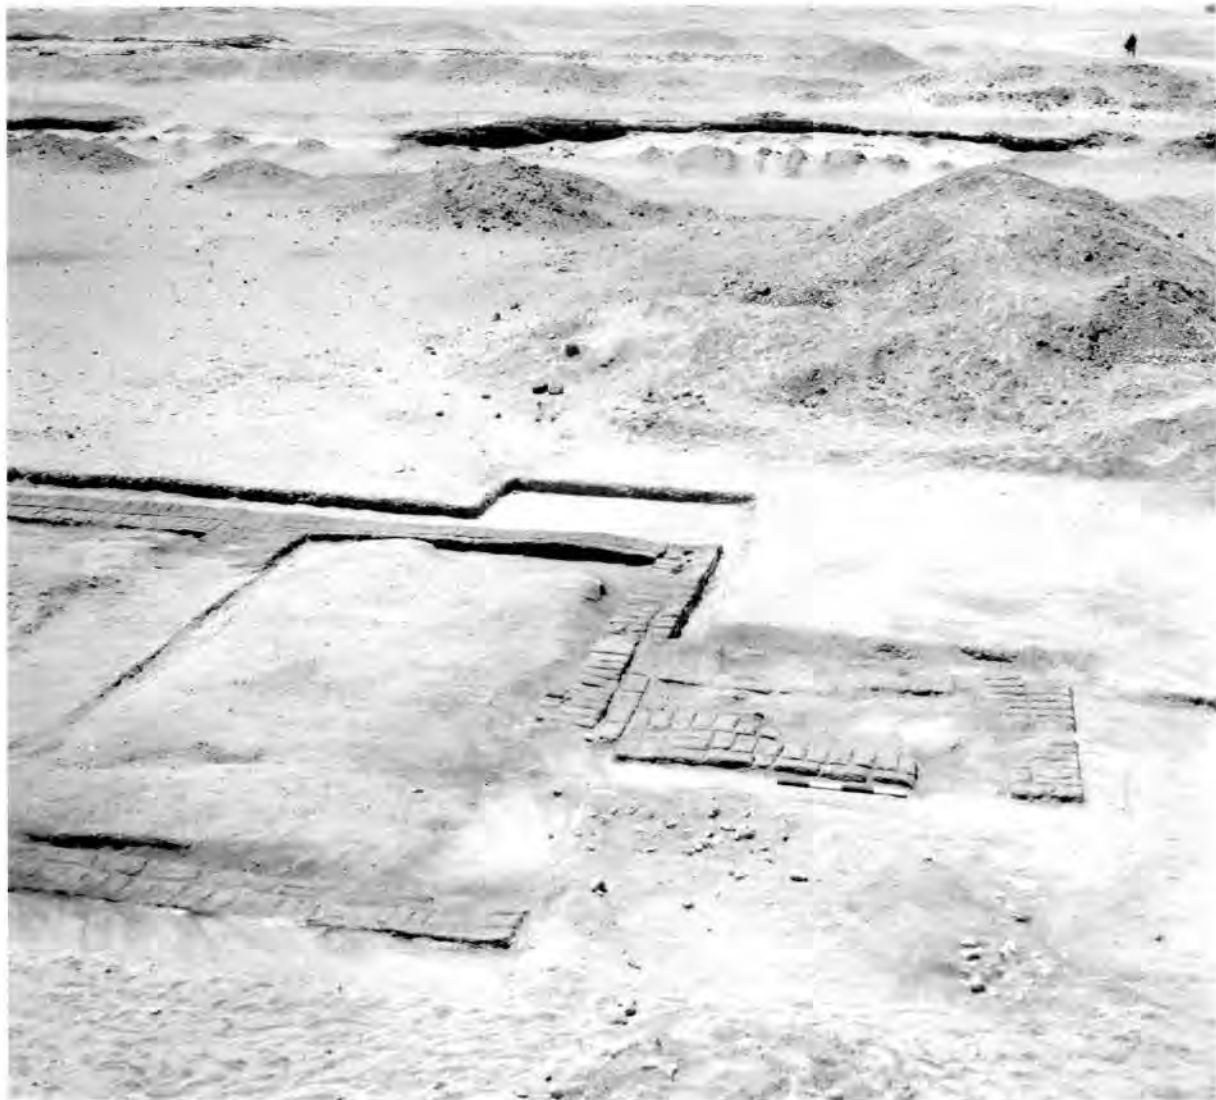
**Figure 6.2.** View of the Great Altar, towards the south, at the end of the 1987 excavation.

lowest one or two courses of brickwork survive (Figures 6.2 and 6.3), and these reduced through weathering to a soft and dusty consistency, the lines between bricks are often clearly visible, making a detailed plan possible (Figure 6.4). The mud bricks of the structure had been whitewashed externally, this whitewash [3769] extending over the surrounding floors.

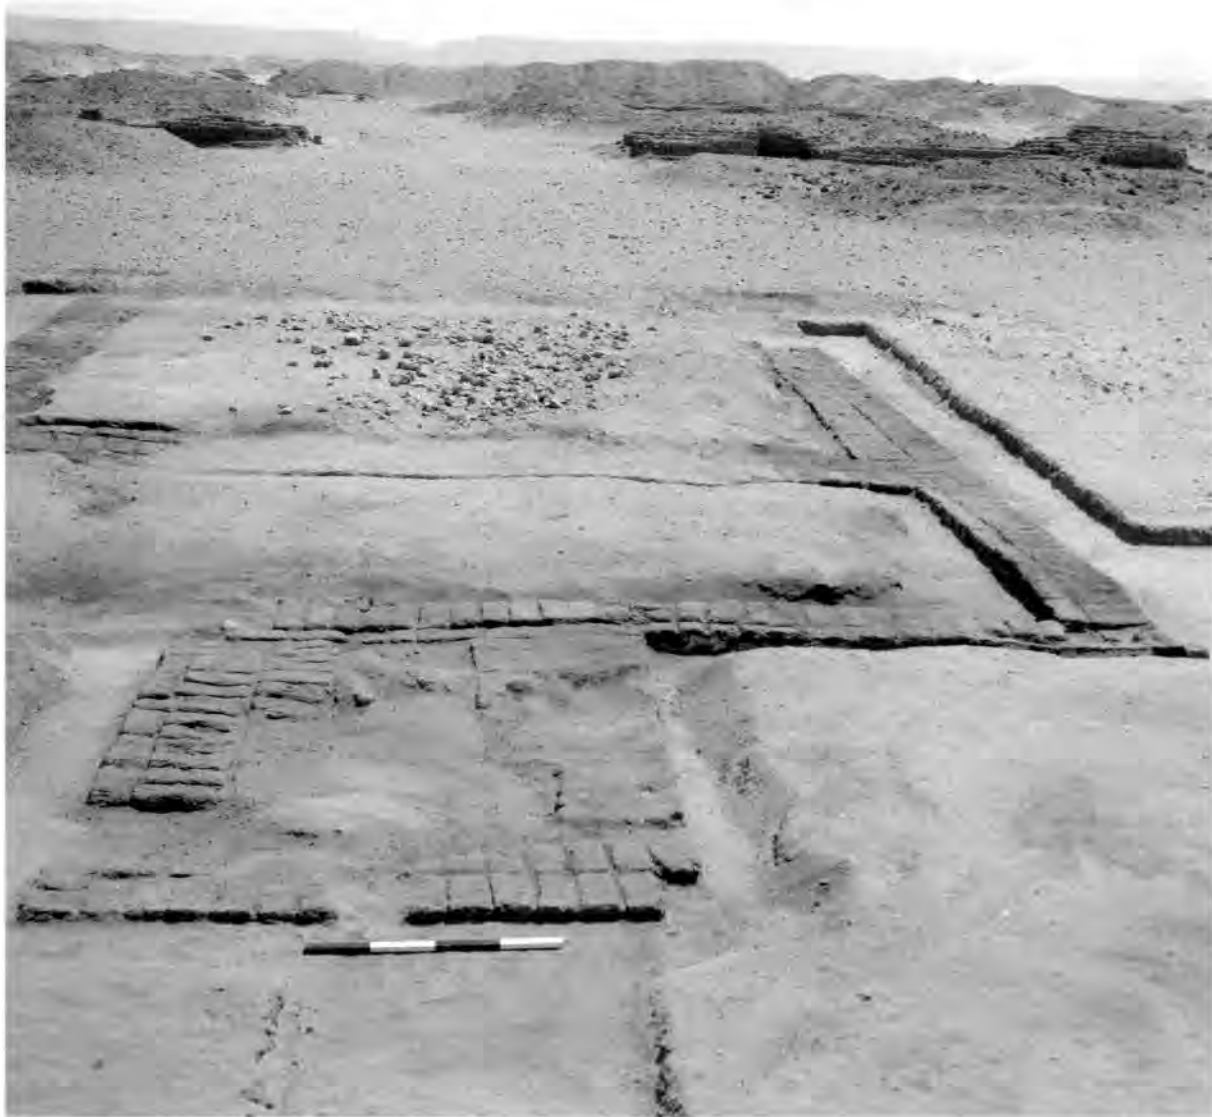
**Figure 6.3.** View of the Great Altar, towards the east, at the end of the 1987 excavation.

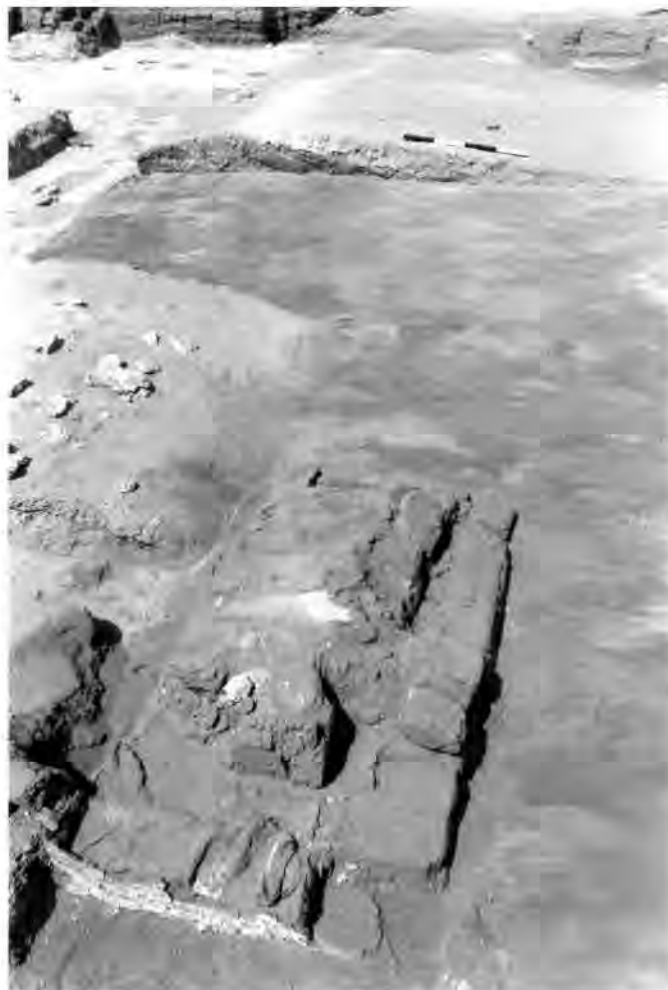
Figure 6.6. One of the pair of small altars rebuilt in Phase IIb flanking the inside of the gateway in the First Pylon.

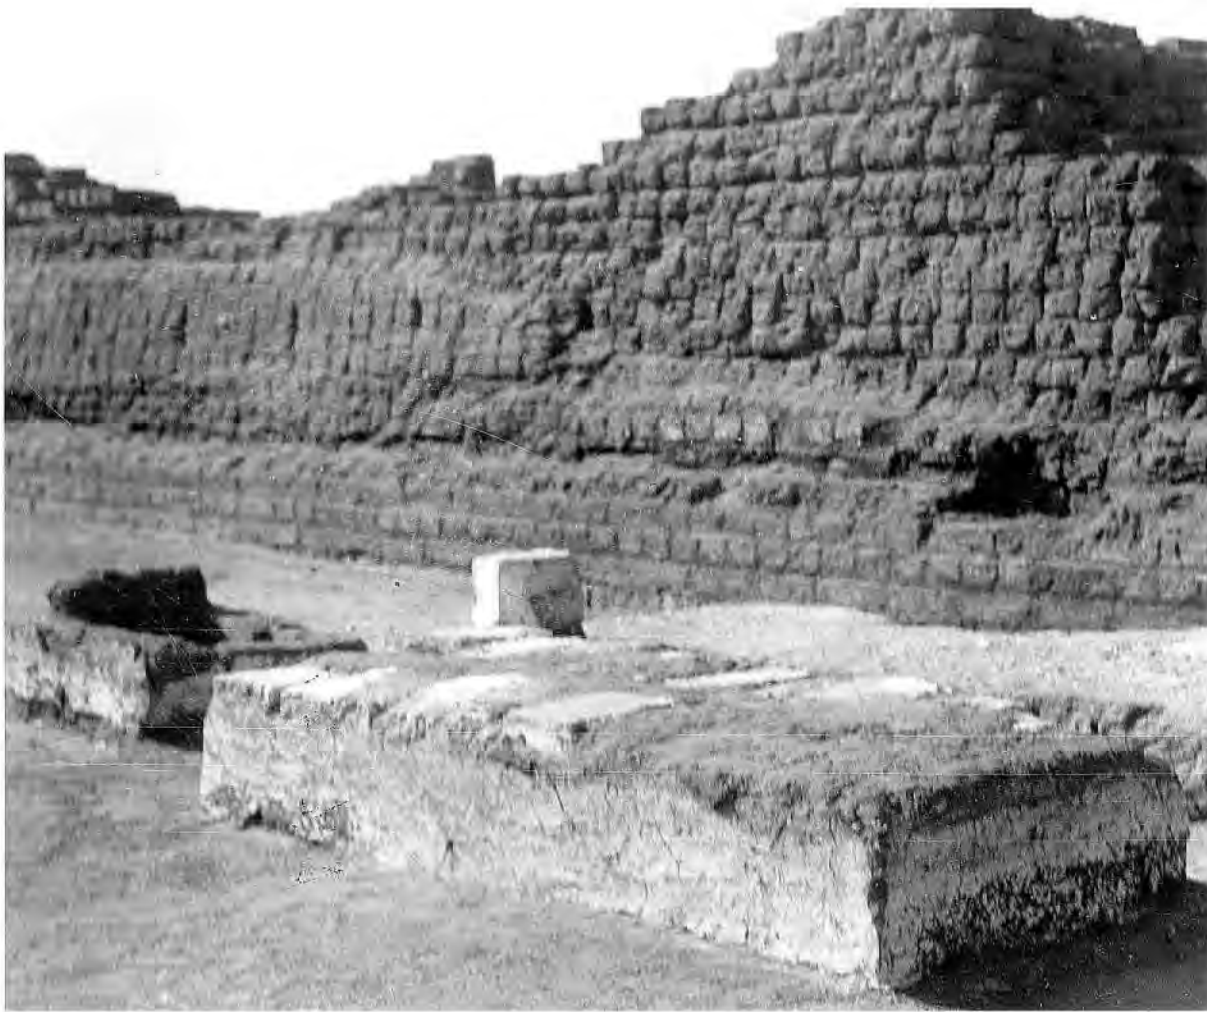
**Figure 6.7.** The southern rebuilt small altar [3774, 3775], as excavated in 1931, viewed to the south-west. Archive photograph 31/32.A160.

Some time after the construction of the pylons the Great Altar seems to have been systematically destroyed to ground level and a mud floor laid over it. It is evident from present appearances and from early maps that, prior to modern excavation, it formed no mound above the surrounding ground.<sup>4</sup> Since most of its mass consisted of stones and gravel fill this cannot be explained as the result of erosion, especially in view of its relatively protected location. It speaks much more of deliberate demolition to clear it away from the forecourt altogether, leaving only a foundation course invisible beneath a new and slightly raised floor level. Bricks from this demolition seem to have been incorporated into the enlargement of the two small altars on either side of the entrance way of the main gate, when the original brickwork [3775, 3787] became the cores for brick extensions [3774, 3403] which made them much longer (Figures 6.5, 6.6, and 6.14). Evidence for this can be seen in the whitewash that still clung to the faces of the bricks of the extensions when turned inwards and thus remaining invisible and protected within the masonry of the altars. Pieces of small stone are also interspaced with these bricks, and they, too, may have come from the Great Altar. These enlarged altars, which could perhaps have also been bases for wooden statues (as tentatively reconstructed in Figure 6.19), were whitewashed and measure 2.1 x 1.0 m, as shown in the 1931 photographs (A213, A160, A175, A201, A233, A125; see Figures 6.7 and 6.14).

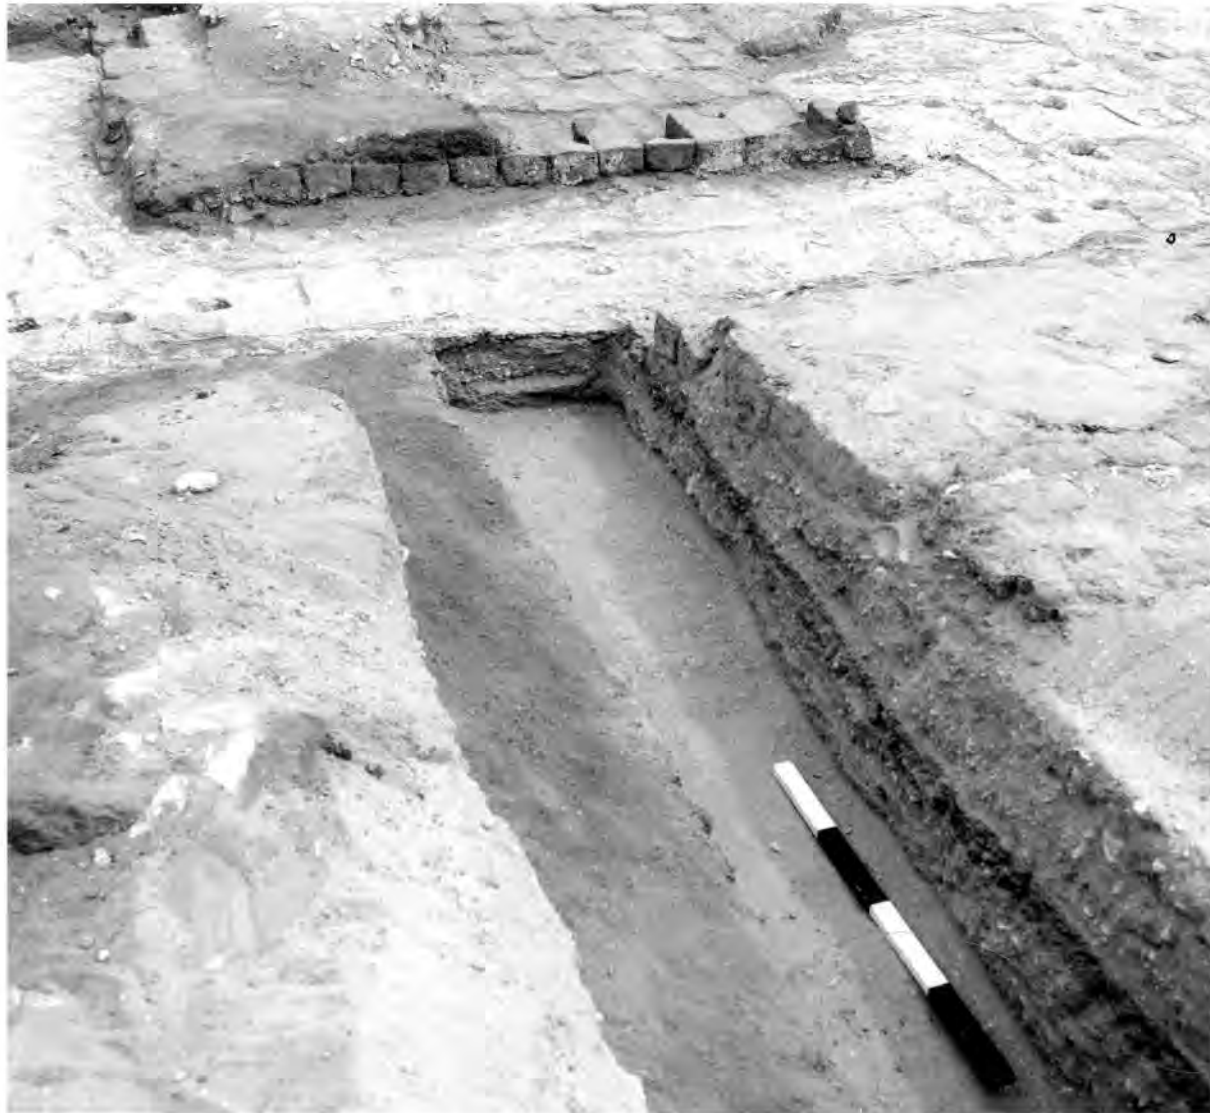
**Figure 6.8.** The gateway between the First Pylon towers, as excavated in 1987, viewed to the south-east. In the foreground is a trench cut down to natural desert, and passing between the walls of the little forecourt [3909]. In the background is the gypsum pavement, and the remains of the Phase IIa brick pavement [3907].

The entranceway of this phase between the pylon towers was extensively damaged by Phase III rebuilding, but two features remain: firstly the bases of two mud-brick piers or nibs (called “brick offsets” by Pendlebury) remain against the middle of the large pylons, measuring 3 m x 1.20 m wide and standing from this phase two courses high ([3904] on the north side, Figures 6.11, 6.15, and 6.17); secondly in the centre of the gate is a mud-brick platform [3907], much destroyed, measuring 6.8 x 2.5 m, which also remains in places to two courses in height (Figure 6.13, and visible in the photograph Figure 6.8).

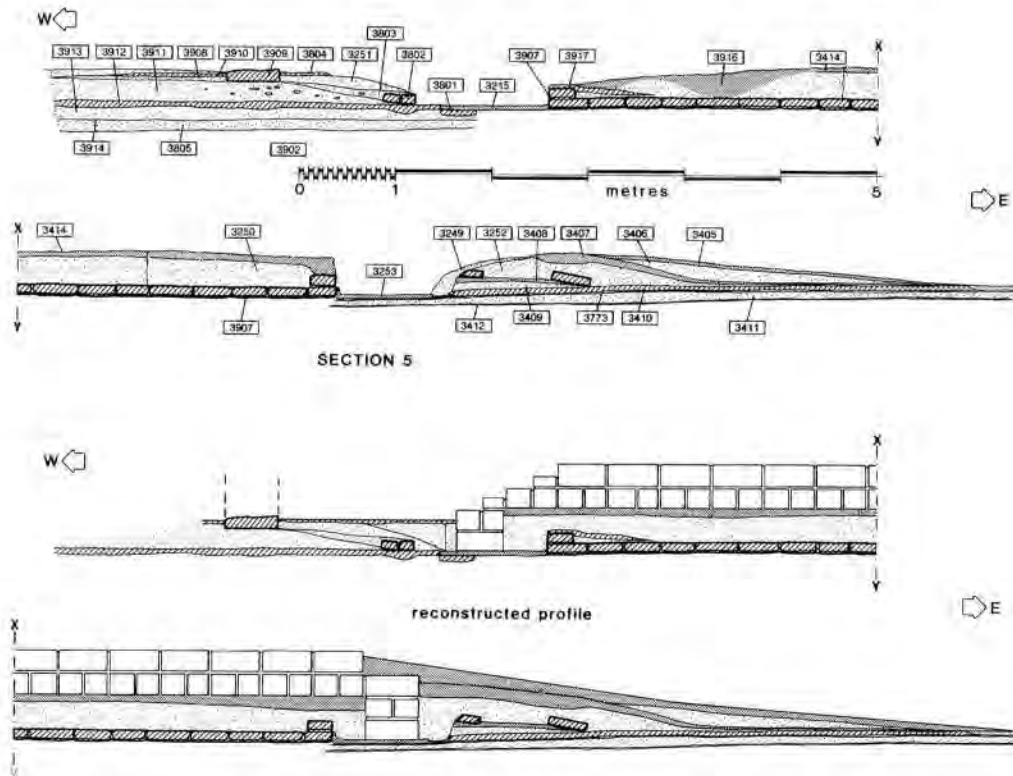
Figure 6.10. Section 5, the main east–west section on the temple axis, both as found and with the original limestone blocks restored. Unit [3250] contained the ring bezel of Ankh-kheperu-rē.

gypsum [3414] and the central area again raised with a layer of sand [3250] (Figures 6.9, 6.10, 6.21). The third layer, it is conjectured, was then placed over the inner side of the gateway and the central ramp. All this stone was then finished in a flooring coat of gypsum (Figure 6.21). The impressions of part of this third layer were recorded by Lavers (and copied on to our plan, Figure 6.12) but have since been eroded away.

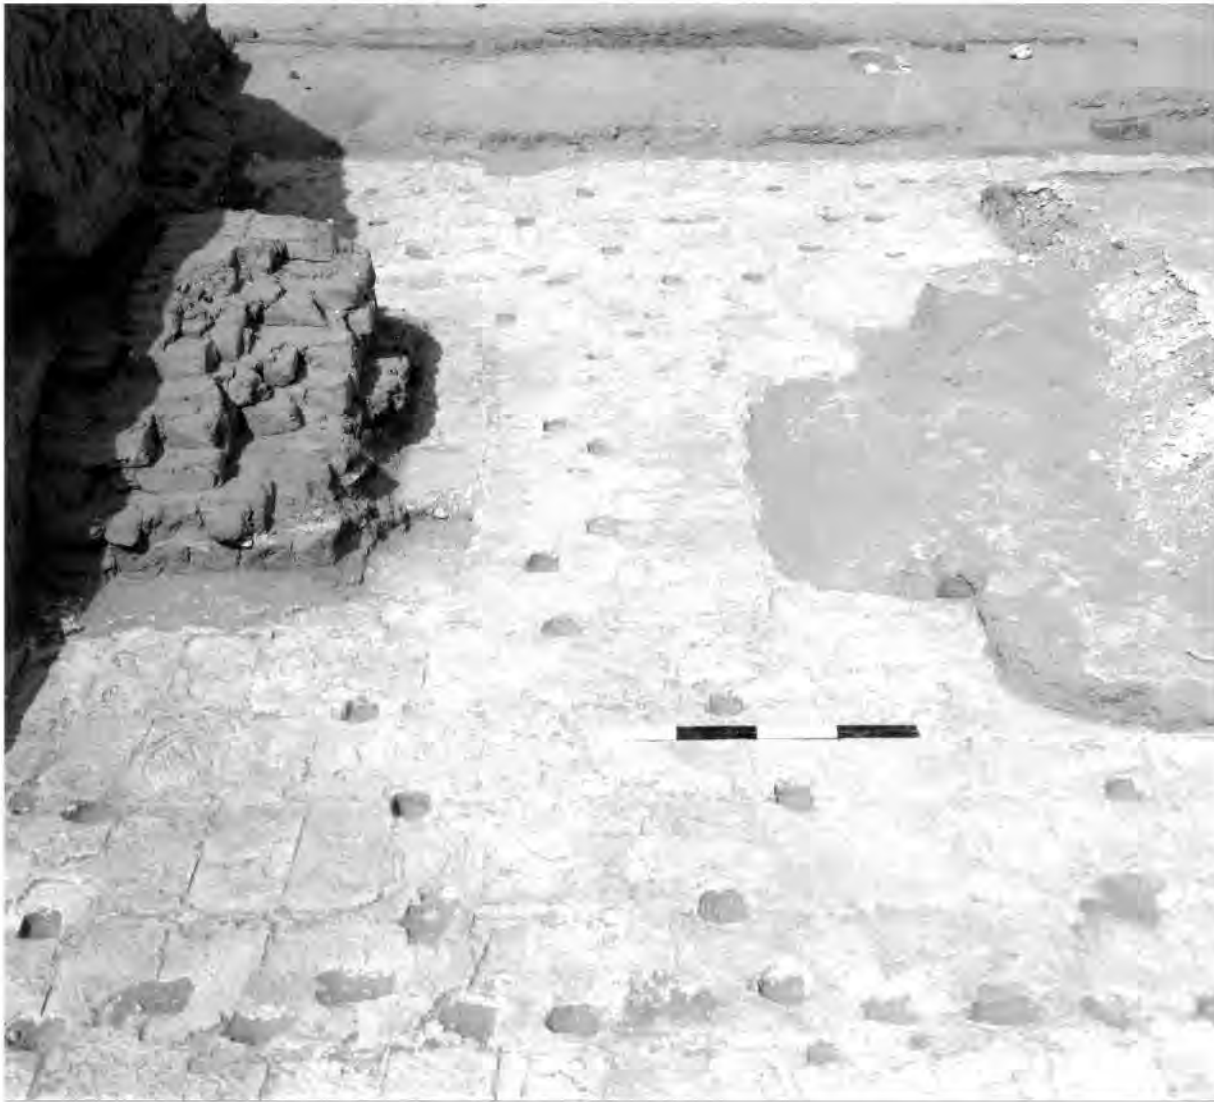
**Figure 6.11.** The gypsum floor inside the main gateway, southern half, viewed to the west.

Between the block-impressions left behind is a series of deep post-hole like pits set in the gypsum (Figures 6.11, 6.21, and 6.22). Similar marks on a gypsum foundation pavement can be discerned on Newton's plan of one of the buildings at Maru-Aten (*COA I*: Pl. XXX, the southern building of Group II, mainly around the northern edge). They must have been made while the plaster was still wet. One explanation which could be considered is that the blocks were laid from a trestle which was moved backwards as the stones were laid and so the holes were left by the trestle legs. However, in that case one would expect regularity in the placing of the holes, which

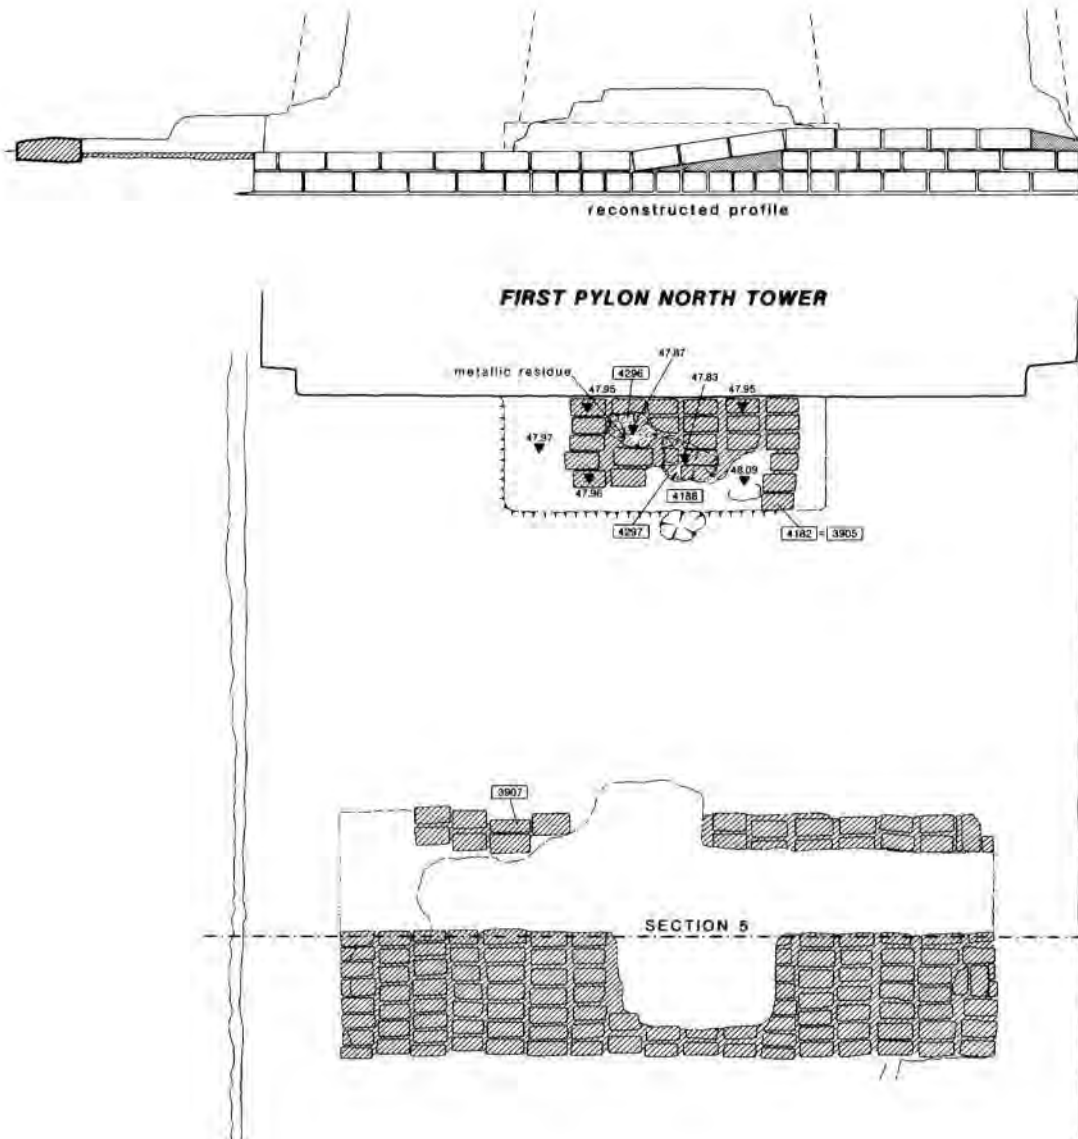
**Figure 6.13.** Plan of Phase II brickwork in the gateway, underlying the plan of Figure 6.12, and elevation of the south face of the north pylon, with restored section of the stonework which would have lain in front.

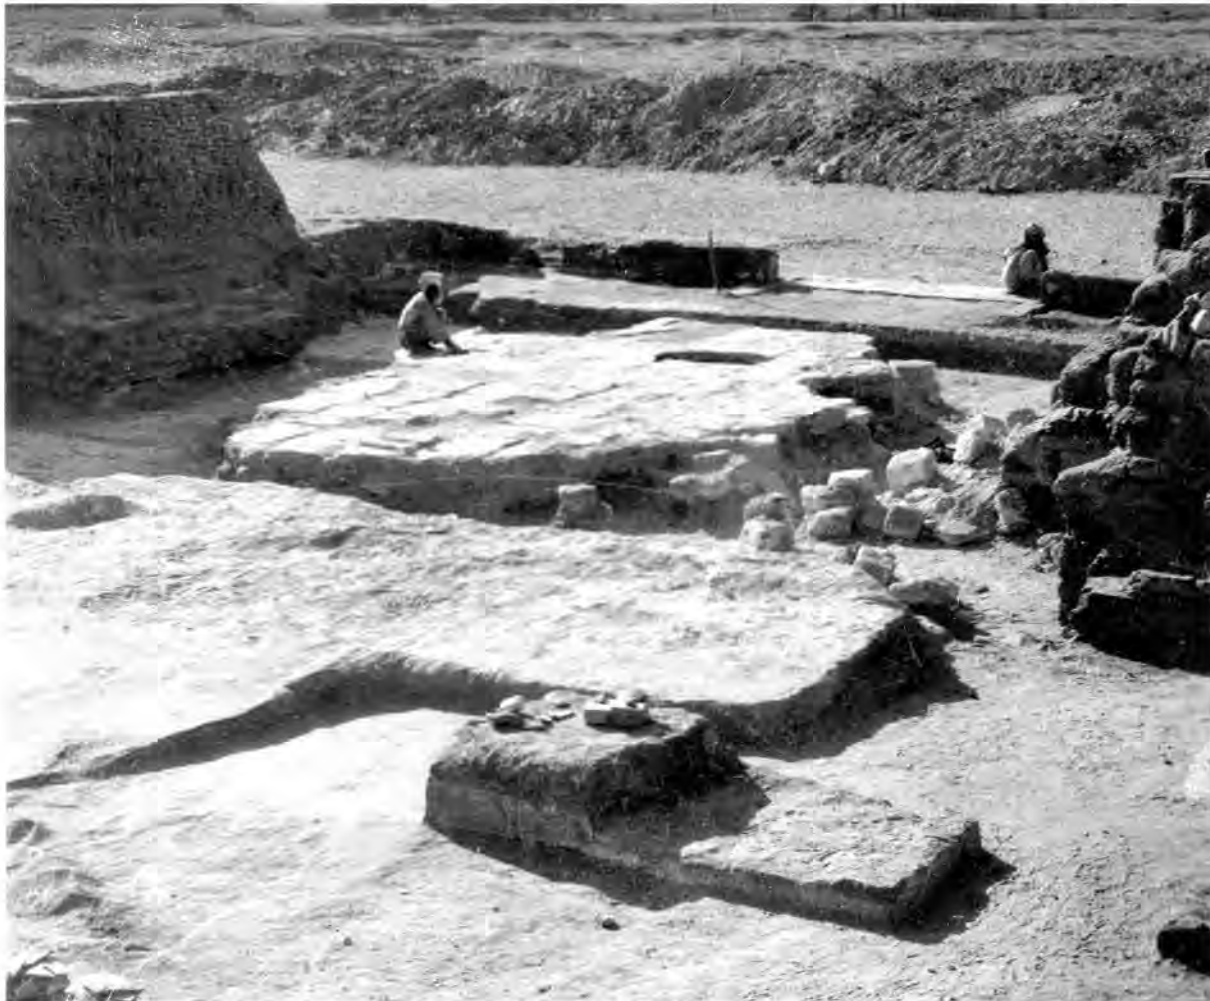
**Figure 6.14.** The gateway at the end of excavation in 1931, viewed to the south–west, showing the gypsum-covered ramp in the foreground. Archive photograph 31/32.A125.

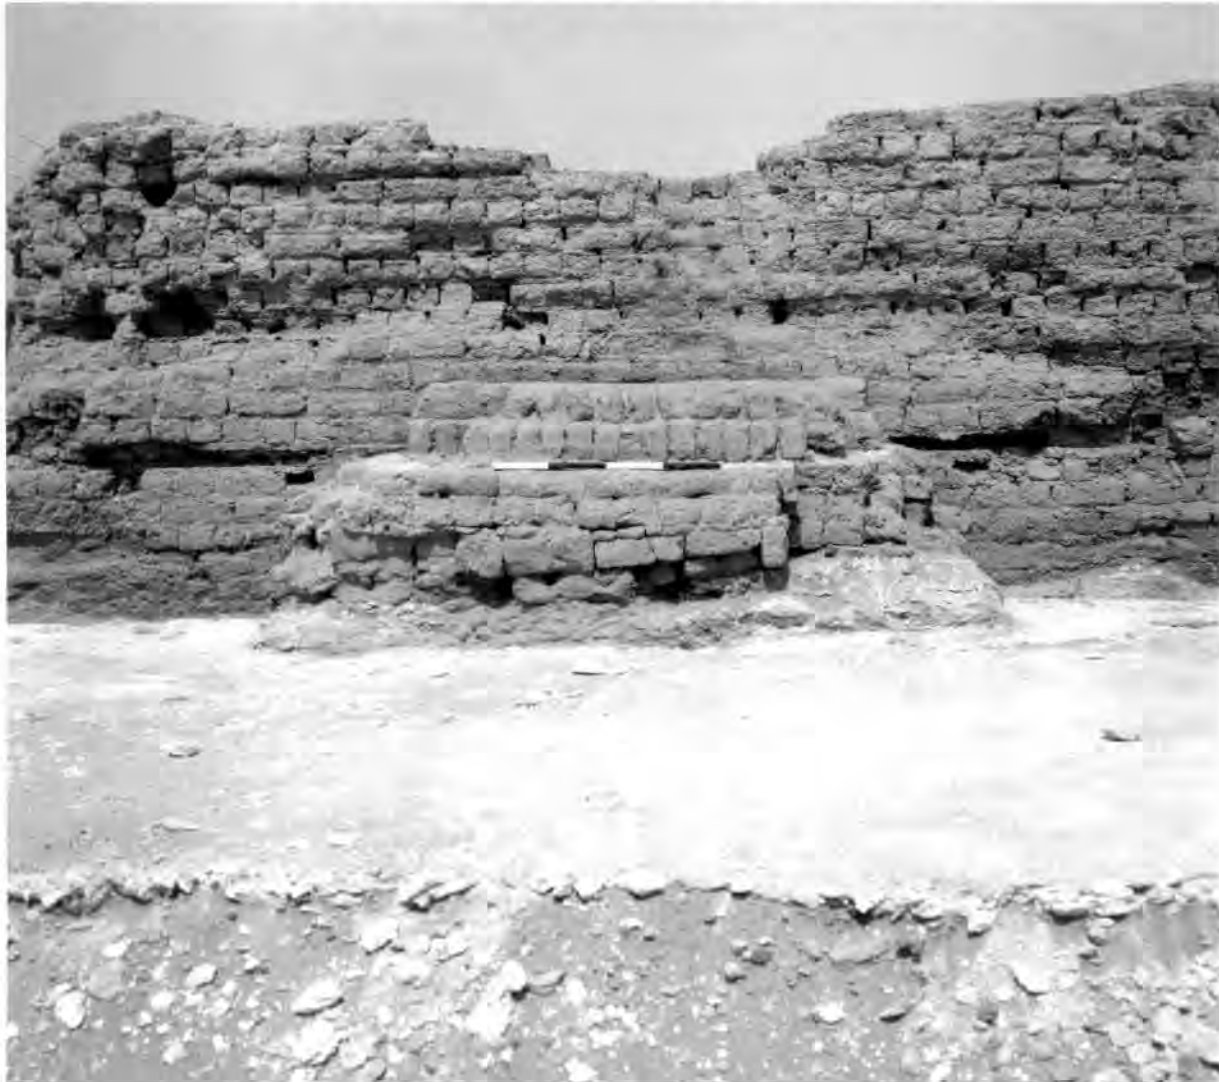
**Figure 6.15.** The south face of the north pylon tower, viewed to the north, showing the brick nib with the outline of a ramp preserved as an angled course of brickwork towards the bottom. In the foreground is the gypsum surface [3414] of the central platform.

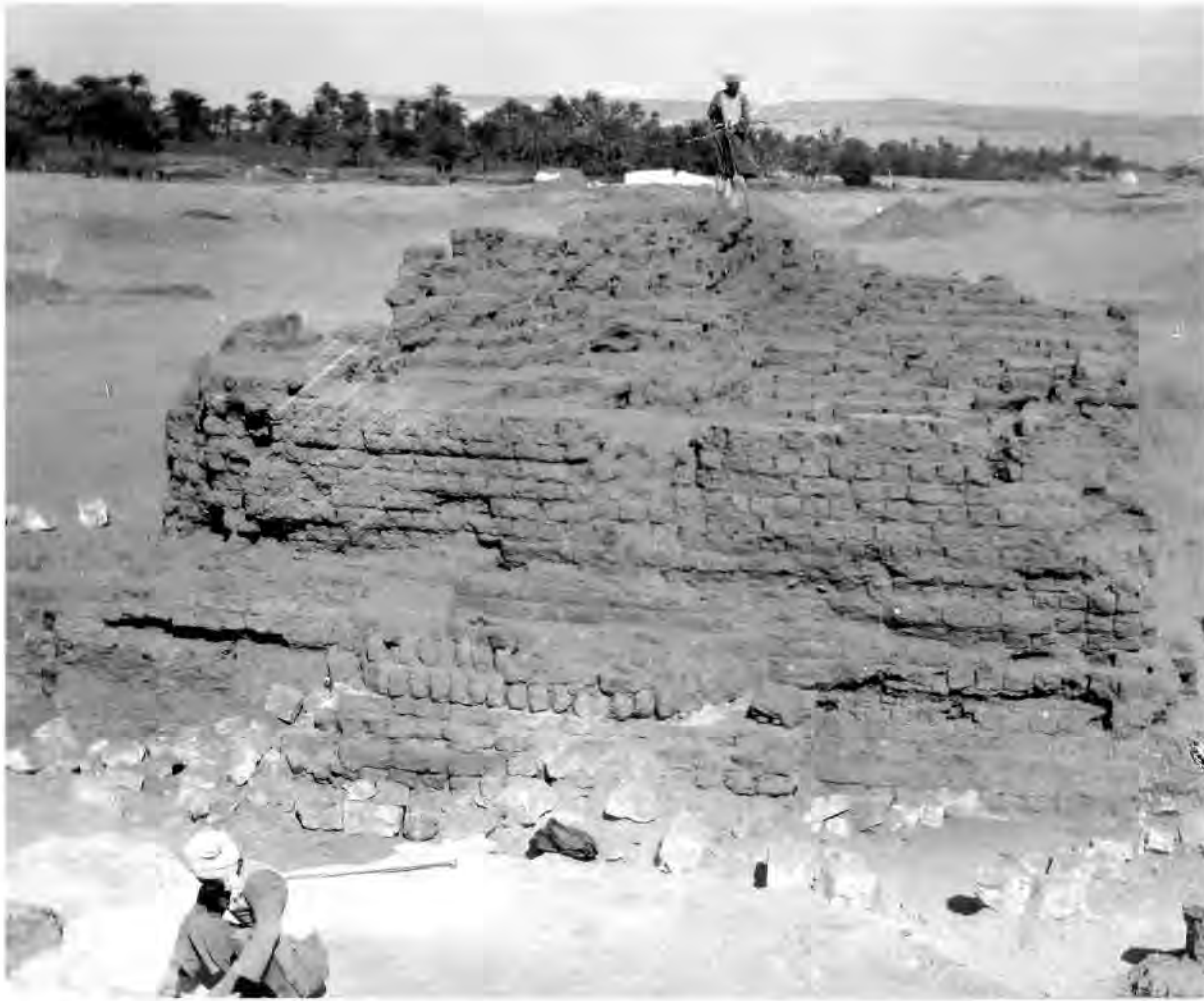
**Figure 6.16.** The gateway of the First Pylon during excavation in 1931, viewed to the north. Note the limestone blocks remaining from the platform, scarcely any of them, it would seem, *in situ*. Archive photograph 31/32.A127.

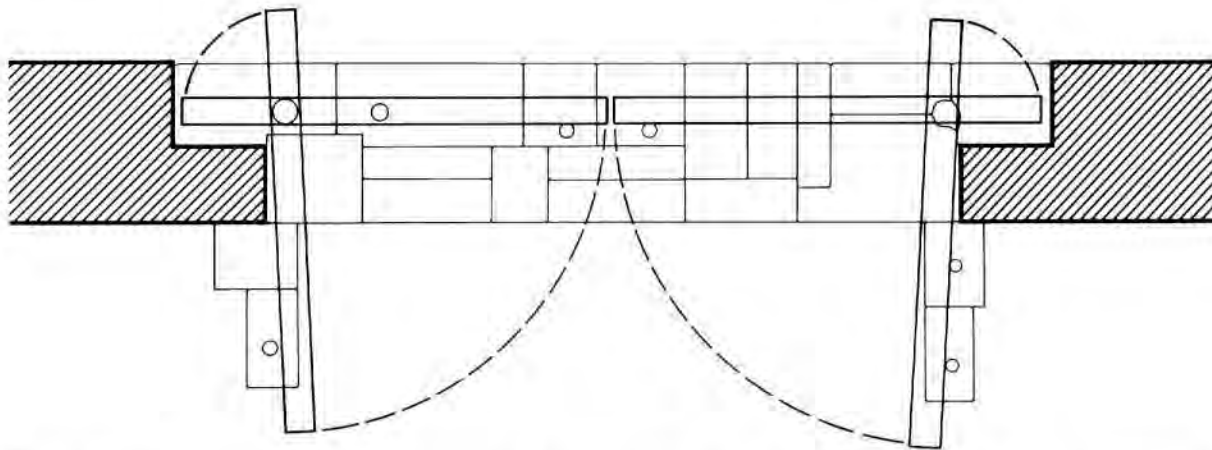
**Figure 6.17.** Plan of the outer gateway (after Lavers), with outlines of possible door arrangement superimposed. The edges of the stone blocks have been adjusted from the 1931 photograph (Figure 6.20).

The remains of the outer entrance create an interesting problem of interpretation. To Pendlebury the pattern of holes on the threshold blocks showed that the doorway had been closed with a pair of wooden doors, and the blocks which projected inwards became sockets "provided to bolt back the doors" (*ibid.*: 92). The doors would thus have opened inwards, but, if the design had been of the normal ancient Egyptian type, the projecting brick nibs would have been on the wrong side. Doors were normally designed so that the outer edge and pivots were screened from outside view behind the nibs, whereas here the pivot holes (if such they are) are placed for doors opening outwards (Koenigsberger 1936; Hölscher 1951: 29–30, 34–37). If there had been a wooden frame set in front of the holes, one would have expected some trace of its anchorage on the stones in the form of a rectangular hole for a tenon, or at least a patch of gypsum, but there is none. The difficulty is overcome if we assume that the architect, working in an architectural environment which was less tied to tradition than was normal, provided a form of door which was an improvement on the old design, in that the pivots were moved a short distance towards the centre of the door leaf, so distributing the weight of the door more evenly. The outline of a pair of such doors is superimposed in Figure 6.17 on to Lavers' plan of the stone blocks. The width of each leaf would have been 2.10 m. The outlines of the stone blocks have been adjusted

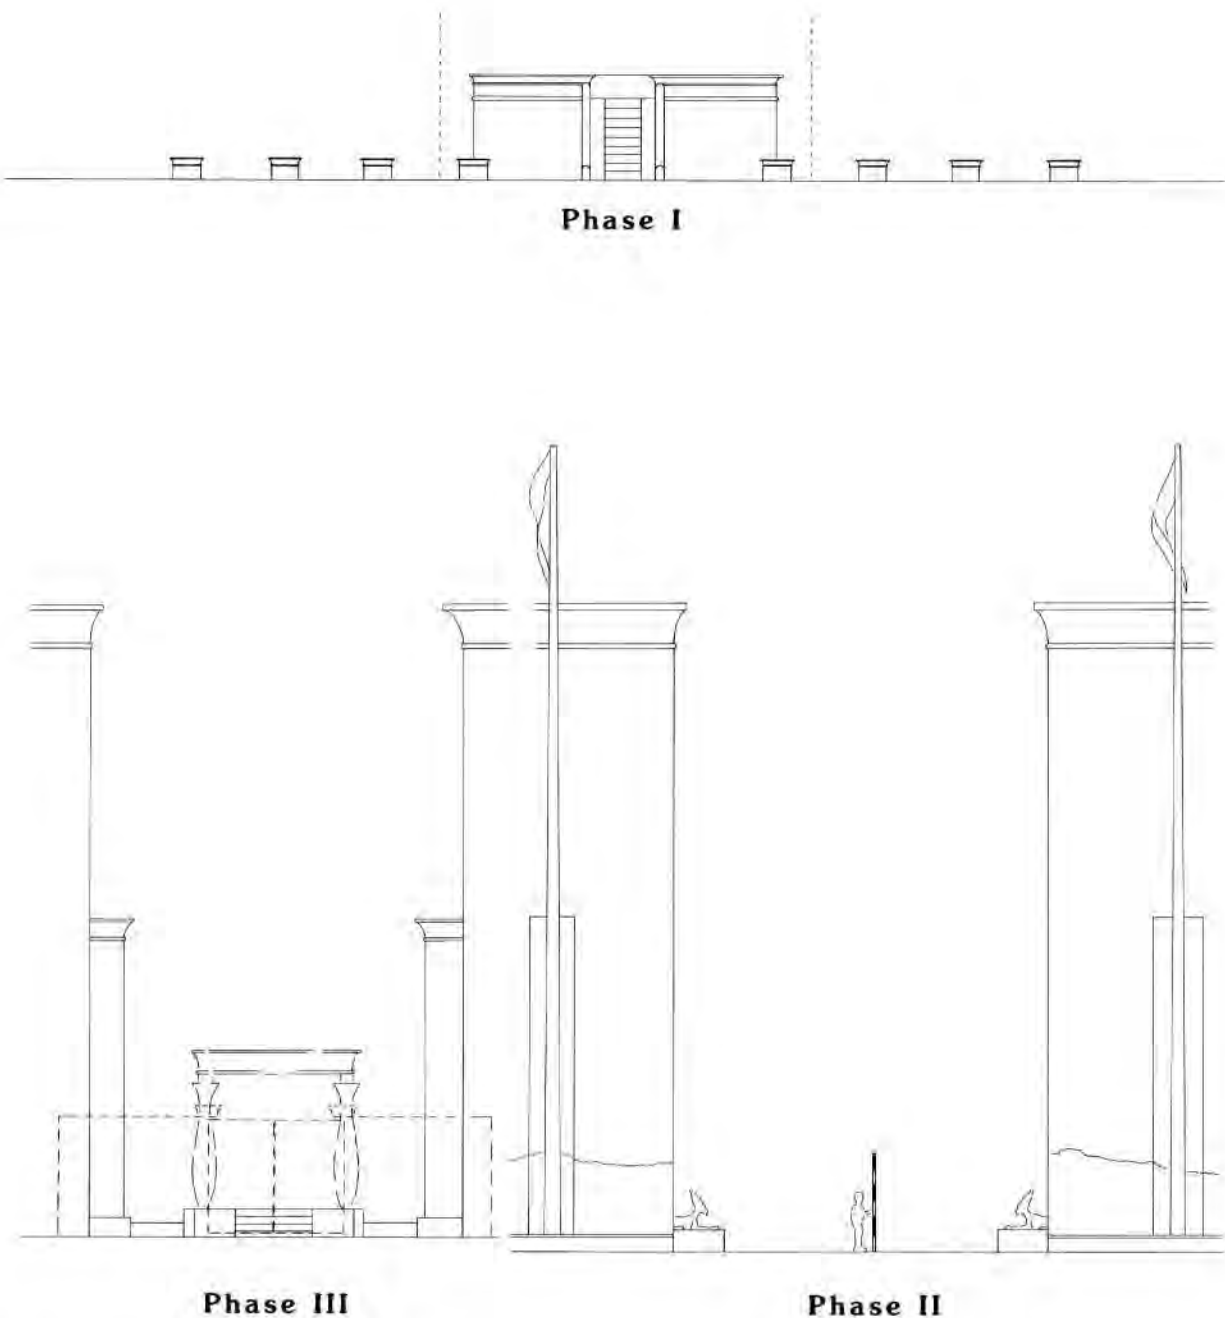
**Figure 6.18.** Restored elevations showing the suggested development of the gateway in the First Pylon.

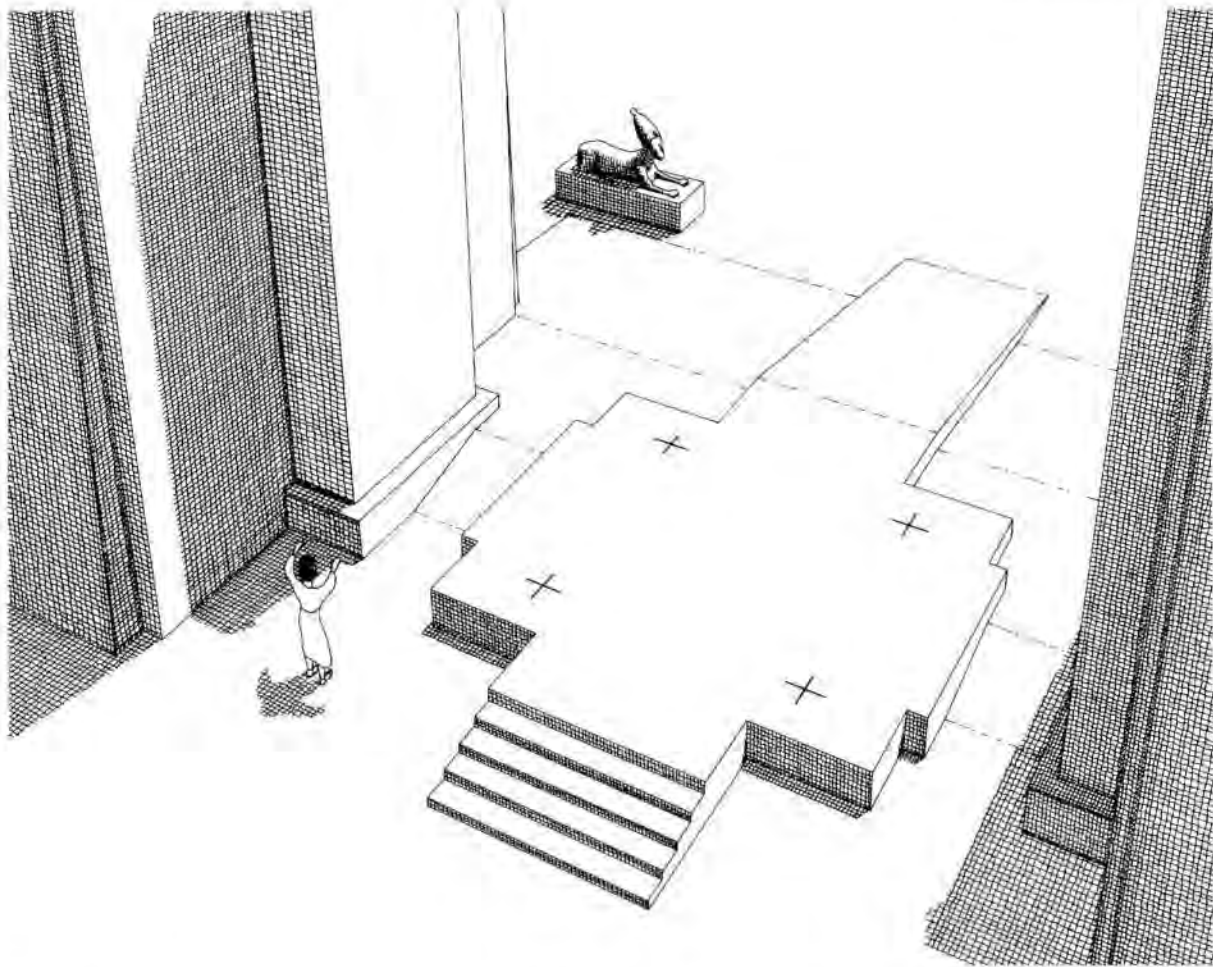
**Figure 6.19.** Restored perspective view of the gateway in Phase III. The crosses at the corners of the platform mark the positions of hypothetical columns to support a canopy.

In summary, the overall form of the temple gateway in Phase III (assuming that it followed its floor plan) would seem to have been a central square limestone platform approached from inside by a ramp (Figure 6.14) and outside possibly by steps, with two side ramps bypassing between it and two projecting brick nibs attached to the side faces of the pylon towers (Figures 6.18 and 6.19). This platform carried perhaps a canopy or wooden doors, on the assumption that the irregular extensions to north and south indicate the footings of some kind of frame (see reconstruction, Figure 6.19). The platform would have been protected from the outside by the projecting wall [3909] with its wide gateway closed by a pair of pivoting doors. The platform would have afforded the double use of both a ceremonial entrance and also a place of presentation to the Royal Road outside.

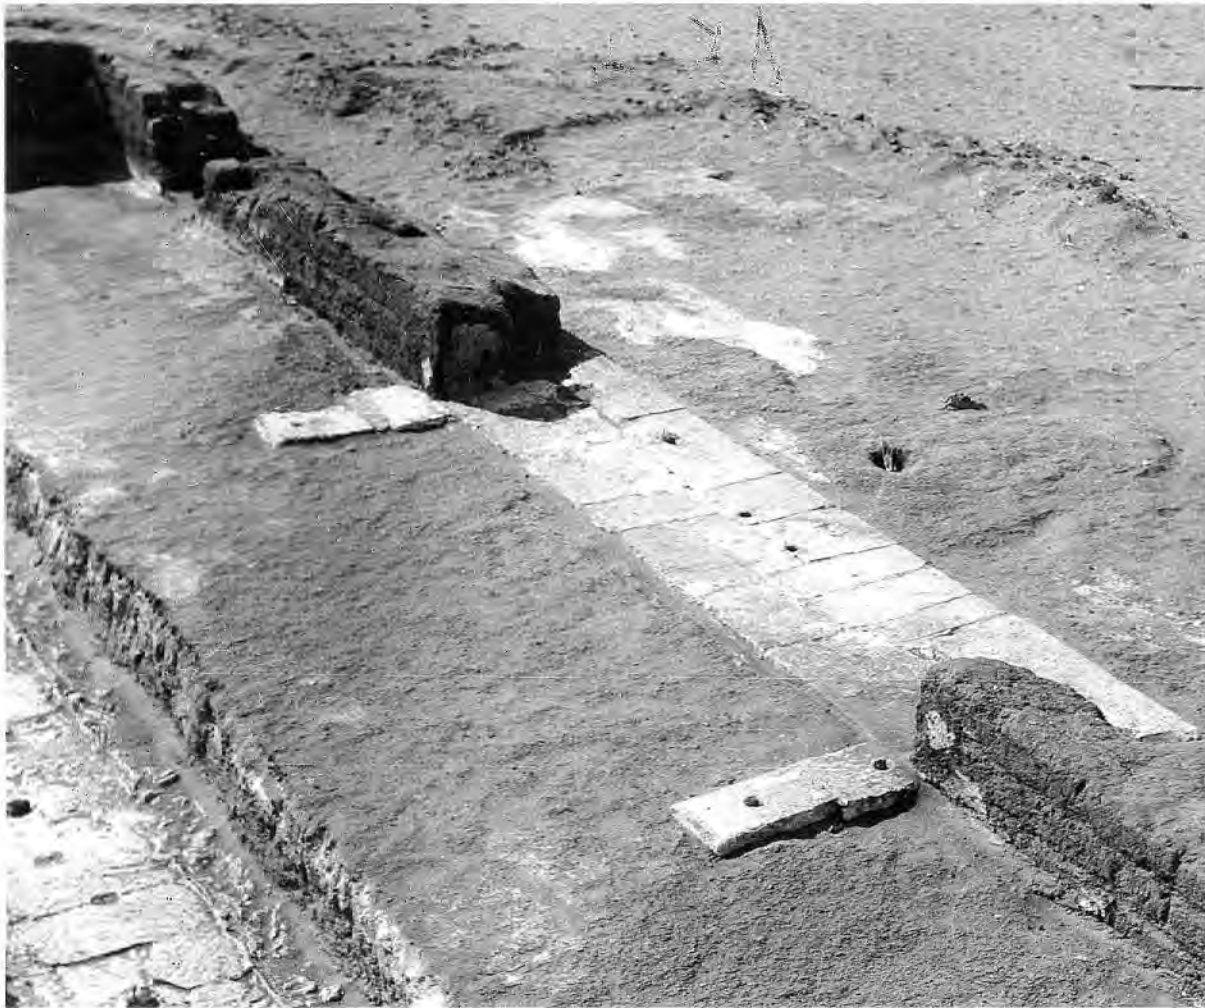
**Figure 6.20.** The outer gateway in front of the First Pylon, as excavated in 1931. Archive photograph 31/32.A155.

slightly from an examination of the 1931 photograph (Figure 6.20).

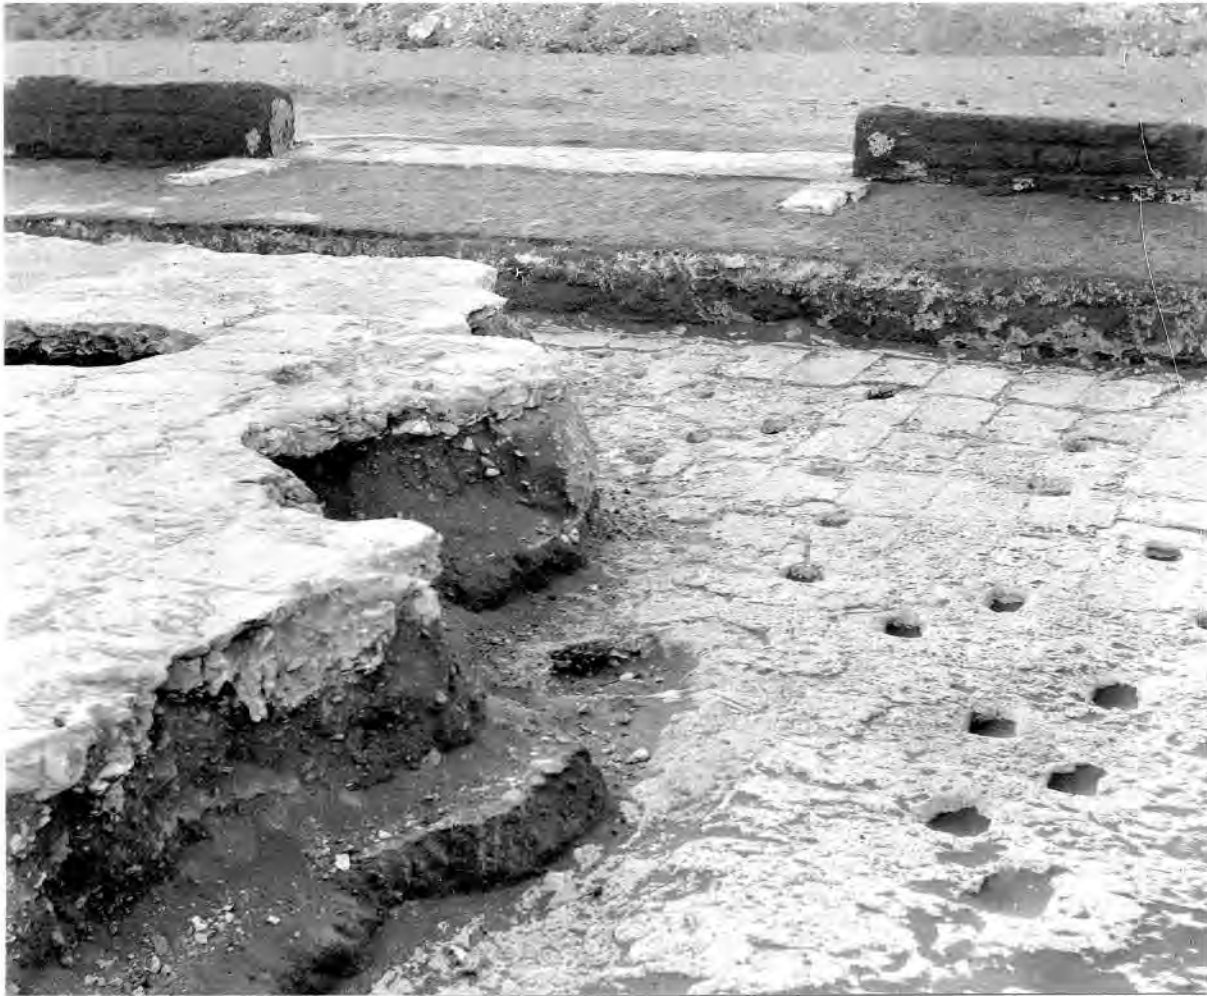
**Figure 6.21.** The gypsum foundations for the upper layers of stone of the platform in the centre of the gateway, viewed to the south-west at the end of the 1931 excavations. The outlines of stone blocks are visible. Archive photograph 31/32.A199.
