## CHAPTER 6

REPORT ON THE 1987 EXCAVATIONS  
INVESTIGATION OF THE SMALL ATEN TEMPLE

Michael Mallinson<sup>1</sup>**6.1 Introduction**

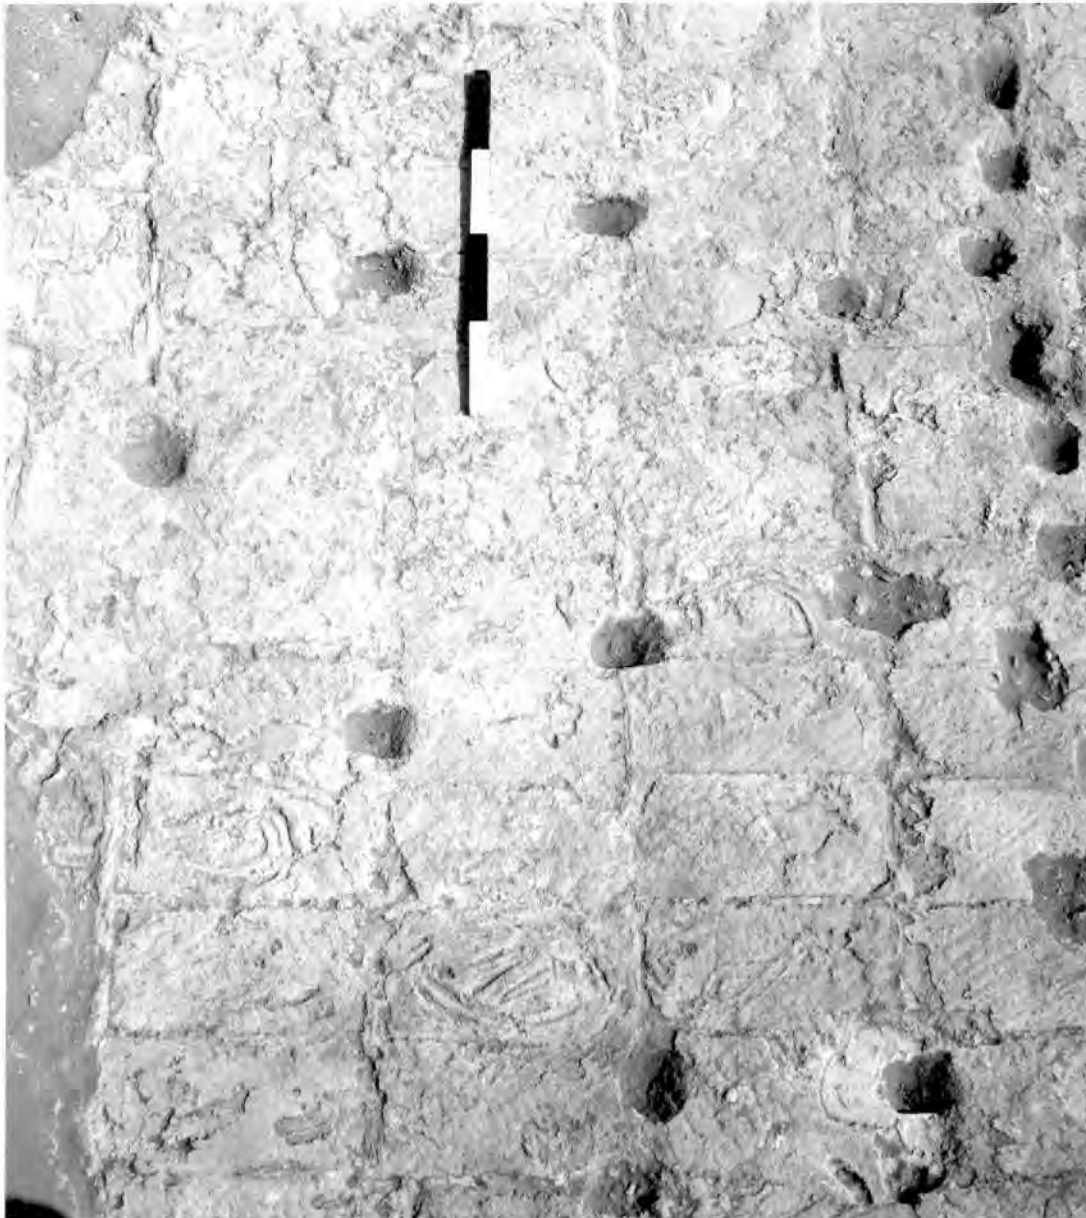
**Figure 6.22.** The south-eastern portion of the gypsum floor of the First Pylon, viewed to the north.

Island Pavilion, the Great Aten Temple and the North Palace, together with the building at Kom el-Nana (Kemp 1978: 26–34). As already noted, the Phase IIa floor was much damaged and cut about in preparation for the new entranceway and its bricks incorporated into the approach ramp from the interior to the new level. The prepared floor was then covered in a 50 mm-thick layer of gypsum plaster [3253] (Figures 6.11 to 6.13, 6.21). On to this plaster was laid the lowest level of stone blocks, the first layer of gypsum receiving a thin bonding layer of gypsum shortly before the blocks were placed. This may have been on the blocks themselves, which might explain the high quality of some of the marks left when this level of stone blocks was removed. Fingermarks of the masons can still be seen where they spread the gypsum to give a good area of cohesion shortly before laying the blocks (Figure 6.22).

Between the block-impressions left behind is a series of deep post-hole like pits set in the gypsum (Figures 6.11, 6.21, and 6.22). Similar marks on a gypsum foundation pavement can be discerned on Newton's plan of one of the buildings at Maru-Aten (*COA I*: Pl. XXX, the southern building of Group II, mainly around the northern edge). They must have been made while the plaster was still wet. One explanation which could be considered is that the blocks were laid from a trestle which was moved backwards as the stones were laid and so the holes were left by the trestle legs. However, in that case one would expect regularity in the placing of the holes, which

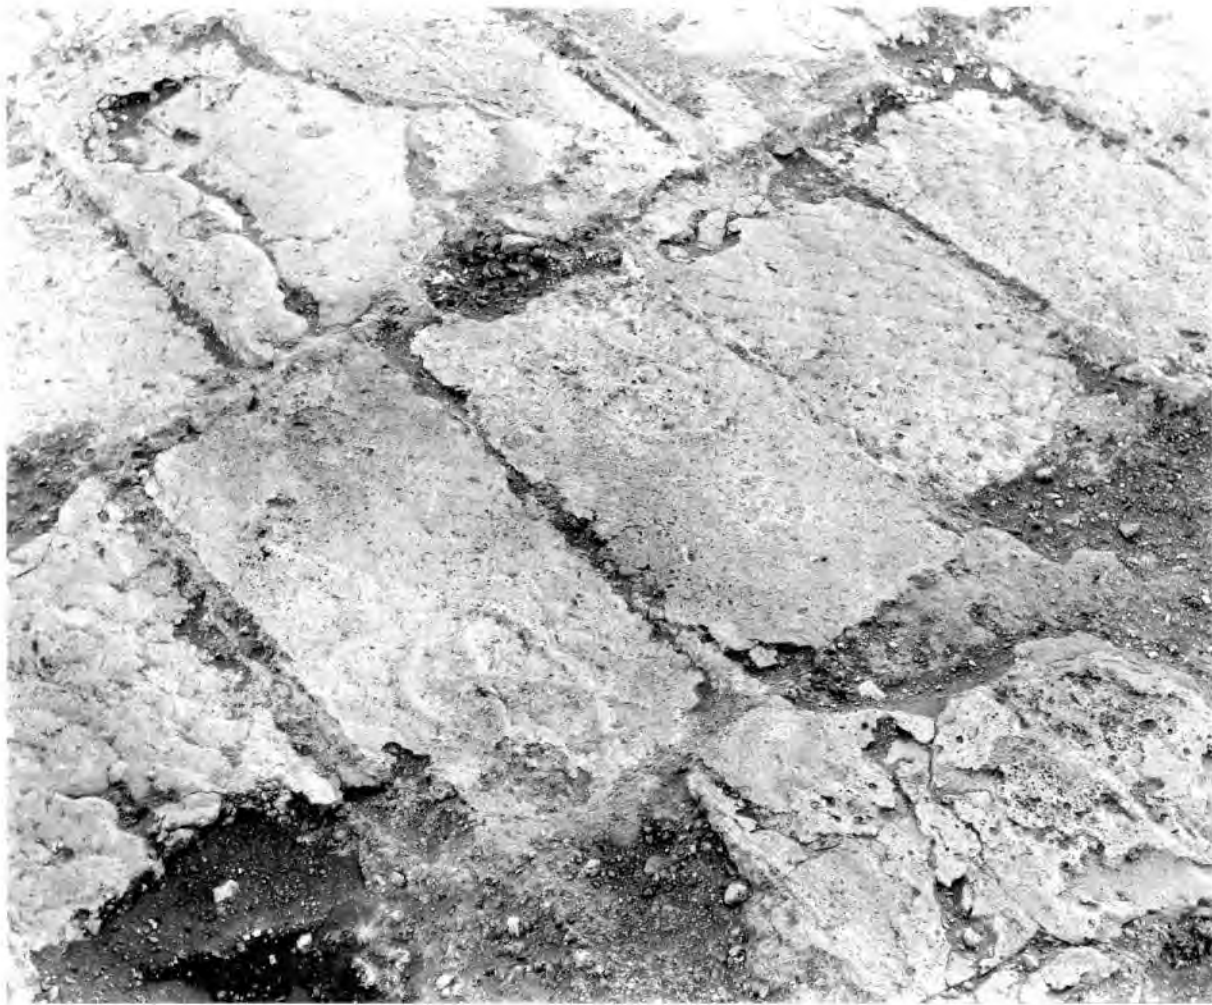
**Figure 6.23.** A portion of the gypsum floor, photographed in 1931, showing masons' marks. Archive photograph 31/32.A194.

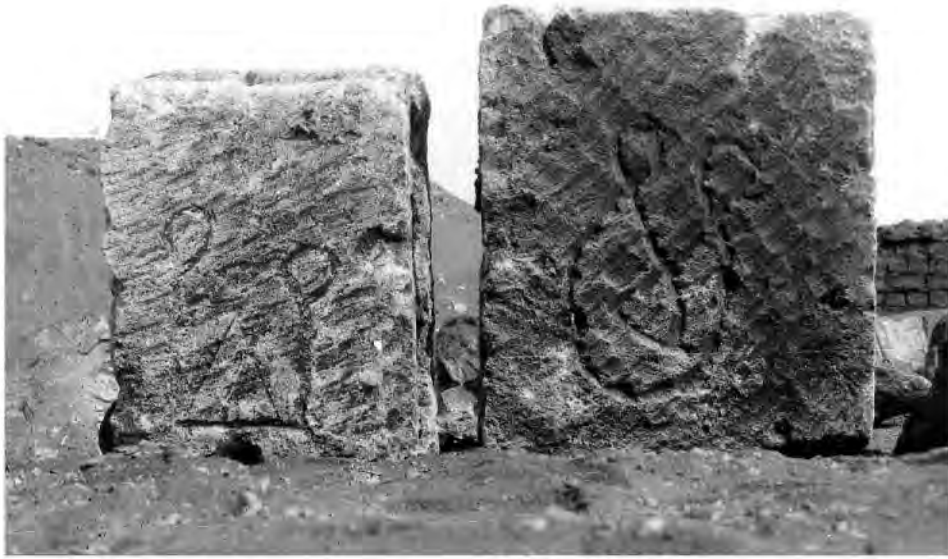
Figure 6.24. Two limestone blocks with masons' marks found and photographed in 1931. Archive photograph 31/32.A256.

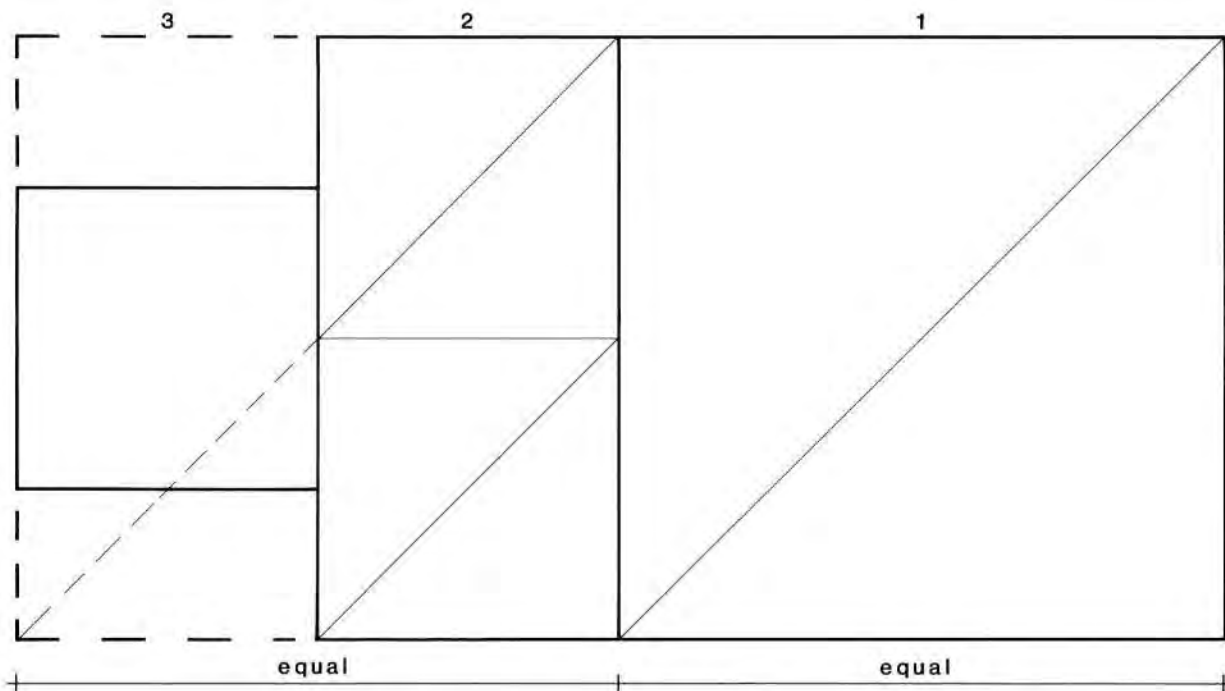
Figure 6.25. The Great Altar: proportions.

The stonework of the entranceway seems to have been a standard 52 x 26 x 20 cm high. These dimensions correspond to the Royal Cubit and thus ensure that the dimensions of the gateway are in whole cubits: 16 x 20 cubits for the gate, the Central Platform being about 8 x 8 cubits. The Ramp is 14.5 cubits long by 5 cubits wide. These proportions are not elaborate but approximate to 4 x 5, 1 x 1 and 1 x 3 quite well. On the Great Altar there is no obvious use of the golden proportions, rather the Double Square prevails. The whole construction is a double square, the smaller of the larger sections (2 in Figure 6.25) is a double square, and the large section 1 is square. These proportions show that a simple proportional system was used, one easily executed using rope and pegs and possibly worked out on the ground as the builders went along.
