CHAPTER 1

REPORT ON THE 1987 EXCAVATIONS THE EXCAVATION OF HOUSE P46.33

Site supervisor: Ann Bomann

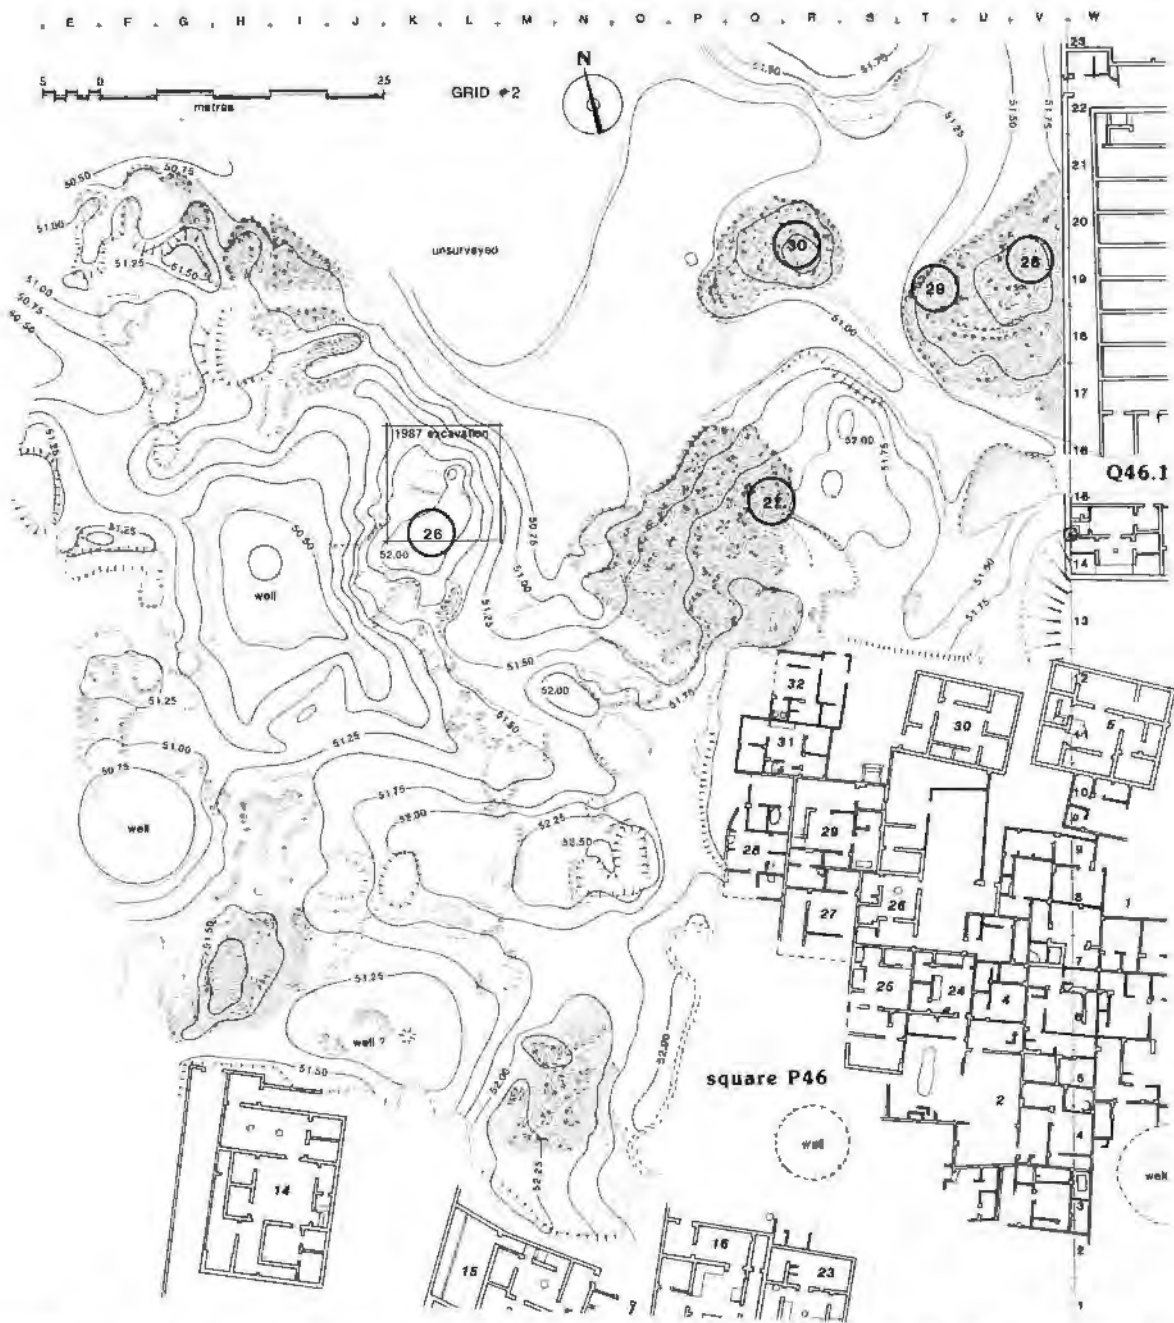
Figure 1.2. Eastern end of the research strip freshly mapped in 1987 in more detail. The reference marks for Grid no. 2 are included, as are the sherd-survey circles 26–30. Contours are at quarter-metre intervals.

The area of more intensive mapping (Figure 1.2) has not suffered as badly as many. This is because it lies towards the furthest limit away from the modern cultivation. The most conspicuous local feature is the large house excavated by the DOG in 1914, Q46.1, the so-called "Weihnachshaus" (Borchardt and Ricke 1980: 23-7, Plan 2). The line of its western enclosure wall is still clearly visible and served as a convenient base line for the mapping, and for laying out the excavation grid, Grid no. 2. The co-ordinates for this grid are marked on the map. The originating point for the grid is a wall junction in the small building at the south-west corner of the compound surrounding Q46.1. The reason for choosing this rather than the actual corner of the compound itself is that the latter is deeply buried by an excavator's dump which probably derives from the Society's own excavations in 1923 (see below). In order to expose the wall junction that we used the tail of the dump had to be removed, instantly bringing to light a cache of pottery within a deposit of sand which lay on the floor of the little building in the south-west corner of Q46.1. The cache has an interesting repertoire of forms which now awaits study. This little discovery was a timely reminder that any "cleaning" of the site, even of apparently excavated areas, can produce fresh archaeological material and should not be undertaken lightly.

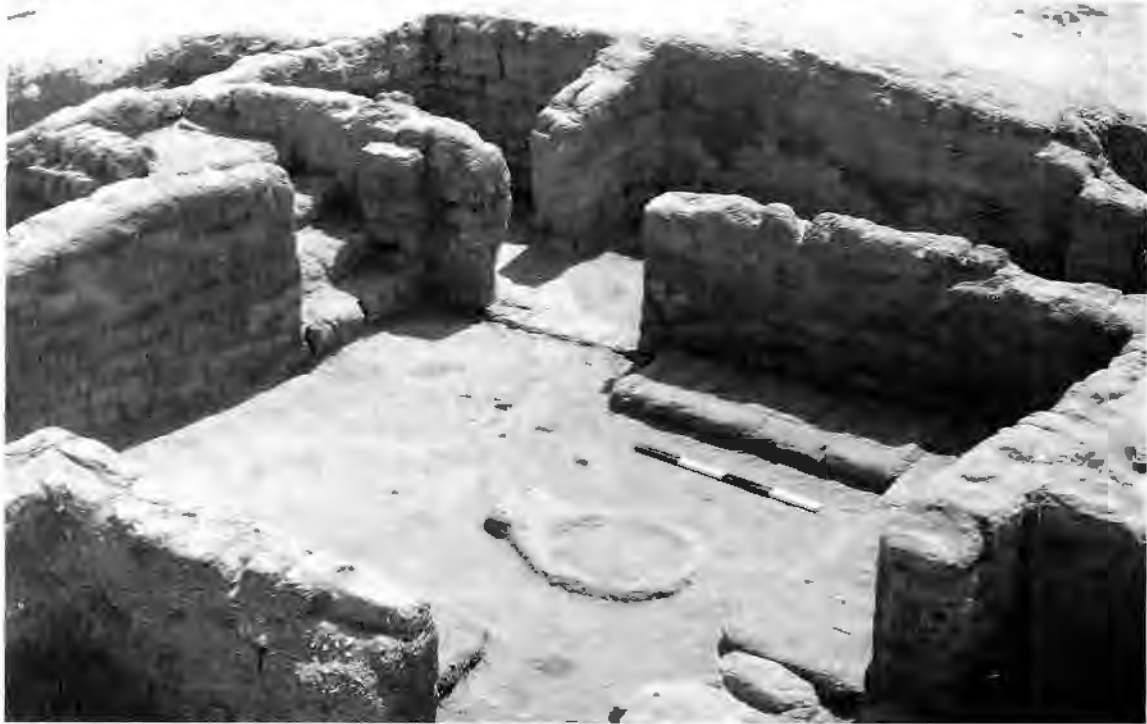
Figure 1.6. House P46.33 viewed to the south-east at the close of excavations.

Area 3, measuring 3.35 (NS) x 3.83 (EW) m, served as the Central Room for the house (Figures 1.6, 1.9). Patches of an original mud wall plaster (without traces of whitewash) remained on all four sides, and ran down behind both of the daises. It was entered from the outside via a doorway, 1 m wide, from area 1, across a brick threshold [3884]. Although the sides of the doorway were rounded from wear, the top surface of the brick threshold was relatively fresh, as if it had not been exposed to traffic, whilst at either end two circular pats of mortar had been pressed flat, and the bottom parts of the brick jambs had been cut back by c. 13 cm to a depth of c. 17 cm on the outer side of the wall (Figure 1.8a). These are signs which, when taken together, point to the original existence of a separate threshold with projecting tongues on the outer edge which had been laid down over mortar pads at either end. A slight ridge between the mortar pads on the east side could be interpreted to show that the threshold had consisted of two narrow wooden beams or planks, the outer slightly longer than the inner. It is logical to suppose that a built-in threshold supported a full doorframe for a closing door.

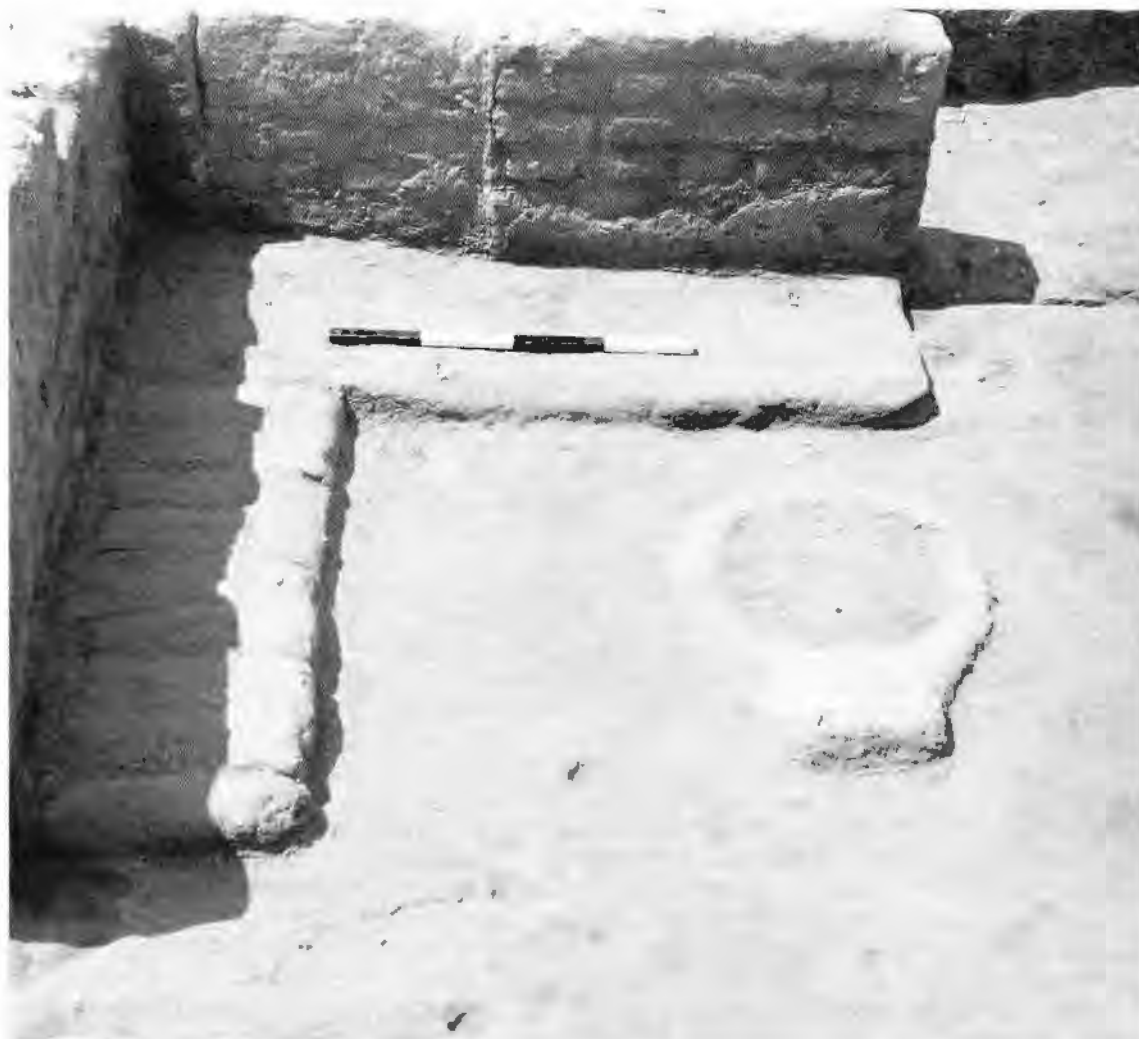
Figure 1.9. View to the west of the dais and hearth in the Central Room, Area 3.

The internal walls of all excavated rooms apart from areas 2 and 4/5 bore patches of mud plaster tempered with straw (Figure 1.9 illustrates a good example). Nowhere, however, was any white colouring found. A few traces were noted within and around the house of a yellow pigment. Some were on three of the loose bricks in unit [3333], the result of wall collapse into area 7; a deposit was found inside an amphora in rubble deposit [3186] in area 13 (traces of red

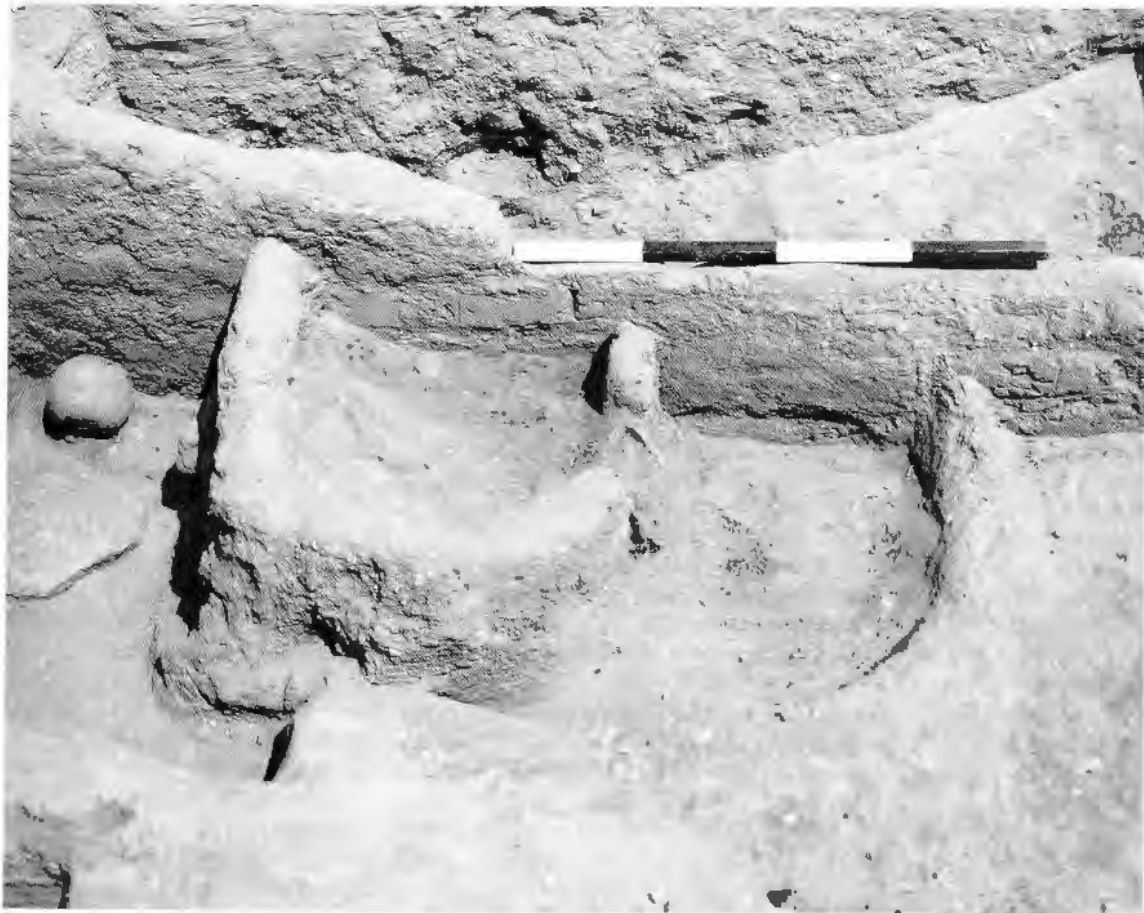
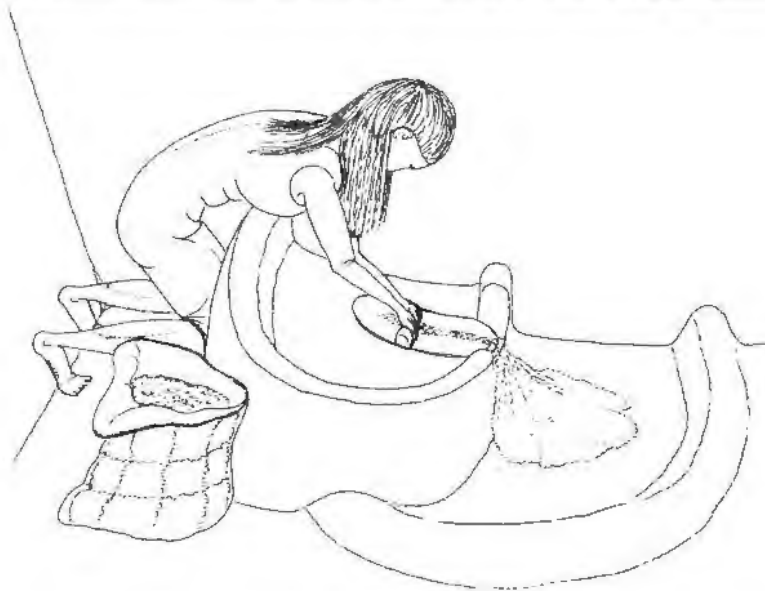
Figure 1.11. (a) view to the north of the quern emplacement in area 13; (b) reconstruction of quern emplacement showing likely method of use.

It is to be expected that the taller part of the emplacement contained a quern stone (see the discussion in *AR* V: 260-3). A large piece of quartzite of irregular outline [3308] lay against the south side of the emplacement. Of its surfaces only the top was smooth. With the top surface measuring 51 x 35-19 cm, and a thickness of 16 cm, it is considerably larger than the usual

quern (an example of which [3305] was found in area 11), and also much heavier. If set sideways in the emplacement (its long dimension north-south) it would fit into the area of surface damage to the interior of the emplacement, although this had very ragged edges and no sign of a “scar” from the removal of such a stone. It might be expected that the removal of such a large and heavy piece of stone would have inflicted much more damage on the brick emplacement, and it is probably more sensible to consider that this large stone was used for grinding in the place where it was found, on the floor, and that a normal quern stone (e.g. [3305]) had originally been set in the emplacement. Behind the emplacement, in the short space (c. 50 cm) between it and the wall of the house [3080], a rough flattish stone lay on the mud floor, measuring c. 37 x 30 cm, and 9 cm thick. If in its original position, it could have helped to support the feet of the person who leaned forward here to do the milling (Figure 1.11b, for the position adopted see AR V: 270, Figure 12.12). It should be added that this area also produced three stone rubbers or hammerstones (object nos. 8422, 8423, 8519, Figure 2.29).

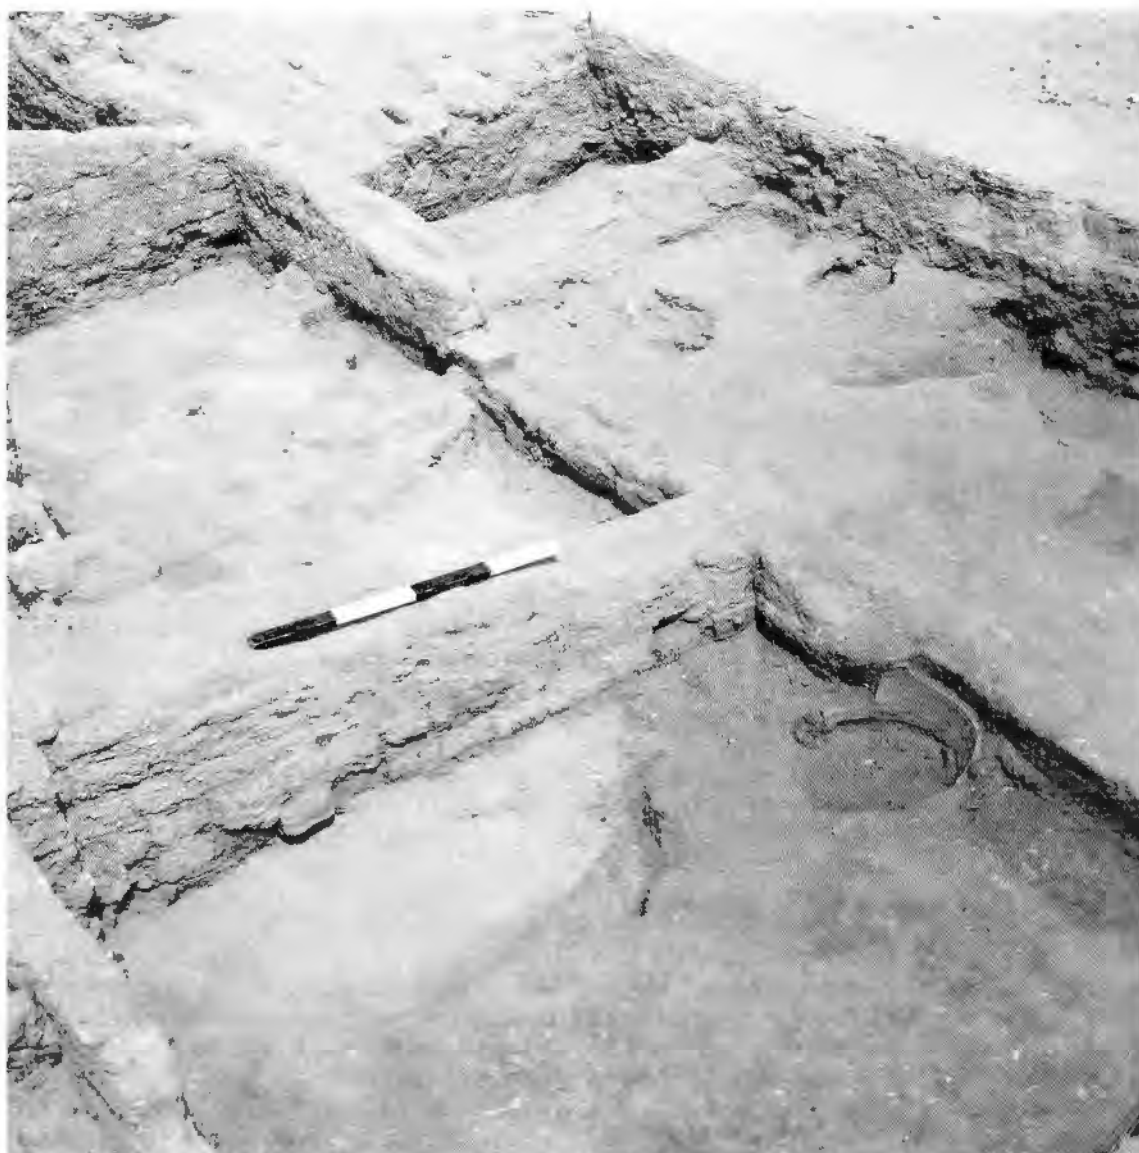
Figure 1.13. The northern part of the house and adjacent space, **area 15**, at the end of excavation, cleaned to floor level, with the base of pottery oven [3811] in the north-west corner of **area 14**. **Area 15** lies beyond, also cleaned to floor level. The collapsed wall [3174] still covers **area 16**. View to the north-west.

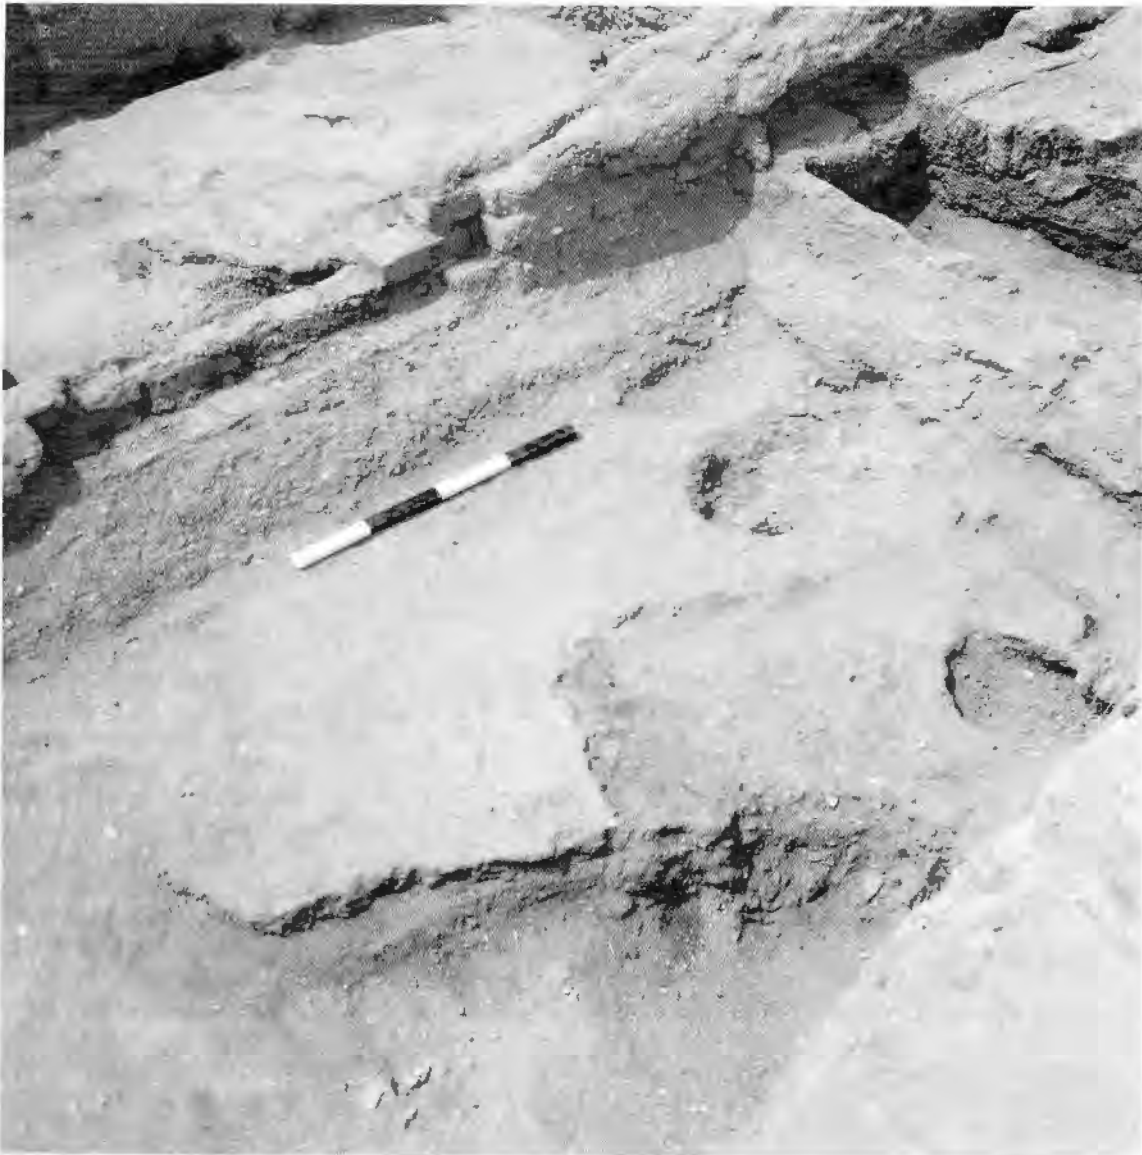
Figure 1.14. Mostly area 15 with mud floor [3756] exposed. Note the sloping base [3800] to wall [3231] in the background. In the foreground lies the unexcavated pit. View to the south-west.

The south-west corner area of **area 15** (that part protected by walls) was largely covered with a two-layered mud floor, an upper [3756] of 16cm and a lower [3813] of 4 cm, separated by 1.5 cm of sand and gravel [3891] (what appeared to be a floor [3888] was also noted beneath the

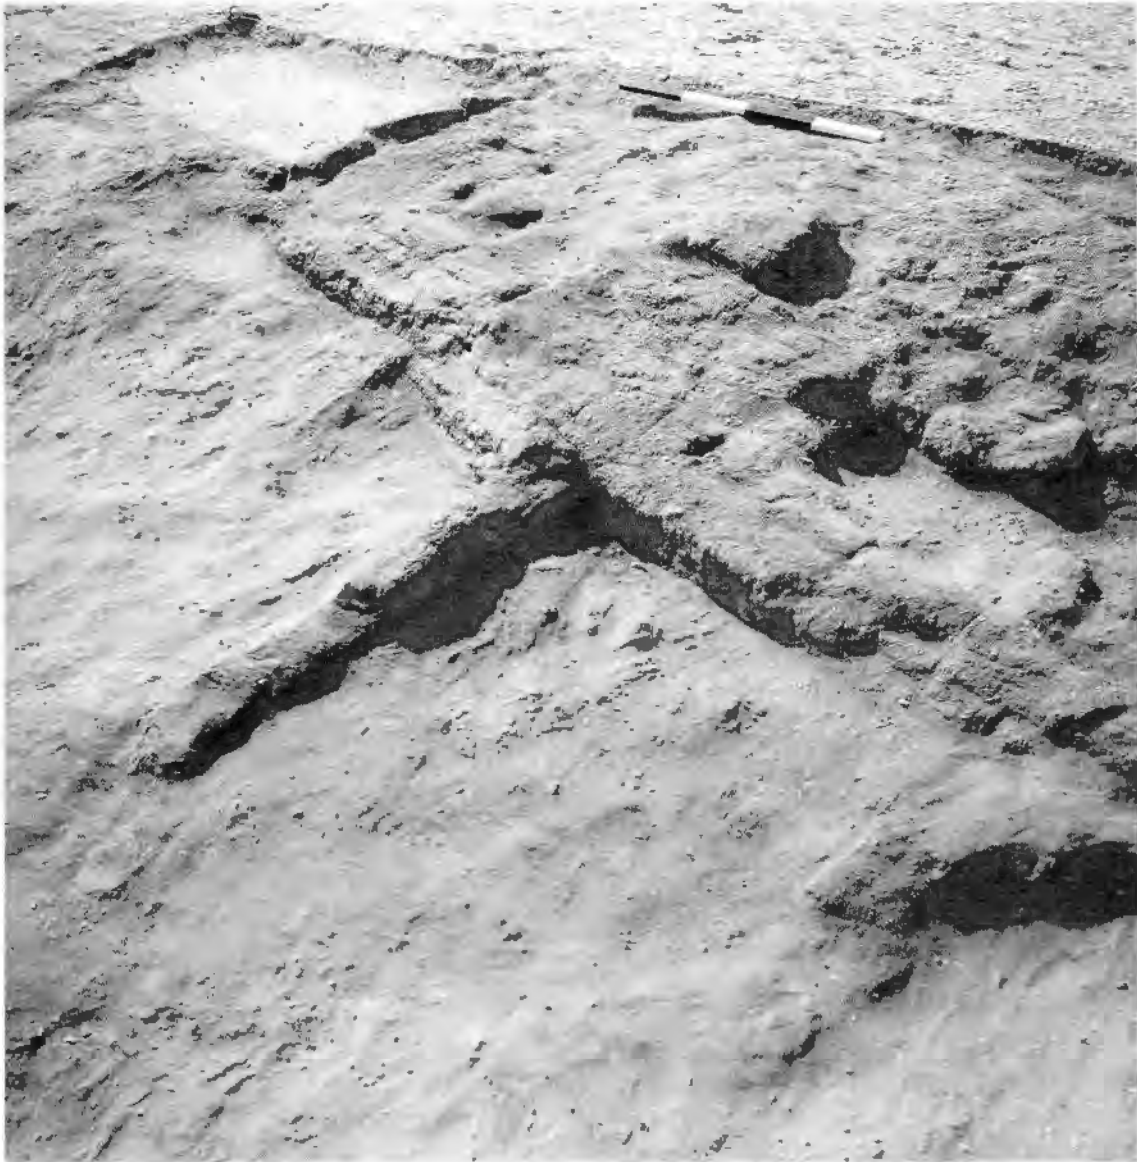
Figure 1.18. Square L15 viewed to the south-west after removal of the topsoil. Wall [3080] crosses the picture diagonally. Rubble fills the staircase, areas 4/5 in the upper right of the picture, sand and rubble fill areas 11–14 in the lower and left part.

With **area 11** we move to the group of spaces (**areas 11 to 14**) which adjoined the house on the east. In all of them the fill deposits tailed off steadily towards the east. Over the floor lay 20 cm of decayed brick rubble [3185], to a large extent reduced to silt. Incorporated within it was the collection of objects marked on the plan, Figure 4.11. It was sealed by a layer of collapsed brickwork [3071] a good part of which had retained the shapes of the individual bricks. The visible pattern of collapse showed that the southern part had almost certainly fallen northwards from the southern wall of **area 11**, which was not exposed by excavation, whilst a patch on the north could perhaps have fallen from wall [3098]. The pattern of bricks is a clear demonstration that it had remained undisturbed since it fell; nevertheless, despite its origin and relative height above the floor, it yielded objects (including two stone grinders or rubbers, nos. 8370 and 8430, from near the north-west corner), as well as sherds and bones. Following the collapse of the walls a layer of sand [3069] had accumulated over the rubble (Figure 1.18).

Area 13 contained the quern emplacement which had suffered little damage, despite the fact that the tops of its walls projected slightly above the rubble fill. The narrow surrounding spaces were floored with an ashy-silt deposit [3188]/[3226] which was probably contemporary with the period of occupation; above this and partly over the quern emplacement lay a mixed deposit of sand and brick rubble, the greater part of which was designated unit [3072], with a depth of around 23 cm, which formed a continuation of unit [3071] in **area 11**. Part of this unit (which included the stretch of articulated bricks [3227]) comprised bricks fallen from the adjacent walls (probably in the main from wall [3098]). It also included mud roofing fragments, thus indicating that, in all likelihood, the quern room possessed a solid roof. An area of sandy rubble [3186] which lay over the basin [3302] attached to the quern emplacement was treated separately, and found to contain part of an amphora which had been re-used as a container for yellow pigment, and a hammer stone (object no. 8423). All of these rubble-fill units were sealed by a deposit of sand and weathered rubble from the decay of the house [3068] (Figure 1.18).

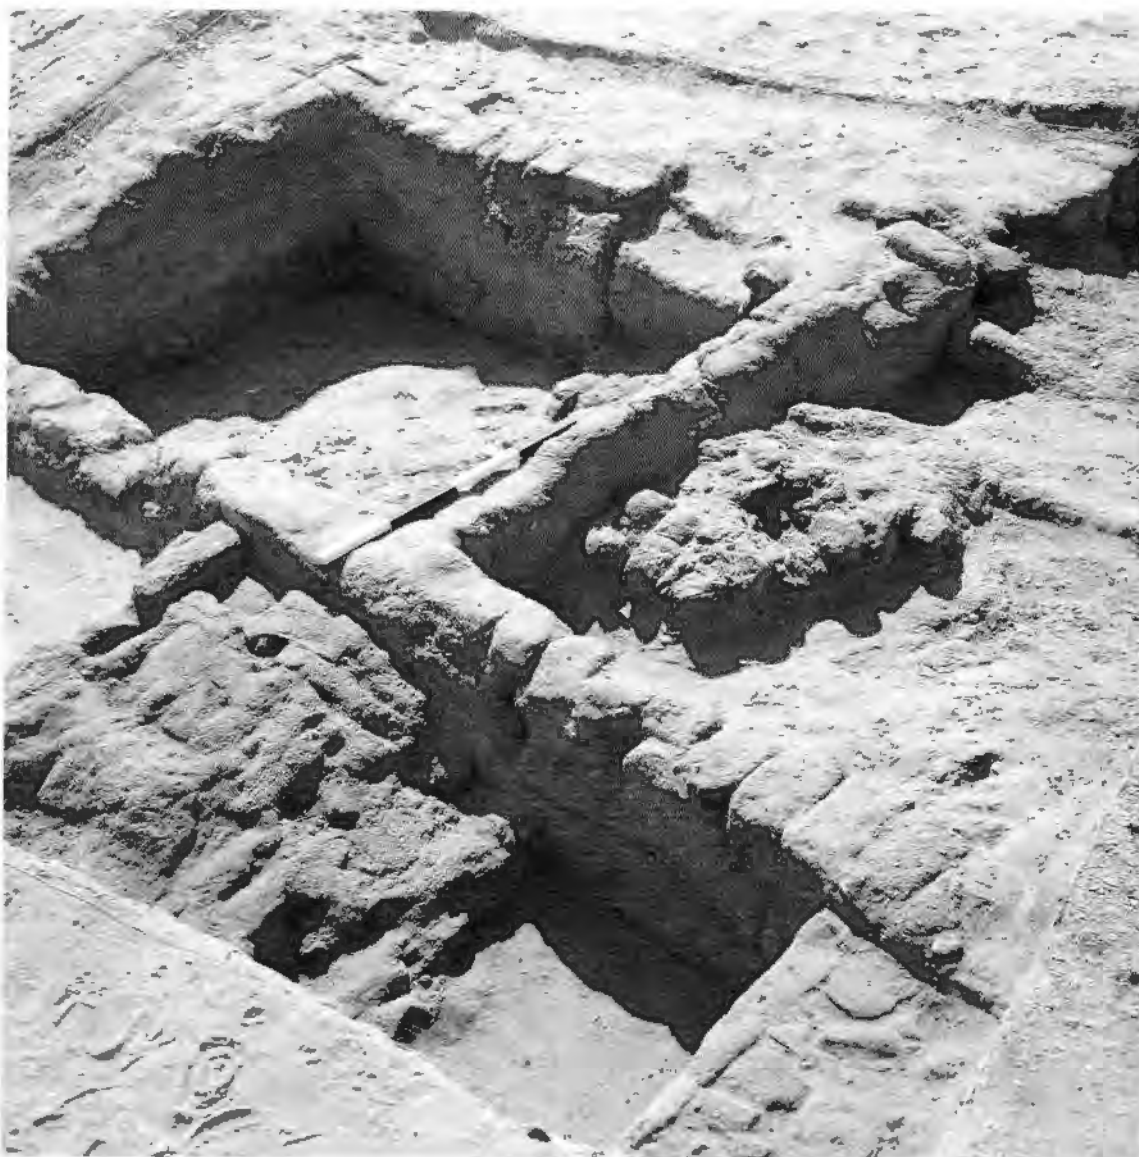
Figure 1.19. Square K16 viewed to the south-east following removal of superficial deposits. The deeply exposed room is area 6. Behind is a small strip of area 3 with rubble filling it almost to the surface. Area 17 lies in the foreground.

The north-west corner room of the house, area 6, stood out by virtue of the small quantity of rubble found (Figure 1.19). The remains of the mud floor were wholly covered by a deposit of coarse reddish sand and gravel [3178], about 23 cm thick. It was in this deposit, in the north-west corner of the room, that the two mud jar stoppers (nos. 8426 and 8427) were found. Over the eastern two-thirds of the room this passed directly upwards into a further deposit of sand [3033]. Of rubble there were two deposits: a lens [3171], with a maximum width of 73 cm and depth of 21 cm, which lay along the west wall [3235] and looked as though it had fallen from it as a result of a channel having been scoured by weathering into its face; and a thin patch of decomposed rubble in the south-east corner in the top of unit [3033]. The rubble fill in rooms comes primarily from the collapse of walls, so that its general absence here is presumably to be explained by the fact that the surrounding walls generally collapsed outwards. Even so, however, one would have expected there to have been a layer of earth or rubble on the floor from the fall of the roof, but of this there was no trace at all. One is therefore led to conclude that this room was open to the sky and began to sand up once the house was abandoned.

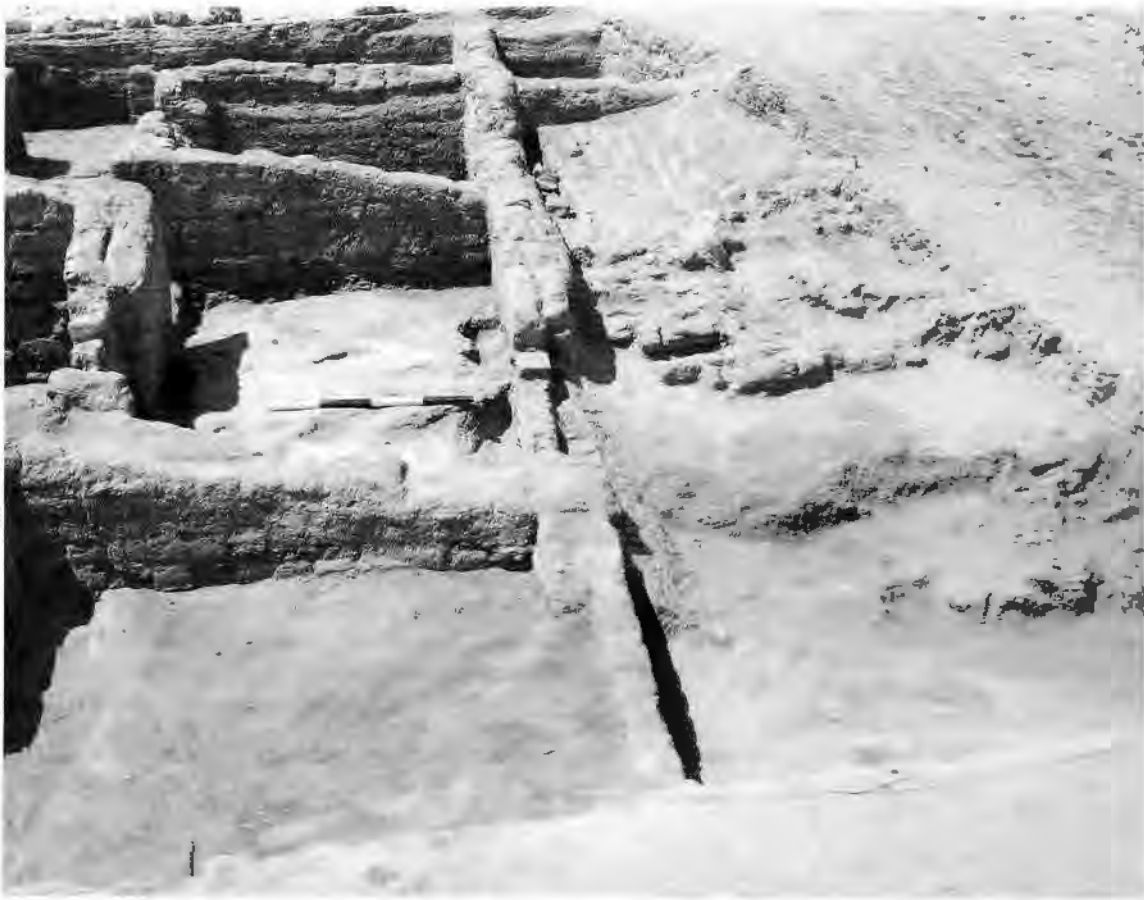
Figure 1.20. The northern part of house P46.33 and adjacent space, **area 15**, with fill units removed to expose floor deposits; also the spaces to the north, **areas 15–17**, with the lower fill units exposed, principally the collapsed wall [3171] and deposit [3754], which contained the Late Period sherds. View to the west.

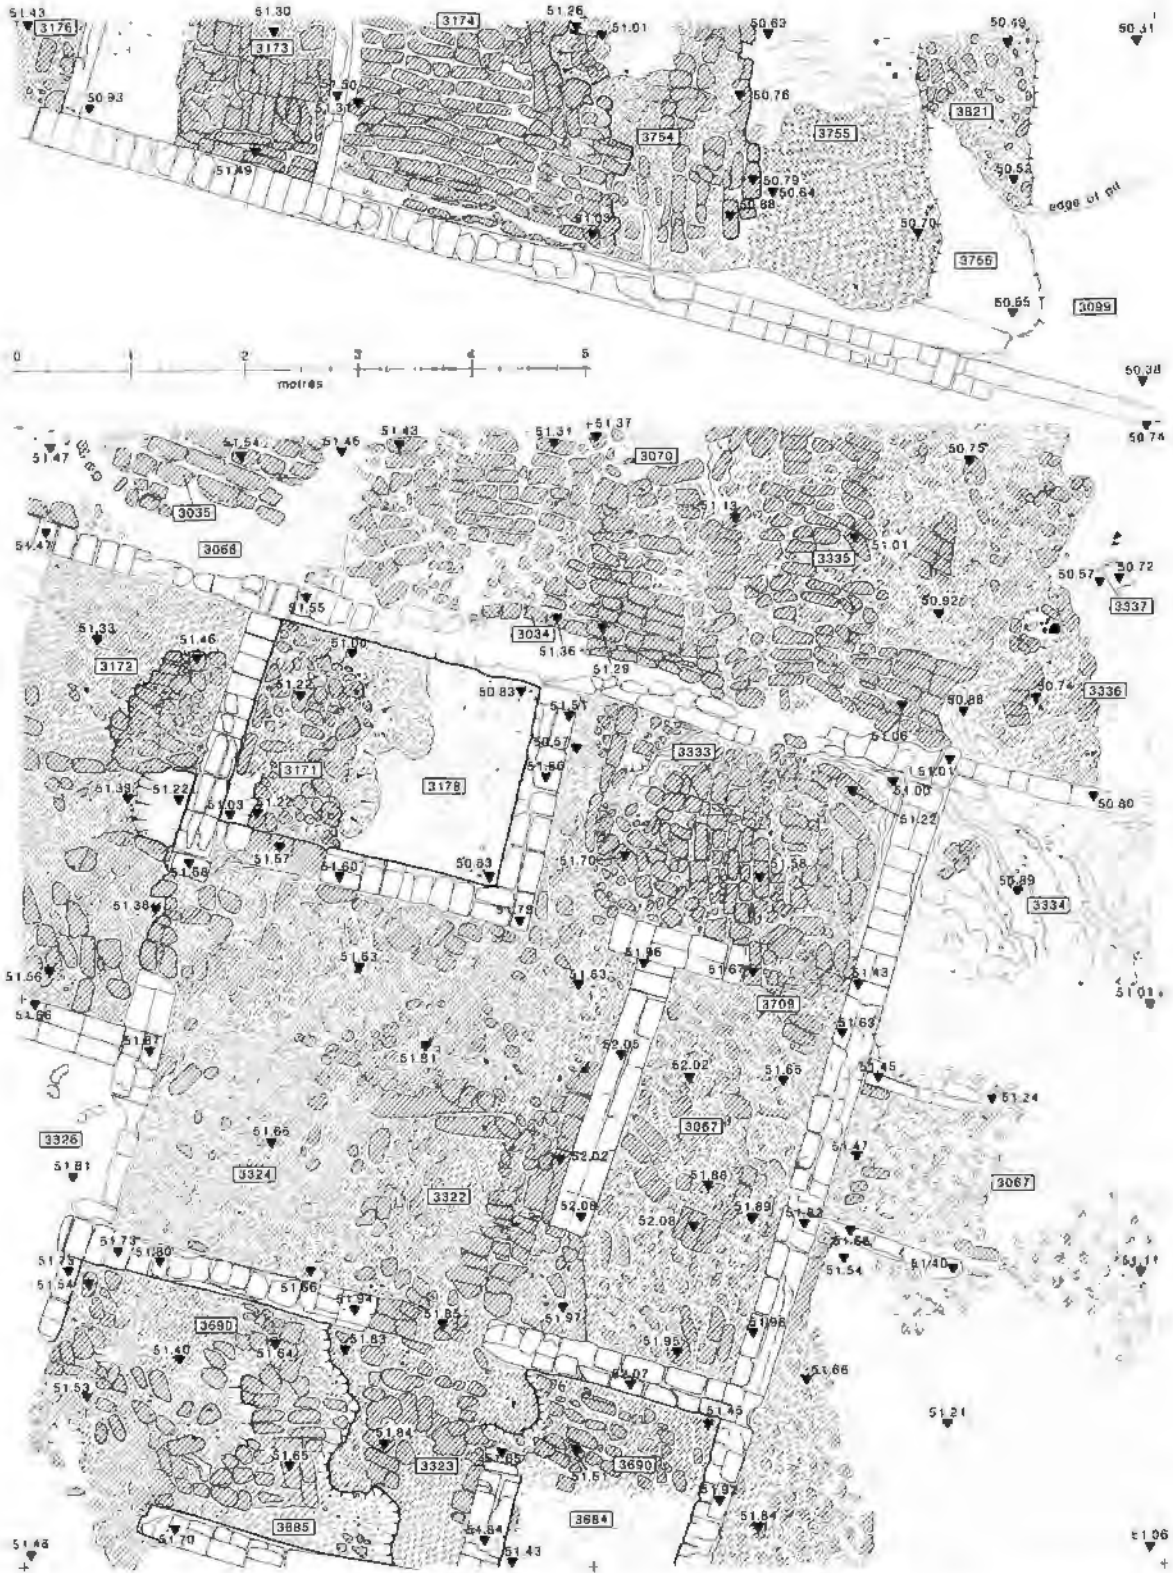
Figure 1.21. Plan of the fill units in house P46.33. The separate plan along the top is at a lower level. Originals by A. Bomann.
