CHAPTER 4

SITE FORMATION PROCESSES AND THE RECONSTRUCTION OF HOUSE P46.33

Barry J. Kemp

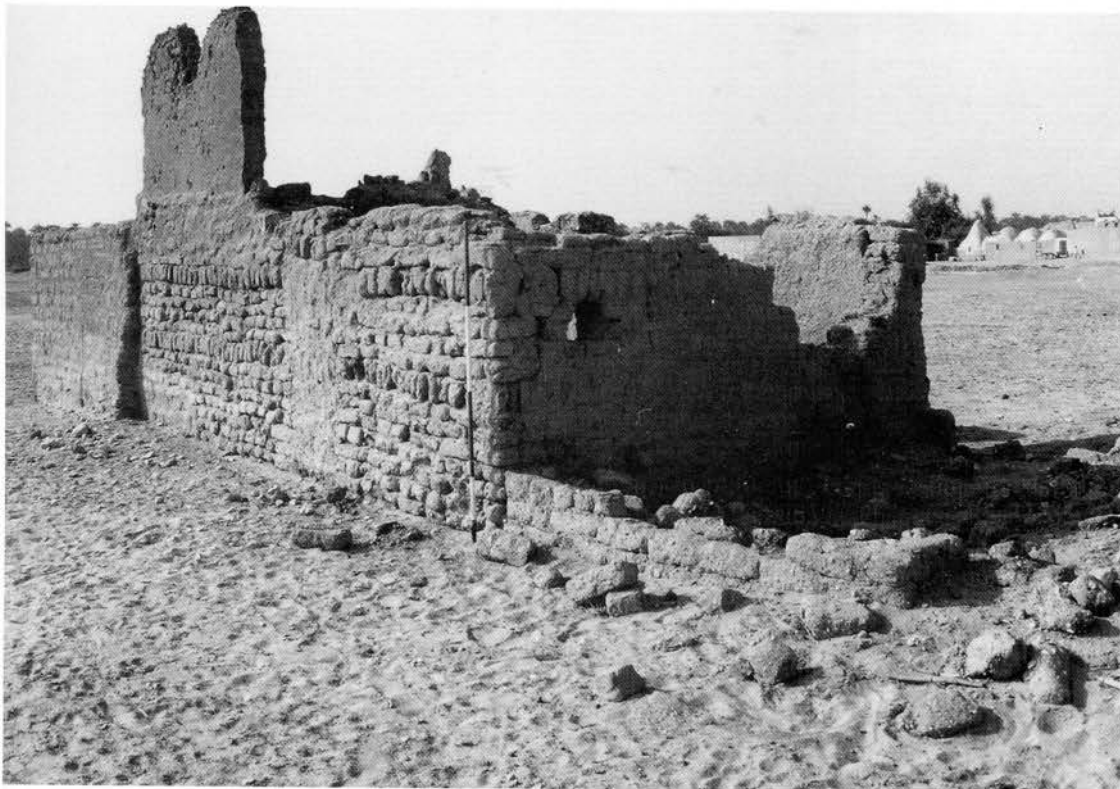
Figure 4.1. The “experimental house” at Amarna, photographed in 1992 from the south-east.

The example that I will use (Figures 4.1 and 4.2), which also illustrates the processes of decay of mud-brick buildings, is provided by a small ruined house which stands 150 m to the south of the present EES expedition house, thus east of the modern village of el-Hagg Qandil. It seems to have belonged to the expedition house in the early 1920s and was perhaps used to accommodate some of the Egyptian dependants (guards or Qufi workmen, although some, at least, of the latter were probably housed in a separate and larger line of huts, now vanished, lying to the west of it). For convenience I will refer to it as the experimental house, since we have occasionally used it for this purpose. Photographs of the walls appear in AR V, in Chapters 11 and 12, as background

The interest of this house lies especially in its upper room. The ground floor walls rise to a height, measured externally, of c. 2.20 m. The upper room had been built on top of this using smaller bricks, only 24 cm long as distinct from 30–35 cm. At its highest the remaining south wall is, at the time of writing, still preserved up to c. 3.80 m, implying an original height to the whole building of around four metres. By 1977 the east and west walls of the upper room had fallen, leaving half of the north and the whole of the south upper walls free-standing, both of them containing a small window set in the middle at the top edge. The north wall came down at some time around the summer of 1990; the south wall still stands. This is a remarkable demonstration of the stability of even thin mud-brick walls, for the house stands isolated on flat ground, exposed to the full force of the sand-laden winds which blow both from the north/north-west and the south, thus directly on to the face of the wall.

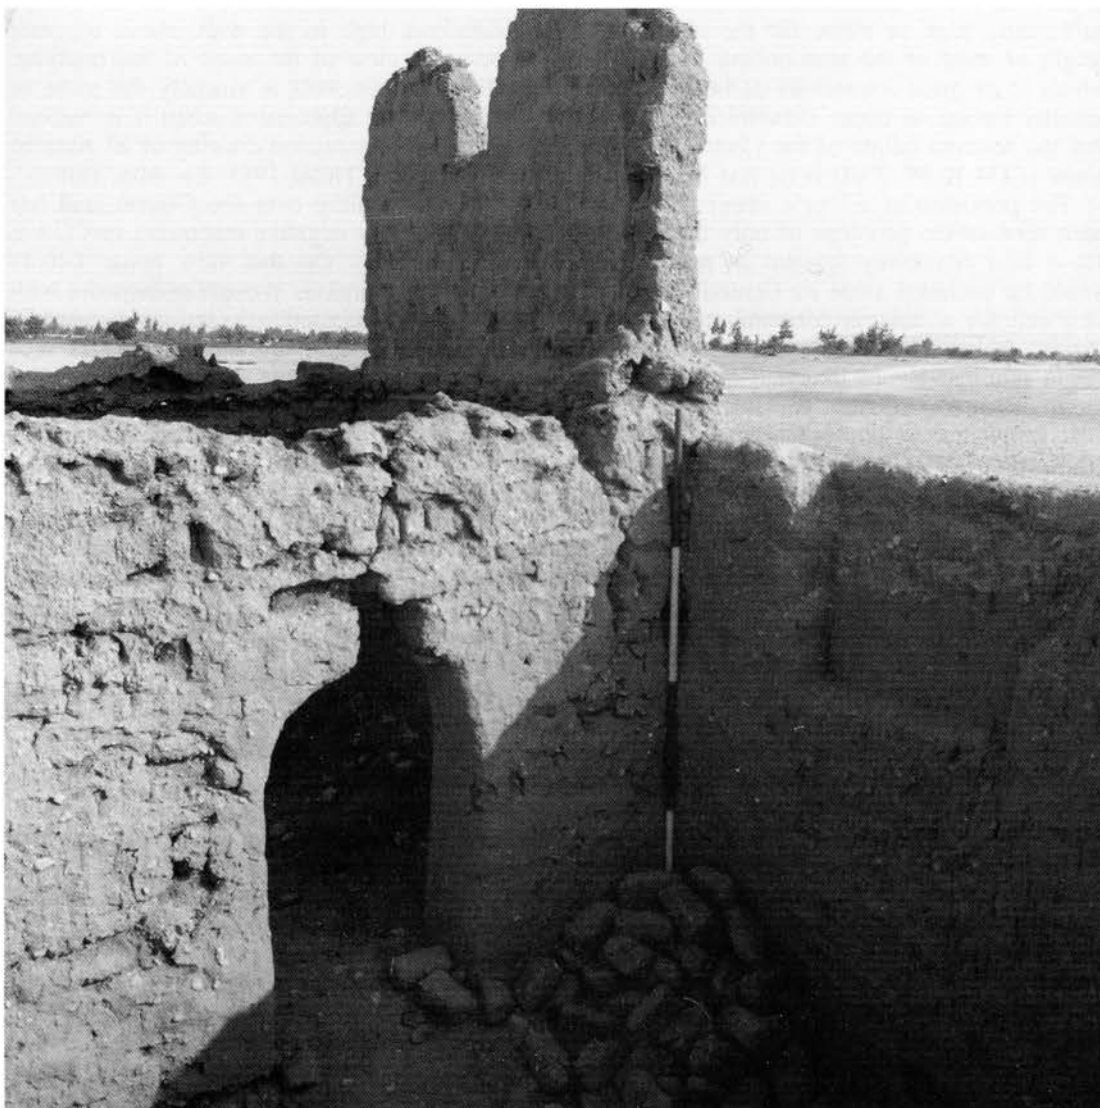
Figure 4.2. The interior of the “experimental house” at Amarna, from the north-west.

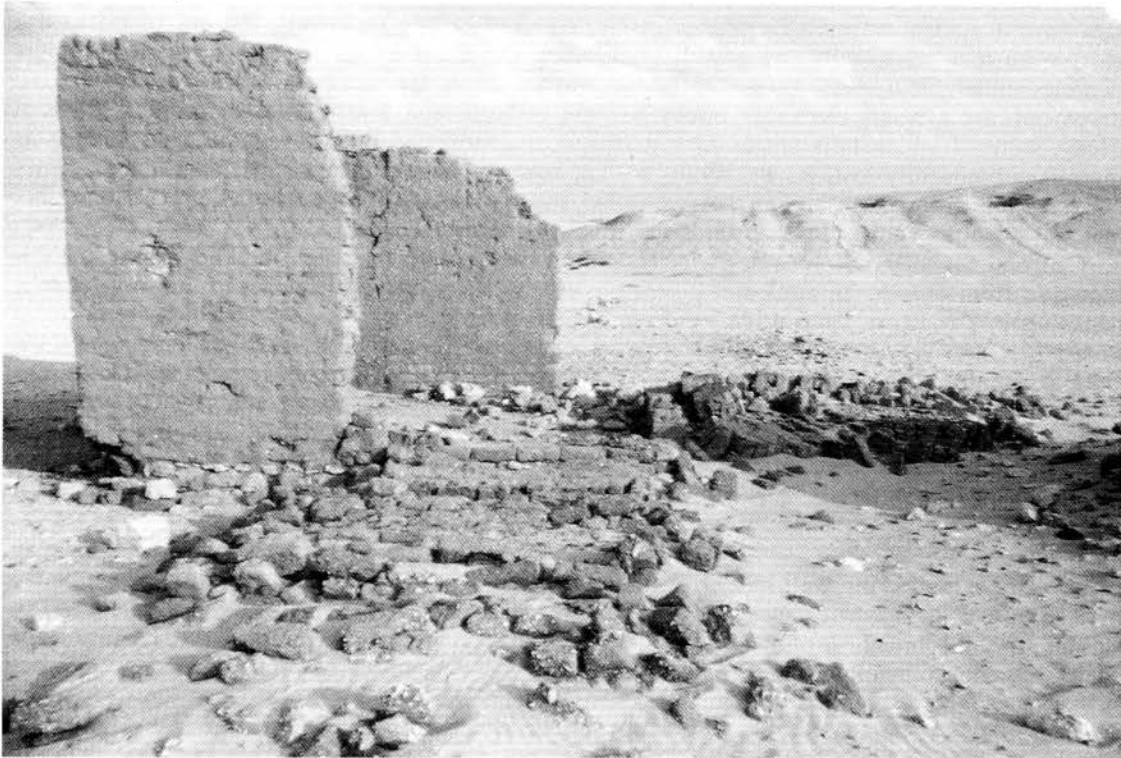
Figure 4.4. A modern example of sheet collapse, at abandoned huts west of the South Tombs at Amama.
