# AMARNA REPORTS II

## AMARNA REPORTS II

Figure 0.1. Map of the Workmen's Village, showing cumulative fieldwork carried out between 1979 and 1984.

### REPORT ON THE 1984 EXCAVATIONS CHAPEL 581/450 (THE "MAIN CHAPEL")

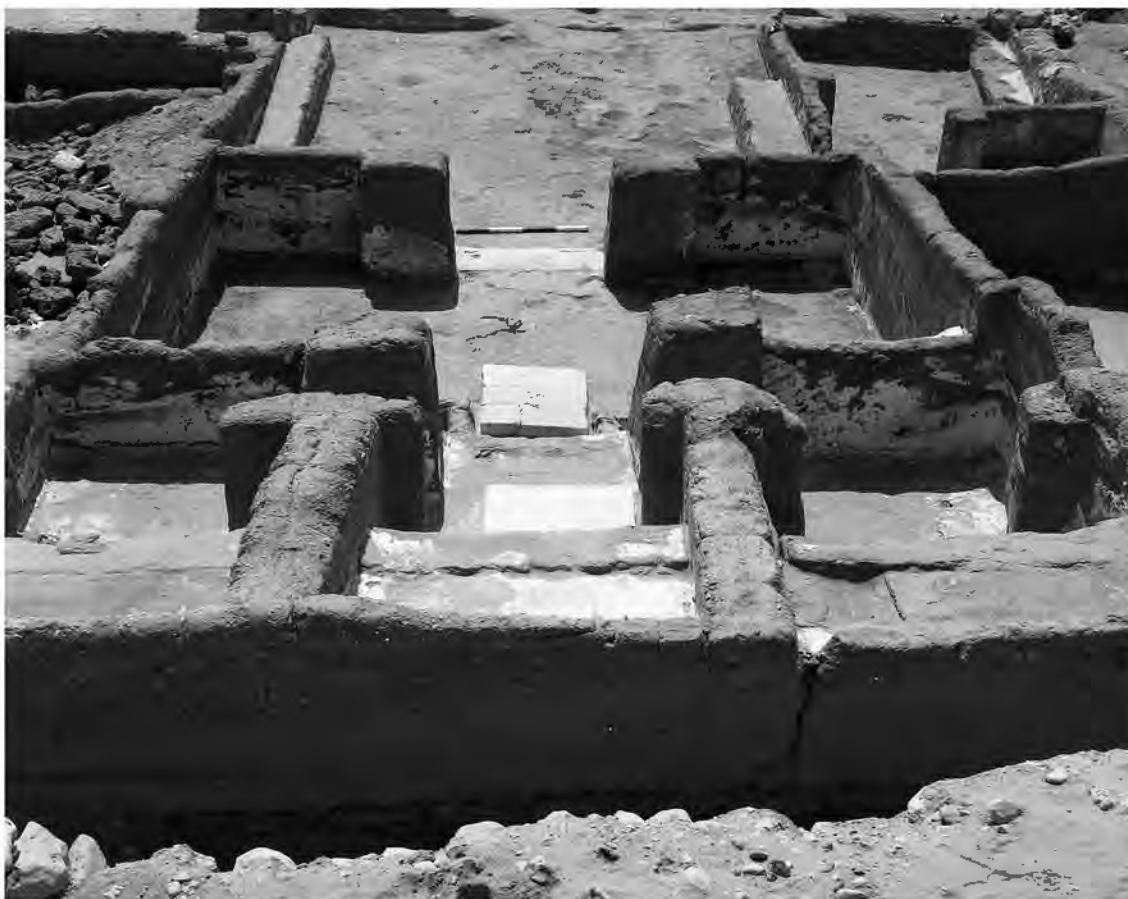
Figure 1.1. General view of the Main Chapel from the east.

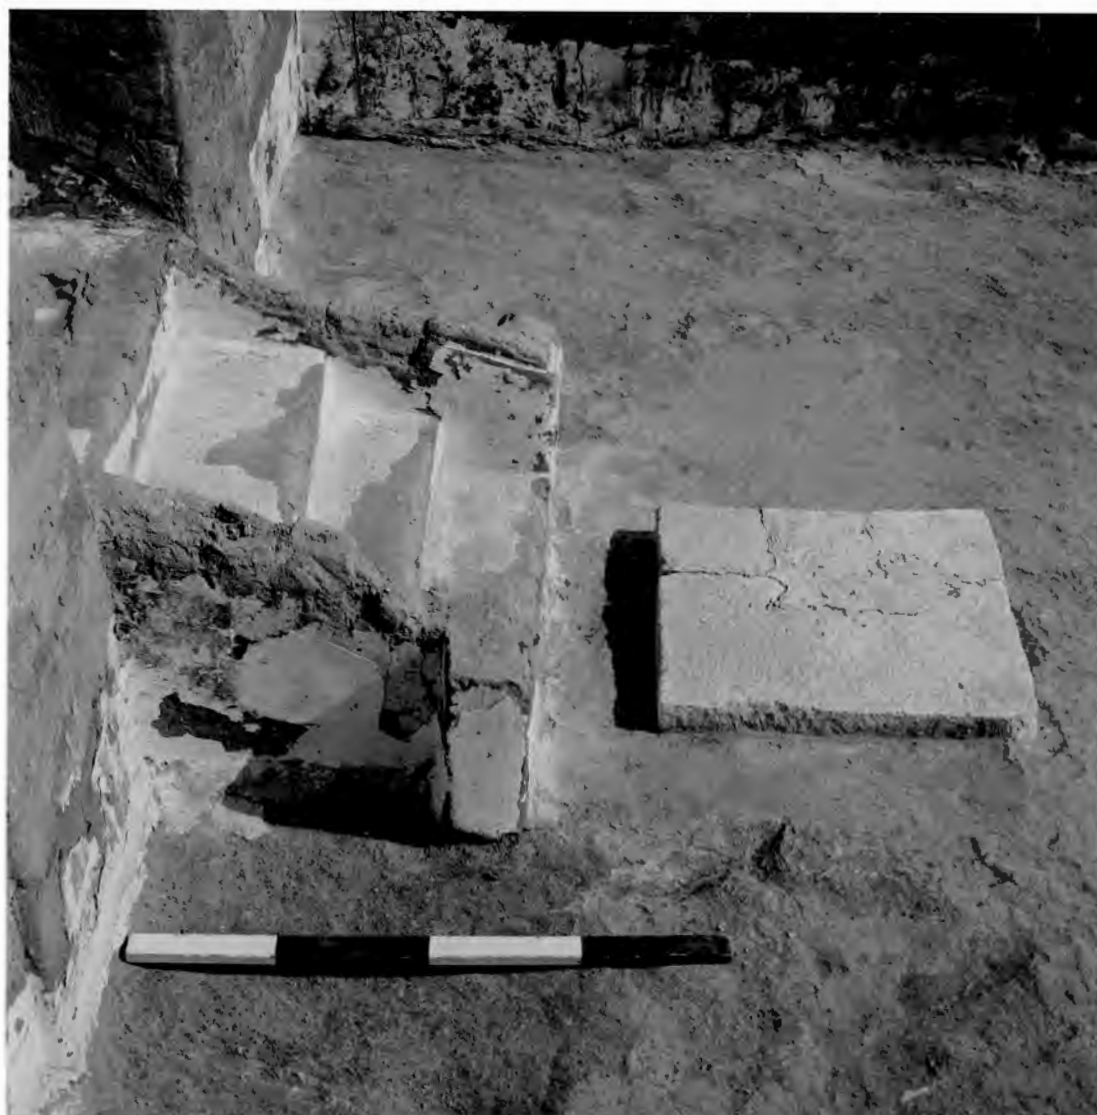
Figure 1.3. Main Chapel: the Inner Hall looking south, showing steps up to the Sanctuary, and limestone dais [999].

The Sanctuary was reached by a flight of four steps [1000] (Figure 1.3), reaching a total height of 65 cms. The steps were flanked by low walls [1160] with curved tops, ending at the bottom with short flanking projections. These also had curved tops running perpendicularly to the others.

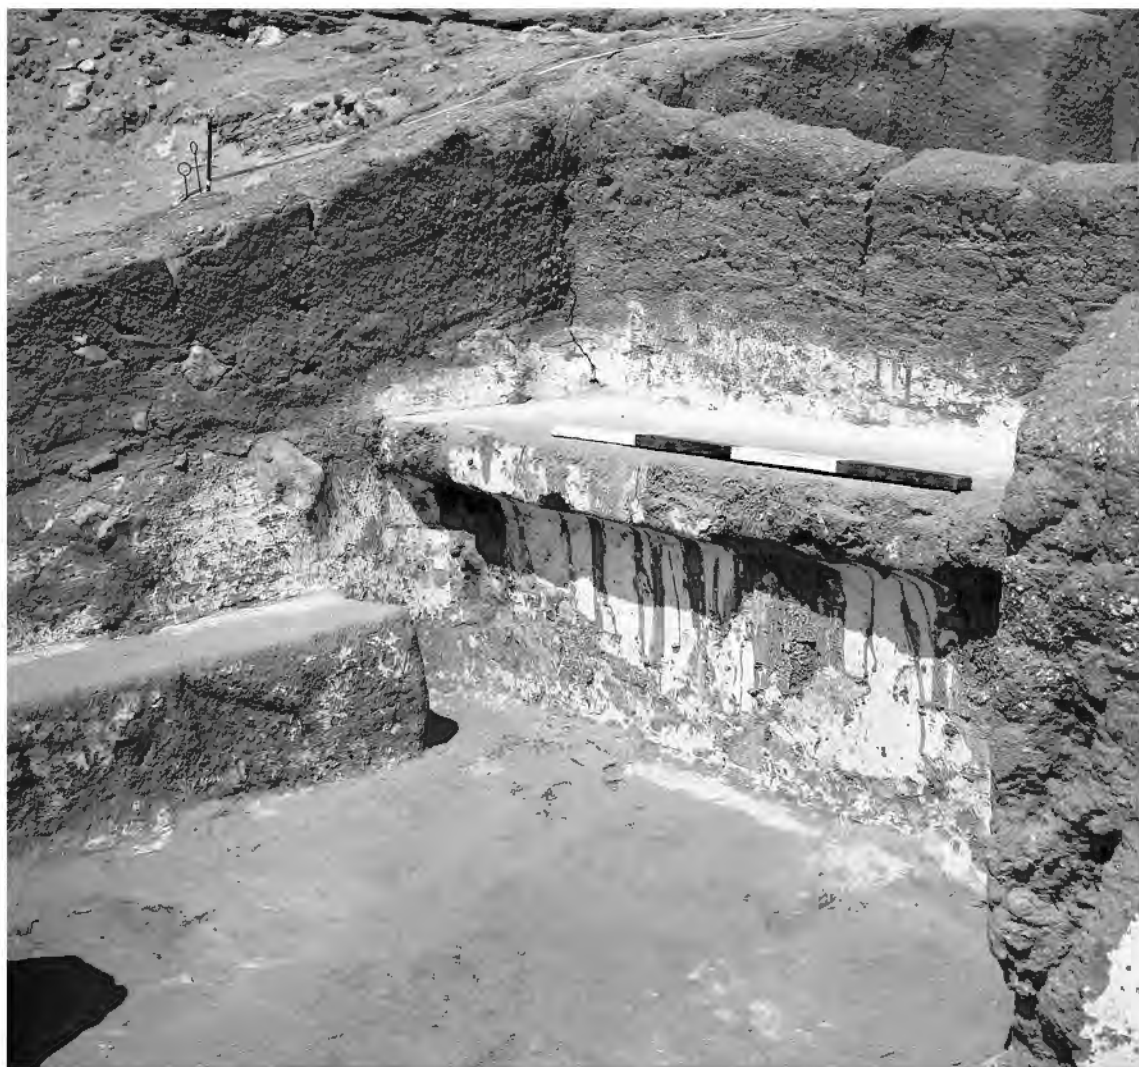
Figure 1.4. The Main Chapel: sanctuary of the Side Chapel, looking north-east.

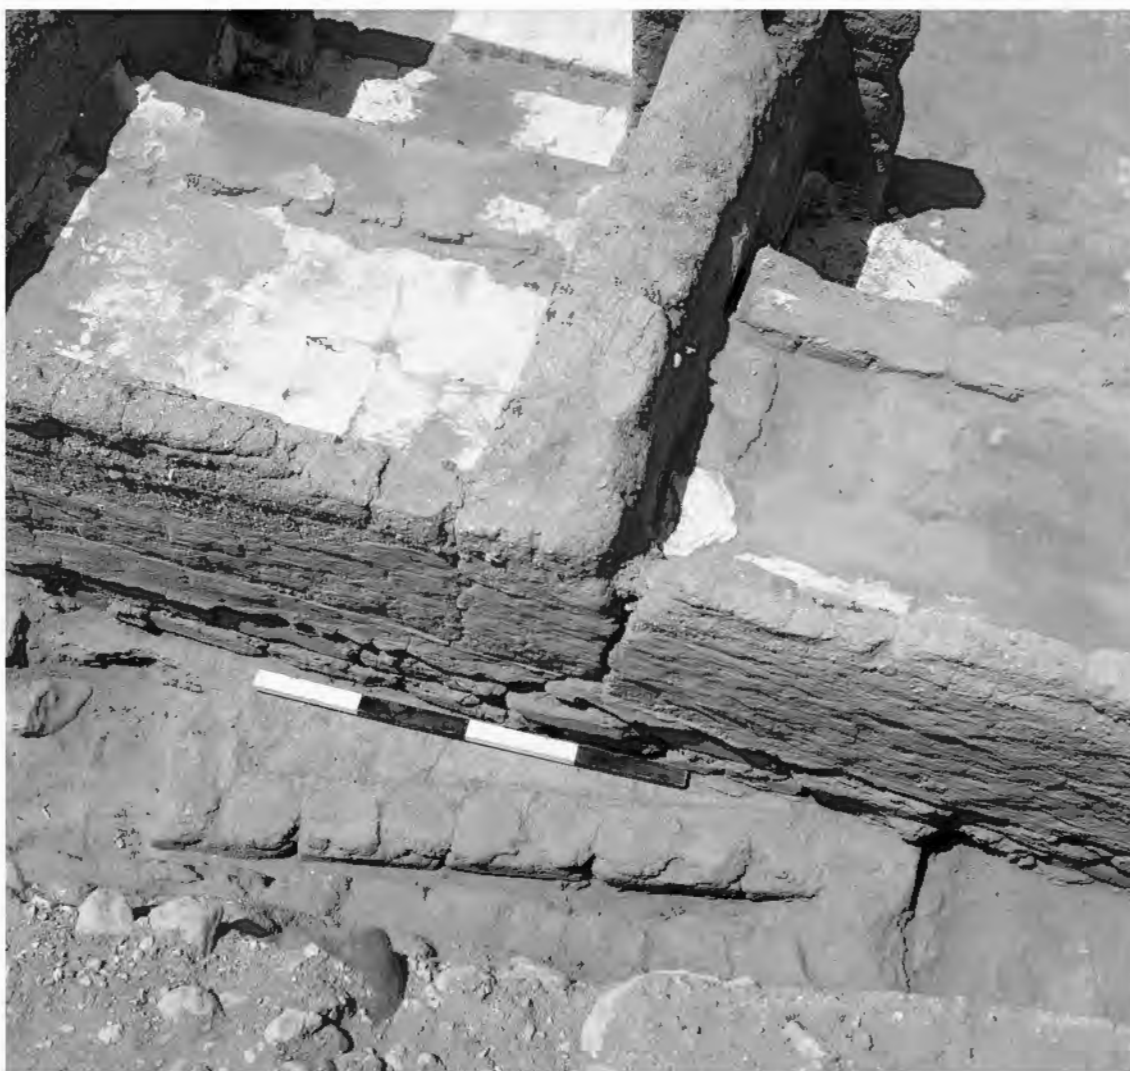
Figure 1.6. The Main Chapel: rear corridor, looking west, showing the earlier foundations in the corridor floor.

fewer blade cuts on the bench and on the floor (Figure 1.6).

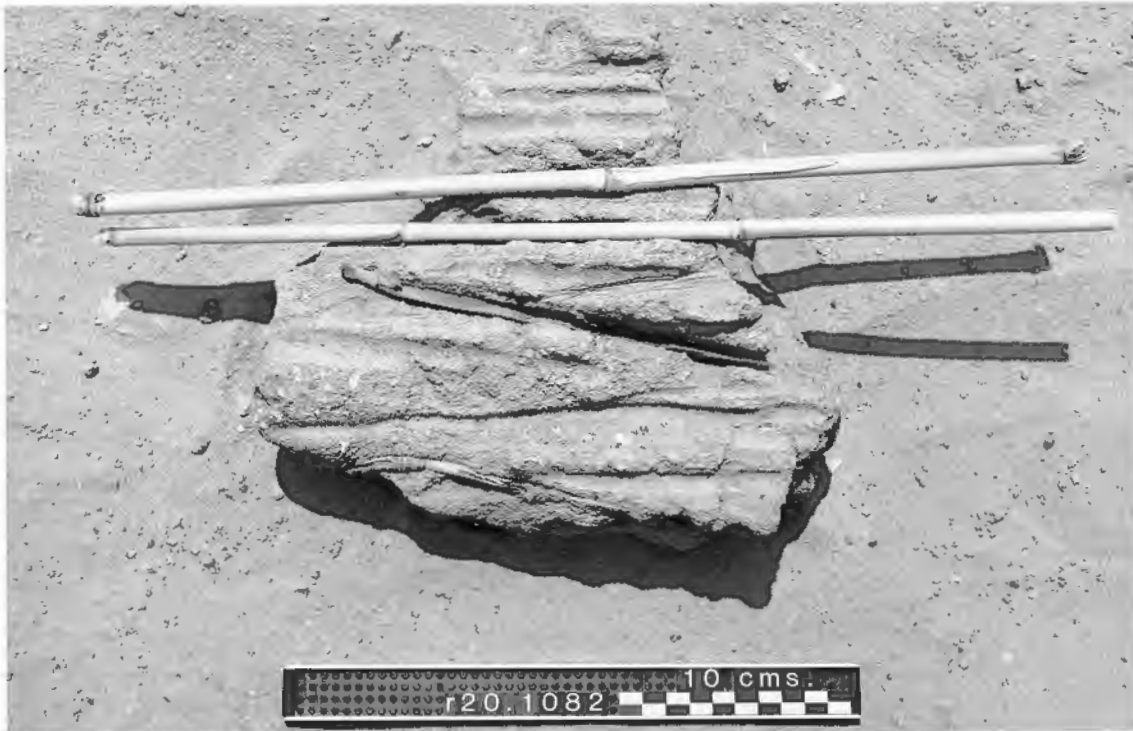
Figure 1.7. Mud roofing fragment from R20 [1082] with reed impressions, and lengths of modern reed fitted into the grooves.

Most of the pieces from within the Main Chapel bear impressions either of round bundles of coarse grass bound with cord (as appear in the fragment illustrated in Figures 1.9 and 1.10) or of lengths of reed. Figure 1.7 illustrates one such piece. Fitted into the impressions are some lengths of reed which grow beside a drainage canal not far from el-Amariya and which resemble closely the forms impressed into the mud.

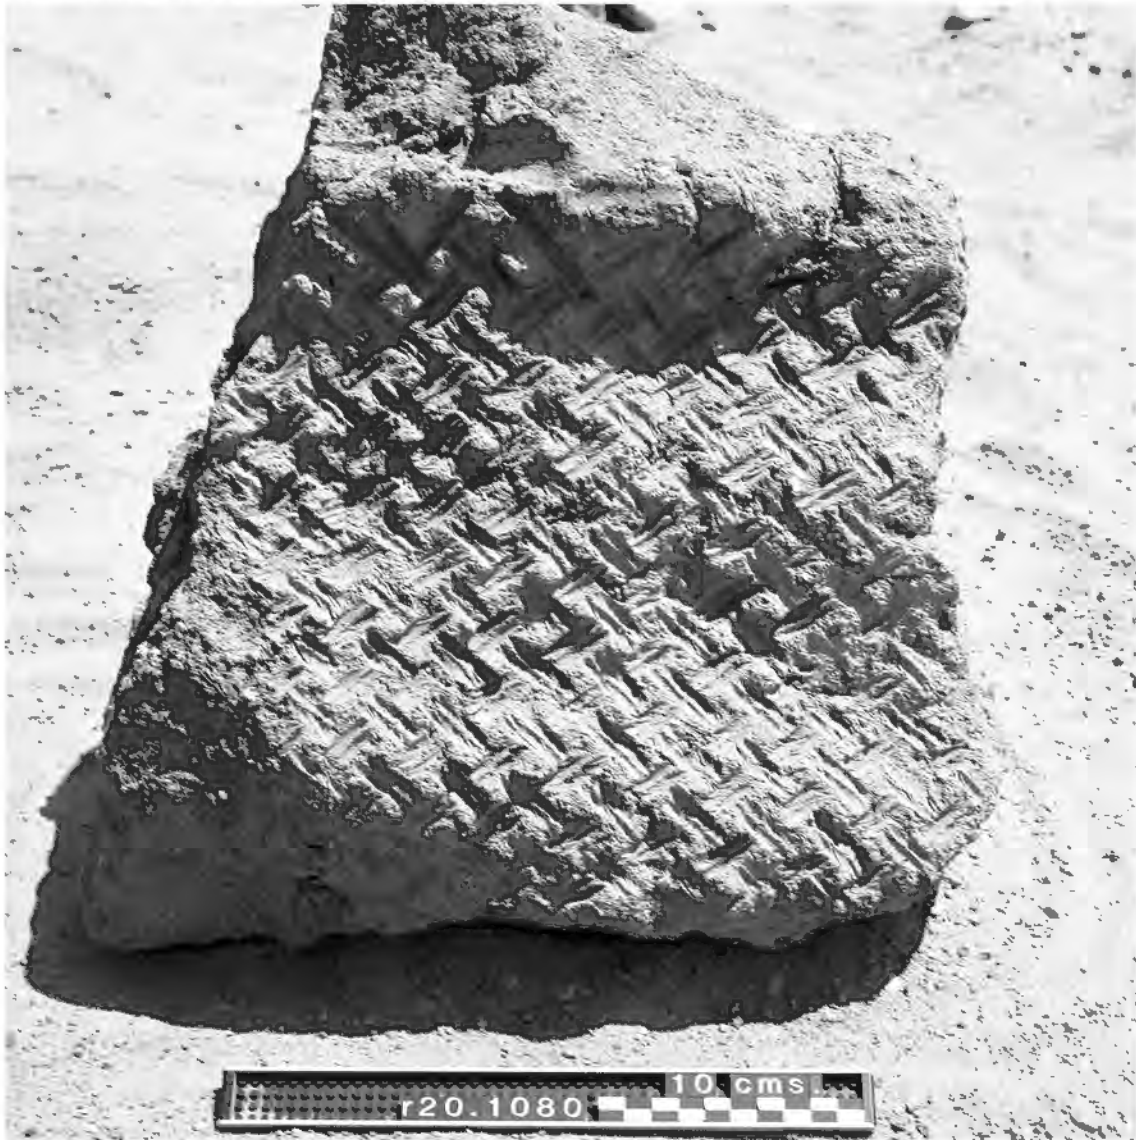
Figure 1.8. Mud roofing fragment from R20 [1080] bearing the impression of a rope mesh laid across closely set circular wooden beams.

A less common category, very thick, carries impressions of a coarse but evenly made mesh of double strands of thin rope. The impressed surfaces undulate slightly, implying that the mesh had been laid across rounded wooden beams closely set (Figure 1.8). This type of impression was confined to the North Annexe and must represent its roof. The roofing beams themselves had largely perished everywhere. Several pieces have survived, however, of a thick coating of mud which had been applied to the rounded undersides of the beams as a casing.

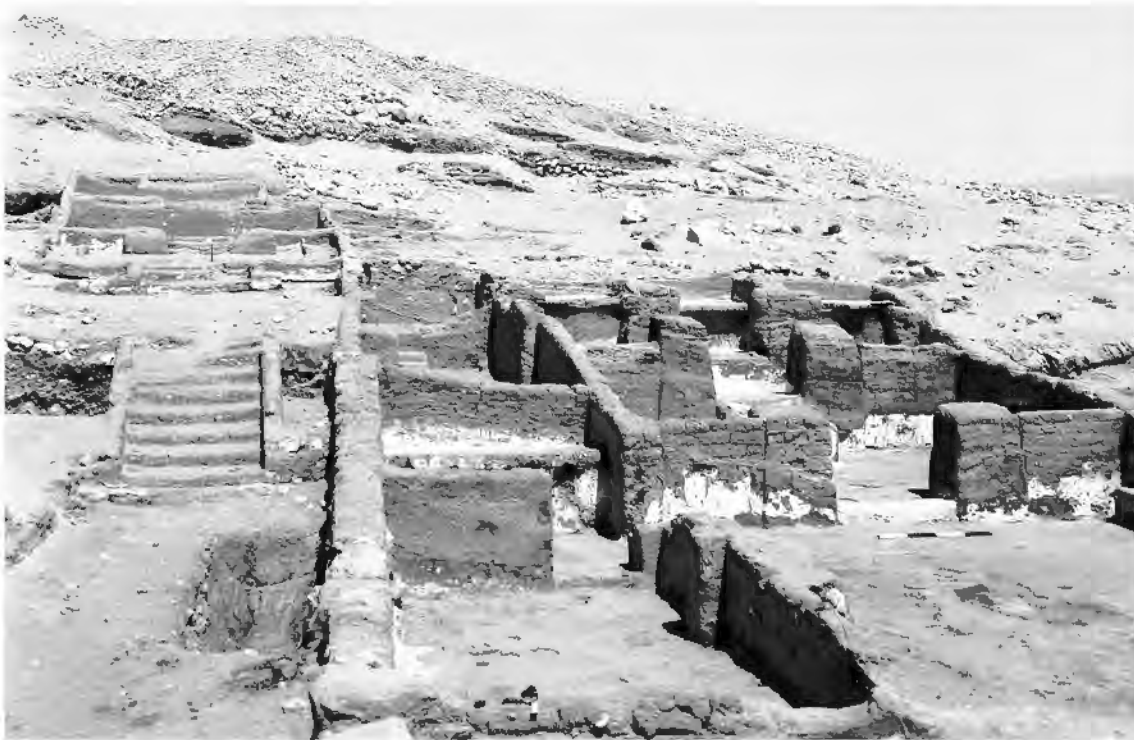
Figure 1.11. General view to the east of the Main Chapel, and, on the left, of the steps up to the terrace and to Chapel 522 lying behind. The late burial pit is in the left foreground.

The general setting of the Main Chapel is now much clearer. The hillside rises in the direction of the north-east corner of the building (Figure 1.11). Although the ground on which the Chapel stands also rises towards the east, it does so to a much lesser extent because it forms the floor of a shelf cut into the hillside to a maximum depth of about one metre (cf. the sections, Figures 1.5 and 2.3). The vertical sides to this shelf, plastered and partly reinforced with bricks and stones, form the boundary of the Chapel enclosure on the east, and along part of the north side as well. The north-eastern part of the Chapel was thus protected by this low escarpment on two sides, and in consequence has been exposed to erosion to a much lesser extent so that a good part of the brickwork still stands (Figure 1.1). The escarpment and the ancillary rooms on north and south surround the main body of the Chapel on three sides, and create, in effect, a small temenos for it. When the small area in the south-east corner has been cleared we will have excavated an unusually complete miniature temple.

The terrace had been reached by a flight of eight broad but shallow steps [1123] between low walls [1027] (Figure 1.11). They had been built at an angle to the terrace and a little to the north of the Main Chapel, the intention being to align them with the steps and entrance to Chapel 522 which lay at the back of the terrace. This part of the terrace had thus been turned into a forecourt for this chapel, and had been coated with marl plaster [1151]. A little further to the north (just off the edge of Figures 1.2 and 1.11) a low wall crossed the

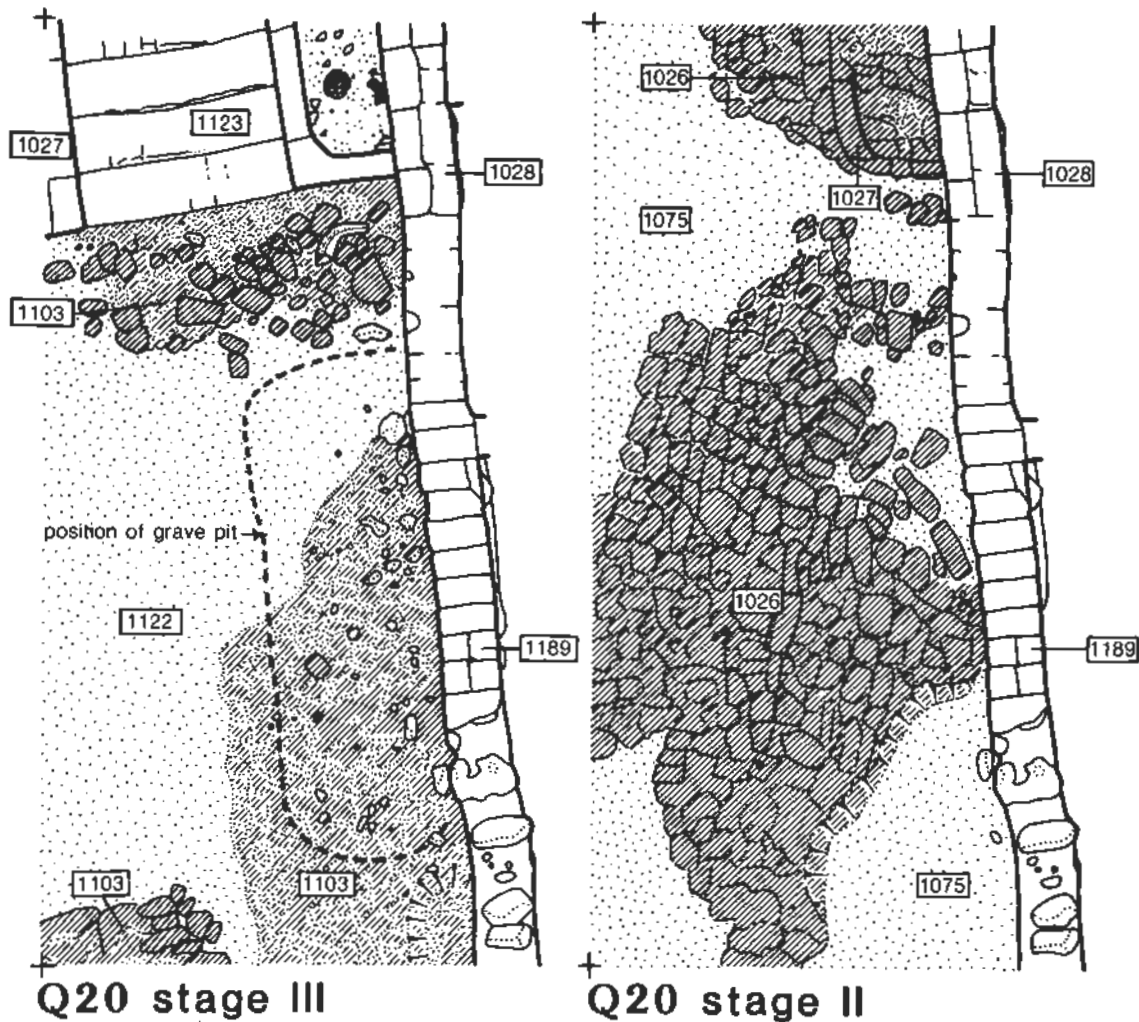
Figure 1.12. The northern part of square Q20 planned at the second and third stages of excavation. They show how the late burial pit was covered and sealed by the collapsed wall rubble from the Main Chapel (originals by A. Bomann).

The north wall of the Side Chapel had largely collapsed outwards. When the surface sand and modern dump was removed part of the collapsed rubble was found lying in a sheet [1026], and this was planned (Figure 1.12). The south-west corner of this layer is missing; instead a patch of sand [1075] appears. This probably fills a hole cut in modern times into the rubble from the surface at the foot of Peet's dump. A second patch of the same rubble appears on the eastern side of the square, partly burying the staircase and its walls.

From inspecting the plans of the site made during the course of excavation (Figure 1.12) it is abundantly clear that when the burial was made the north wall of the Main Chapel [1028, 1189] was still standing. The two layers of rubble from

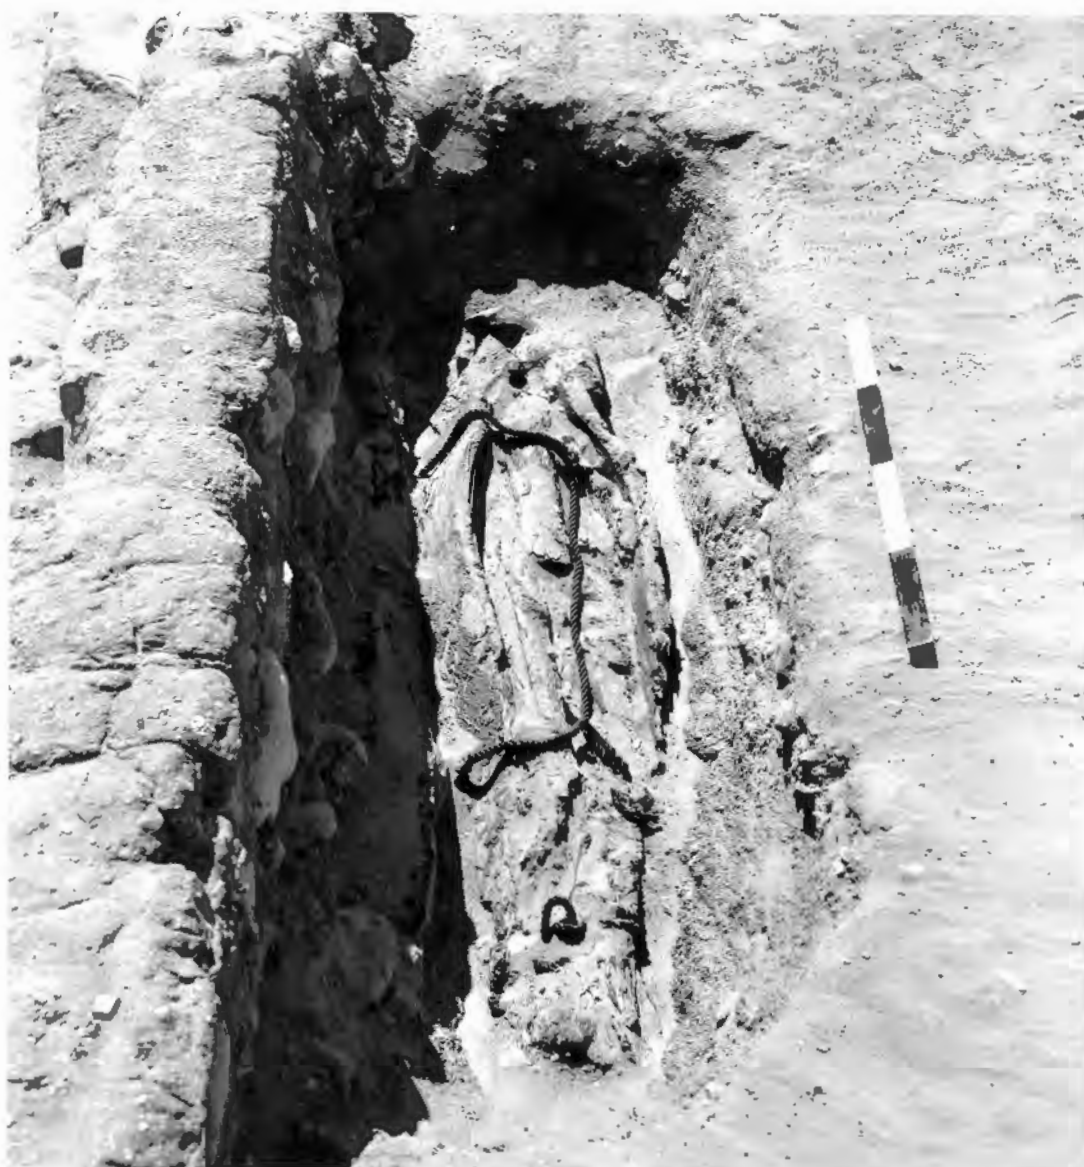
Figure 1.13. The late burial in its pit, looking west.

The burial had been laid in a narrow pit cut through the terrace [1211] into the underlying bedrock [1216] for a depth of between 60 and 80 cms. (Figure 1.11). A single mummified body had been placed in a painted anthropoid coffin and carried to the site slung by means of stout ropes beneath two narrow tree branches still retaining their bark. When the bearers reached the grave they lowered the coffin into it, and laid the carrying poles beside it, leaving the ropes still wound round the coffin (Figure 1.13). At the foot end they laid a pottery jar containing a liquid and a group of little pottery bowls. The jar had been carried up in a separate rope sling, much of which survived. The ceremony completed, the pit was filled with sand, and the burial left without any marking on the ground.
