## CHAPTER 1

### REPORT ON THE 1986 EXCAVATIONS WORK INSIDE THE WALLED VILLAGE (1): SOUTH-WEST CORNER

Site supervisor: Ibrahim M. el-Saidi

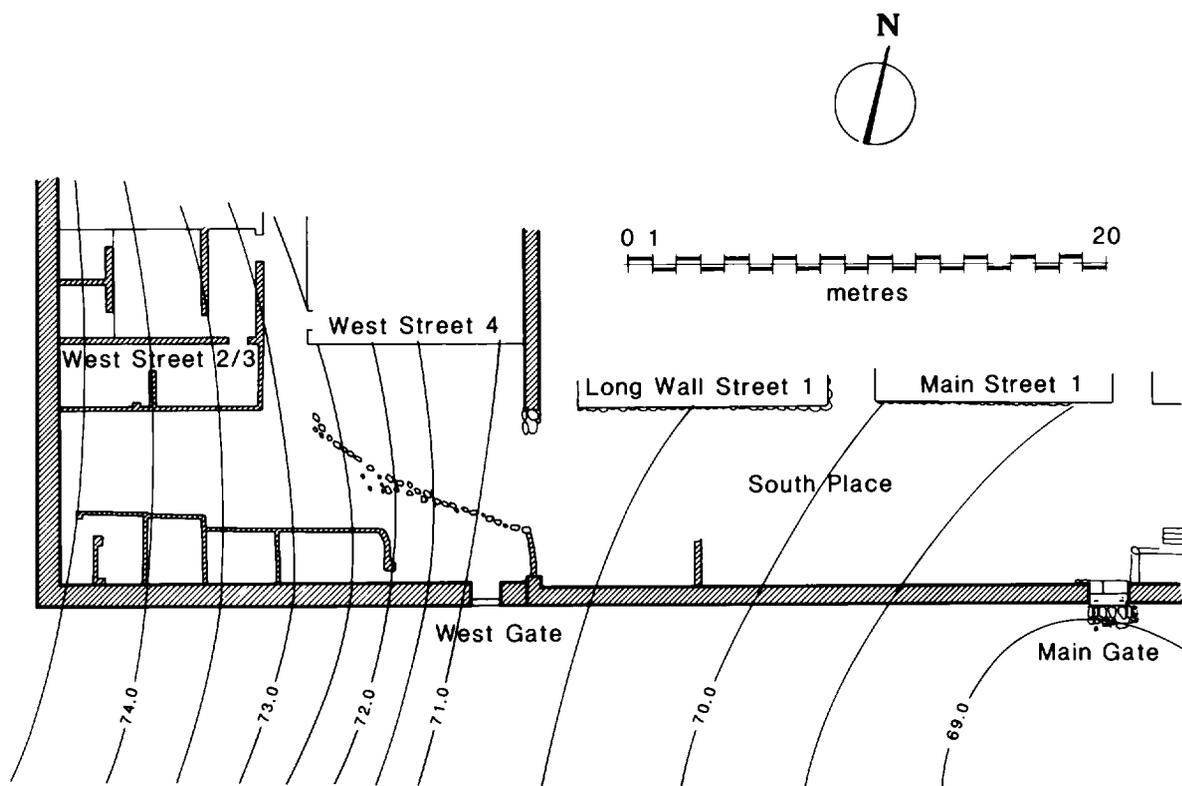
Figure 1.1. Outline plan of the south-west corner of the Walled Village. The contours are those of the original ground surface, and are partly reconstructed.

With such time and resources as remained the next priority was to examine the ground eastwards, paying particular attention to the second gateway in the Village Enclosure Wall which Peet and Woolley located in this sector. In the event a 6.5-metre length of the Enclosure Wall which took in the gateway was re-cleared and planned in detail. But for the surrounding area it was possible to make only a limited exploratory trench and to clear sand from around the upper level of the stone wall. The results were planned at a small scale (Figure 1.1).

The "breast-high wall of uncut stones" still remains, deeply buried in sand. Enough of the sand was cleared to enable its general course to be included on the plan of this area (Figure 1.1), and its junction with the Village Enclosure Wall appears in the detail plan (Figure 1.2). At this

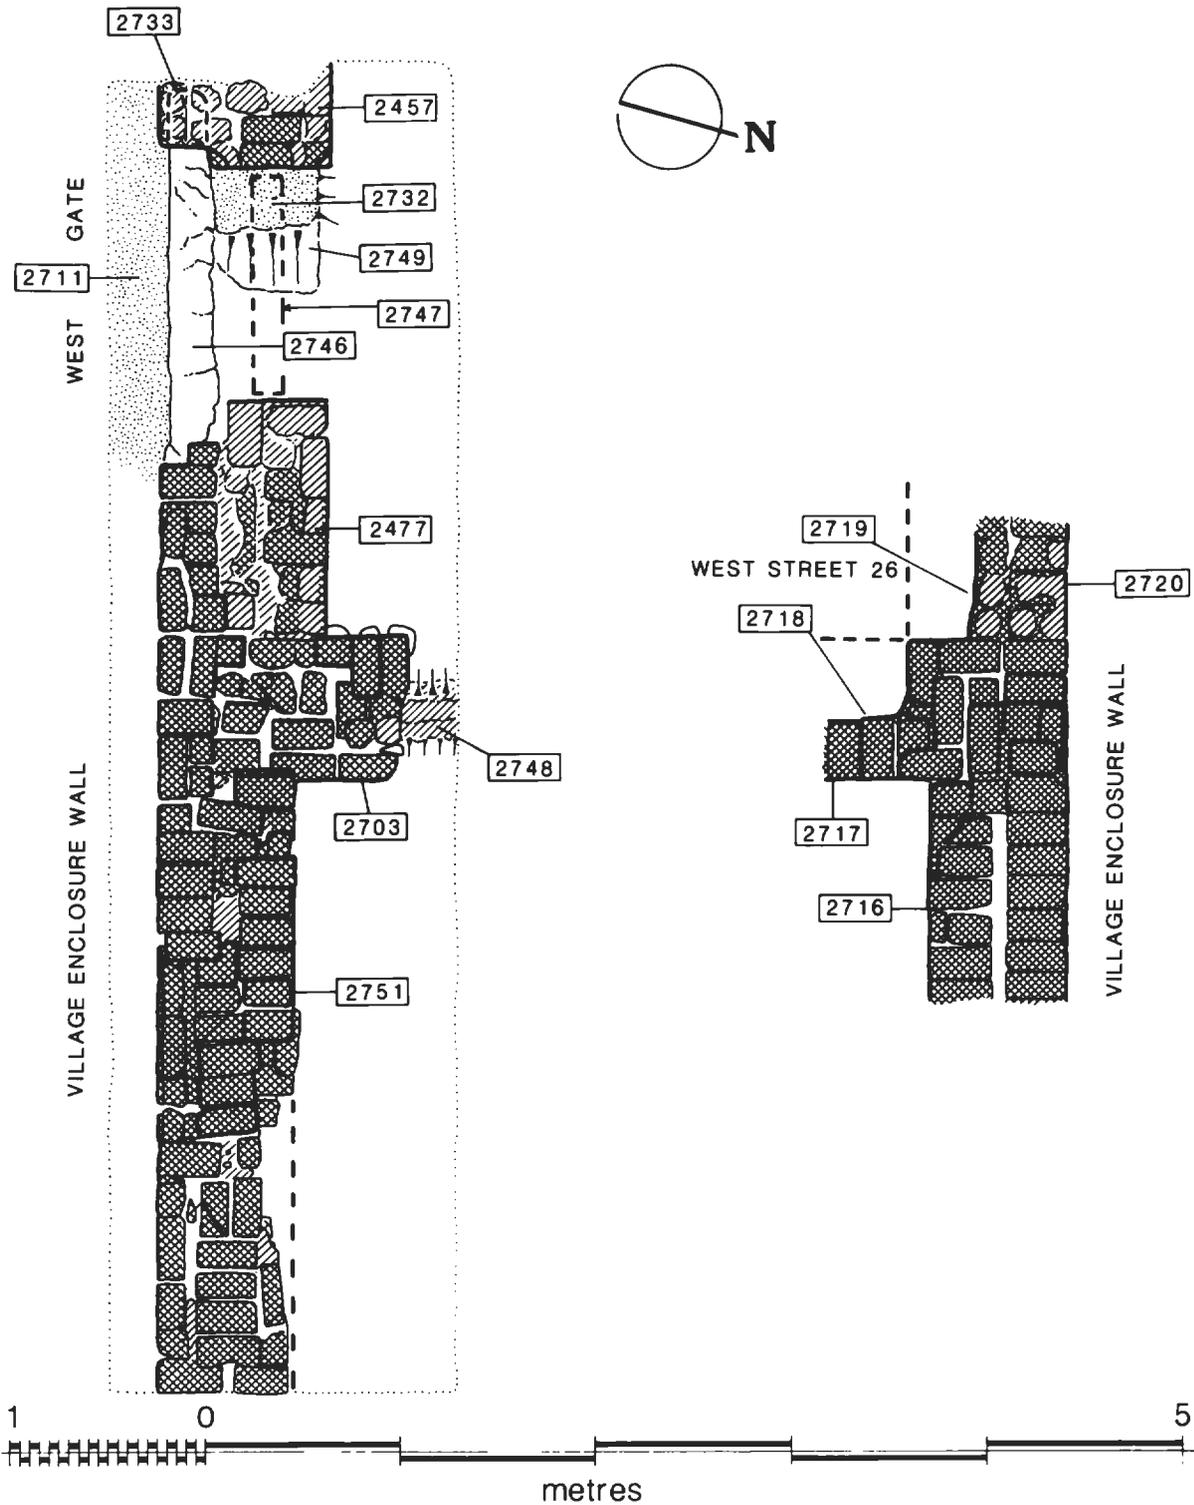
The detail plan of the length of Enclosure Wall cleared is given in Figure 1.2. It runs in from the east [2751] with a width of 71 cms., and then originally turned a corner to continue northwards [2703] at the same width. As had been noticed in the first excavation (Woolley 1922: 50, 60; COA I: 53), the western sector of the town was an addition to the initial rectangular village of four streets. The plan of the brickwork (Figure 1.2) reveals this, and also that the Enclosure Wall, when subsequently continued westwards, was done so at the slightly greater thickness of 87 cms. It was in this new part that the second gateway was constructed. The gap in the brickwork measures 1.18 metres across, compared to 1.75 for the main gateway. The main gateway had been paved with a stone threshold which had been left in place along with an area of paving made from natural boulders (cf. COA I: 67, Plates XVI, XVII.2; AR I: 12, Figure 1.4).

Figure 1.2. Detail plan of two sections of the Village Enclosure Wall; left: part of the south wall in the vicinity of West Gate; right: part of the north wall, at its junction with the Village dividing wall.

A short stretch of the north Enclosure Wall was also cleared, at the point of junction with the north-south dividing wall. In the plan (Figure 1.2) the incoming wall from the east [2716] belongs to the initial laying out of the Village, when this part was the north-west corner, the wall turning through a right-angle and continuing southwards [2717]. Subsequently the Village was enlarged by the construction of West Street, and the north wall was therefore continued westwards [2720], though at the same slightly greater thickness as occurs in the south and west sections. Wall [2717] now became a dividing wall within the Village. A house, West Street 26, was next constructed in the corner between walls [2717] and [2720], and to achieve a slight increase in space the surface of both walls was cut back to form shallow alcoves [2718, 2719].

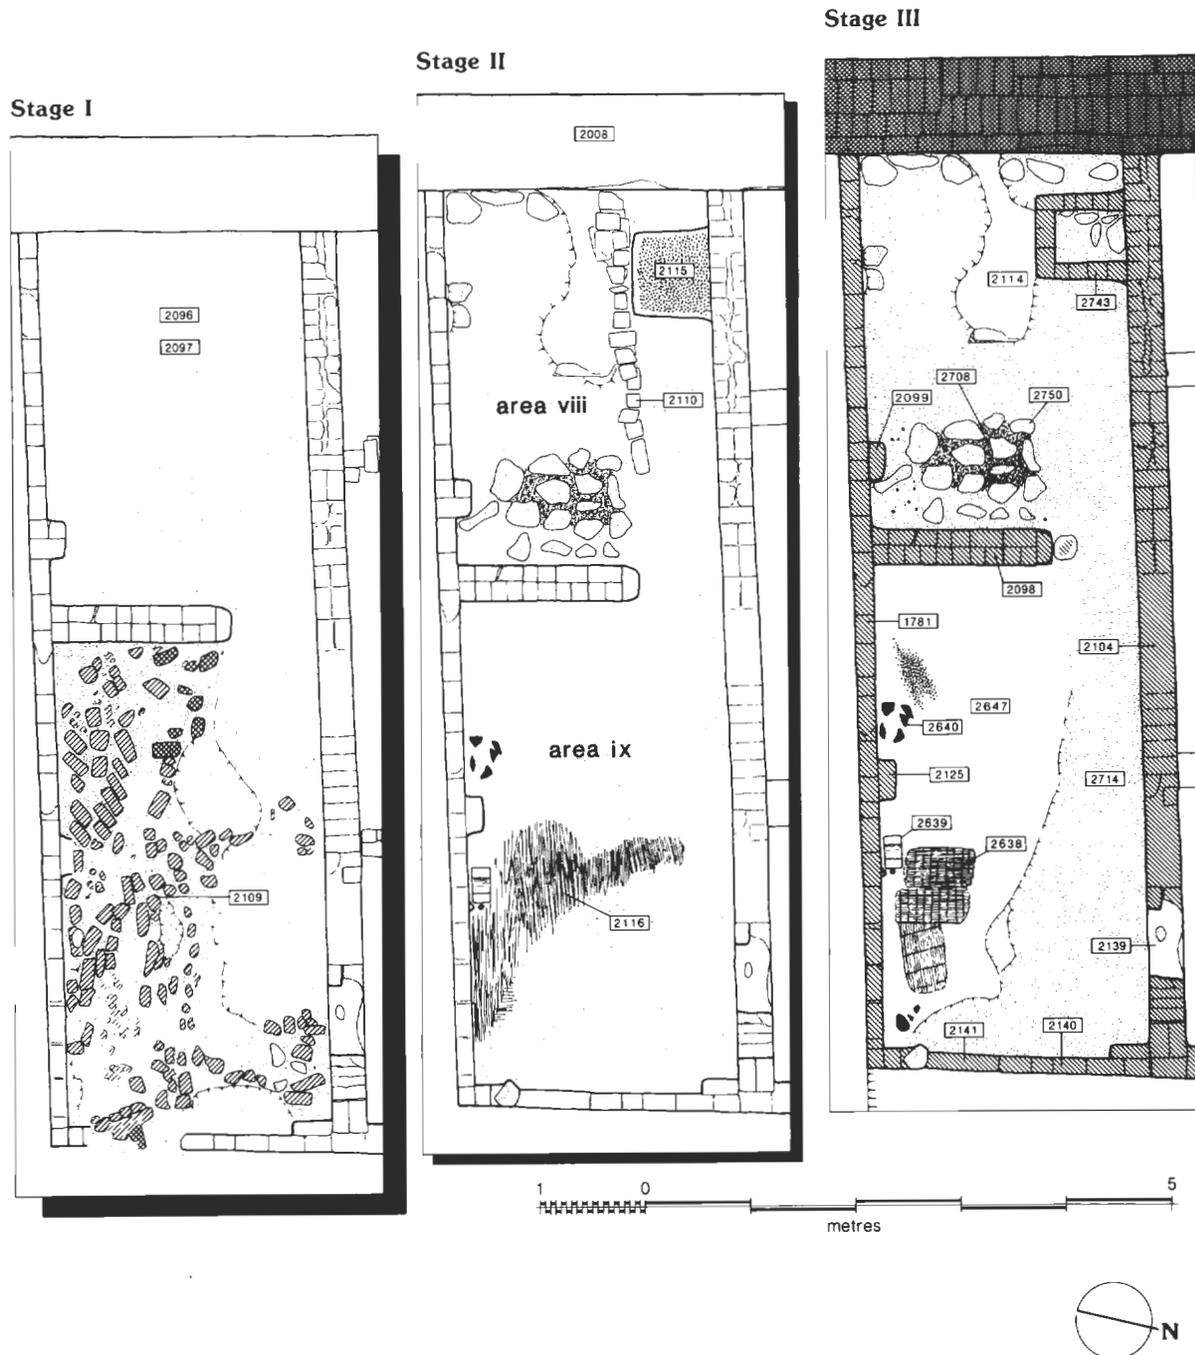
The excavation of this narrow area (Figure 1.3) involved the removal of a considerable quantity of loose sand over both the western half [2096, 2097, 2103] and the eastern half [2172, 2106]. With the former the depth of this deposit reached 1.5 metres, and also contained within it a lens of grey redeposited organic material [2102]. Once cleared the pattern of the expected modern robbing of the site was clearly revealed. A trench of about 60 cms. width had been dug along the side of the north wall for its whole length. As it cut ever more deeply into the drift sand on the west a rough retaining wall of mud bricks had been thrown up to keep the sand back. The diggers of this trench had also managed to slice off the top of a quern emplacement as they went. Having got this far, the whole of the rear part of the annexe, Area viii, had then been turned over. They did leave, however, a small floor area in Area viii, and much of the lower deposits in Area ix, untouched.

Figure 1.3. Plans of three successive stages of excavation of the south annexe to West Street 2/3 (originals by I.M. el-Saidi).

Much of the floor deposit of the eastern half of the annexe, **Area ix** (c. 2.50 x 4.60 metres), was found undisturbed (Figure 1.3). The rubble and the remains of the light roof lay on a mud floor [2647]. Also on this floor, against the south wall [1781], were sherds from a pottery storage jar [2640], and a limestone beam-end holder [2639], partially secured in place by a vertical wooden peg against one side (Figure 1.4). These limestone objects have been found before, both by the current excavations and also by those of the 1920s. They tend to come in pairs, and in fact a second example occurred in the loose sandy fill [2097] above **Area viii**. The original explanation that they were to help anchor "the bed-beam of an upright loom" (*COA I*: 60-61) seems still to hold, and since they were usually found in association with the front rooms of the standard houses this particular discovery in West Street 2/3 again shows how the side annexe of this house is really equivalent to the front part of a normal house.

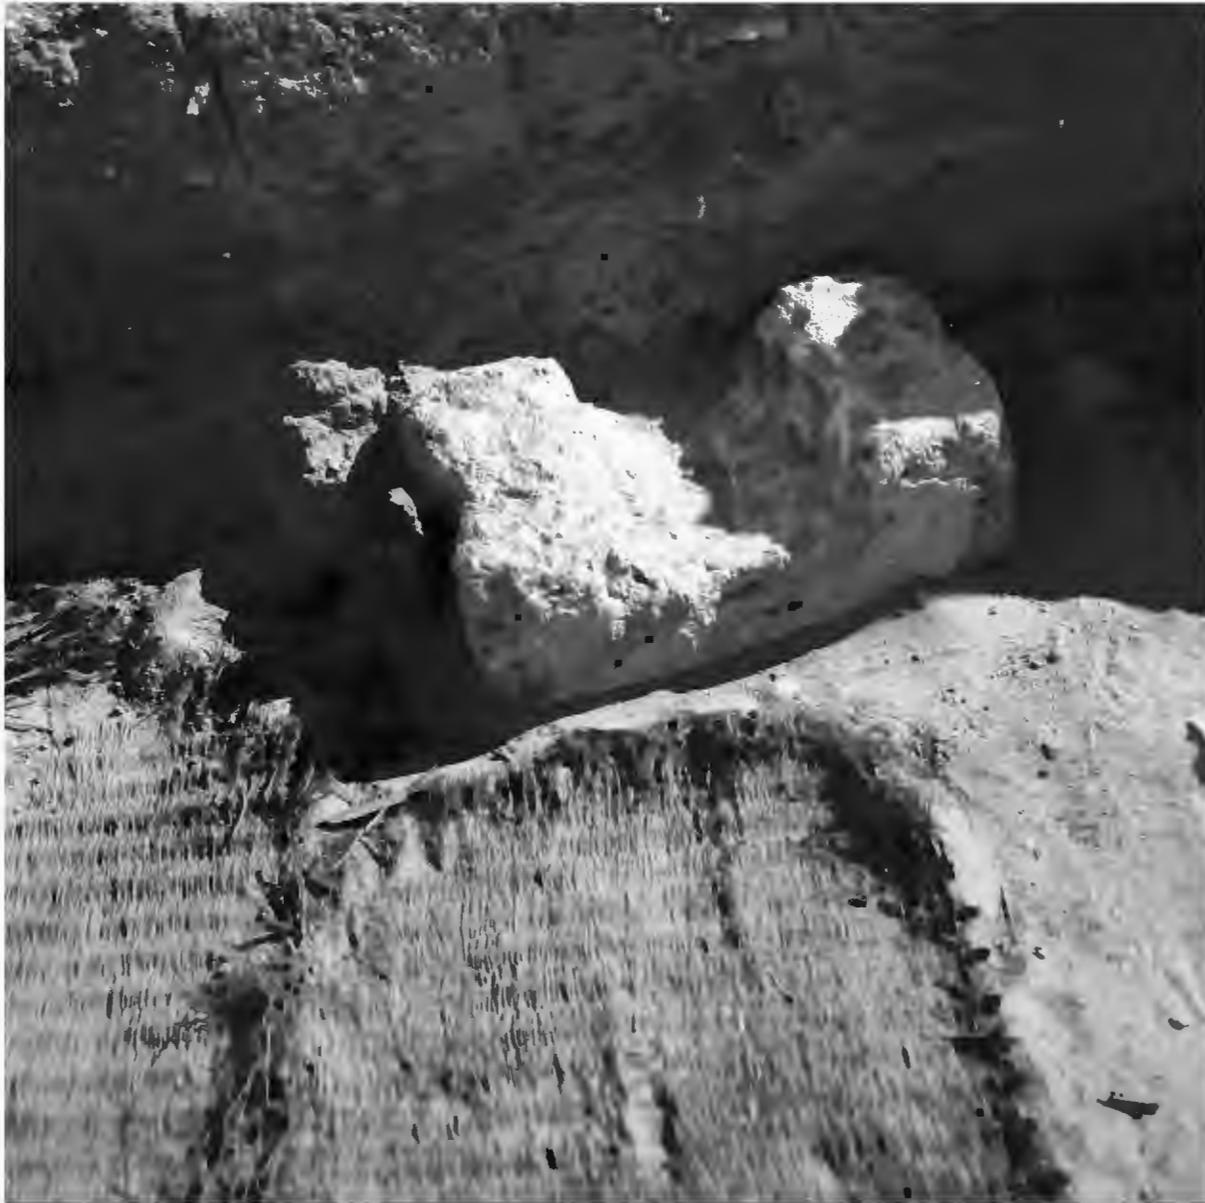
Figure 1.4. Limestone beam-end socket [2639] and supporting wooden peg in Area ix of the south annexe. Note the pieces of fallen matting in the foreground.

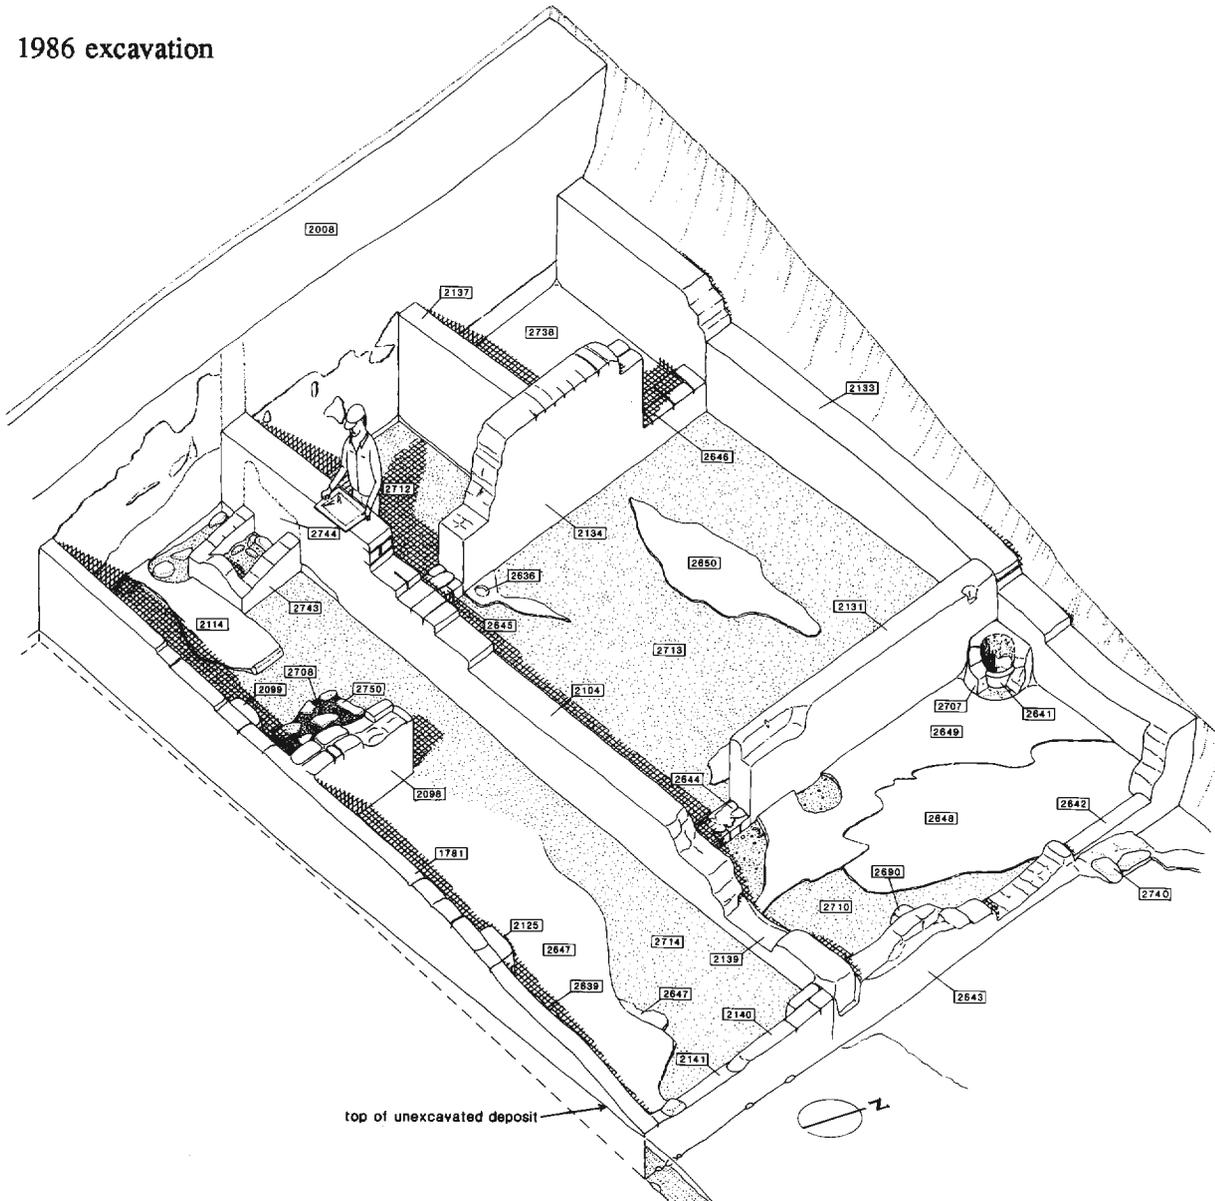
Figure 1.5. Isometric drawing of West Street 2/3 at the conclusion of the excavation (after plans, elevations and spot heights by I.M. el-Saidi).

### 1.3 The house West Street no. 2/3: the house proper (Figures 1.5 and 6)

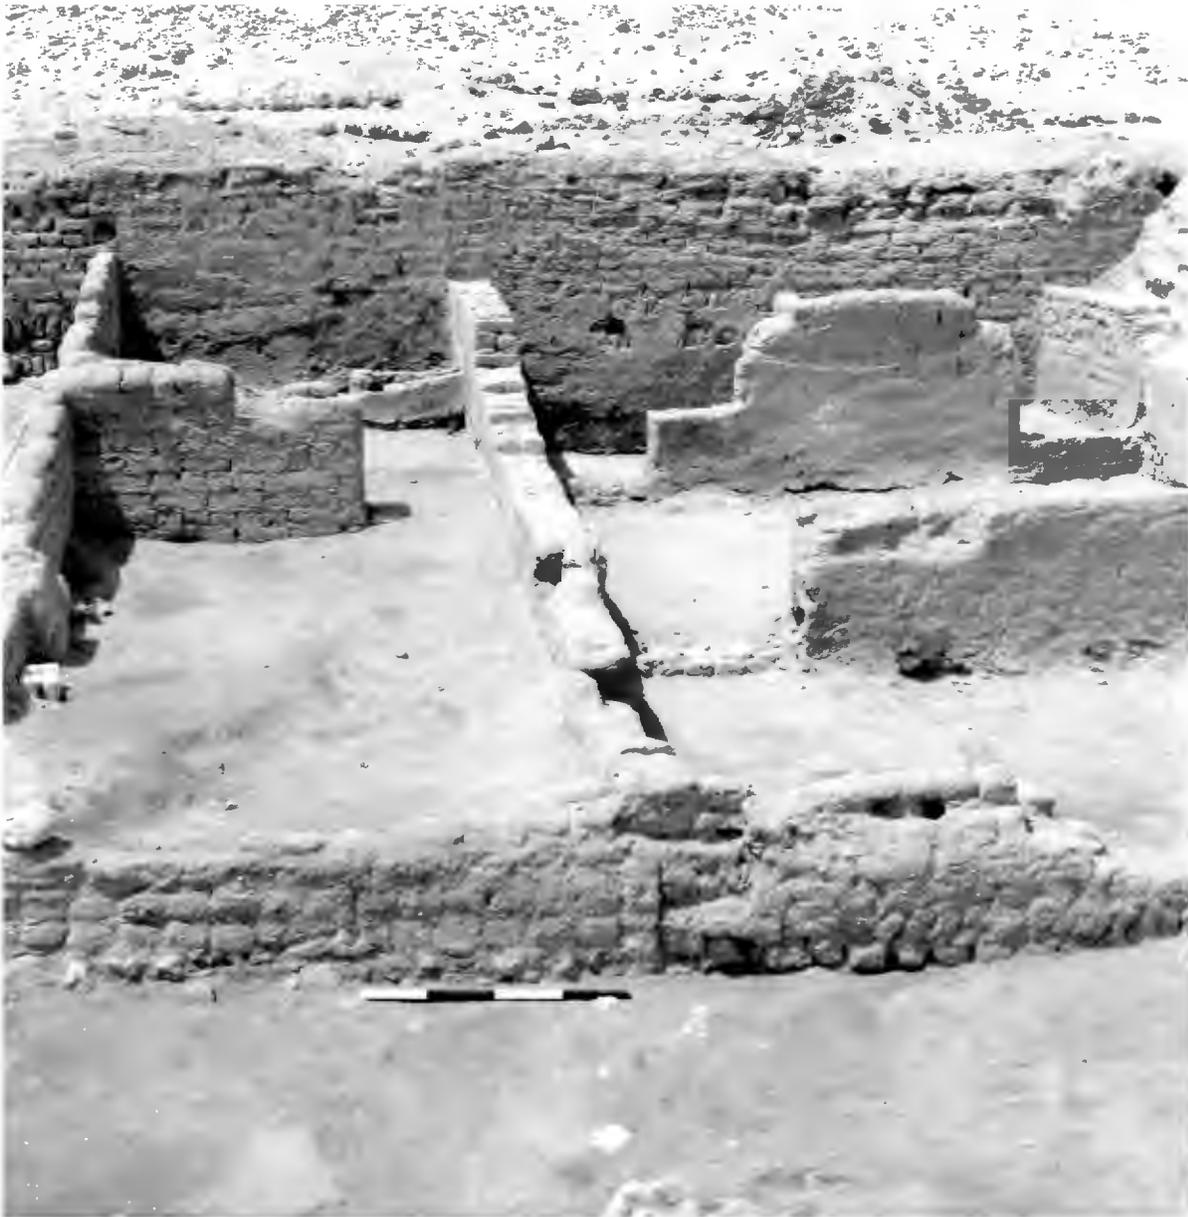
Figure 1.6. General view of the main part of West Street 2/3, looking west at the conclusion of the excavation.

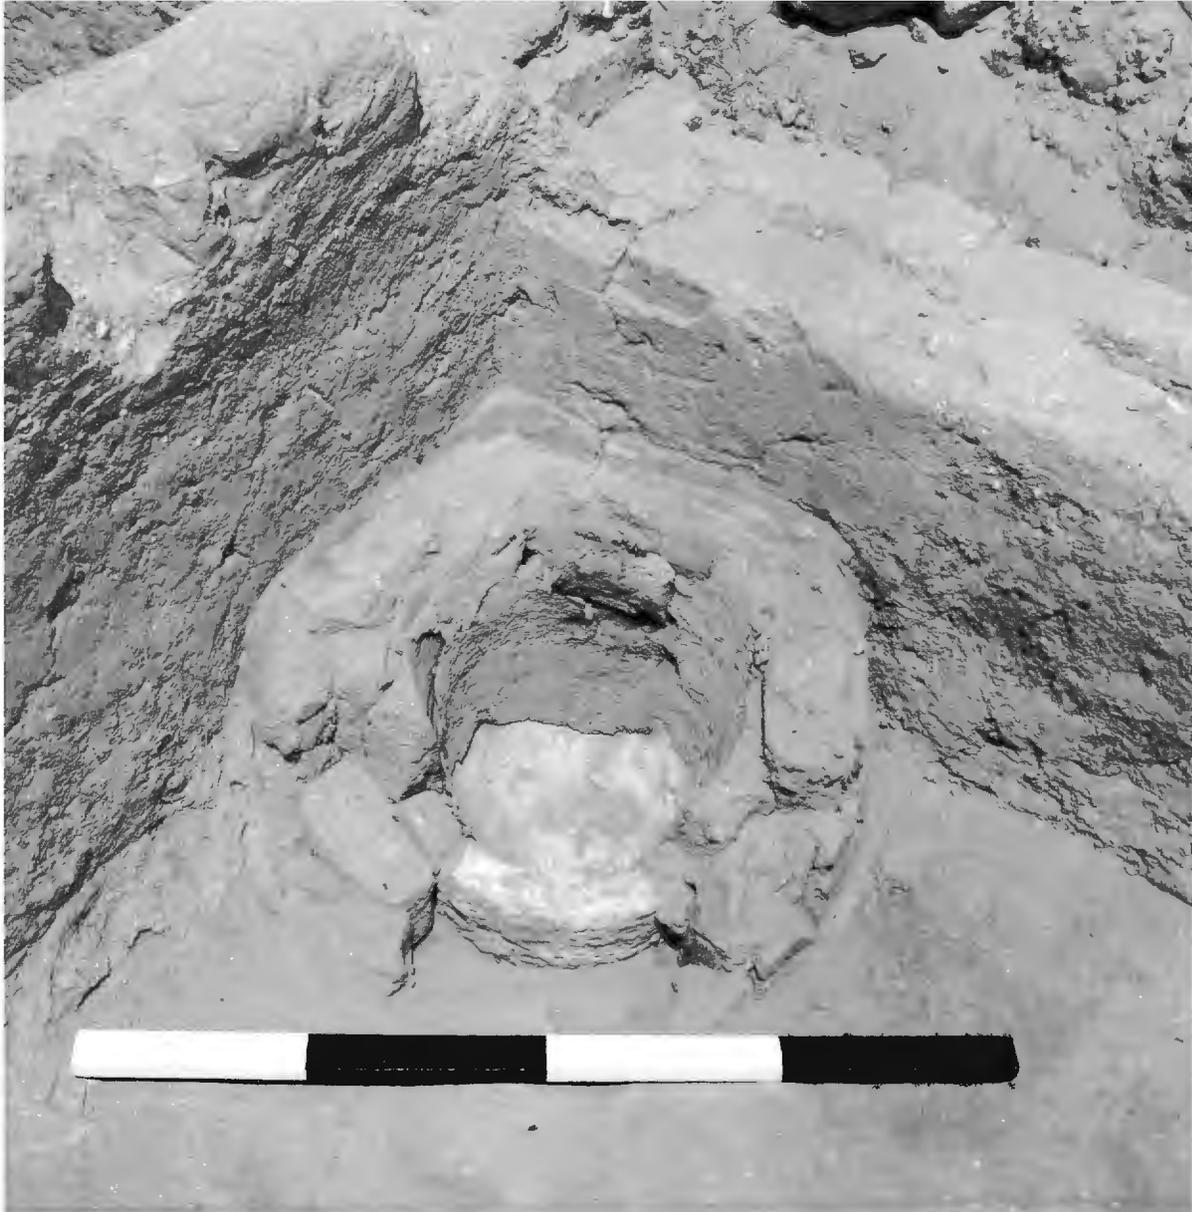
and two constructional features: a small projection of mud brick [2690] on the east, surrounded by a deposit of ash [2127] and of uncertain purpose, and a limestone mortar [2641] set in place in bricks and mud plaster in the north-west corner (Figure 1.7). This is the kind of mortar used

Figure 1.7. The mortar emplacement in the north-west corner of the Front Room of West Street 2/3, looking north-west.

anciently for the initial crushing of grain prior to grinding,<sup>2</sup> often let into the floor (as in Gate Street 9, see Figure 3.1), but here carefully built into a corner to be above floor level. The separation of the mortar from the quern, both occupying two distinct rooms, is unusual though not unique at the Village. However, this disassociation is probably misleading. For, as noted above, a second mortar was found in the loose disturbed fill [2096] of West Street 2, Area viii. This presumably had originally stood beside the quern, and the one in the corner of the Front Room was a second example.
