CHAPTER 8

REPORT ON THE 1986 AMARNA SURVEY

8.2 The Sanctuary of the Great Aten Temple by Barry J. Kemp

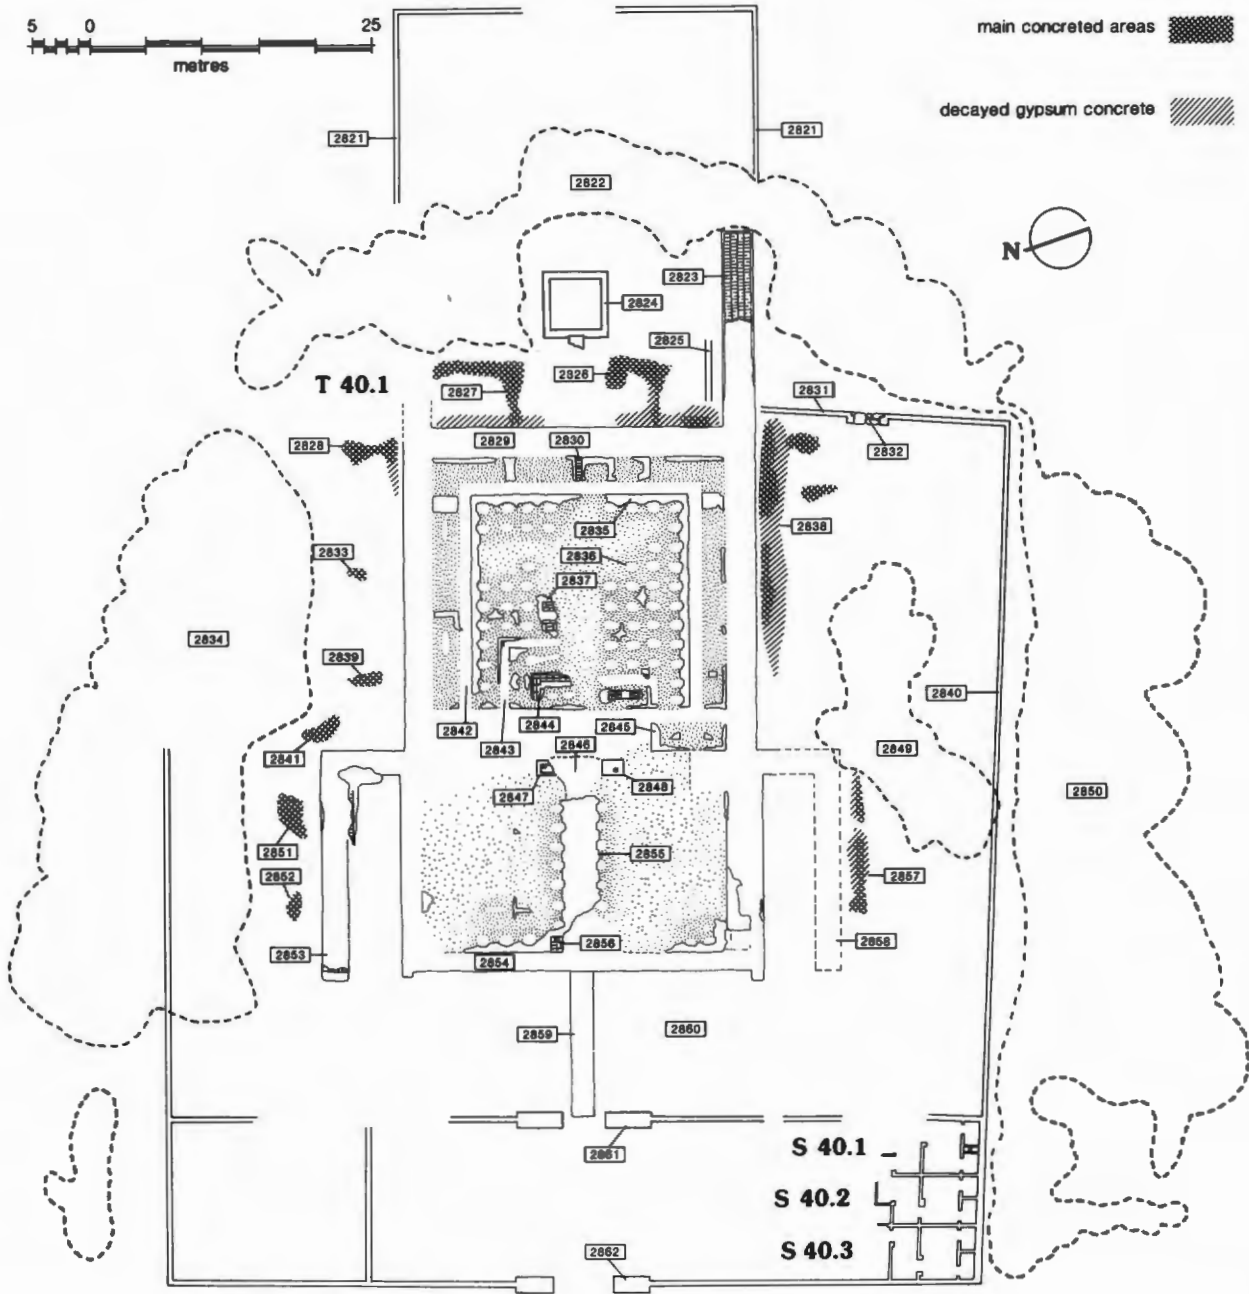
Figure 8.1. Plan of the Sanctuary of the Great Aten Temple, after Lavers, with additions and corrections from the 1986 Amarna Survey.

The Lavers' plan shows the remains of foundations from a stone building lying within an enclosure of mud brick. Herein lies the first correction. Not all of the brick walls are necessarily contemporary with the stone building, nor are they quite so regularly aligned as they appear on Lavers' plan. Moreover, in the south-east corner the Lavers' plan does not express the

relationship correctly. Not only does the brick wall [2831] containing the doorway [2832] not follow the same alignment as the stone structure, the stone wall trench [2823] actually cuts through it showing that it is later. What effect this has on the overall interpretation of the Sanctuary's history is hard to assess without re-clearance. Lavers assumed that the wall fragment [2825] was part of the rear brick enclosure [2821], but this is not the case, and so the connection between the rear brick enclosure and the brick walls on the south [2831, 2840] is severed. Since these were also built on a different alignment we have to consider if, when the stone Sanctuary was erected, this part was demolished and removed from view. If this applied all the way along the network of brick walls it would also remove from this phase the two pairs of small brick

Much more important, however, is the omission from Lavers' plan of a conspicuous embankment of gypsum concrete which seems originally to have surrounded the Sanctuary on three sides. It is best preserved now on the south and east sides, running along the outer edge of the main outer foundation trench, and is well portrayed in some of the photographs of Pendlebury's excavations published in *COA III*: Plate XXVI.1, 2, and 4. Figures 8.2 to 8.5 show its present condition. On the plan, Figure 8.1, each main part is designated by a separate unit number. On the north side much less of it survives, but several definite patches with northward slope downwards can be identified, units [2828, 2833, 2839, 2841, 2851, 2852]. The last two run beside the trench of the north wing-wall [2853].

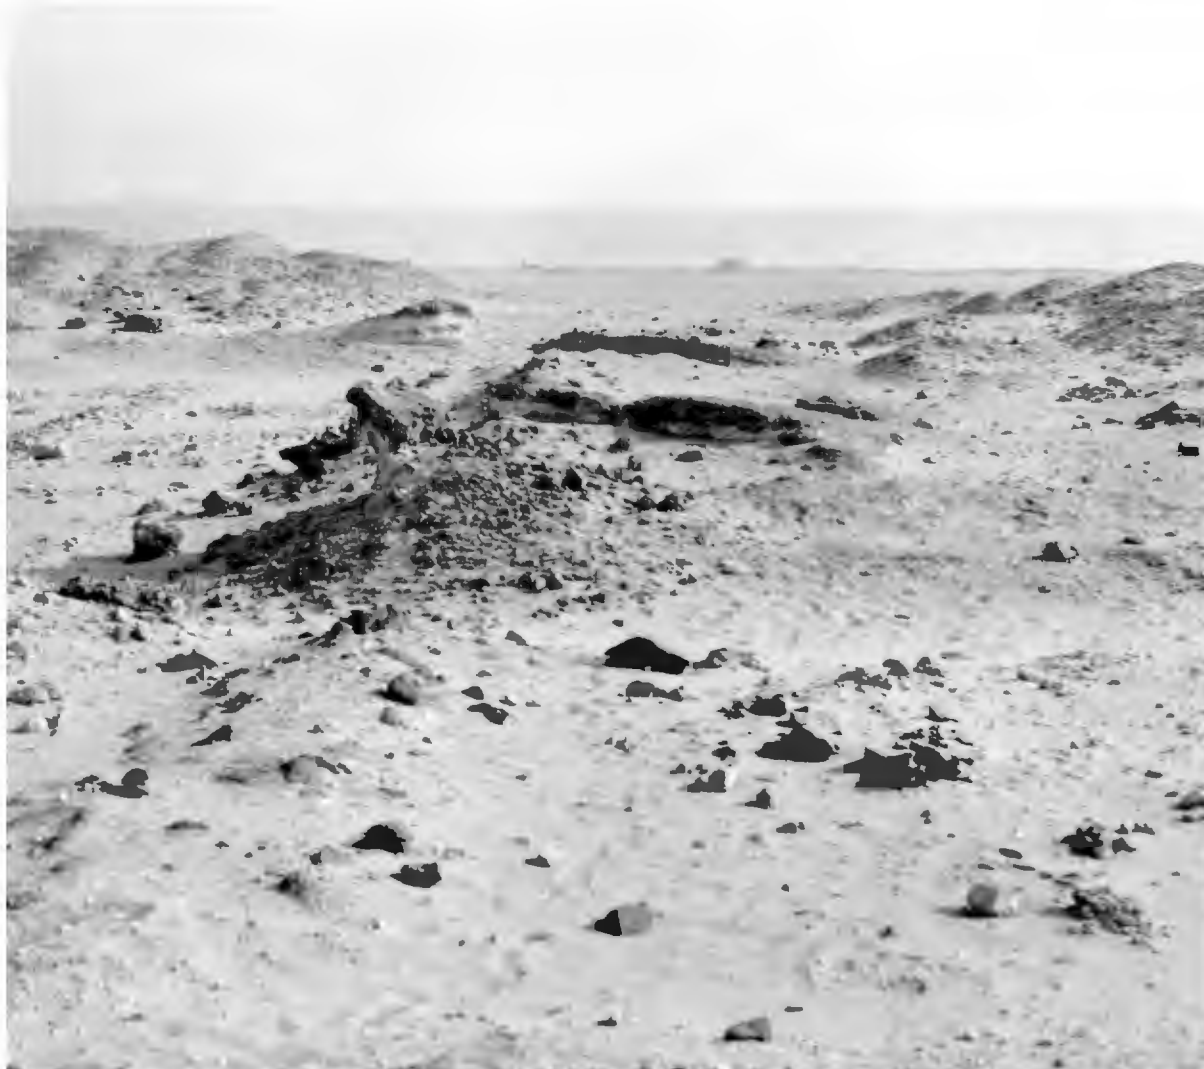
Figure 8.2. Remains of the embankment along the rear of the Sanctuary, looking north.

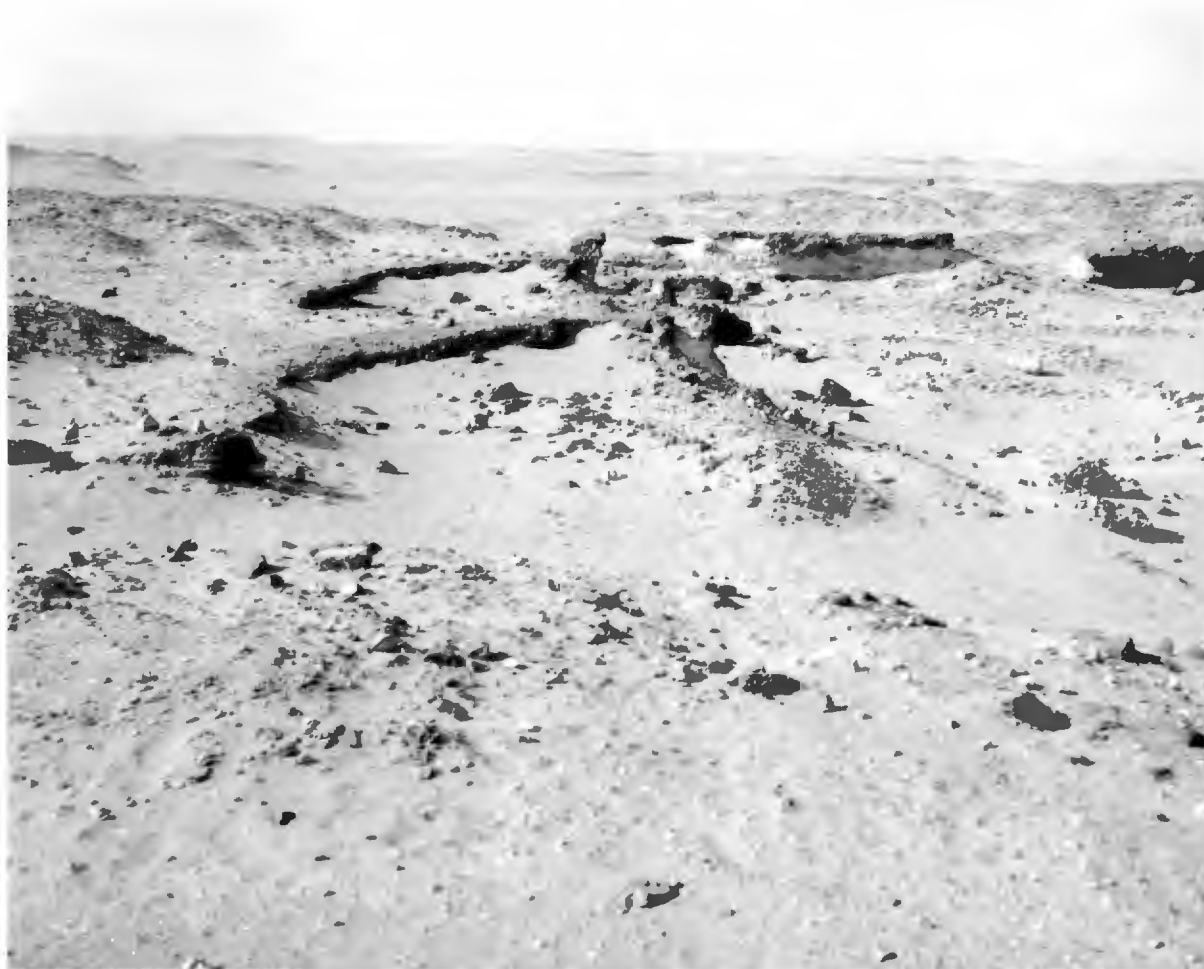
Figure 8.3. Remains of the embankment along the rear of the Sanctuary, looking south.

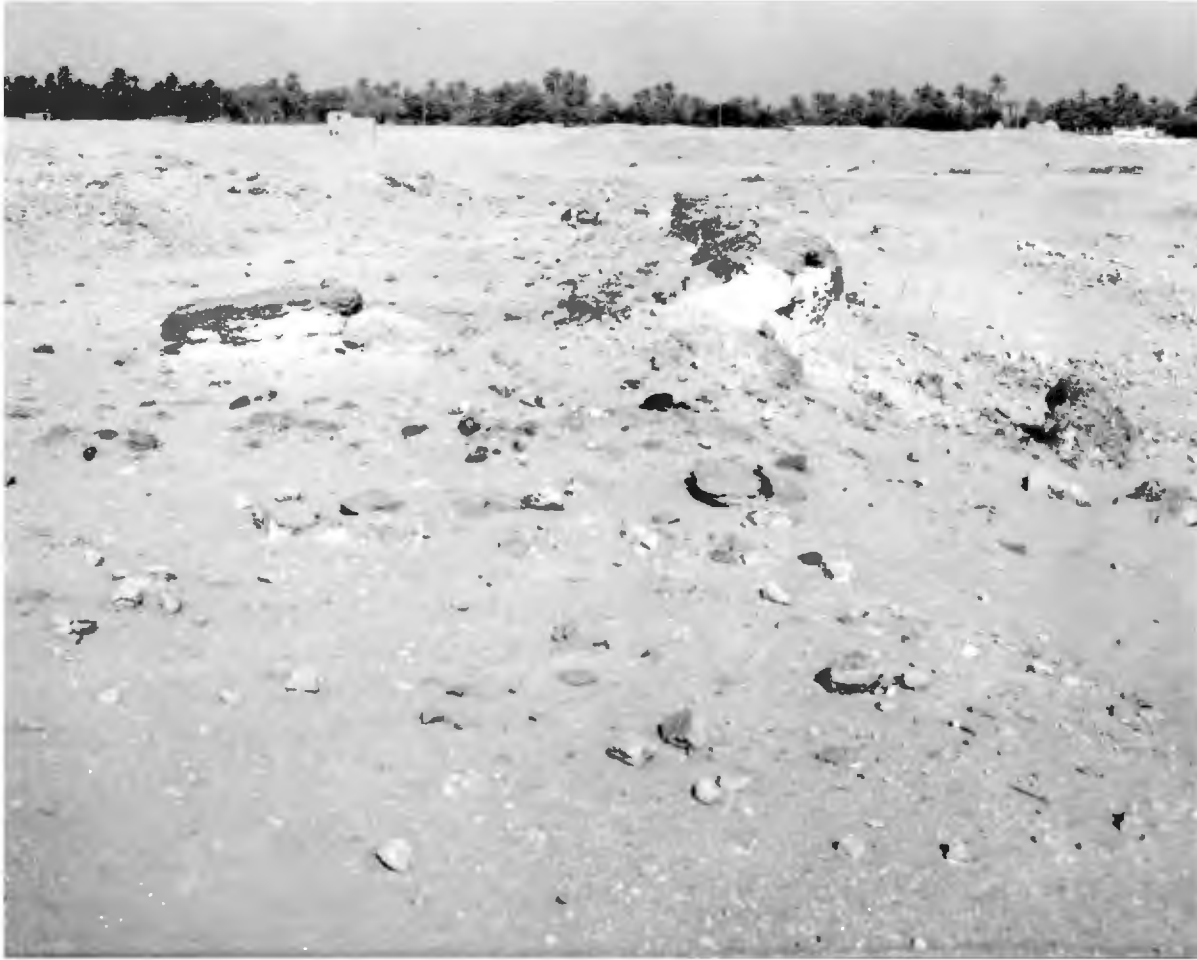
Figure 8.4. Remains of the embankment along the south side of the Sanctuary, looking west.

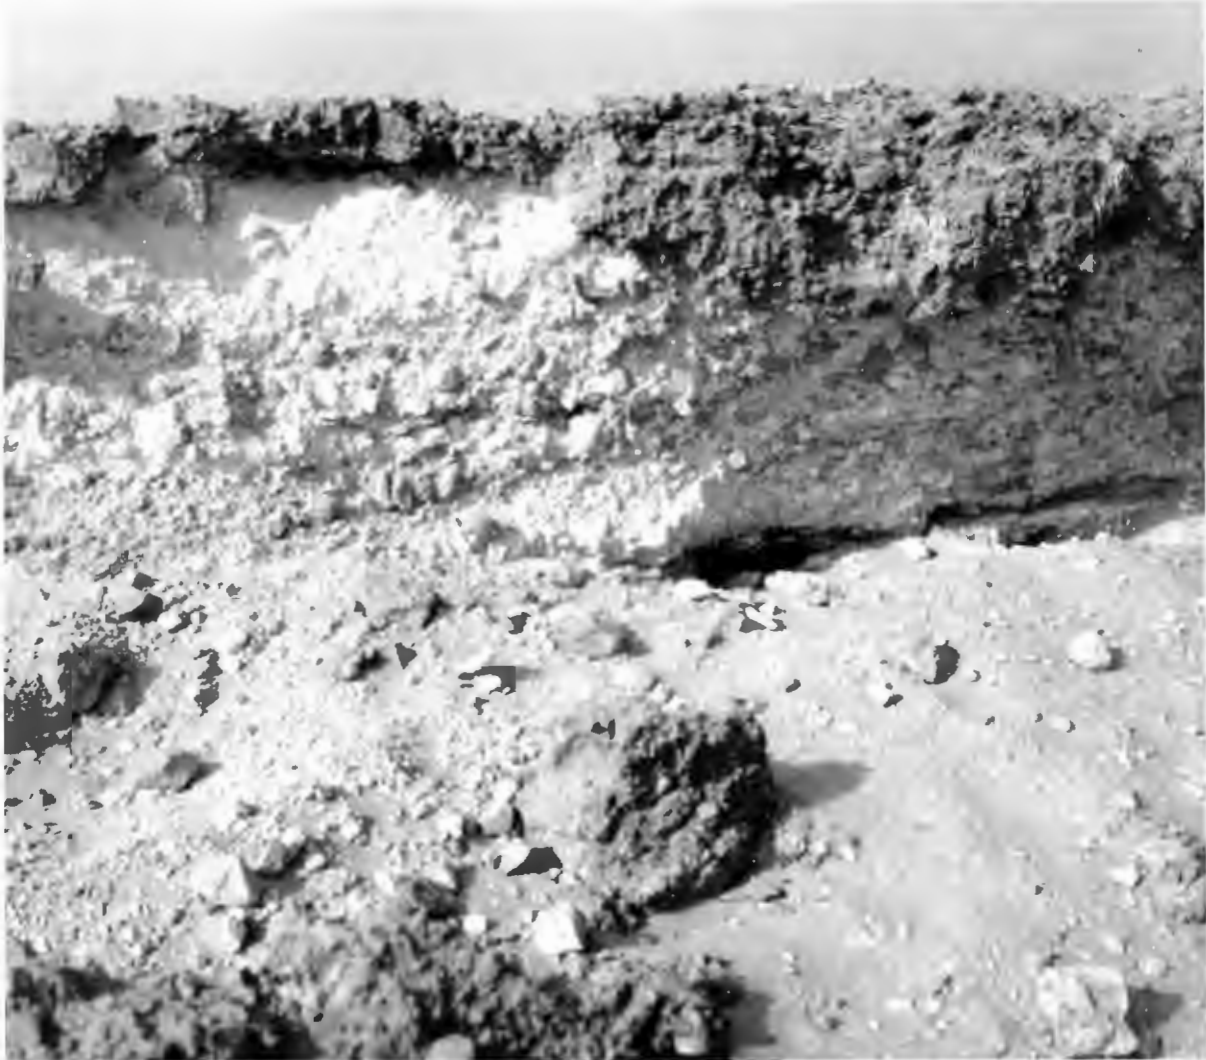
Figure 8.5. Detail of the embankment on the south side, showing the darkened weathering crust that has formed on the top of the gypsum concrete, and the horizontal division lower down between the base of the concrete and the top of the natural desert.

The material of the embankment is one that is very common on sites of stone buildings at Amarna: a concrete made from chips of limestone and some sandstone mixed with gypsum. Over a long period of time it weathers from white to brown, and exposed surfaces appear to take on an added hardness, so that the result is fairly durable. The embankment was perhaps mistaken in Pendlebury's time for rubble deriving from the destruction of the stonework of the Sanctuary, but if so this was wrong. Wherever portions are at all well preserved they display a constant and even slope downwards away from the walls of the Sanctuary, and, as the *COA III* photographs show, when viewed laterally it has an impressive evenness of thickness and disposition in relation to the underlying ground. It has to be accepted that it is part of the original building.

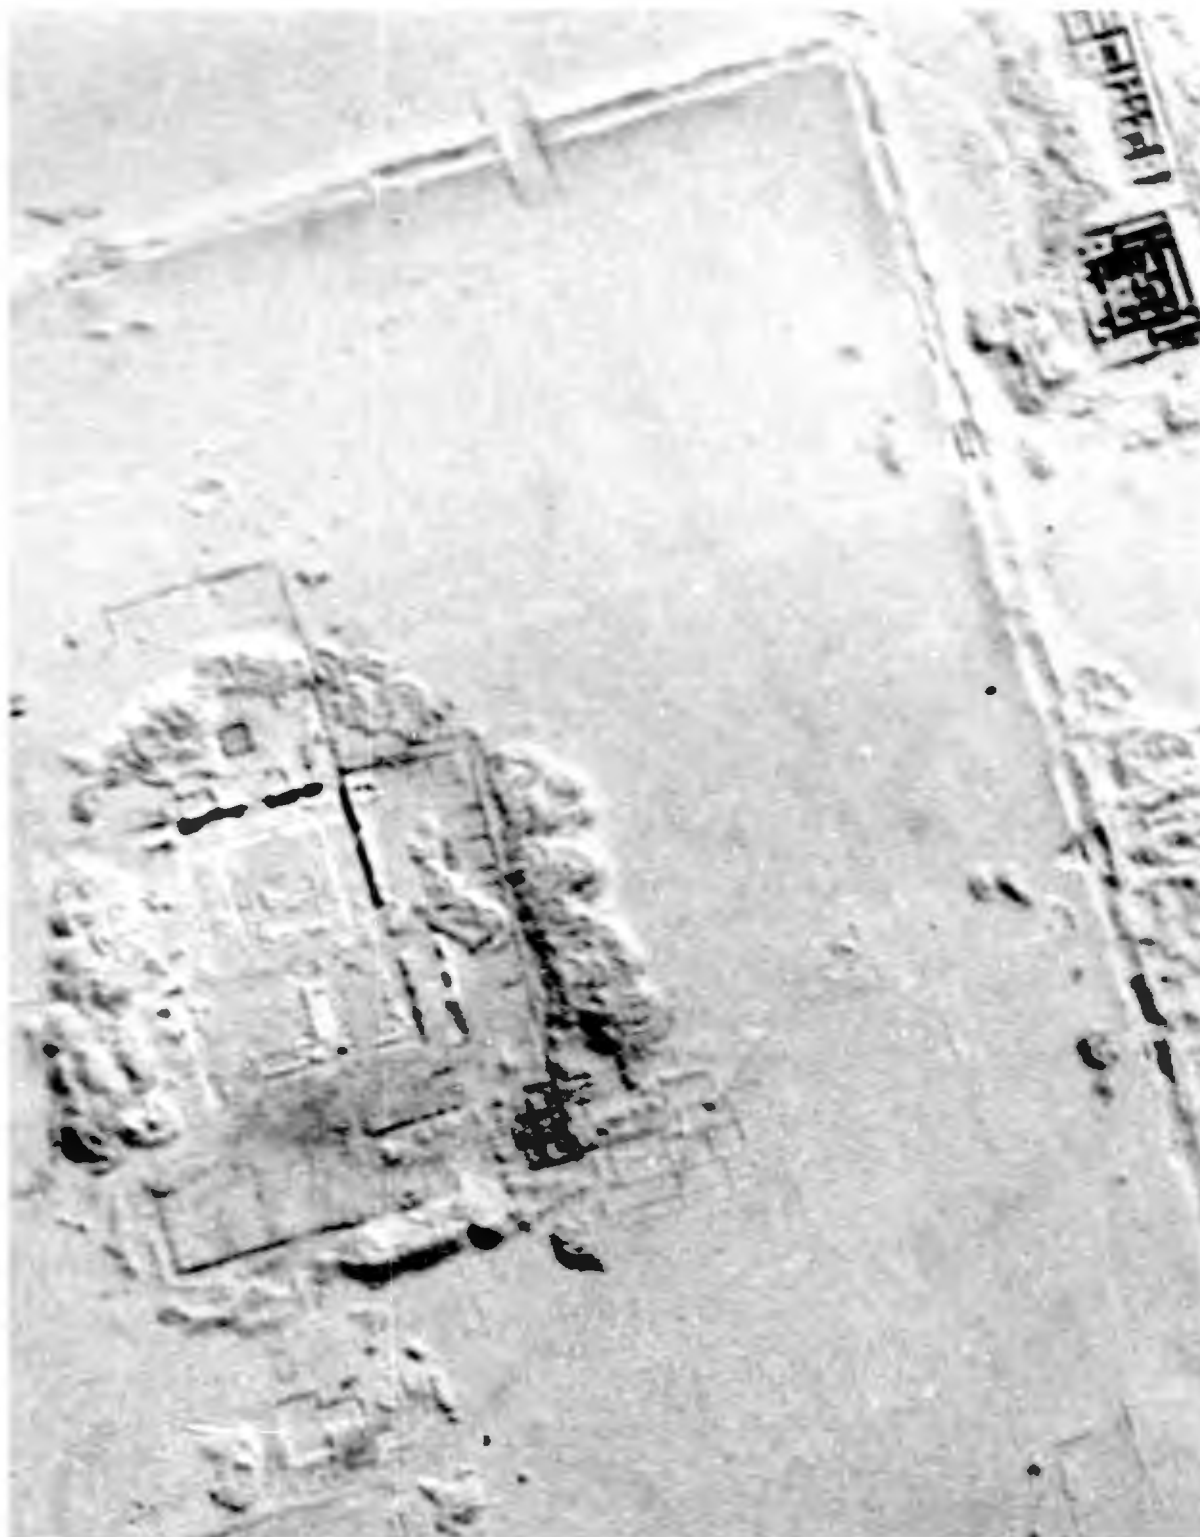
Figure 8.6. Aerial photograph of the Sanctuary of the Great Aten Temple taken in 1935 after the completion of Pendlebury's excavations in 1934.

The Sanctuary was excavated under Pendlebury's direction in 1933-4. The written account and illustrations, which include the plan of the remains made by Lavers, form part of *City of Akhenaten* III (5-10, Plates VII-IX, XXV-XXVI; also Pendlebury 1934: 129-133, Plates XIV-XVI). Pendlebury stripped off the loose covering of rubble to expose the lowest level of foundations, and these have since been reduced by weathering. Nevertheless, one major feature survives which has passed without comment, despite the fact that it is the most conspicuous one of all. This omission was first noticed during the first phase of the Amarna Survey in 1978. With the second phase now covering the same ground the opportunity was taken to look again at the Sanctuary and to add to a copy of Lavers' plan the necessary corrections and additions (Figure 8.1). These include a series of spot heights, related to one of the Amarna Survey's bench marks of 49.05 metres a.s.l. on the concrete base of the nearest electricity pylon (no. 68). Use was also made of a fine low-level aerial photograph taken in 1935, a small portion of which is reproduced here (Figure 8.6).

Petrie was the first archaeologist to work at the Sanctuary. He entrusted the task to Howard Carter, and the aim seems to have been simply to search for sculpture: "The site of the temple, or shrine, which was entirely excavated by Mr. Carter, is marked by heaps of broken pieces of mortar and stone; and the cores of the walls consisting of mortar and chips still remain to shew the position. Mr. Carter turned over nearly all of this without finding anything more than two or three blocks of the great stele" (Petrie 1894: 18). By the end of Pendlebury's work, whatever was left of the concrete foundations, except the embankment, had been removed. There is, however, a possible discrepancy in the history of the site to be accounted for. An aerial photograph taken in 1922 shows the site of the Sanctuary as, presumably, Carter and Petrie had left it. The photograph is not as sharp as one would like, but one can see the site covered with a low mound of pale debris pitted with holes. There is, however, no sign of a dump to one side. This appearance is consistent with the "turning over" which Petrie mentions and which was a common practice of his. Pendlebury includes a photograph of the site before his excavations in *COA* III: Plate XXVI.1. It is taken from the rear, just east of the piece of concrete ramp labelled [2827] in Figure 8.1. It shows a thin cover of chippings, reduced to almost nothing on the south side where some of the plaster flooring is already visible. On the left of the picture the line of the embankment on the south side appears. Furthermore, behind the photographer there must have been a tall heap of debris which is casting a long shadow. This is the dump which Pendlebury ascribed to Petrie and which is marked as such on Lavers' plan.⁵ These features are not evident on the 1922 photograph, which, in particular, reveals no trace of "Petrie's dump". One cannot be absolutely certain, but there must be a strong suspicion that between 1922 and 1933 the Sanctuary was illicitly dug in a very thorough manner. Pendlebury himself noted recent interest on the part of the villagers of el-Till: "A feature of the site used to be the quantity of cut and carved stone on the south side. This was removed by the villagers in the summer of 1933. From a previous, admittedly superficial, examination, however, nothing of importance has disappeared" (*ibid.*, 6, note 2; cf. Pendlebury 1934: 129, note 1; 133). The villagers's removal of pieces may have extended to an excavation which threw up an extensive spoil heap on east and north. Even so, Pendlebury's pre-dig photograph seems to show a patch of the gypsum concrete platform, towards the right of the picture, well within the confines of the Sanctuary walls.

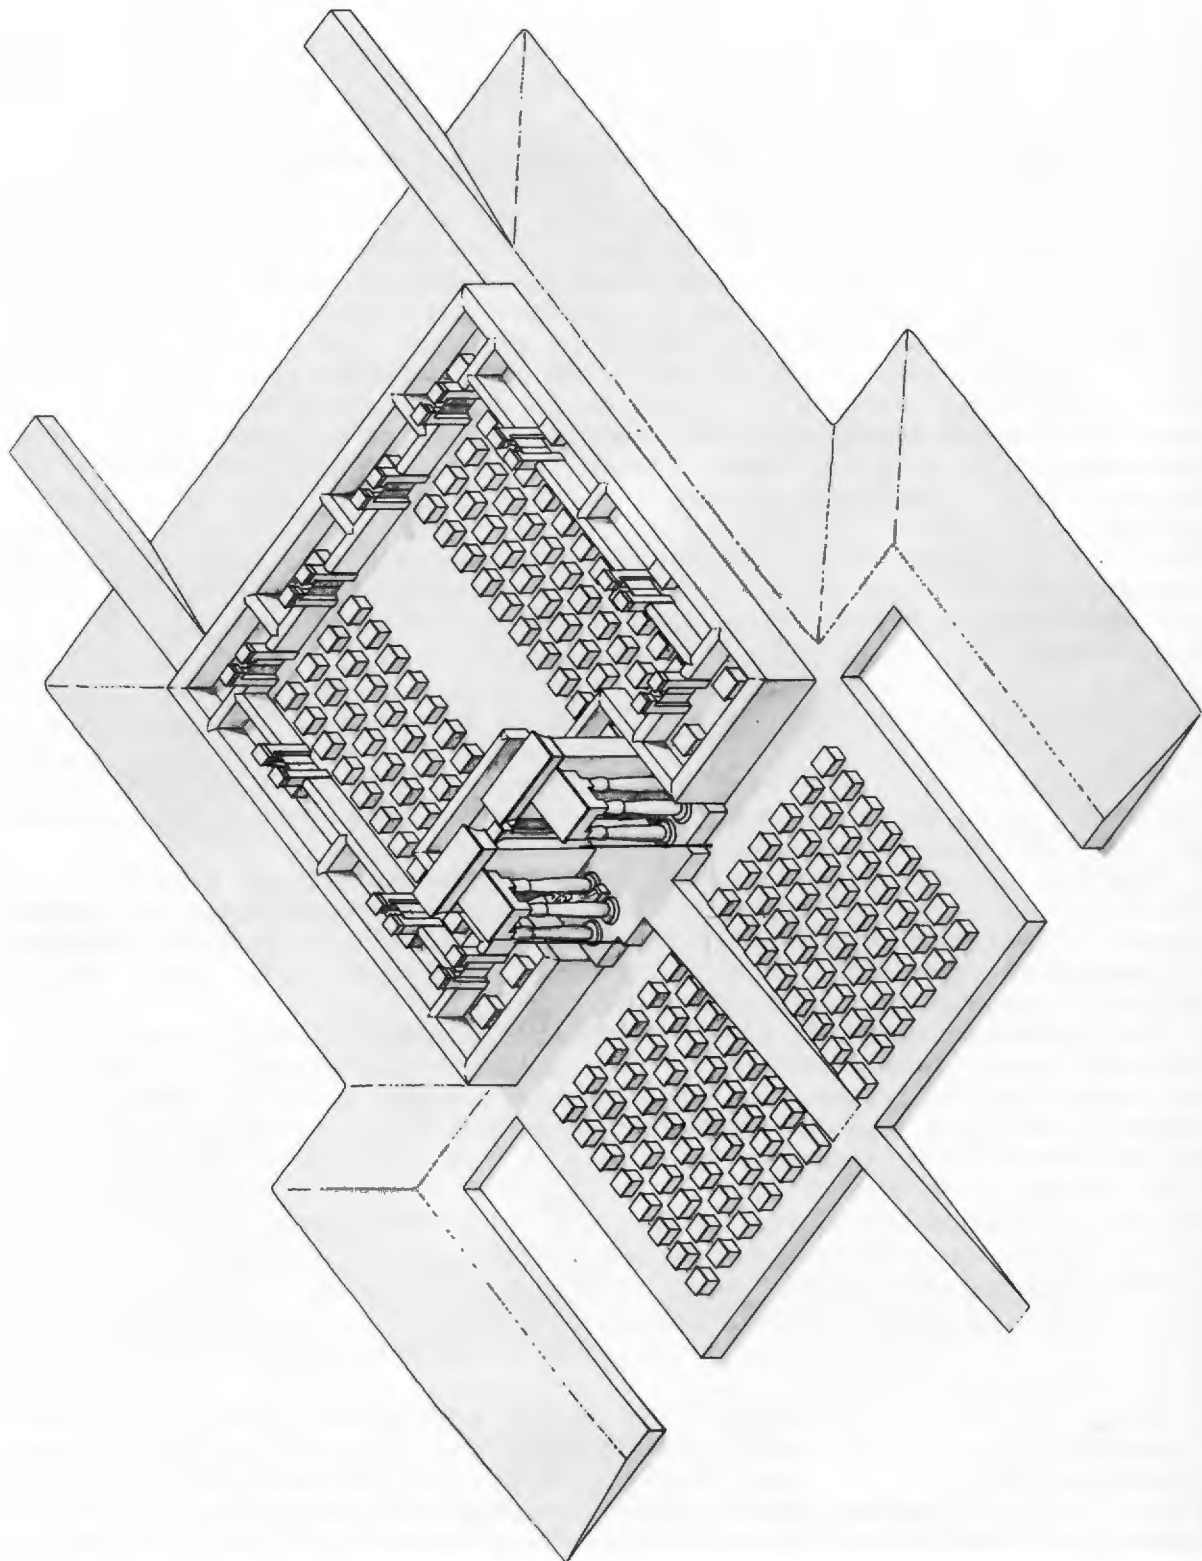
Figure 8.7. Reconstruction of the Sanctuary of the Great Aten Temple (original by B. Kemp).

The reconstruction begins with a low platform overall, and there need be no doubt as to what principally lay on it: a large number of small rectangular stone offering-tables. The tomb pictures are valuable here, for they show that this is what the numerous rectangular foundation marks supported. The slightly sunken strip [2859] running perpendicularly to the front then becomes the foundation trench for an access ramp. Making the basis of the Sanctuary into a low platform then frees one from the necessity of making the Sanctuary into an entirely enclosed building, for the wall that rose from the main foundation trench [2829, 2854] could have served only as a retaining wall. In our reconstruction (Figure 8.7) the front part of the Sanctuary has been left as an open platform supporting offering-tables. The foundations of this part include a strengthened concrete strip running along the axis [2855]. This has been interpreted as the foundations for a second ramp, which then necessitates raising the rear part of the temple to a greater height. This is one of the more speculative elements.

The remaining elements are the projecting walls at front and back, the former [2852, 2858] laid out like wings, the latter [2823] continuing the line of the sides of the Sanctuary. The solution adopted here is to keep them no higher than the terrace so that they become extensions to it. Although the effect is odd, it is less so than to place walls of full height on these alignments, and one can set the musicians, dancers and "audience" for the king's visits on them (they would have been about two metres wide). The rear extension walls presumably related to the square brick platform at the rear [2824] which still rises well above the surrounding ground level and was therefore visible when the Sanctuary in its final phase was in use. Unfortunately the concrete embankment has been destroyed just where it passes in front, so that we cannot judge if it was interrupted in some way. This element remains most enigmatic.

The correctness or otherwise of some of the elements in the reconstruction of Figure 8.7 is probably not very important. The overall design, however, becomes part of the basic material by which we form our impressions of Akhenaten's style of rule. In the Lavers' reconstruction, although the temples were open to the sky, they retained the traditional atmosphere of seclusion by being entirely surrounded by high walls which would, for most of the day, have kept the interiors in shadow. In the new reconstruction a good part of the temple is entirely open, and elevated, making the king's entry into an extension of the semi-public drama of the king's progress that seems to underlie the tomb pictures. If we keep the walls of the rear part reasonably low we also remove the principal source of internal shadow and make the whole more fitting to the worship of the sun's disk. It would also better convey the air of openness to view which the tomb pictures suggest.
