1932 EXCAVATION PHOTOGRAPHS

The Egypt Exploration Society archive contains 35 negatives that cover the excavation of the Long Temple. They are not individually datable and the numbering of the negatives seems not to reflect the order in which they were taken. Only one was definitely taken whilst the excavation was in progress. This is Photo 32/1 (p. 18) and was taken as the sand and stone fill that covered the interior of the First Court of the second temple was being removed. Photos 32/16 and 32/9 (pp. 19, 12) were probably taken also taken during the course of the excavation. The remaining photographs, in so far as it is possible to judge, show the site fully excavated, the appearance conforming to how the site looks in the 1935 aerial photograph. No workmen are visible (although one or two guards appear in Photo 32/3, p. 15), and there is no sign of the Decauville railway that had produced the linear dumps that are scattered around the sides of the excavation. This points to the bulk of the photographs having been taken after the end of the excavation, perhaps in the course of a single day. The shadows in Photos 32/35 and 32/12 (pp. 6, 7), although the places from which they we

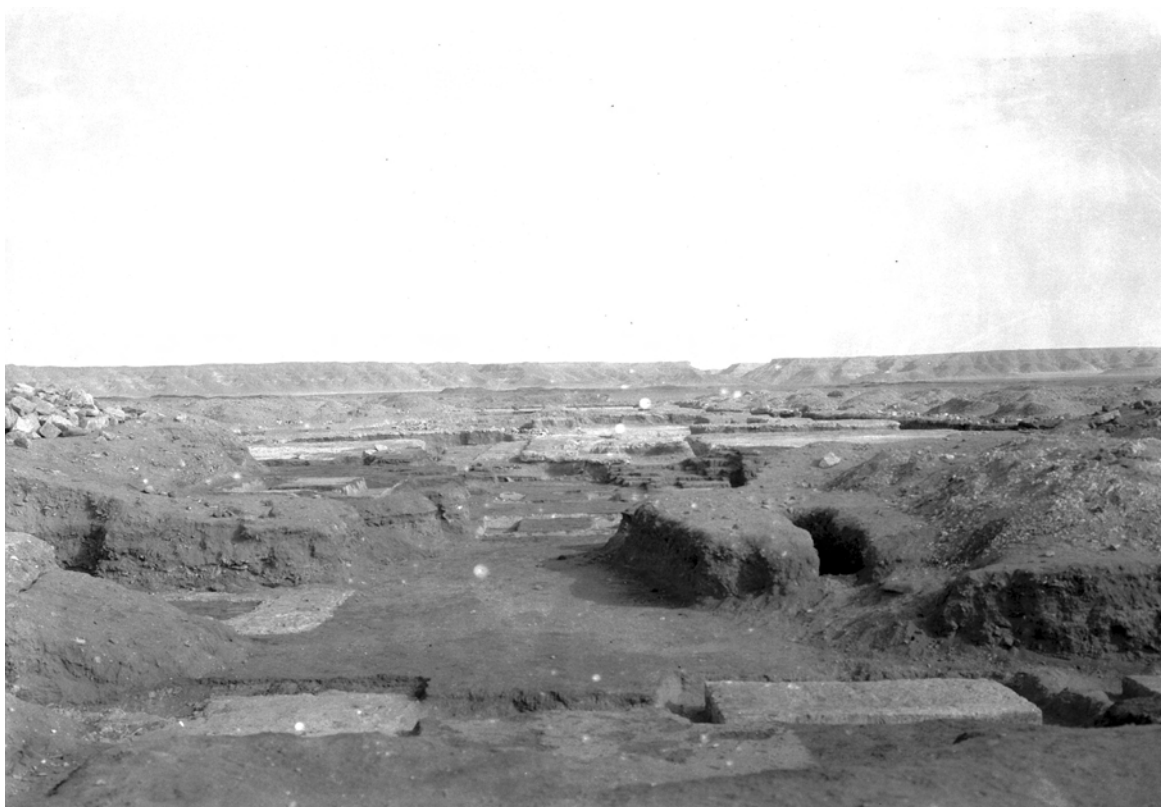
Photo 1932/30

View eastwards along the temple axis, taken from the area of the threshold of the mud-brick pylon. The foreground is crossed by a line of rectangular bases made of limestone blocks laid on a north-south axis and belonging to the earliest phase of the temple. Beyond runs Pendlebury's wide trench dug along the temple axis and cutting through the layer of levelling rubble that separated the floors of the first and second temple. Just beyond the left rectangular base the gypsum concrete foundation for the entrance vestibule of the Small Palace is visible. On the axis, and further to the east, comes the first of the line of rectangular gypsum-lined basins laid along the axis of the first temple. To the left and on top of the layer of levelling rubble is a basin surrounding a rectangular pedestal belonging to the second temple. The levelling rubble on the right (south) side of the trench has also been cut by a narrow exploratory trench. In the mid-distance comes the pale layer of gypsum concrete that belongs to the entrance portico and pathway of the approach to the second temple, and the mud-brick 'wall' that extended in front of it. On the left and right sides it can be seen how Pendlebury piled the spoil from the excavation over the layer of levelling rubble, the pile on the left partly covered by a heap of large stone fragments.

EES catalogue entry: 'Great Temple. View East from entrance.'

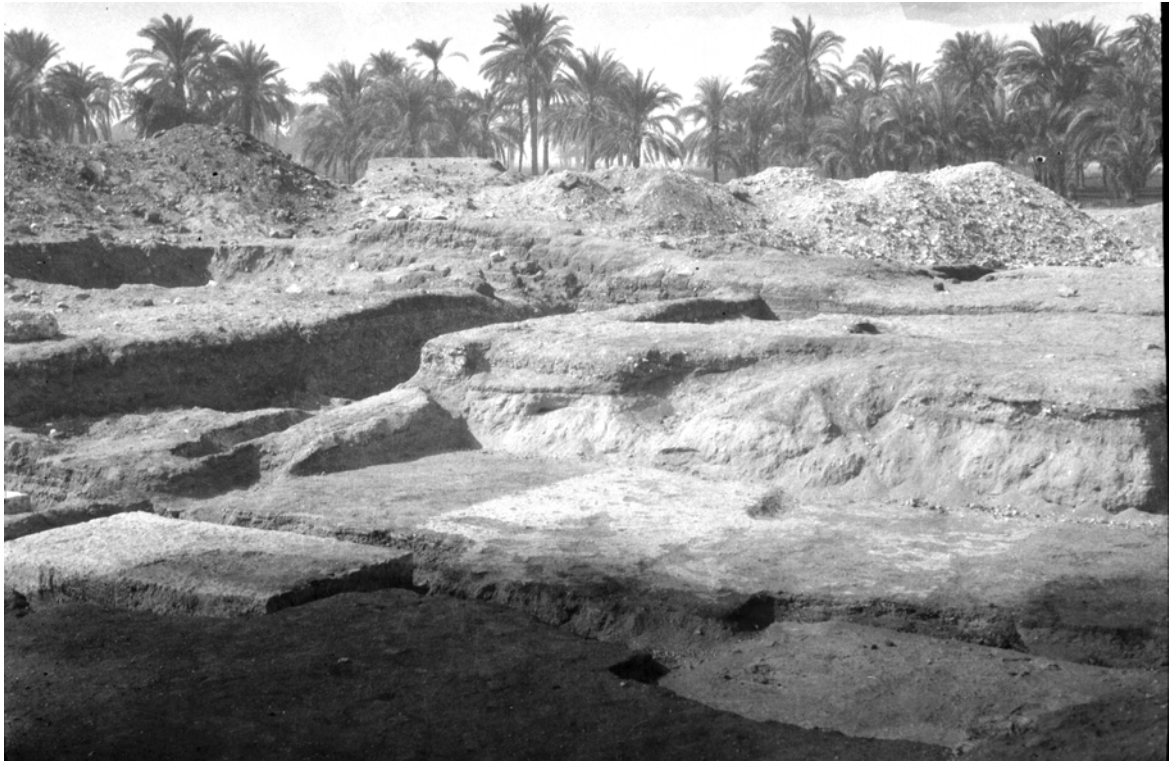
Photo 1932/2

View south-westwards across the entrance ramp on the inside of the temple mud-brick pylon. The inside face of the southern pylon is clearly visible, rising away from the entrance and then dropping again as it approaches a particularly tall spoil heap. The ground in front of the spoil heaps at the left edge of the picture shows a vertical face (in shadow) where debris has been removed to expose the top of the layer of levelling rubble. The middle distance is largely occupied by the entrance ramp, composed of sand with a thick layer of mud on top. The excavation has cut into this, to create a vertical section across it. It is bounded on the left by the inclined mud-brick wall that forms its southern edge and which extends towards the lower left-hand side of the picture. To the left of this runs a Pendlebury trench (its southern face in deep shadow) cut through the levelling rubble down to the mud floor of the first temple. The removal of the ramp fill has exposed the mud floor of the first temple and a clearly defined area of very well preserved white plaster coating. The line of limestone bases crosses the bottom of the picture, defined by narrow trenches dug in 1932. Originally the tops of the bases seem to have been flush with the mud floor. The blocks of the right-hand base had been removed during one of the rebuilding phases of the temple.

EES catalogue entry: 'Great Temple, entrance. Stone bases, Ramp and earlier floor.'

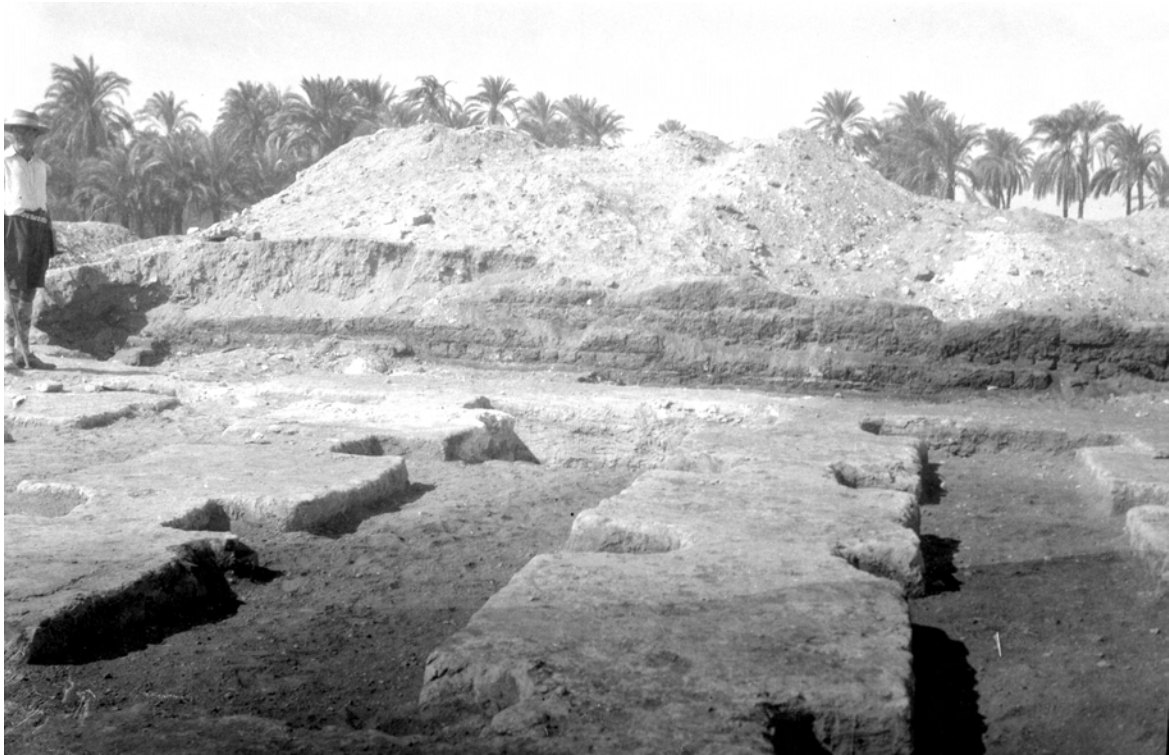
Photo 1932/4

The gypsum concrete foundations of the main columned hall of the Small Palace, the building also named as the 'Altar' on the 1932 plan. The pattern of foundations was the normal one for columns, roughly square blocks joined into lines by short linking walls. The spaces between the lines had been filled with sand, which the excavation has removed to a sufficient depth to expose the foundation pattern. Behind the foundations rises the east face of the northern mud-brick pylon tower covered by one of the large excavation spoil heaps. Towards the left side of the picture, this has been cut back to a vertical face. View to the west.

EES catalogue entry: 'Great Temple. Cement foundations of Pavilion North of the entrance.'

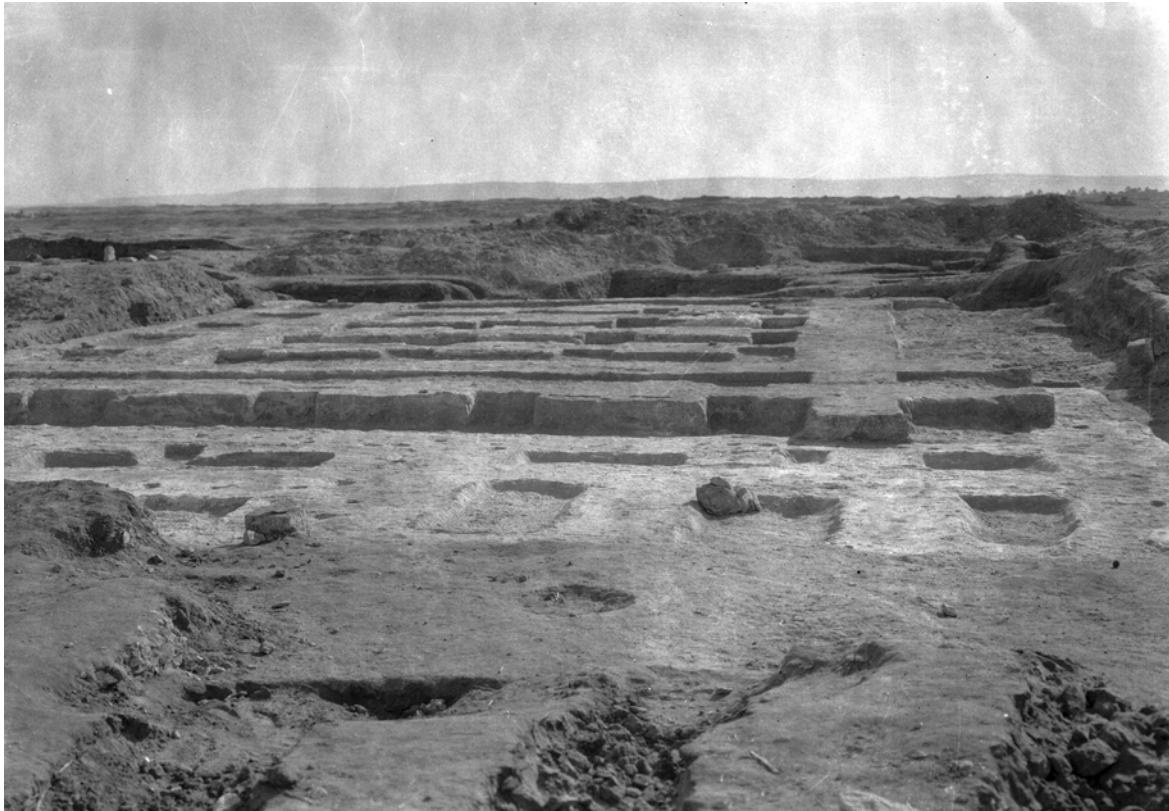
Photo 1932/31

The gypsum concrete foundations of the Small Palace (the 'Altar'), viewed to the south. The southern portion formed a pattern of foundations for walls and columns made from gypsum concrete that had been heaped into shape by hand, the spaces then filled with sand. On the upper surface traces remained to show that limestone *talatat*-blocks had then been laid on top and this had been the final foundation layer. Closer to the camera, the gypsum concrete foundation had been laid as a thinner bed on the desert surface, so that an extra layer of blocks was needed to bring the foundations to a common level. One explanation for the closely spaced walls is that they created stable compartments filled with sand over which a layer of paving stones had been set, to create an enclosed courtyard. The nearest strip of ground, in which shallow holes have been dug, contains a northwards continuation of the foundations that the 1932 excavation did not expose.

On the right of the picture the eastern face of the mud-brick pylon is visible. Just before it disappears beneath a large spoil heap, a brick wall can be seen projecting eastwards for a short distance. This is one of a number of short projecting walls built against the face of the pylon at a late stage in the temple's history.

EES catalogue entry: 'Great Temple. Foundations of Pavilion N of Entrance.'

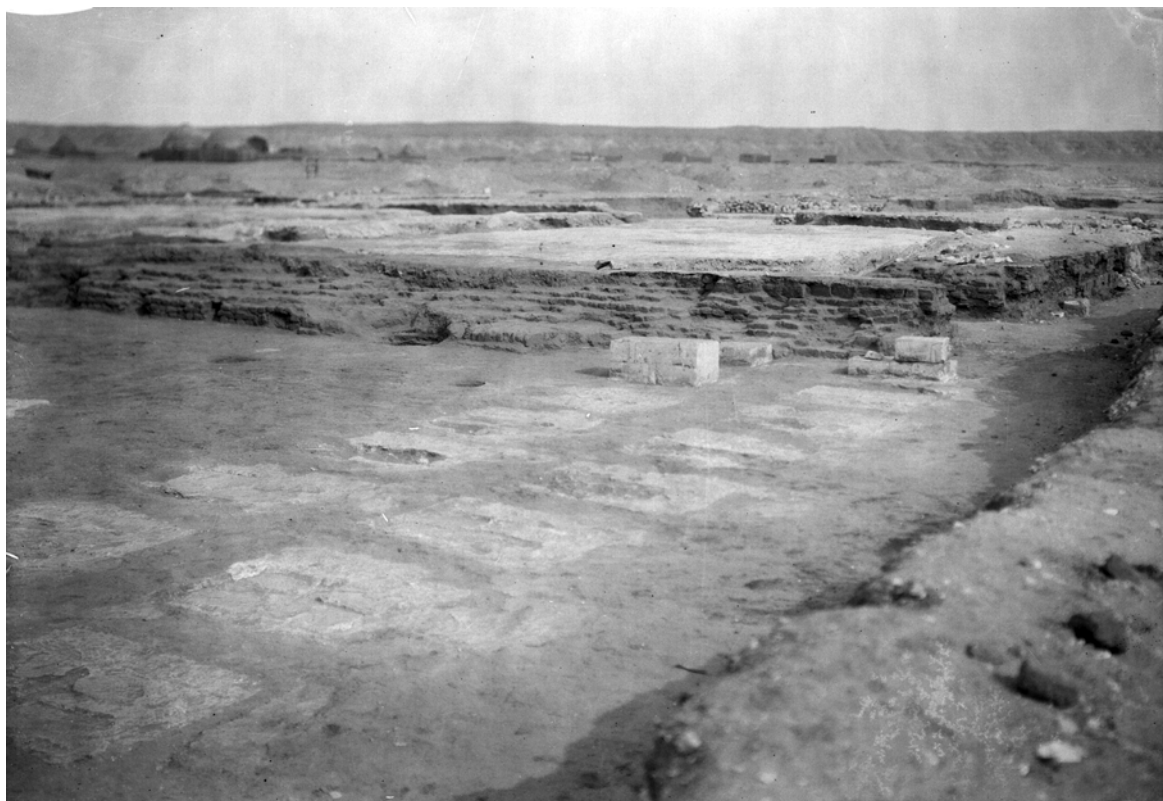
Photo 1932/35

View north-eastwards across the ground in front of the colonnades that stood in front of the second stone temple. When Pendlebury began, the then surface of the ground must have approximated to the top of the layer of levelling rubble that separated the floors of the two temples. In this picture it has been removed from across the whole area in front of the brickwork, except along the right side of the picture. The edge of the excavation runs diagonally across the picture. The undisturbed ground to the right is mainly a continuation of the levelling rubble that must have buried the field of mud-brick offering-tables (see Photo 32/40, p. 9). The circular, gypsum-lined basin of Photo 32/19 (p. 8) must have lain a short distance beyond the right side of the picture.

Two rows of separate rectangular foundations of gypsum concrete cross the floor of the first temple from west to east. Stone *talatat*-blocks still remain in place on three of the foundations, showing that each was built up as a separate rectangular structure, presumed to be an offering-table. The one with two complete courses is on the foundation that is in the north-east corner of square L27 of the 2014 excavations. By this time, however, the blocks had been removed. Unlike the blocks that survived on the foundations in the first court of the second temple (see Photo 1932/18, p. 21), these were not also foundations but were part of the visible final structure. Although they could have been plastered, the plainness of finish is noteworthy. See also Photo 32/12 (p. 7).

Behind the bases runs the thick mud-brick retaining wall that probably belongs to the construction phase of the second temple and was of temporary use only. Its weathered western face probably reflects the fact that the Petrie/Carter excavation of 1891/2 had outlined the two large colonnade foundation platforms and had thus left the brickwork exposed. The top of the southernmost of these platforms, also made from gypsum concrete, is the pale surface behind the wall.

In the mid-distance a rough stone wall can be made out. This was built by the Pendlebury expedition to enclose a part of the modern cemetery that had intruded into the north-east part of the First Court of the second temple.

EES catalogue entry: 'Great Temple. SW corner of Per Hai. Brick pylons and earlier bases.'

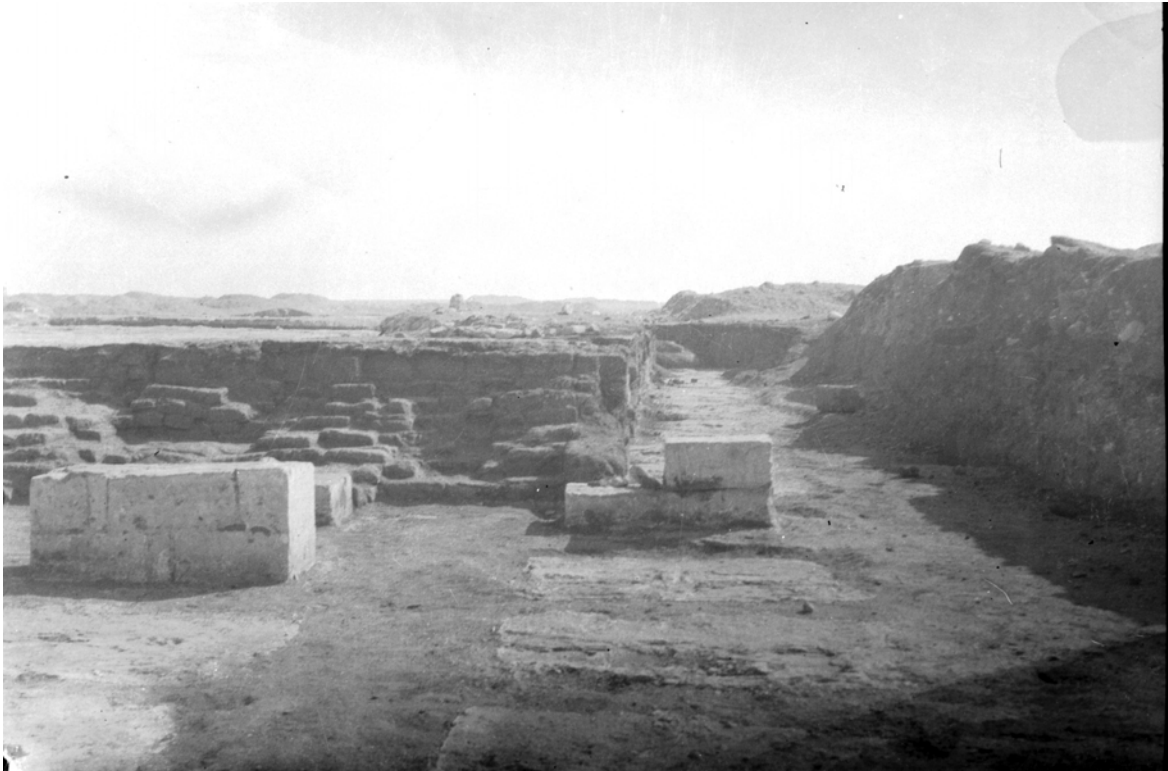
Photo 1932/12

A closer view of the three offering-tables still retaining some of their stones, built on the ground of the first temple. View to the east. See also Photo 32/35 (p. 6). Behind them is the mud-brick retaining wall for the foundations of the second temple. The southern face of the wall looks relatively fresh, as if it had not been exposed before by the Petrie/Carter excavation. Running into the middle distance on the right is Pendllbury's trench along the line of the right-hand line of offering-tables and along the face of the brick wall. It extends not much further than the end of the line of offering-tables. The right side of the trench is a vertical cut through the thick layer of levelling rubble that has not been cut back sufficiently to expose the mud-brick offering tables that it had buried and which must lie a short distance further to the south. This section face is visible in the background of Photo 32/18 (p. 21).

EES catalogue entry: 'Great Temple. SW corner of Per Hai. Earlier stone bases.'

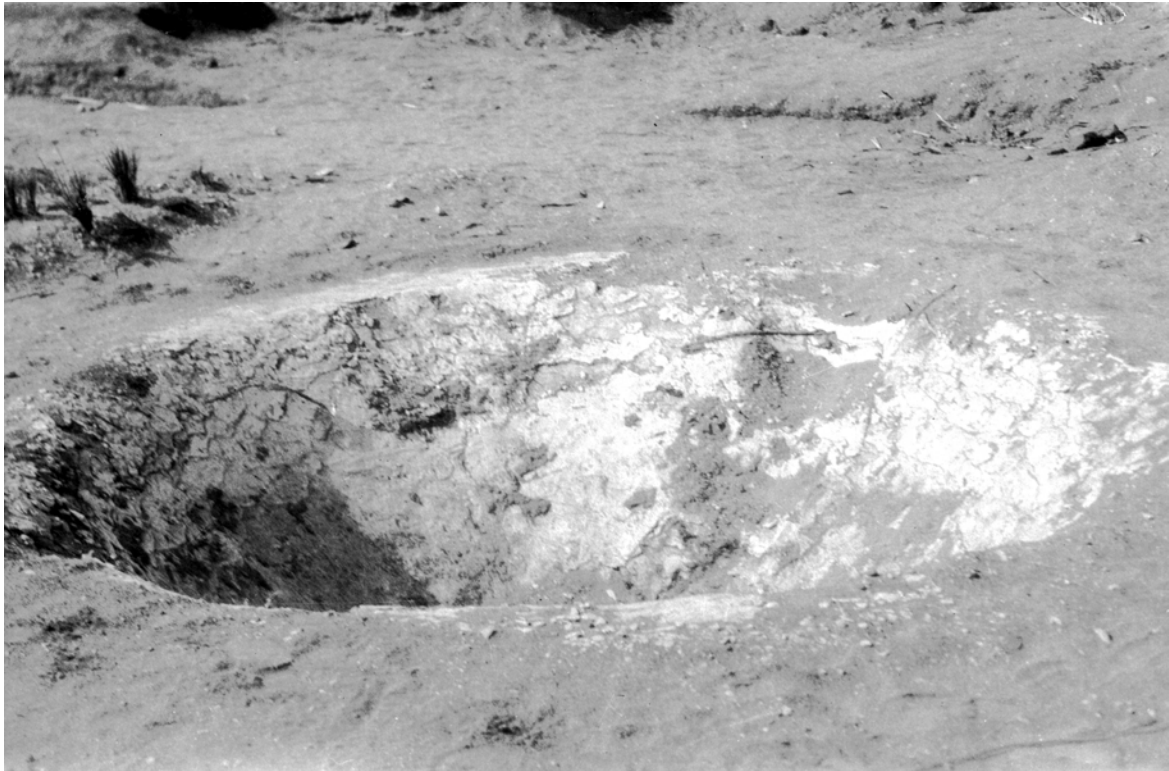
Photo 1932/19

A circular basin lined with gypsum plaster. One such basin is reported in *City of Akhenaten* III, p. 14, and appears in the reconstruction drawing of Lavers on Pl. VIA. It is faintly visible on the 1935 aerial photograph. The 2014 excavation located it again and re-excavated it, but also found a second similar basin further to the south (in excavation squares K26/L26). This also seems to be visible in the 1935 aerial photograph although it is not mentioned in *City of Akhenaten* III. A comparison of the remains of both basins, as exposed in 2014, with a print of this photograph strongly points to the photograph being of the second, southerly basin, the one not mentioned. The basin, like its northerly companion, had been formed in a pit dug through the layer of levelling rubble and down for a short distance into the underlying mud floor and desert. The photograph shows it surrounded by a flat rim of gypsum plaster. The position of the camera must have been close to where photograph 32/35 (p. 6) was taken. If taken at almost the same time, the direction of the shadows suggests that the direction of this photograph is towards the east.

EES catalogue entry: 'Great Temple. SW corner of enclosure. Plaster depressions.'

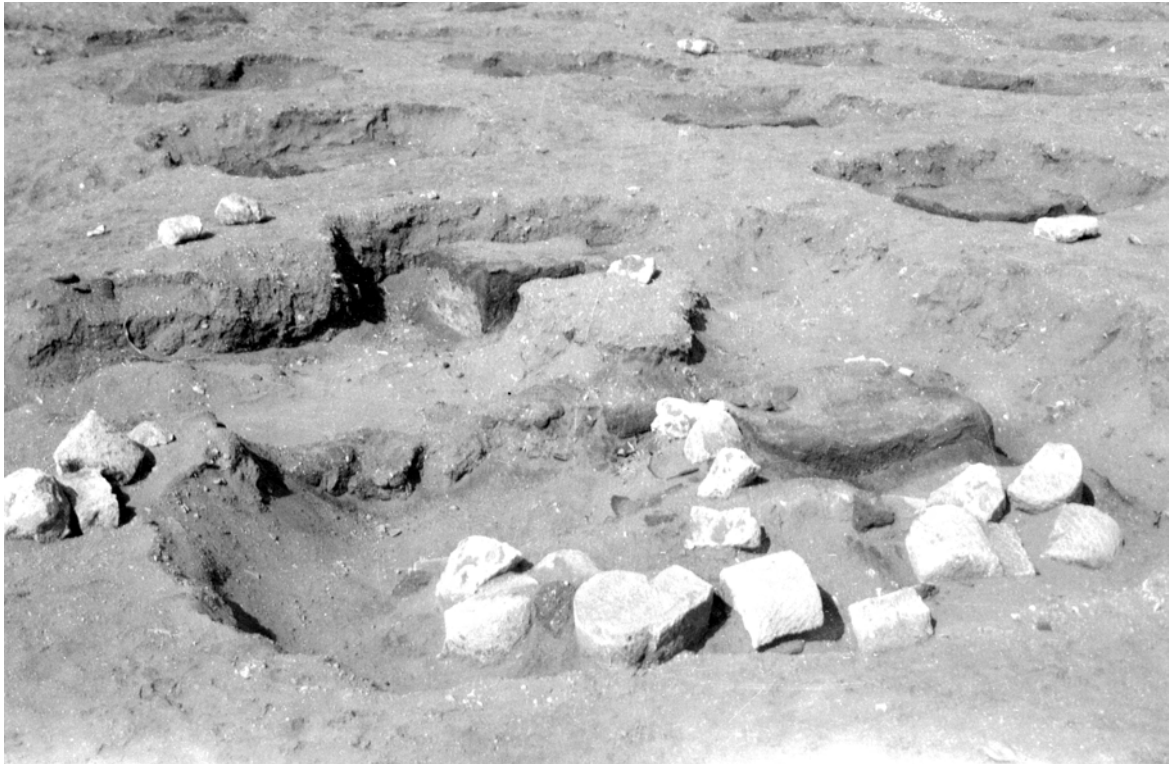
Photo 1932/40

The photograph shows a portion of the field of mud-brick offering-tables that lay to the south of the Long Temple. Each offering-table lies within a small separate excavation pit, although in the case of the two nearer ones the pits have been extended, especially towards the left of the picture's edge. These pits must have been dug into the layer of levelling rubble that raised the ground level for the second temple. Within and around the edge of the nearest pit lie many pieces of worked stone. Many of them appear to be rounded corner mouldings that have been knocked from corner blocks although the one in the bottom middle seems to be complete.

When was this excavation done? Sand has blown in and the sides of the pits are weathered. There is no sign of adjacent spoil heaps; the spoil has evidently been carried some distance away. The 1935 aerial photograph shows the pattern of pits, how it extends widely to the south and east of the Long Temple. There are extensive spoil heaps on the north, beside the temple, but these can be seen to have derived from the clearance of the temple itself. Others lie beyond the southern edge of the pits and so probably derive from the examination of the offering-table, but these spoil heaps are less distinct. The conclusion to be drawn is that Photo 32/40 (p. 9) shows a small part of the area examined by the Petrie/Carter excavation, that had taken place forty years before, an interval that had led to the weathering of the spoil heaps and partial filling of the pits. It follows that the Pendlebury expedition probably did hardly any excavation in this area, the Lavers plan relying largely upon the Petrie/Carter exposures, although it is possible, to judge from the same aerial photograph, that a small patch towards the north-west of this area was excavated, perhaps to reveal just where the northernmost row of the offering-tables was located.

If the photograph was taken in sequence with the others, the direction of the camera is probably to the north-east.

EES catalogue entry: 'Great Temple. S side of enclosure. Stone fragments by offering bases.'

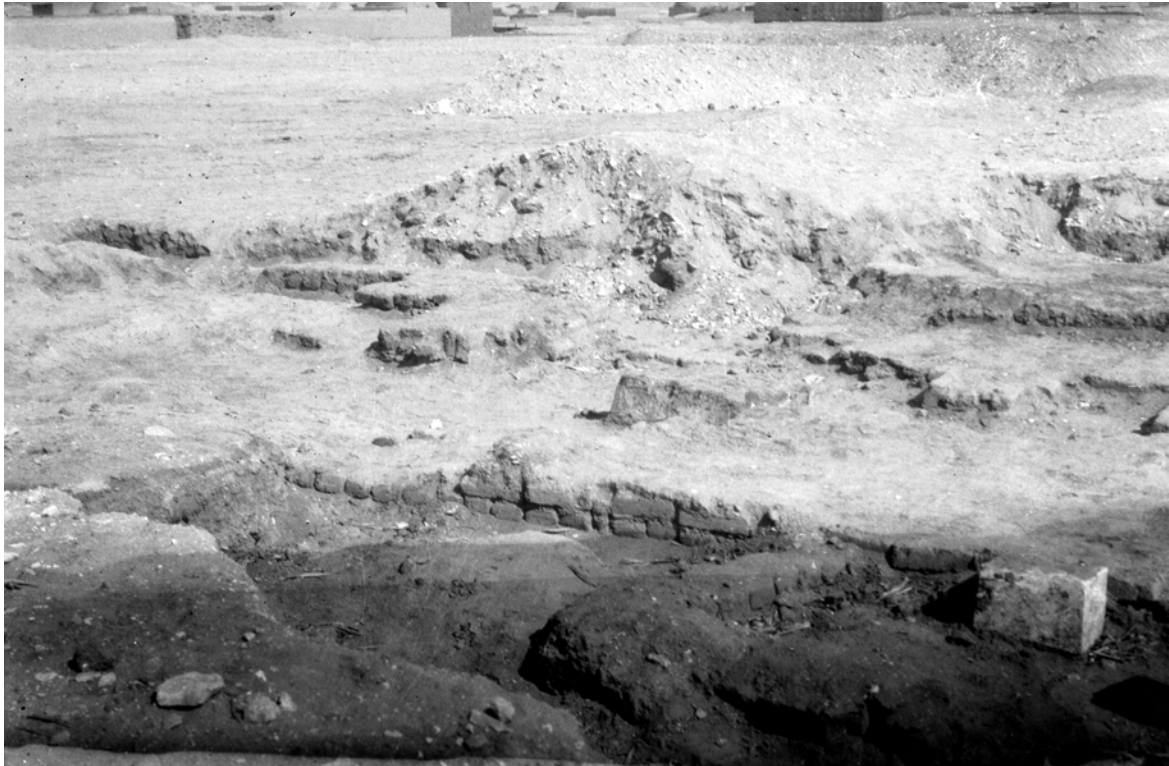
Photo 1932/10

A view, to the north-east, across the brickwork at the north-west corner of the Long Temple. Tomb enclosures of the modern village cemetery can be seen in the background. The brickwork belongs to a thick extension of the revetment wall that runs north-westwards at an angle to the temple axis and probably is the remains of a construction ramp used in the building of the colonnade of large sandstone columns that fronted the second temple. In the middle rises a block of brickwork that is perhaps plastered white. It is separately marked on the 1932 plan. It is one of the mud-brick offering-tables that belongs to a field that extended on the north side of the temple and had been buried by the construction ramp. Along with the remains of several others, it was examined again in 2014.

EES catalogue entry: 'Great Temple. NW corner of Per Hai. Angle built out and running over earlier piece.'

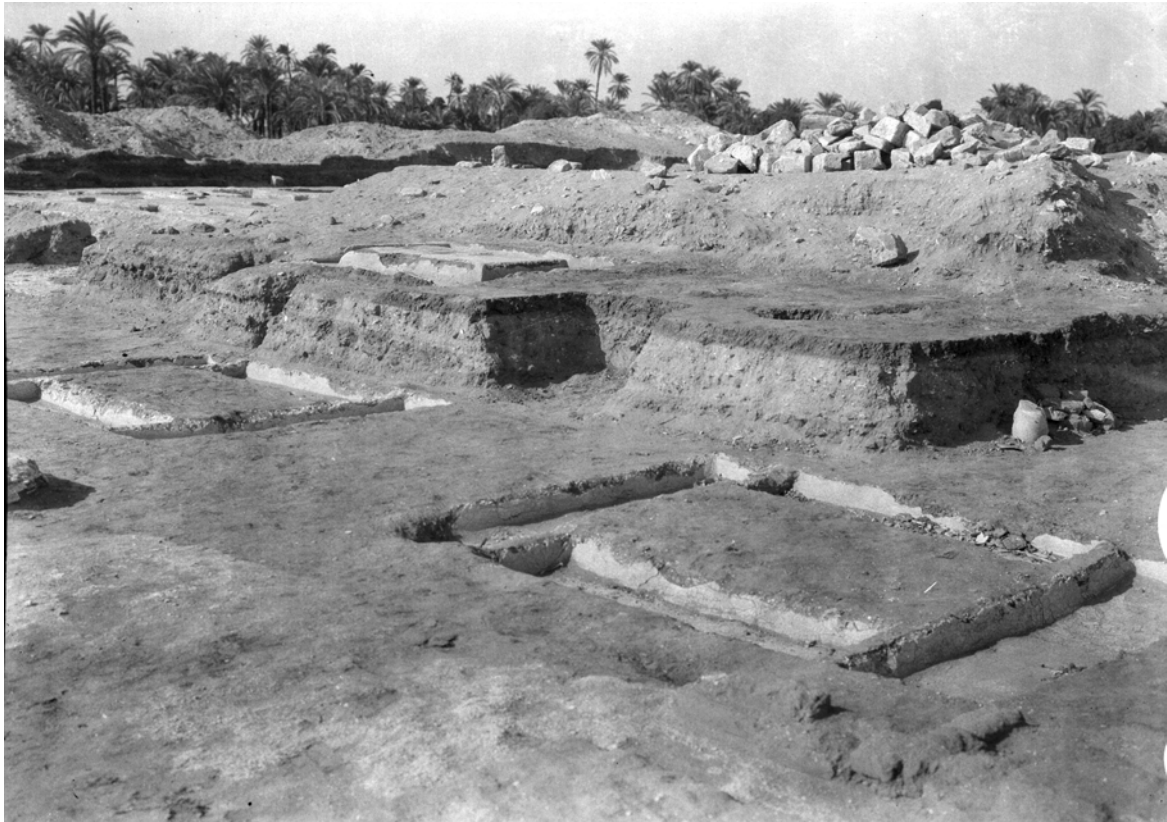
Photo 1932/36

A photograph taken diagonally, towards the north-west, across the wide trench dug through the levelling rubble along the temple axis. The nature of the levelling rubble is displayed, the rubble itself covered by a thick, dark horizontal layer of mud that served as the floor of the second temple. Only one feature is on top of this floor, and that is a rectangular platform, plastered with gypsum and surrounded by a continuous basin without subdivisions. Behind that the upper floor is still covered with unexcavated debris and a heap of worked stones, presumably put there by the Pendlebury expedition.

Along the axis of the lower floor lie two sets of gypsum-lined basins surrounding rectangular pedestals. The nearer one was, subsequent to the photograph being taken, partially filled with decorated stone fragments, a few of them bearing Pendlebury expedition numbers and uncovered again in 2013.

Close to the right side of the photograph is the junction with a northwards trench which ran along the side of the broad mud-brick revetment wall.

EES catalogue entry: 'Great Temple, inside Entrance. Earlier and later floors with plaster baths.'

In just one place do we know that there was further archaeological activity after the photography. This concerns Photos 32/42 and especially 32/36 (pp. 13, 11). The easternmost of the two sets of rectangular basins belonging to the first temple appears clean and empty. But when re-excavated in 2013, it was found that the individual basins were filled with pieces of carved stone, a few of them bearing expedition numbers. Thus, after the photography, unwanted decorated stones were collected from somewhere, placed in the basins and presumably covered with sand.

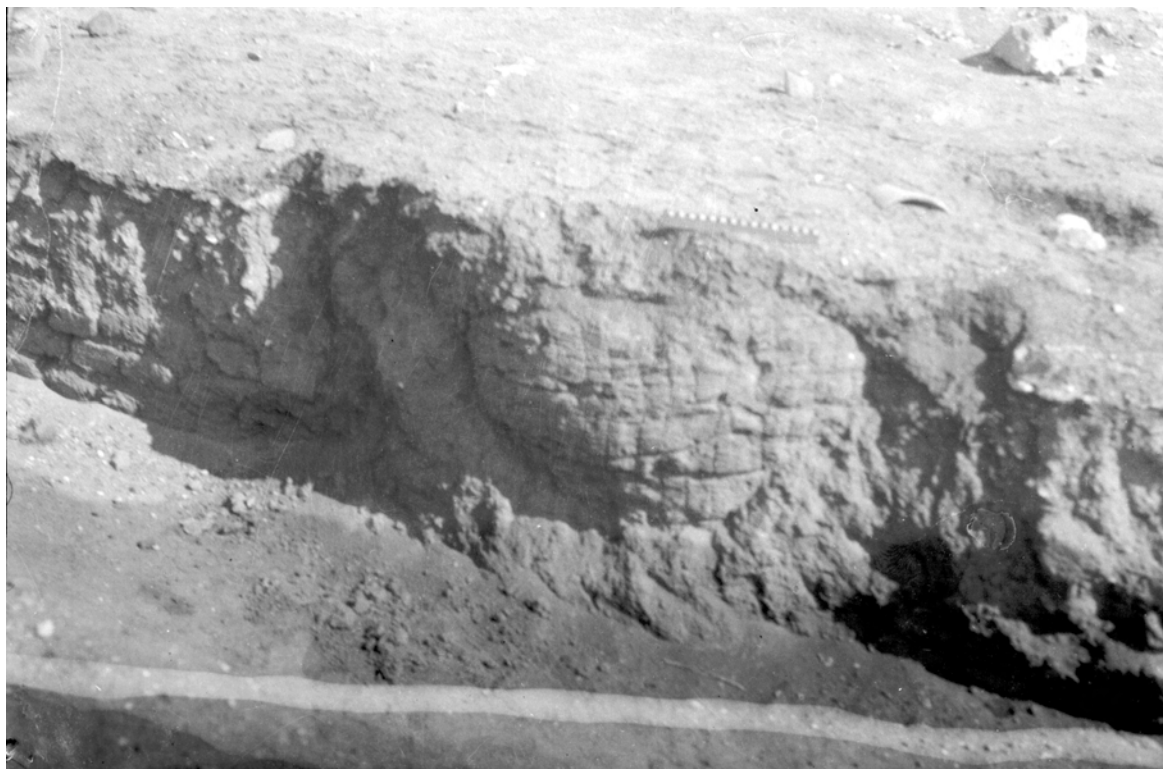
Photo 1932/9

The explanation for this photograph comes from the EES catalogue entry (below) and a statement in *The City of Akhenaten* III, p. 14. In describing what was interpreted as the front of the building housing the giant columns which stood in front of the stone temple (and which was there called the Per-hai), it is said: 'On either side in front of the entrance are the remains of two trees.'

The upper surface of the picture is the desert surface before excavation. A trench has been cut into it, to a lower flat surface that is the mud floor of the first temple. Towards the bottom left of the section up to three courses of mud bricks are exposed. These belong to the wide temporary revetment wall around the foundations of the large colonnades in front of the stone temple and which stood to only a few courses high. The photographer's interest is the spherical mass that protrudes from the face of the trench. The 30 cm scale rests above it. According to the EES catalogue entry, it is a ball of soil in which a tree had been planted. If this were so, the pit would have been dug from a now lost surface that was the floor of the second temple and which, close to the temple itself, was covered with a thick layer of gypsum concrete which had probably supported stone paving. The photograph does show that the tree (if that is what it was) stood on the line of the mud-brick revetment wall and not 'in front'. If it stood within the gap in the brickwork that resembled a doorway, and had a second counterpart, the trees would have been separated by a gap far less than the width of the stone-paved pathway that followed to the east.

EES catalogue entry: 'Great Temple. Pylons of Per Hai, traces of trees in front of Pylon.'

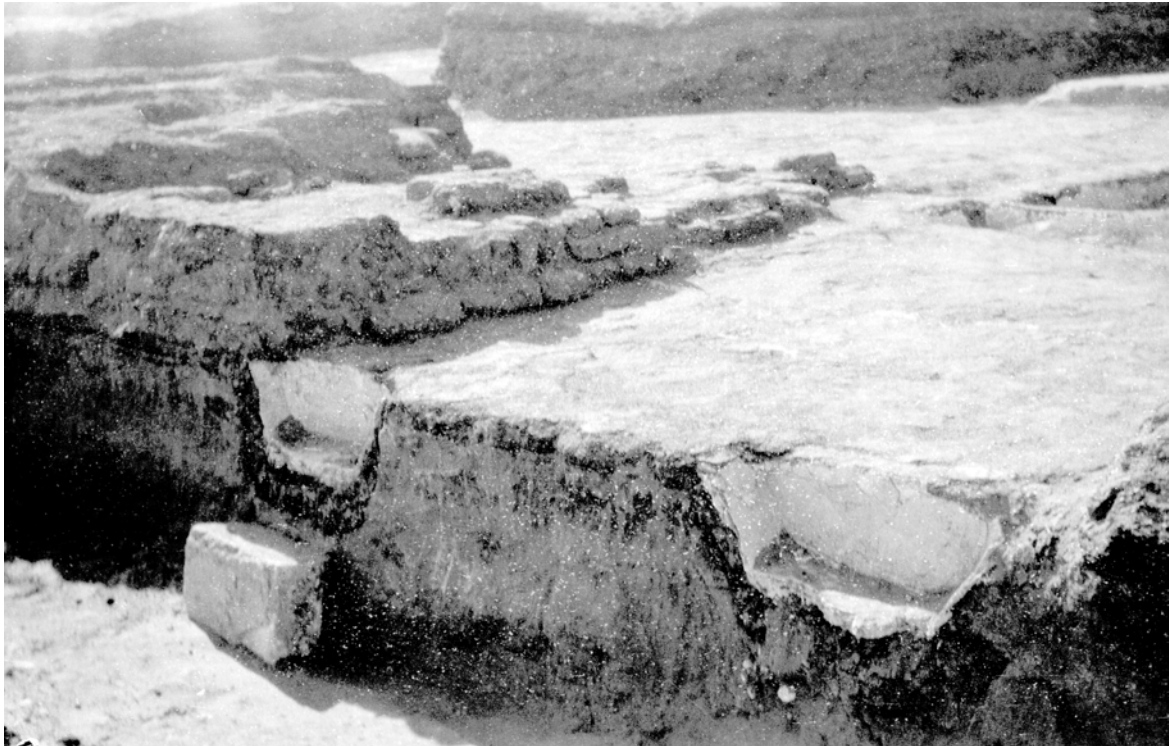
Photo 1932/42

This photograph was taken at roughly ninety degrees to 1932/36 (p. 11), facing south-west. The axis of the first temple is coming in from top right towards bottom left, but has been cut by the foundation trench for the stone wall that formed the edge of the stone pathway between the two large foundations for the colonnades at the front of the second stone temple. The trench has cut through another set of rectangular, gypsum-lined basins that surrounded a central platform. They are mentioned in *City of Akhenaten* III, pp. 5, 13–14. The 2014 excavation revealed that half of this set of basins lies behind the trench but remained unnoticed by the Pendlebury expedition (they had been filled with mud that looked the same as the surrounding floor). The limestone block beneath the left-hand basin seems to have been accidentally left when the post-Amarna Period demolition of the stonework took place. Note how the brickwork of the revetment wall ends irregularly and also partially covers the basin to the left.

The opposite side of the trench is shown in Photo 32/17 (p. 14).

EES catalogue entry: 'Great Temple. Plaster impressions cut into by later W wall of Per Hai.'

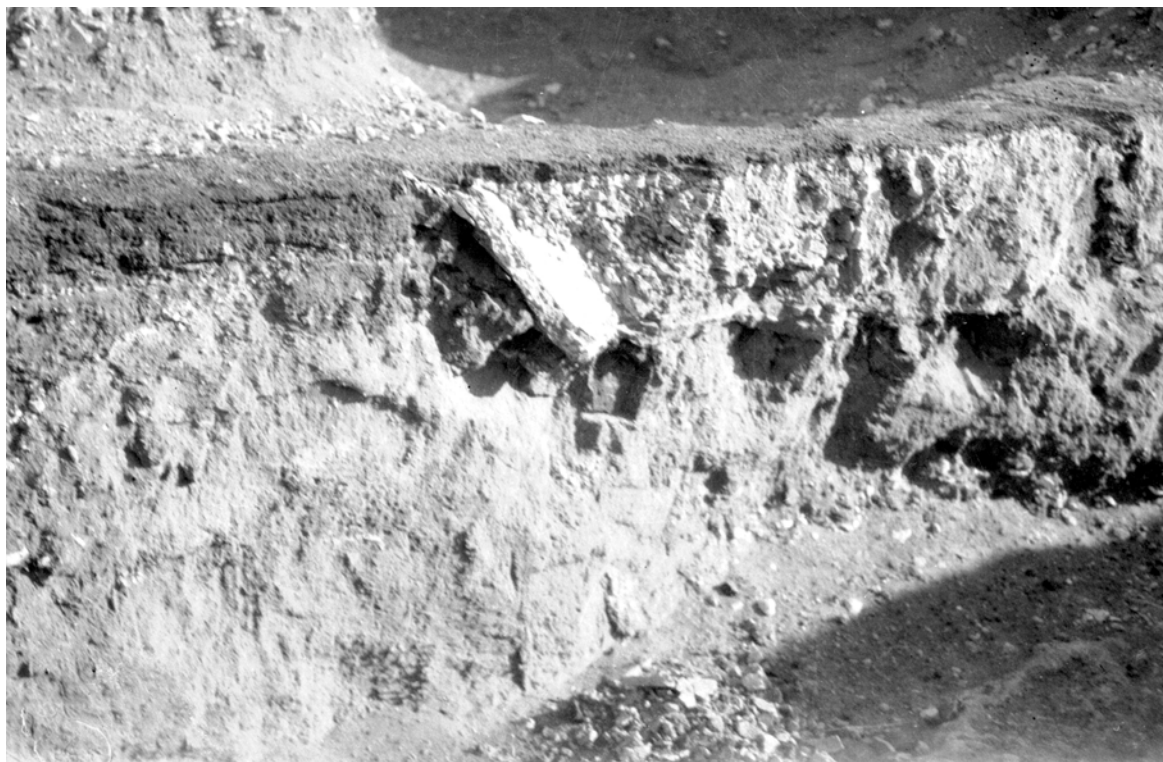
Photo 1932/17

The location of this photograph is given by the EES catalogue entry (below). It is set at the system of foundations for the monumental colonnade at the front of the second stone temple, and the reference to the 'bird-baths' must be to the set of gypsum-lined basins that were cut through by the foundation trench of the second temple. The west side of the trench is shown in Photo 32/42 (p. 13). The present photograph is presumably of the east side, opposite, where the remains of the basins had been more badly damaged. The mud floor of the first temple, into which the basins were cut, stands out sharply. What little remains of the damaged basin is caught in the section in the middle of the picture.

EES catalogue entry: 'Great Temple, Per Hai. Earlier system of 'bird-baths' broken away.'

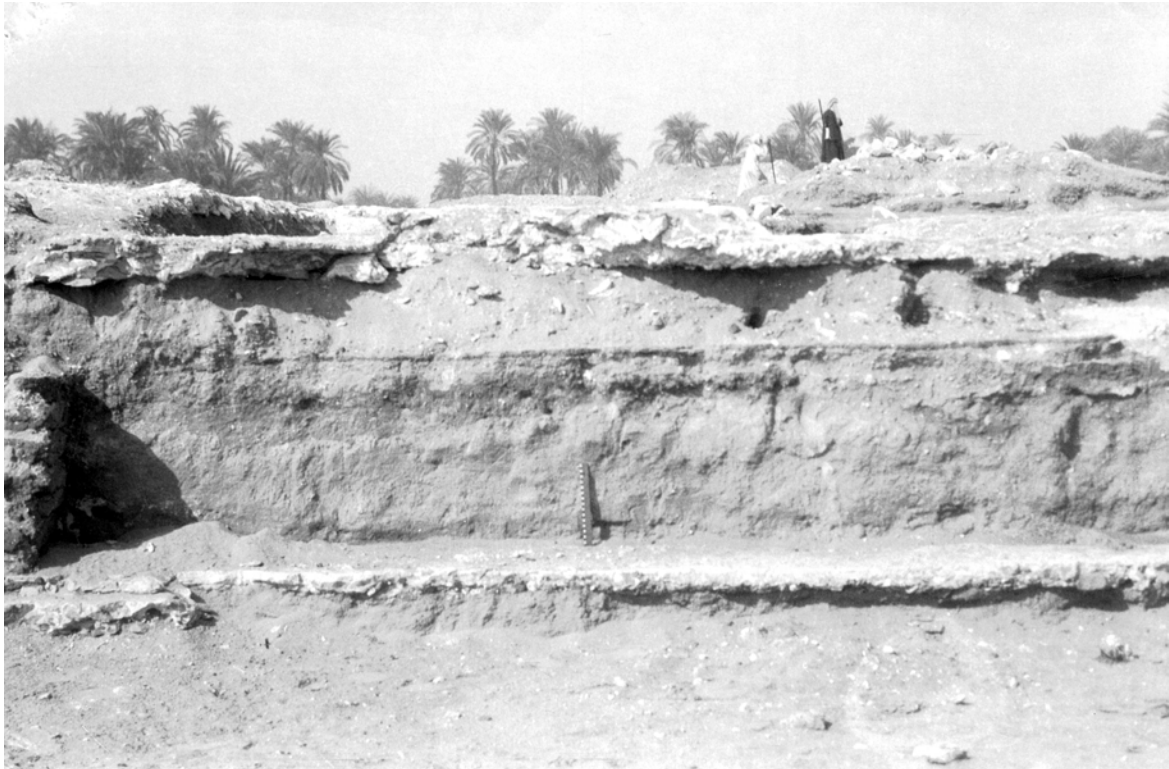
Photo 1932/3

At the front of the second stone temple stood a pylon entrance and, in front of that, two colonnades on massive gypsum foundations. Between these ran a short length of stone-paved pathway (Pendlebury's 'causeway') that would have continued eastwards between the pylon towers and on into the body of the temple. In this photograph, that points towards the west, the wide foundation trench for the stone pylon has been cleared. In this part, almost all of the gypsum-concrete foundation for the stonework has been destroyed, leaving a narrow edge strip that runs along the base of the section. For the lower half of its depth, the trench has been cut through natural desert sand. The top of the desert had been given a mud floor when the first temple was created. This is preserved as a dark horizontal line about half way up the section face (it is a continuation of the floor that appears in Photo 32/17, p. 14). Above this is the equivalent of the levelling rubble at the front of the temple, now a layer of sand and stones containing occasional pieces of broken architectural sculpture. Finally, at the top, comes a thick bed of gypsum concrete. On the 1932 plan, this shown covered with impressions from limestone slabs that had formed a pavement.

At the left side of the picture, a short length of mud-brick wall rises to the height of the mud floor of the first temple. It is visible in Photo 32/37 (p. 20). It must have stood on the narrow space between the wall of the trench which, at this depth, was natural sand, and the wall of limestone blocks that stood on the gypsum-concrete foundations.

The scale in the photograph appears to be 30 cm long.

EES catalogue entry: 'Great Temple. East end of causeway in Per Hai, showing earlier floor.'

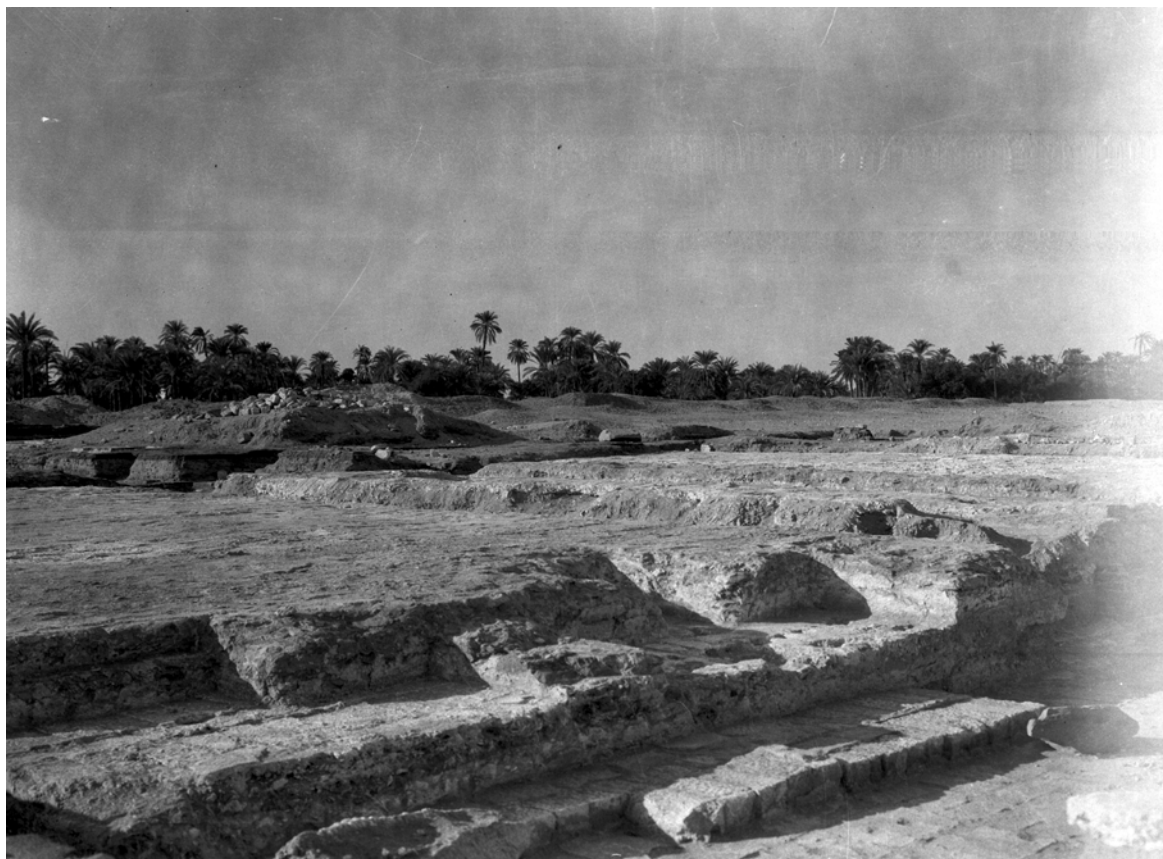
Photo 1932/34

View to the north-west of the eastern face of the southern pedestal of gypsum concrete that served as the foundation for the southern colonnade in front of the stone pylon of the second temple. The irregularly shaped gaps in the platform along its east side are highlighted by the strong shadows. They had originally been filled with limestone blocks to create extra strength for supporting heavy objects. In front comes the foundation trench for the stone pylon. At this southern end the gypsum concrete foundation layer is not only intact but still supports part of the original lowest layer of *talatat*-blocks.

In the distance, in front of the screen of trees, the linear mound that represents the northward continuation of the mud-brick enclosure wall of the temple is clearly visible. Most of this has now been obliterated by the modern cemetery of the village of El-Till.

EES catalogue entry: 'Great Temple. Per Hai from S.E.'

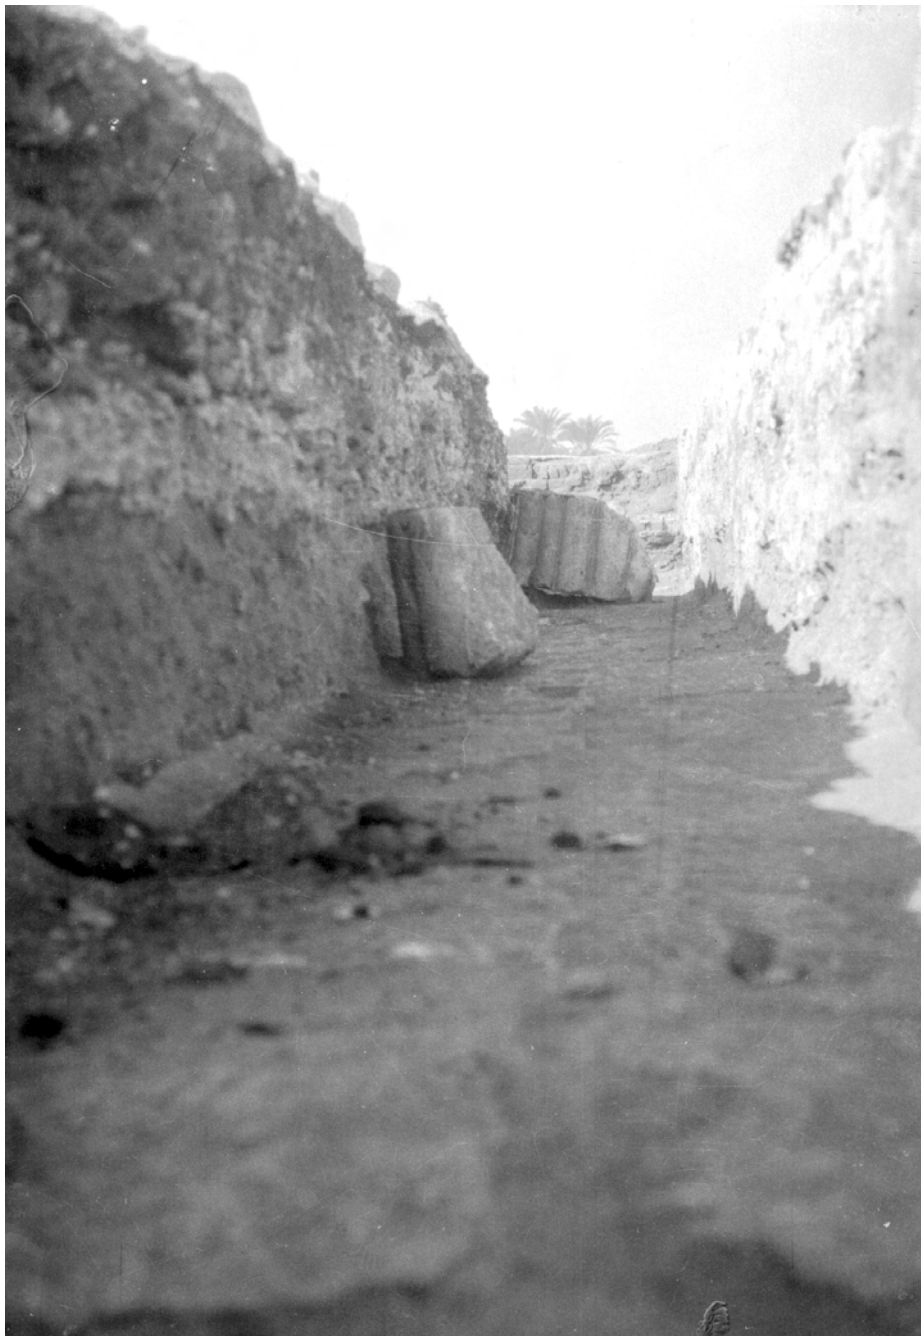
Photo 1932/8

View westwards along one of the foundation trenches surrounding the two gypsum-concrete pedestals that supported the colonnades in front of the second temple. Two large pieces of column drum lie on the gypsum-concrete layer on the floor of the trench. They are almost certainly made from sandstone and derive from large columns in the shape of a cluster of papyrus buds. Beyond them, the mud bricks of the temporary retaining wall can be seen crossing the end of the trench.

The catalogue entry identifies the trench as being along the southern side of the southern pedestal, which rises on the right side of the picture.

EES catalogue entry: 'Great Temple. Per Hai. Foundation trench and fragments of columns, South of Platforms.'
