1932 EXCAVATION PHOTOGRAPHS

The Egypt Exploration Society archive contains 35 negatives that cover the excavation of the Long Temple. They are not individually datable and the numbering of the negatives seems not to reflect the order in which they were taken. Only one was definitely taken whilst the excavation was in progress. This is Photo 32/1 (p. 18) and was taken as the sand and stone fill that covered the interior of the First Court of the second temple was being removed. Photos 32/16 and 32/9 (pp. 19, 12) were probably taken also taken during the course of the excavation. The remaining photographs, in so far as it is possible to judge, show the site fully excavated, the appearance conforming to how the site looks in the 1935 aerial photograph. No workmen are visible (although one or two guards appear in Photo 32/3, p. 15), and there is no sign of the Decauville railway that had produced the linear dumps that are scattered around the sides of the excavation. This points to the bulk of the photographs having been taken after the end of the excavation, perhaps in the course of a single day. The shadows in Photos 32/35 and 32/12 (pp. 6, 7), although the places from which they we

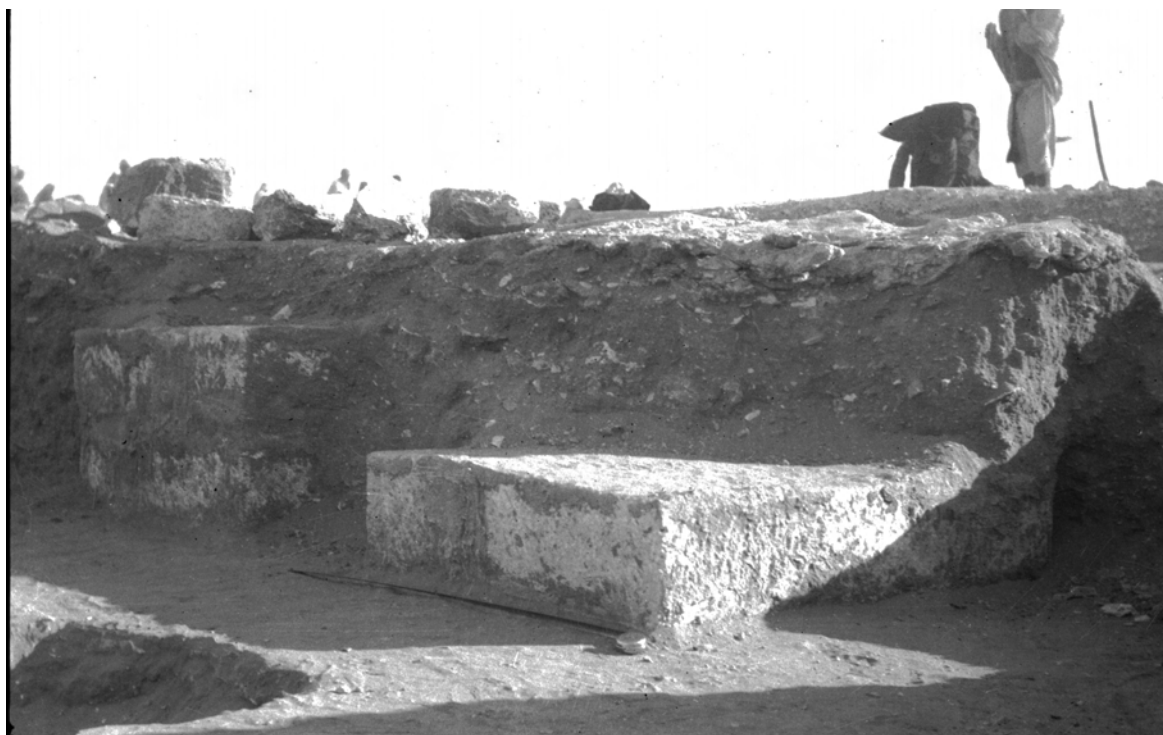
Photo 1932/1

Apparently the only photograph taken whilst the excavation was in progress. On the skyline a man stands, the upright handle of his hoe (*touria* or *fas*) beside him, and appears to be either taking off or putting on his *galabiya*. The darker shape to the left is presumably another figure, or more than one, but it is hard to decide what he/they are doing. The triangular extension on the left of the shape is perhaps a basket being carried on a shoulder. Several more men are present towards the left side, but they are further away. All are on the far side of the foundation trench for the southern wall of the second temple. Many large pieces of stone lie on the edge of the nearer excavation. The picture looks to the south-east.

The location is the southern half of the First Court of the temple, where several of the offering-table positions still supported some of their *talatat*-blocks. The two shown here belonged to the third east-west row from the south. The blocks are covered by a homogeneous layer of dusty sand mixed with stone fragments. Towards the left part of the picture it appears to reach the surface. In the right part of the picture it is covered with a layer, irregular in thickness, of what looks like stone chippings and white dust. In *City of Akhenaten* III, footnote 1 on p. 7 refers to 'the layer of cement – actually no doubt merely a thick layer of fallen rubble that had coagulated in the course of time' and not 'a deliberate sealing-in of the accursed spot'. This seems a reasonable explanation.

This is the only photograph which shows the nature of the material that buried the large areas of foundations for stonework. When, at the end of the Amarna Period, the stone blocks were removed down to foundation level, the sand levelling layer that had been put down to raise the floor level of the temple must have been turned over as the demolition proceeded. This is the material that is illustrated in section in this picture.

In front of the nearer blocks lies a retractable tape measure probably extended to the length of 1 metre.

See also Photos 32/18 and 32/37 (pp. 21, 20).

EES catalogue entry: 'Great Temple, Court 1, Gem Aten. Offering stands and later cementing.'

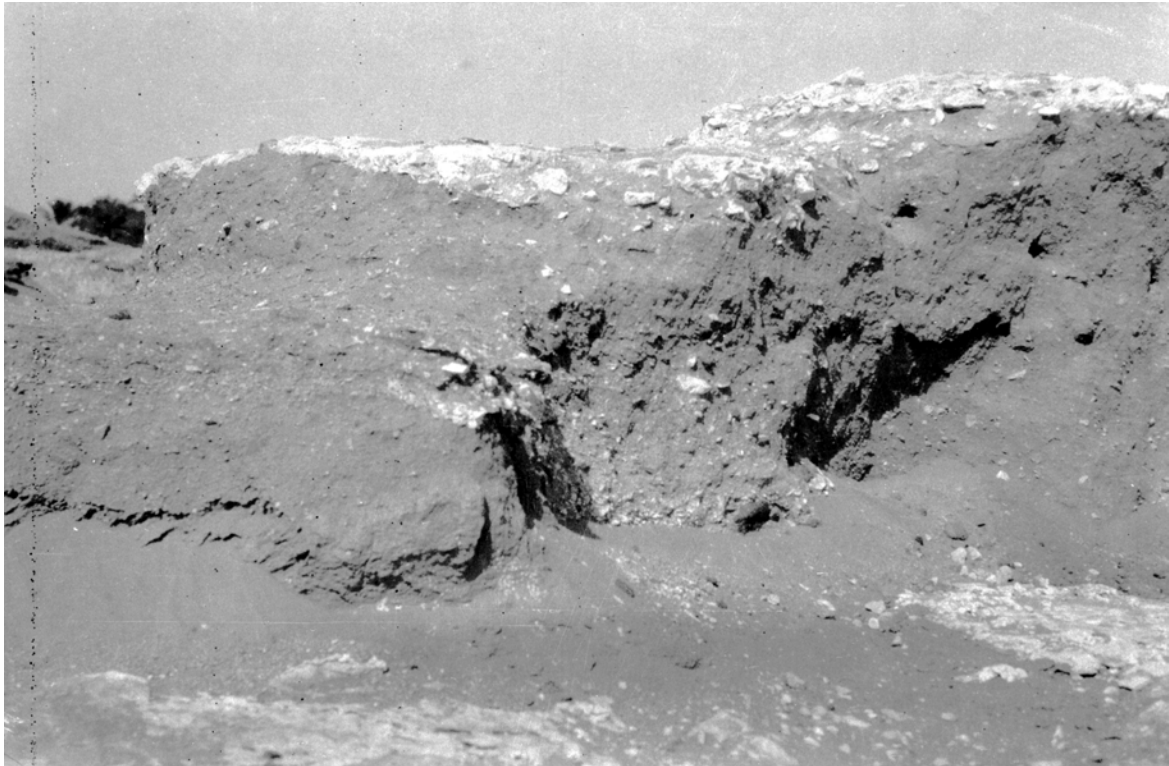
Photo 1932/16

The subject is probably a section cut into the levelling fill that separated the floors of the two temples. The pale patches below could be exposed areas of the main gypsum-concrete foundation layer for the second temple, and above that the levelling fill that seems to be of sand mixed with stones. On top comes a layer of irregular thickness of gypsum concrete. To judge from the small dark patch towards the top left-hand corner, which seems to depict the tops of trees, the location is towards the front part of the excavation area. Taking into consideration sunlight and shadow, the direction could be towards the north or, if the photograph had been taken fairly early in the morning, towards the west. One possible location is the bank or 'platform' of levelling fill that separates the First Court from the foundation trench for the first stone pylon.

EES catalogue entry: 'Great Temple, court 1 (Gem Aten). Causeway from Per Hai, stepping up to platforms.'

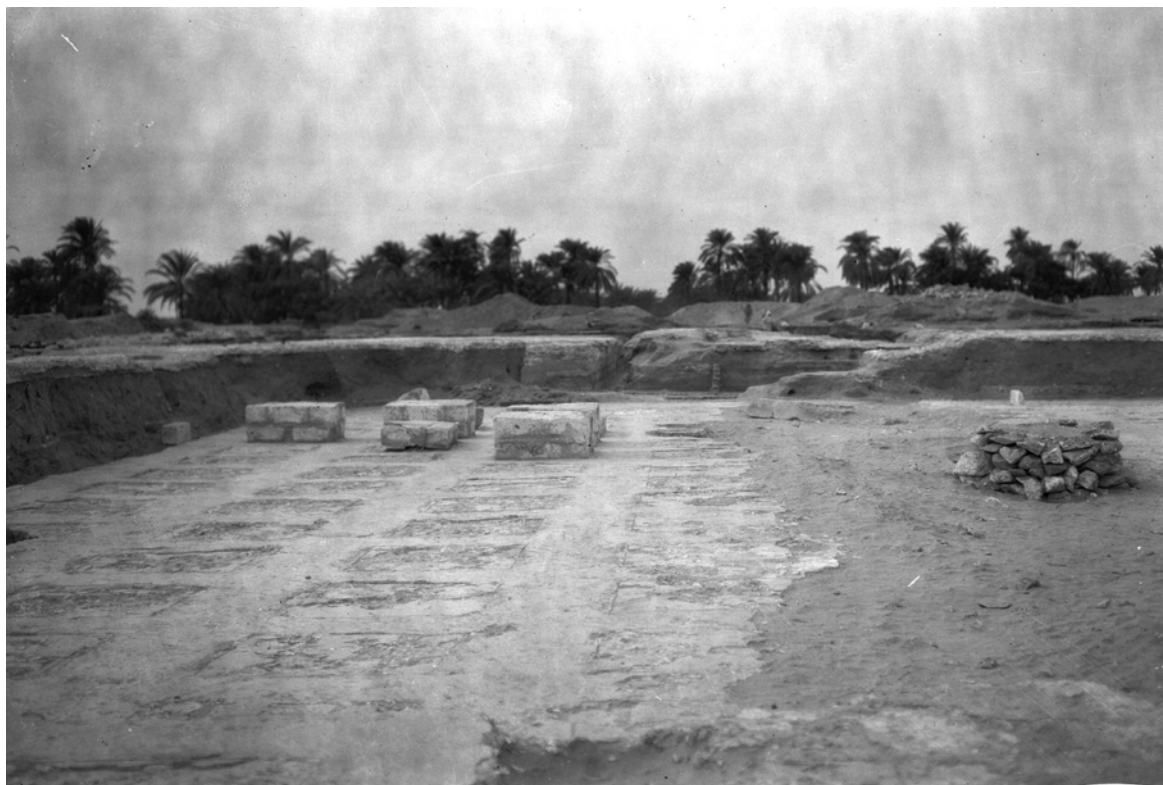
Photo 1932/37

The south-western quarter of the First Court of the temple, viewed to the west. The entire area was originally surfaced with a layer of gypsum concrete on which the rectangular outlines where stone offering-tables were to be built were marked. The central area, however, had been destroyed by the time of the Pendlebury expedition. One cause was the use of the area for burials from the village of El-Till. One such burial, at a higher level, has been surrounded by a stone cairn (which no longer survives). On the surviving area of gypsum surface, the remains of four lines of offering-tables are visible. In six of the positions either one or two courses of limestone *talatat* blocks still remained in 1932 (but no longer). On the west and south sides the excavation ends with a near-vertical face of sand mixed with pieces of stone. This is not the remains of a *gebel* platform surrounding a sunken floor. The sand is an artificial layer (that contains broken pieces of sculpture) and is part of the layer of levelling material that covers a great part of the temple enclosure. At the front and outside to the south and north it is composed largely of alluvial rubble, but within the walls of the stone temple it was largely sand. Over the top had been spread a thick layer of gypsum concrete that is visible as a pale horizontal layer that crosses the picture from one side to the other. This had served as the foundation for a stone pavement.

The two further stone offering-tables in the right-hand line are the subject of Photo 32/1 (p. 18).

The embanked material has a gap in the middle distance beyond which can be seen its continuation underneath the site of the paved pathway between the two colonnade platforms. This part of the picture should be compared to the close-up in Photo 32/3 (p. 15).

EES catalogue entry: 'Great Temple. Gem Aten, court 1. Offering bases and platforms.'

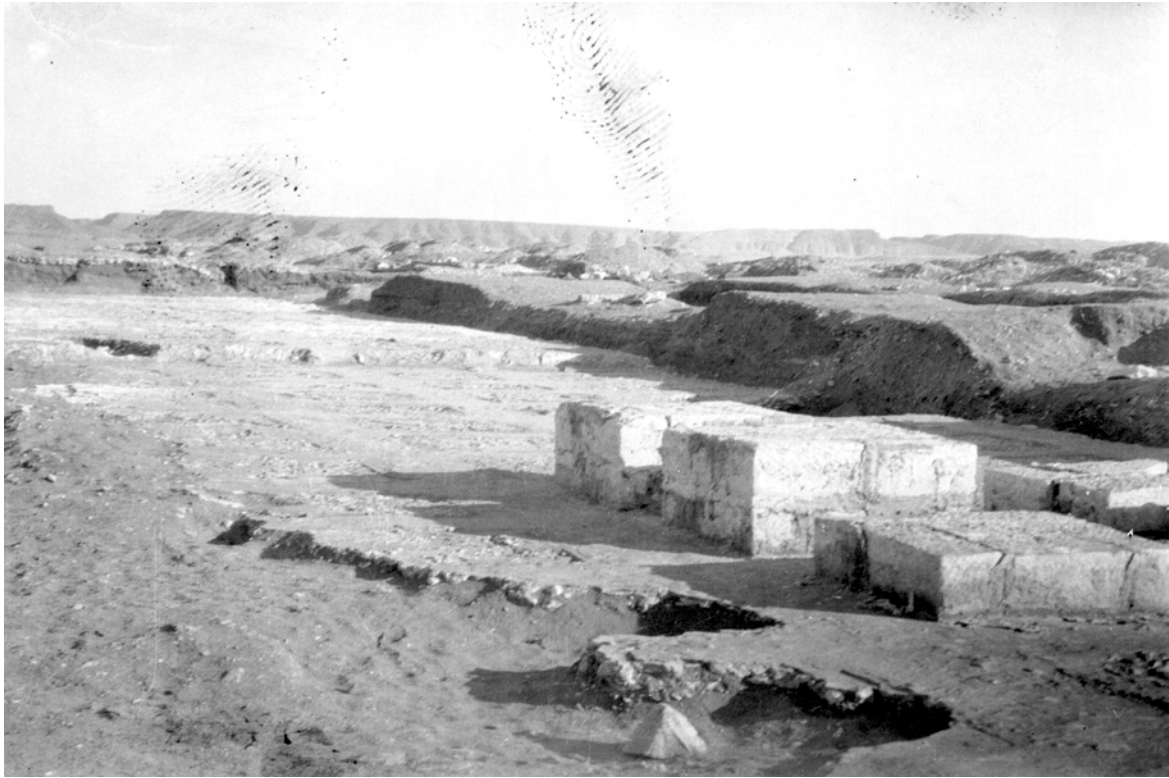
Photo 1932/18

A large part of the southern side of the First Court of the second temple, viewed to the south-east. In the foreground stand some of the offering-tables where one or two courses of limestone blocks remained in 1932. The main gypsum surface is interrupted about half way along by the low step upwards in the surface, made to accommodate the slightly rising ground level. See Photo 32/15 (p. 22). The embanked levelling sand on the right (south) side of the excavation shows an undulating surface. This could be the result of trenches cut across the site a long time previously.

EES catalogue entry: 'Great Temple, court 1 (Gem Aten) General view of S half from W.'

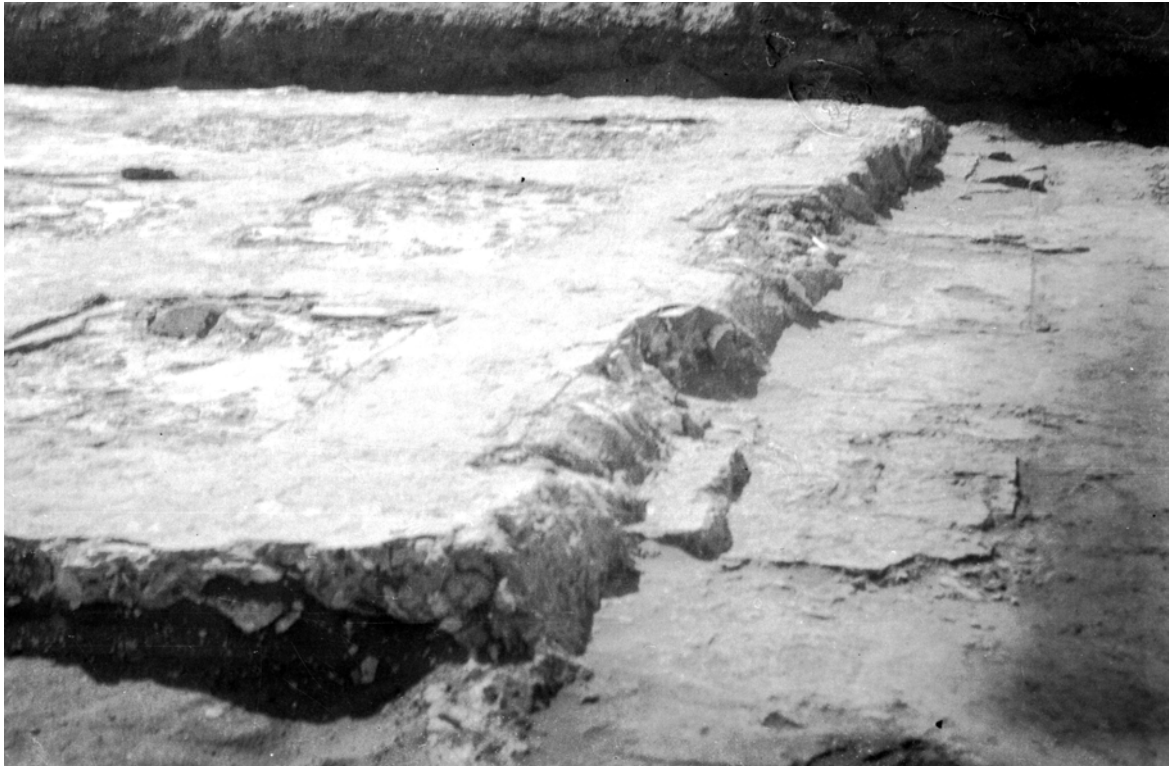
Photo 1932/15

Midway along the First Court the gypsum concrete foundation rises by means of an irregular step to a higher level, reflecting a slight rise in ground level. The line does not run between two rows of offering-table foundations but almost down the middle of one of the rows. This would have had no effect on final appearance since everything that is visible now would have been buried. The break in the foundations in the foreground is probably the site of one or more modern burials.

EES catalogue entry: 'Great Temple, court 1 (Gem Aten) Offering tables running over steps.'

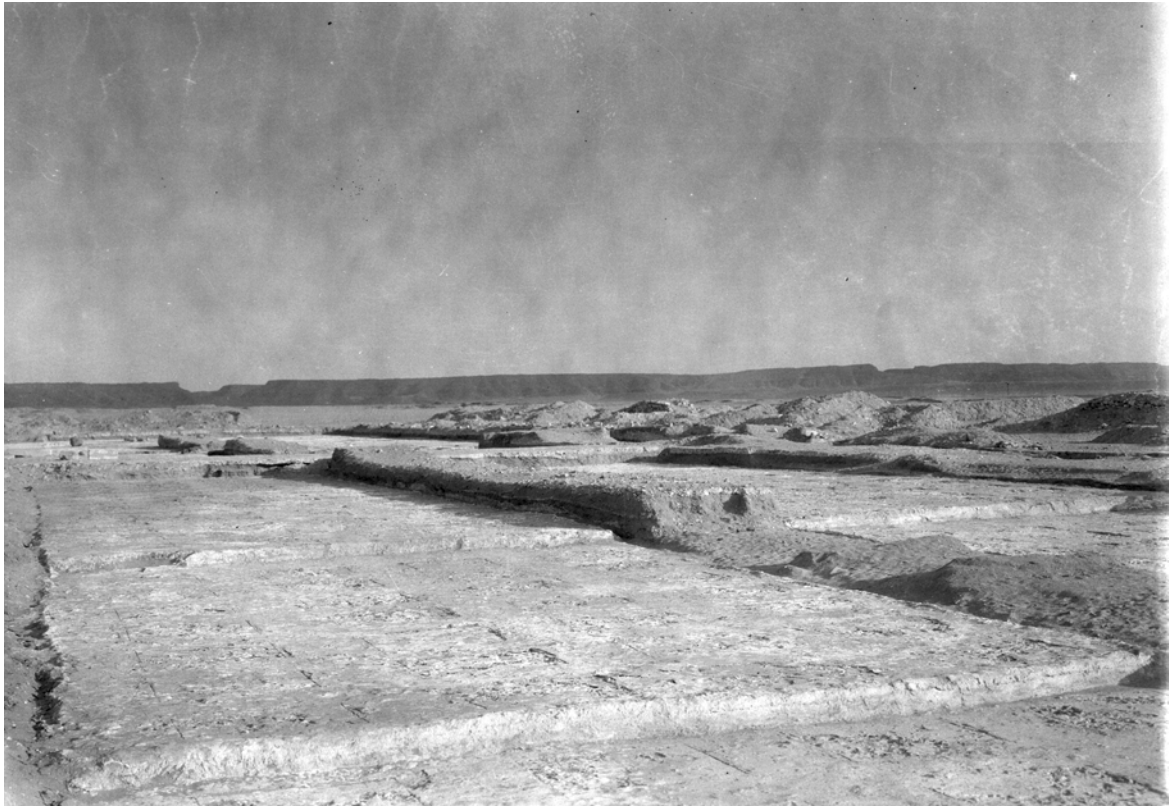
Photo 1932/32

The view is eastwards along the gypsum-concrete foundation of the northern half of the Second Court. Down the centre runs the 'platform' of levelling fill that supported only stone pavement and did not need, therefore, to rest on the full thickness of the concrete which was, along this line, dispensed with. The northern edge of the concrete, where it met the similar bank of levelling fill, follows closely the left edge of the picture. As the gypsum concrete layer recedes, it rises by two shallow steps to take into account the slight natural rise in the desert surface. The undulating surface of the central 'platform' probably reflects earlier digging at the site by means of irregular pits.

EES catalogue entry: 'Great Temple. Gem Aten, court 2 from W.'

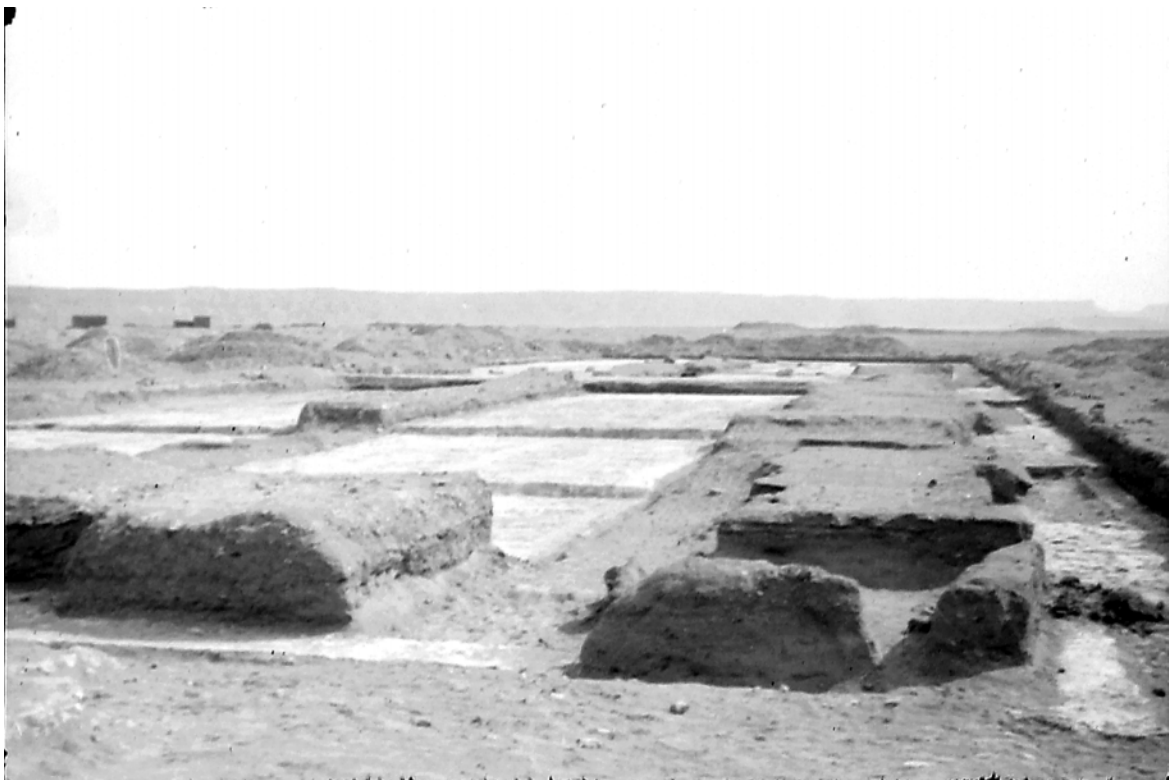
Photo 1932/13

A companion photograph to 32/32 (p. 23) but taken from further south, looking east along the southern section of the Second Court. Note the two shallow steps in the gypsum-concrete foundation layer. Beside it on the right is the bank or 'platform' of levelling fill, and beside that and along the right edge of the picture is the foundation trench for the southern wall of the temple with its flooring of gypsum concrete. The pits and trenches dug into the levelling fill in previous times are particularly clear.

EES catalogue entry: 'Great Temple. General view Eastwards.'

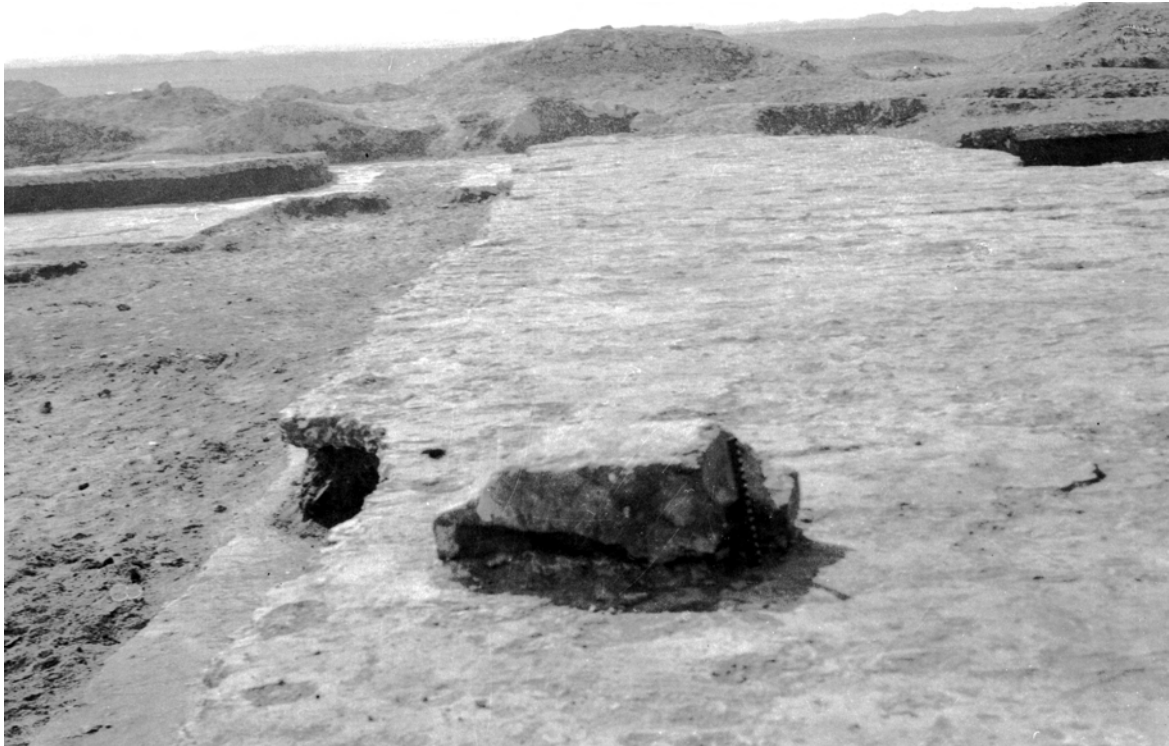
Photo 1932/6

The Second Court of the second temple, near the east end, view to the south. The camera is pointing along a broad strip of gypsum concrete which, according to the 1932 plan, was covered, towards the middle, with impressions from stone slabs, implying that this was a support layer for a stone pavement. To the left runs a broad strip from which the concrete is missing. This is where the pylon ran that divided the Second from the Third Court. The place, in the mid-distance, where it narrows is where the pylon was continued by a dividing wall. The ancient levering up of the blocks when the temple was demolished also broke and removed the concrete layer to which the blocks were mortared. Towards the left side of the picture and also in the mid-distance can be seen the strip where the layer of levelling sand has been left, covered by the gypsum-concrete layer on which the paving had been laid.

EES catalogue entry: 'Great Temple, East end. The surface of the last N-S platform.'

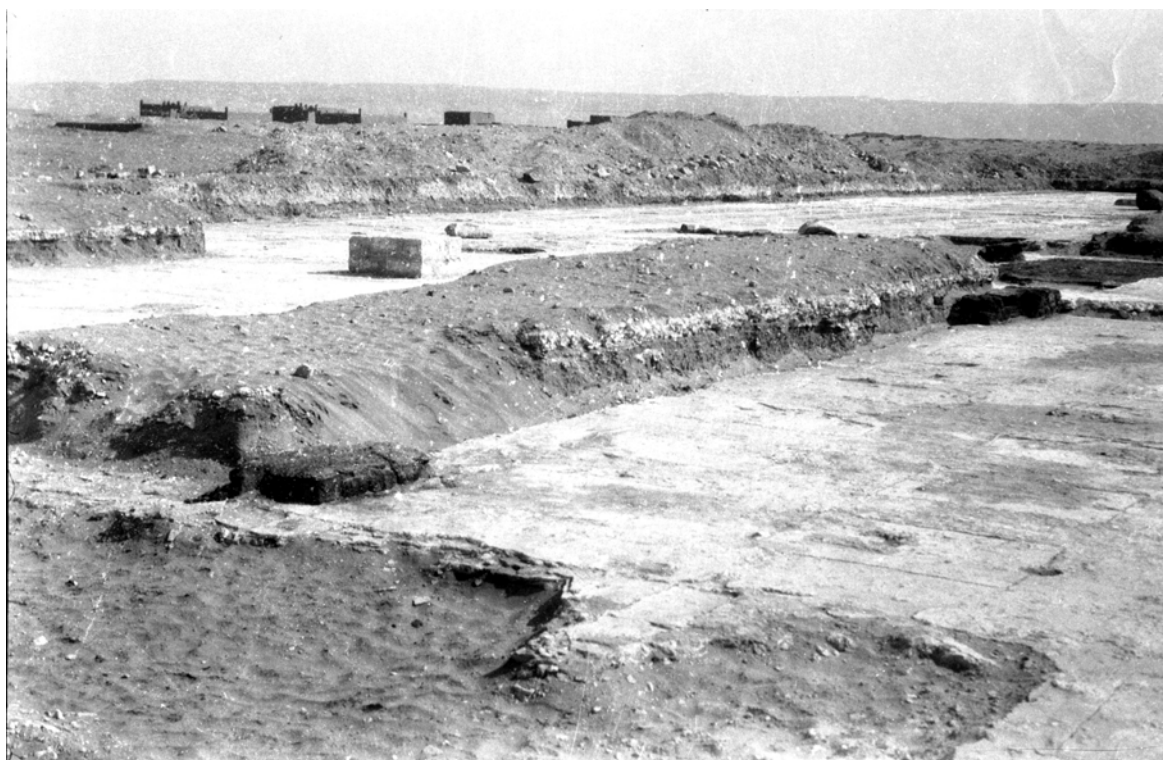
Photo 1932/43

View across the Third Court, with subsequent courts beyond, towards the north-east. Tomb enclosures of the modern cemetery are in the background. This court contained three short lengths of 'platform', isolated areas of sandy levelling fill with gypsum-concrete capping. The middle one runs across the centre of the picture. On the near side, at both ends, are short lengths of mud-brick wall, two courses high. The further one is probably the subject of Photo 32/11 (p. 27). These might be examples of the 'shuttering' mentioned in *The City of Akhenaten* III, 6. On the far side of the 'platform' one of the offering-tables has retained the lowest two courses of limestone blocks. Compare Photos 32/32 and 32/5 (pp. 23, 28).

EES catalogue entry: 'Great Temple. Court 3 (?) from SW.'

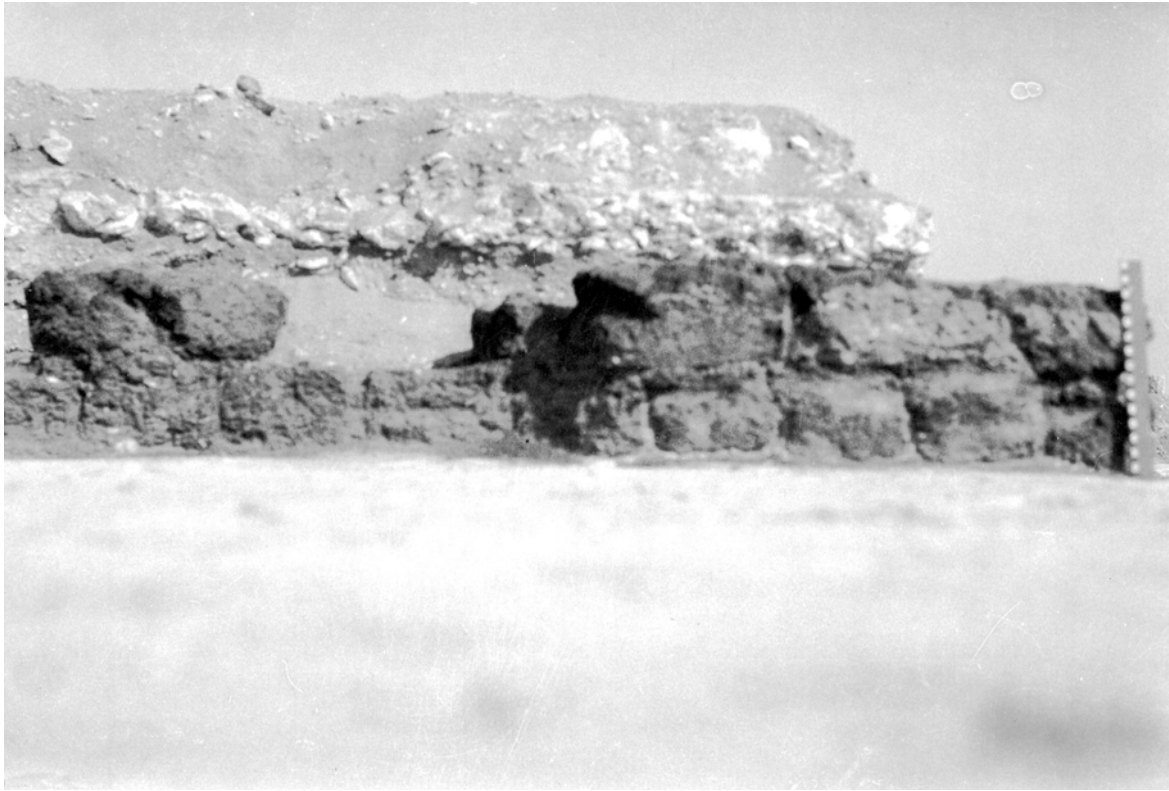
Photo 1932/11

Photograph of a length of laid mud bricks standing in front of layered fill material. The latter appears to be sand/gravel below, a layer of cemented material of irregular thickness above, and a final layer of sand/gravel. The 30 cm scale seems to be propped on the ground; thus the camera was also placed on the ground, perhaps on a gypsum surface. The most likely identification is the brickwork at the east end of the Third Court, at the south-east corner of the central 'platform', the strip of sandy levelling material beneath a layer of gypsum concrete. Thus the direction of view would be to the north. This is the brickwork visible in Photos 32/43 and 32/5 (pp. 26, 28).

EES catalogue entry: 'Great Temple, East end. Brick facing to central causeway.'

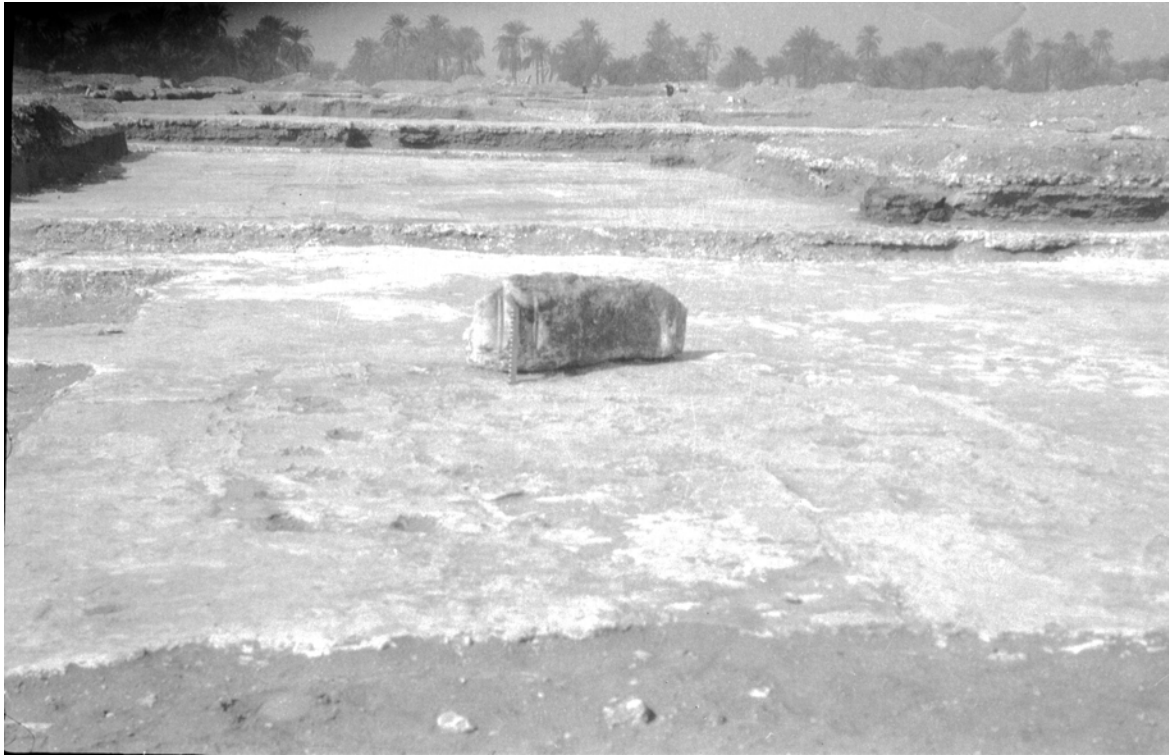
Photo 1932/5

View to the west across the Fourth Court, the Third Court lying beyond. A large piece of column drum of the papyrus cluster type lies in the foreground. At the left edge of the picture are square breaks in the gypsum-concrete foundation layer where square column foundations were once marked. In the mid-distance on the right a small mud-brick construction stands beside a 'platform', probably the wall that is the subject of Photo 32/11 (p. 27).

EES catalogue entry: 'Great Temple, east end. Column fragments and foundation marks.'

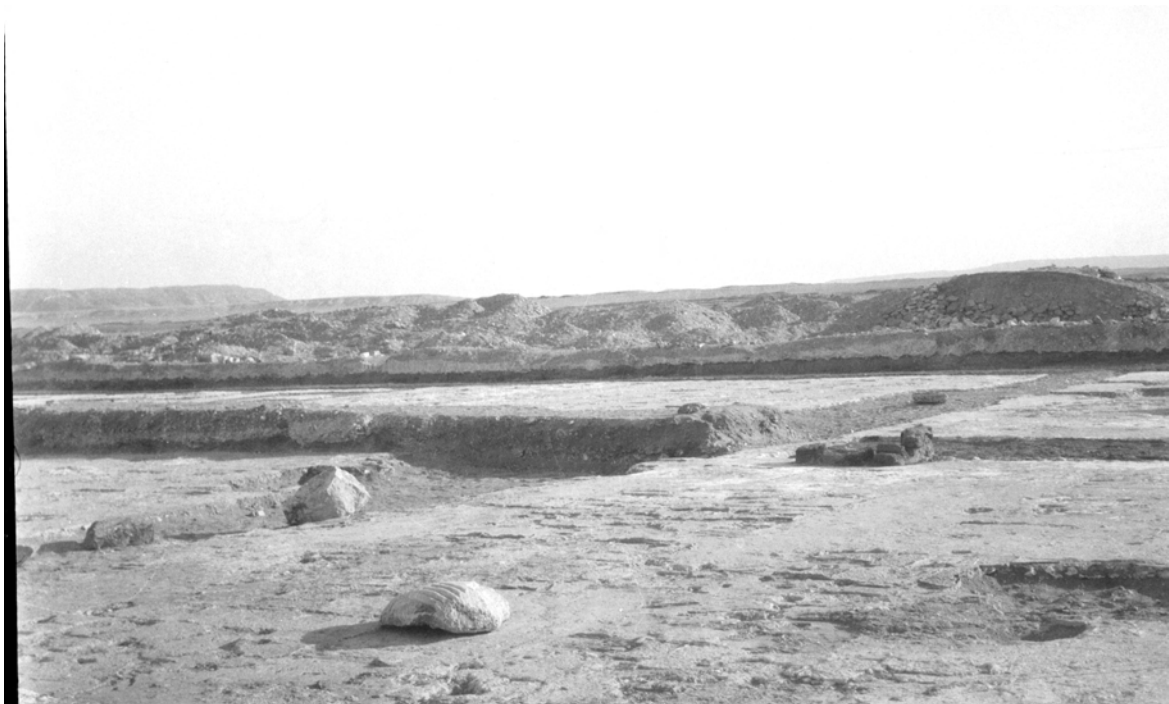
Photo 1932/39

A similar view to Photo 32/21 (p. 29), the photographer having climbed down from the nearby spoil heap to stand on the gypsum-concrete surface.

EES catalogue entry: 'Great Temple, court 6. Column fragments and foundation marks.'

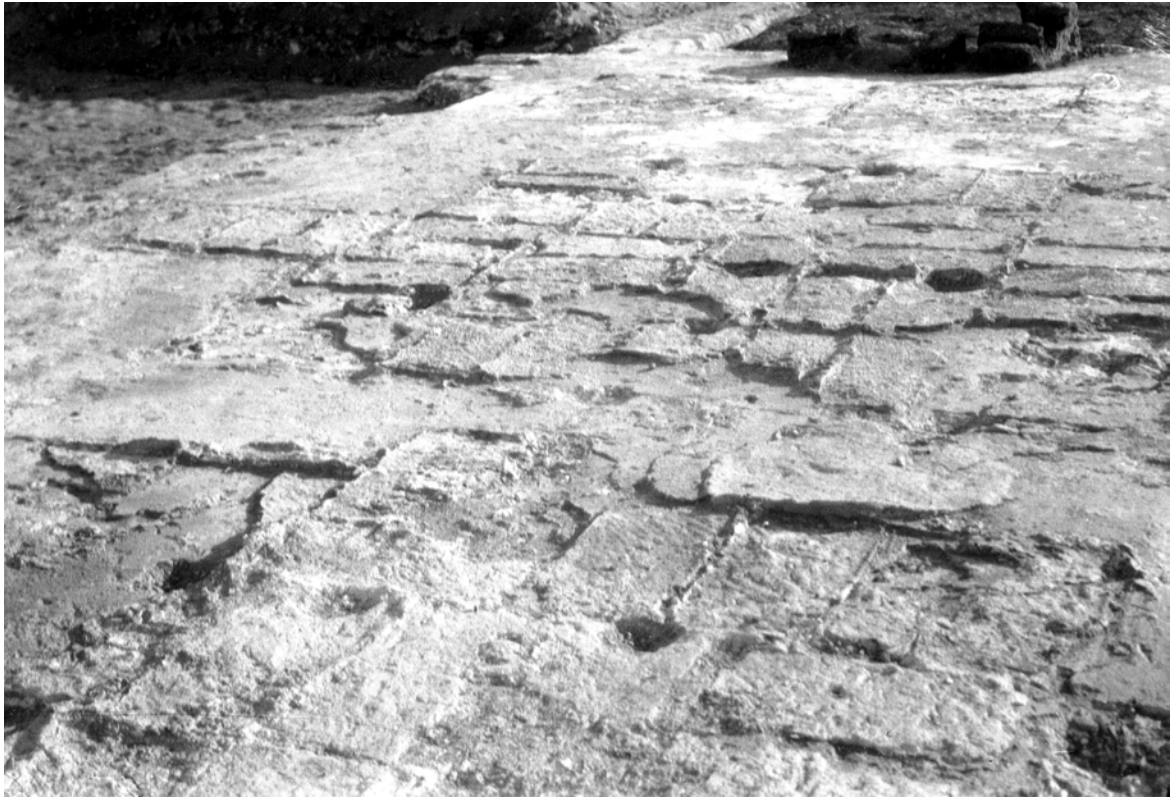
Photo 1932/20

For the location of this picture, of a portion of the Fourth Court, see Photo 32/21 (p. 29). The gypsum surface shows particularly well-preserved impressions of limestone blocks from the pattern of linked squares marking the positions of columns. Note the brick 'shuttering' at the top right edge of the picture. View to the south-east.

EES catalogue entry: 'Great Temple, court 6. Marks for column bases.'

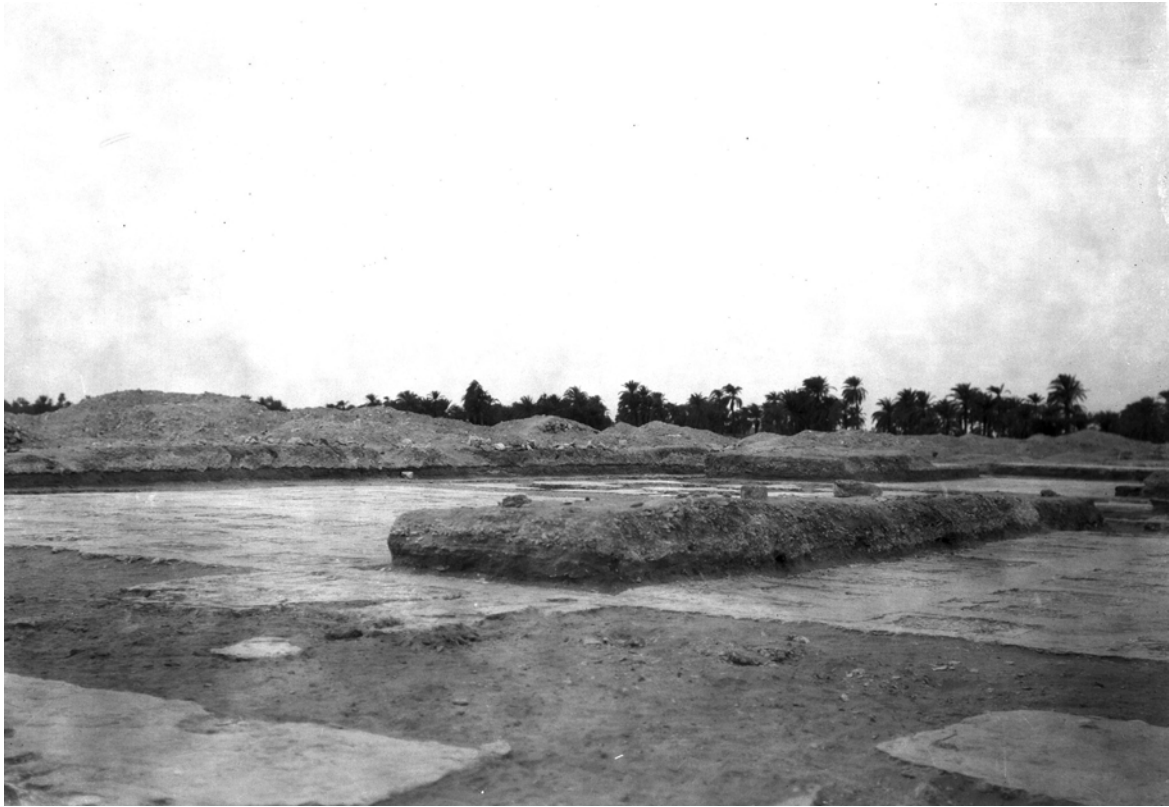
Photo 1932/33

The photographer is standing in the northern part of the Sixth Court, facing south-west. In the middle of the picture is the 'platform' of levelling fill that runs down the centre of the Fifth Court.

EES catalogue entry: 'Great Temple. Gem Aten court 6, end of causeway.'

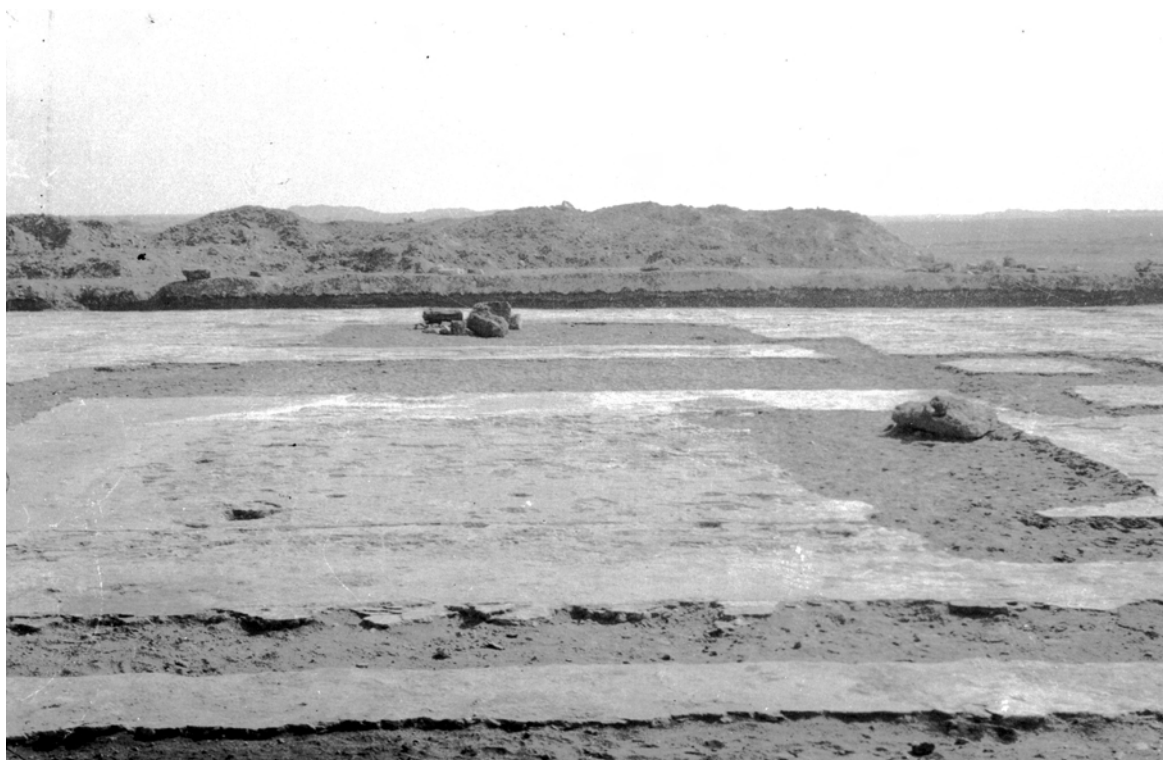
Photo 1932/7

The rear of the temple, the Sixth and Seventh Courts, viewed eastwards along the temple axis. In the foreground are the remains of the first of the two sets of nested rectangular foundations for the main offering-table or 'altar' that presumably stood upon a low stepped platform. By this stage, the gypsum surface of the foundations is close to the natural desert surface, as can be seen from the section face at the back.

EES catalogue entry: 'Great Temple, East end. Foundations of Great Altar.'

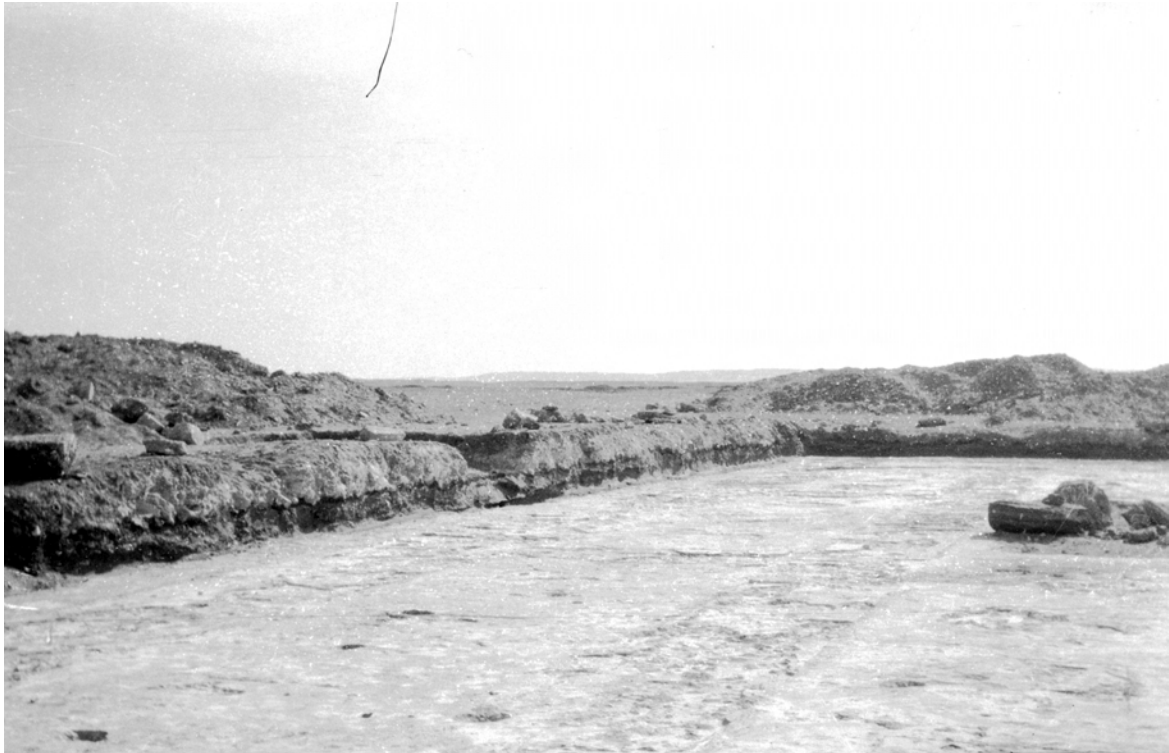
Photo 1932/45

The very rear of the temple, at the back of the Seventh Court, looking almost due south. The gypsum-concrete foundation is fully preserved in a strip parallel to the rear line of the temple (on the left). The slightly darker strip running parallel to this and passing close to the heap of stones bears the block impressions of a continuous wall that defined a series of tiny courts that ran along the back of the temple, each containing a row of three offering-tables.

EES catalogue entry: 'Great Temple, court 7. Rooms at extreme East end.'

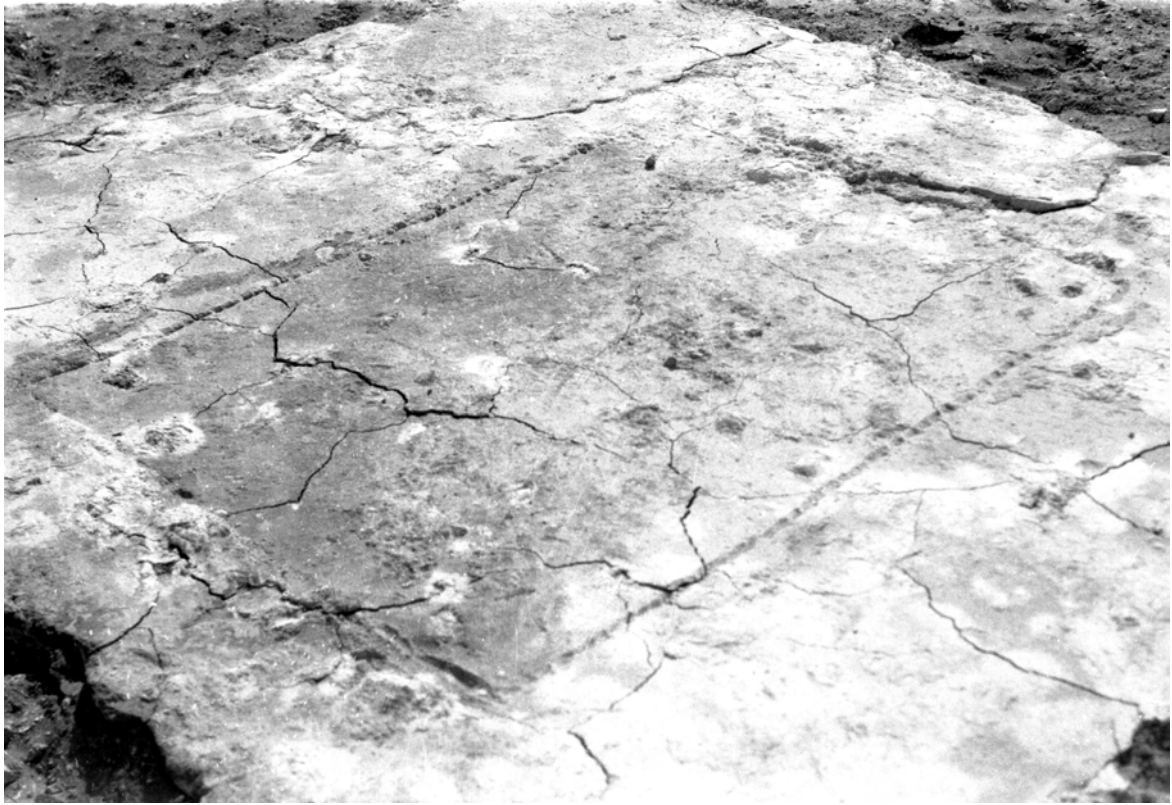
Photo 1932/44

An example of the way that the builders marked the positions of offering-tables to be built on the surface of the gypsum-concrete foundation layer. After marking the outlines with ink (usually black) the lines were emphasised by cutting them into the gypsum surface using a chisel. The catalogue entry identifies the location as within the easternmost court, the Seventh.

EES catalogue entry: 'Great Temple, court 7. Mark for offering base.'
