# Great Aten Temple Autumn 2012 Season

## Preliminary Report

Barry Kemp

January 2013

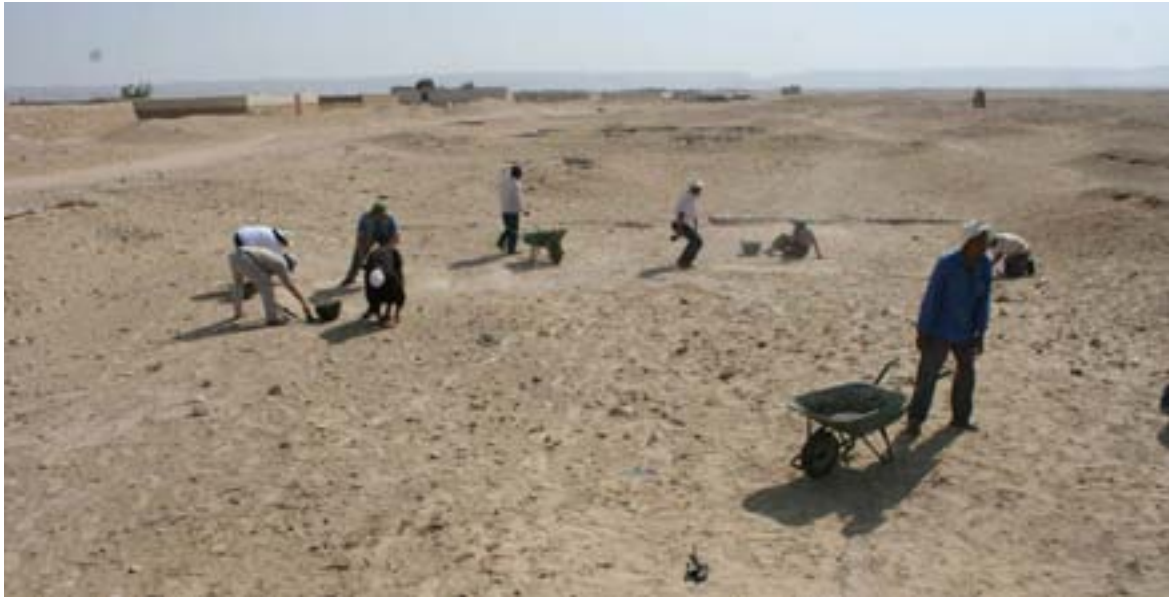
*Figure 3. Beginning the cleaning of the covering of wind-blown sand from the gypsum concrete foundation platform.*

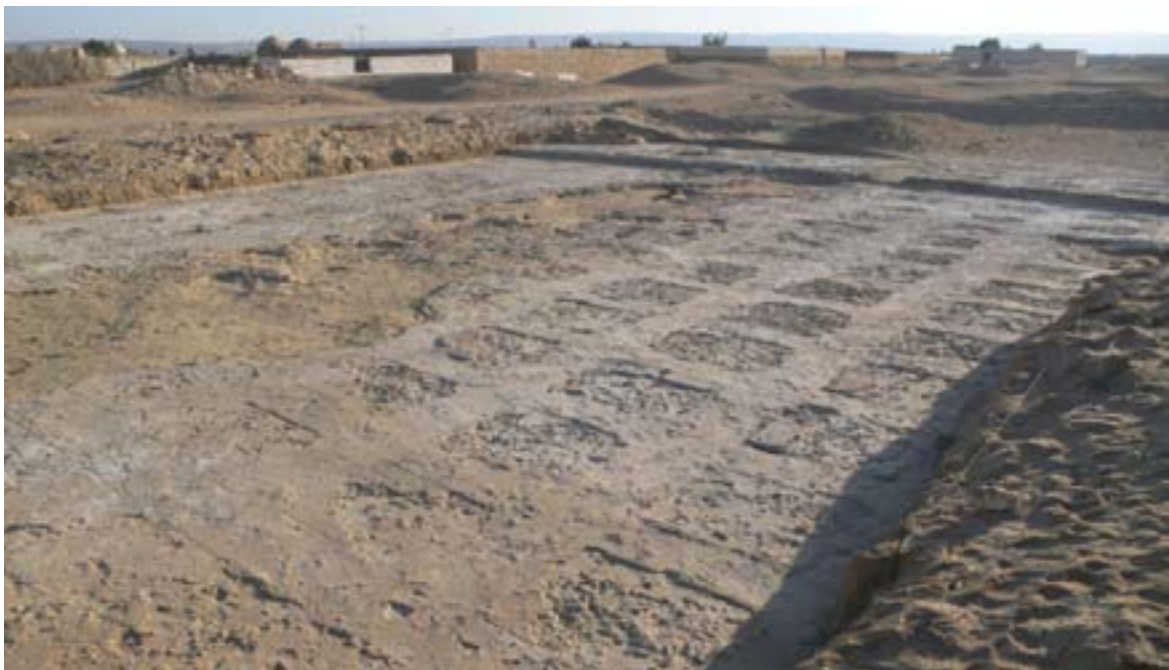
*Figure 4. The gypsum concrete foundation platform at the end of the cleaning, viewed to the east.*

The condition of the surface varied considerably. Where it had been protected by sand, principally along the west, south and north edges, preservation was good, with the details of ancient markings looking sharp and fresh (Figures 4, 5). In other areas the surface had deteriorated, become powdery or broken into patterns of drying cracks, probably formed after rain had fallen. A large strip running down the central axis was missing altogether, something that Pendlebury had found to be the case in 1932.

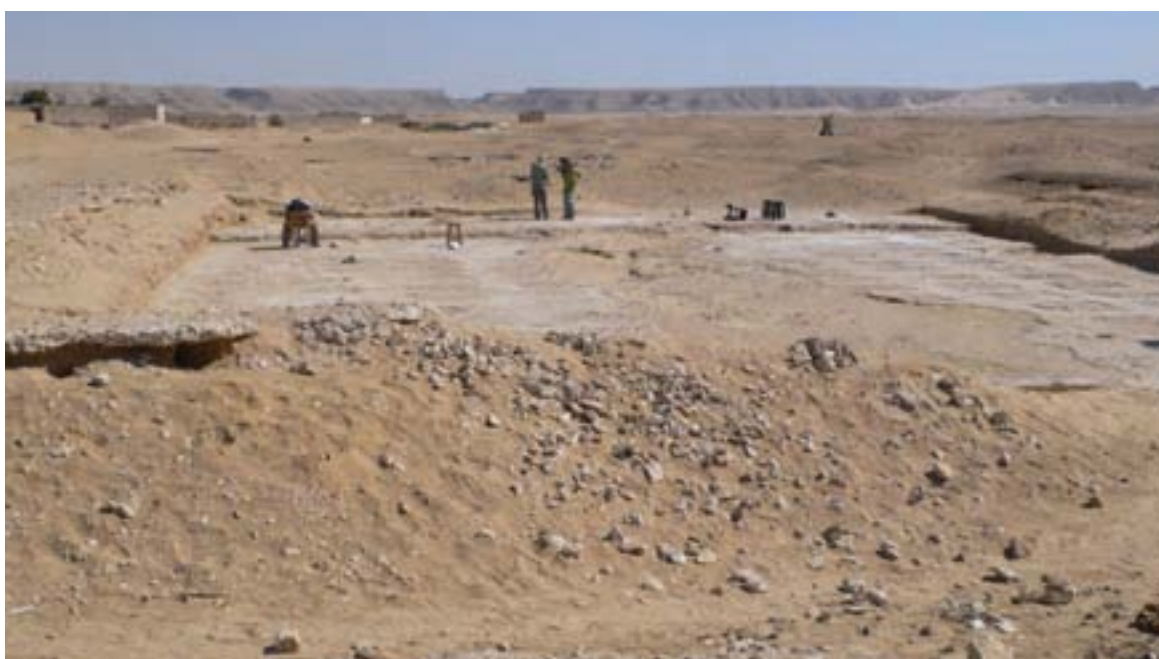
*Figure 5. The gypsum concrete foundation platform at the end of the cleaning, viewed to the east.*

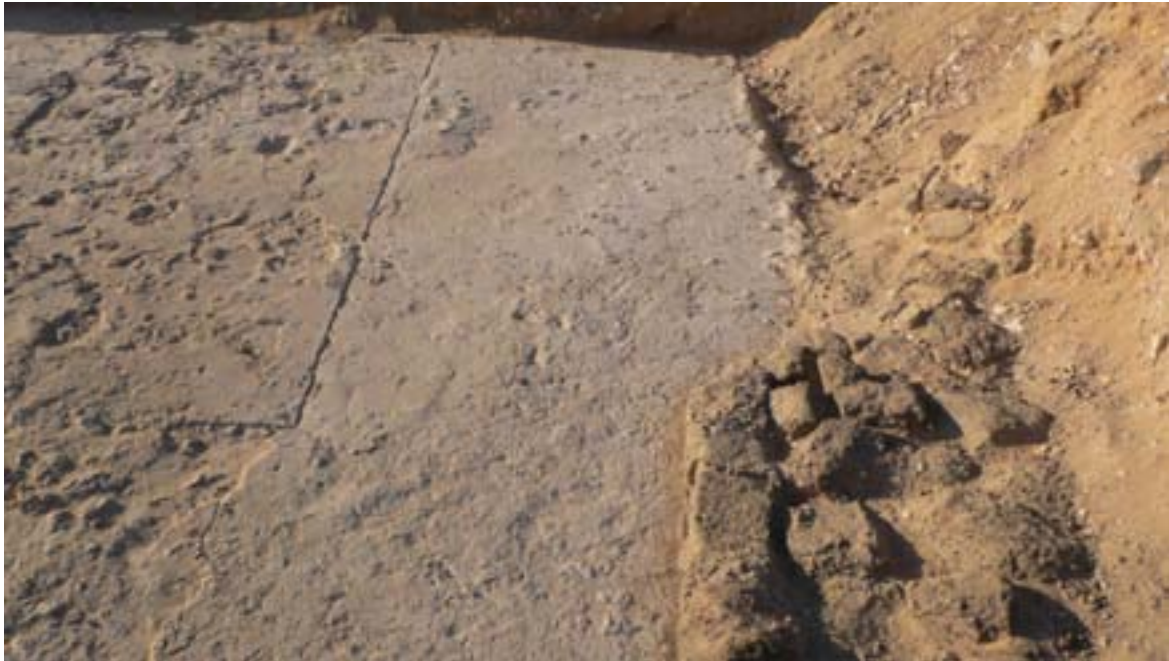
*Figure 6. The south-west corner of the platform showing one of the larger offering-table bases and the remains of a temporary mud-brick construction built directly on the gypsum surface. View to the south.*

The size of the rectangles was 1.06 x 0.90 m, except at the west end, where they were replaced by two pairs of larger rectangles, 2.70 x 1.30 m (Figure 6). When the stone blocks were lifted and removed after the end of the Amarna Period, mostly they pulled up, at the same time, both the bed of gypsum mortar in which they had been laid as well as a thin layer of fine gypsum that had covered the entire foundation platform. Most of the rectangles were therefore marked by a scar where the surface had been lost. In a few places, however, the gypsum mortar layer had stayed behind, leaving the impression of the underside of the block (Figure 8). The ground level rises slightly from west to east. At intervals, a low step was formed in the gypsum foundation platform to allow for this. The first step crossed the site towards the eastern end of the cleared area. It had been made without reference to the layout of the offering-tables, which had straddled the step on either side.

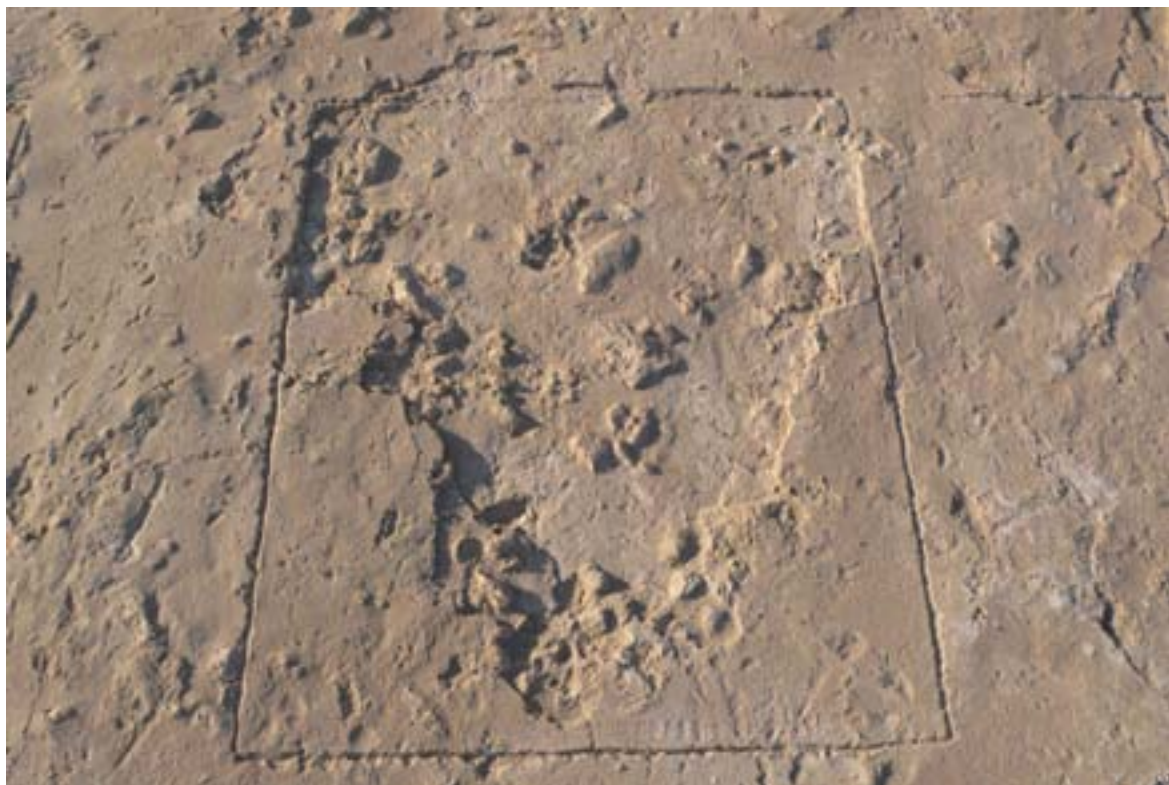
*Figure 7. An example of one of the areas marked for the construction of an offering-table foundation.*

rectangles marked the foundations beneath stone offering-tables. The rows formed two east–west groups, with four rows in each, leaving a broad space in between the two groups, running down the middle axis of the temple. The rectangles had first been marked by black ink lines (with, here and there, short red lines) and then by v-profile grooves cut into the gypsum surface along these lines, by blows from a small adze or chisel (Figure 7).

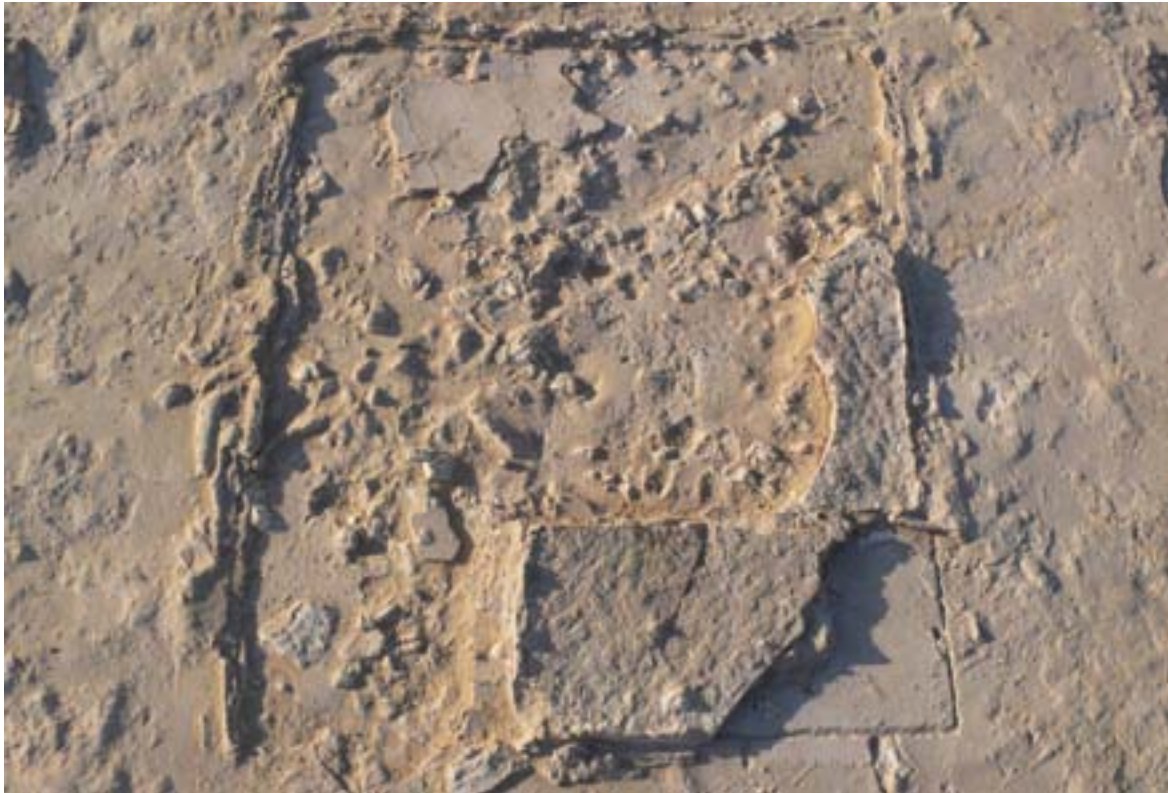
*Figure 8. An example of one of the areas marked for the construction of an offering-table foundation, still retaining a patch of the gypsum mortar bearing the impression of the underside of two blocks.*

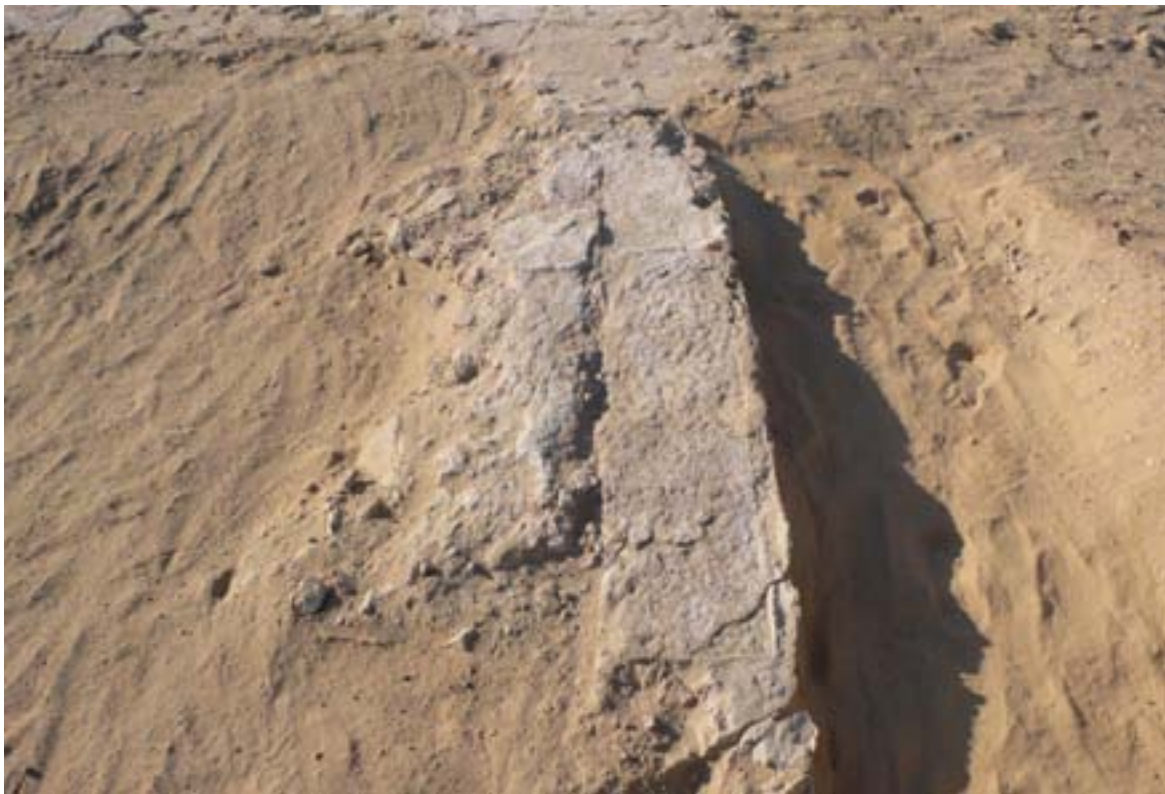
*Figure 9. Foundations for a threshold at the western end of the cleared area of the first court, viewed to the south.*

The loss of the wide strip running down the axis of the temple leaves it uncertain as to whether this had been an open area or had supported a larger and longer offering-place, as is hinted at in the tomb pictures. The remaining rubble in this part contains pieces of gypsum mortar with block impressions, that perhaps shows that a stone construction had stood here. The only structural clue is a length of straight incised line running east–west across the axis near the back of the area. Further back, the gypsum foundation layer has an original edge, marking the beginning of a central strip where there were no foundations and instead the filling material was piled up directly on the desert surface, to be covered by the upper gypsum floor. At the far western end of the clearance, an area of gypsum mortar bearing the impressions of limestone blocks was found, crossing the axis of the building (Figure 9), and probably representing the foundations for a heavy threshold at final floor level, a feature not noted on the Pendlebury-Lavers plan.

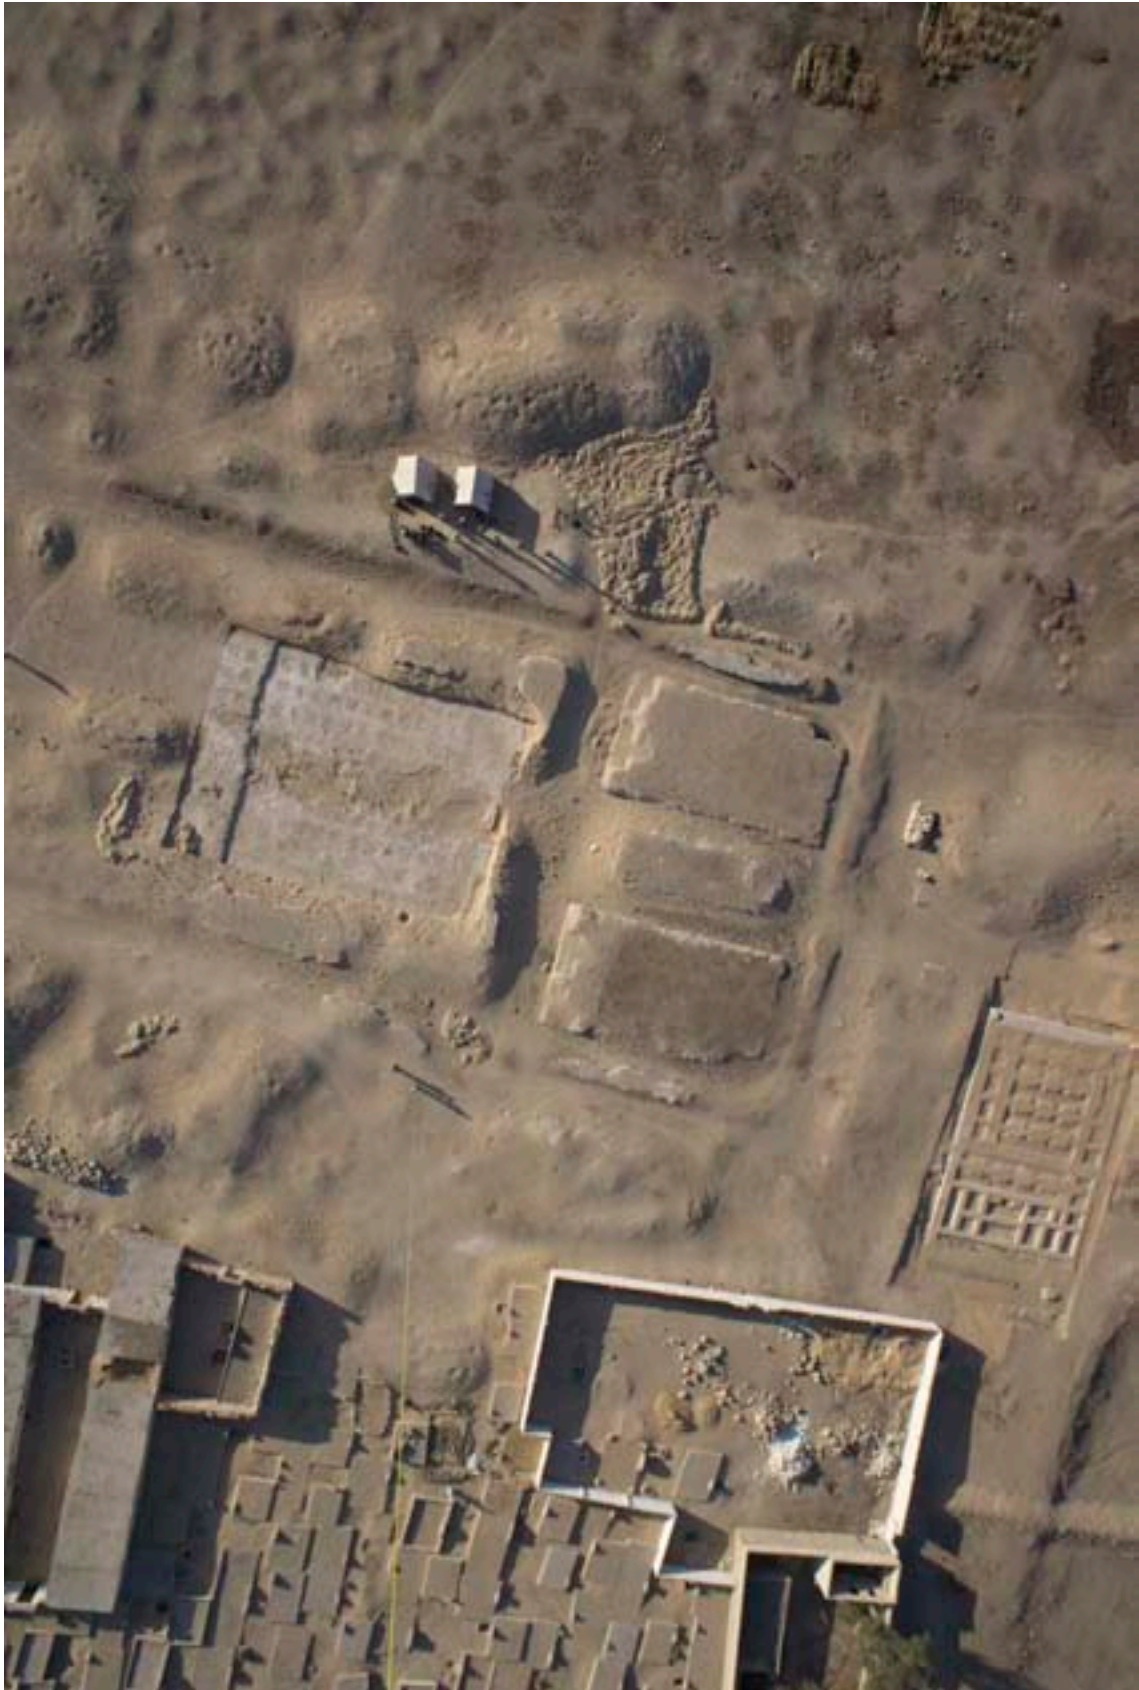
*Figure 10. Aerial view of the front part of the Great Aten Temple at the end of the season (photo by Miriam Bertram and Sue Kelly). North is towards the bottom of the picture.*

The entire area was planned at the scale of 1:25 (Figure 12). Each offering-table position was photographed at ground level. The whole surface was also photographed from the expedition helium balloon (Figures 10, 11). At the end, a layer of sand about 10 cm deep was spread evenly over the gypsum foundation layer to protect it.

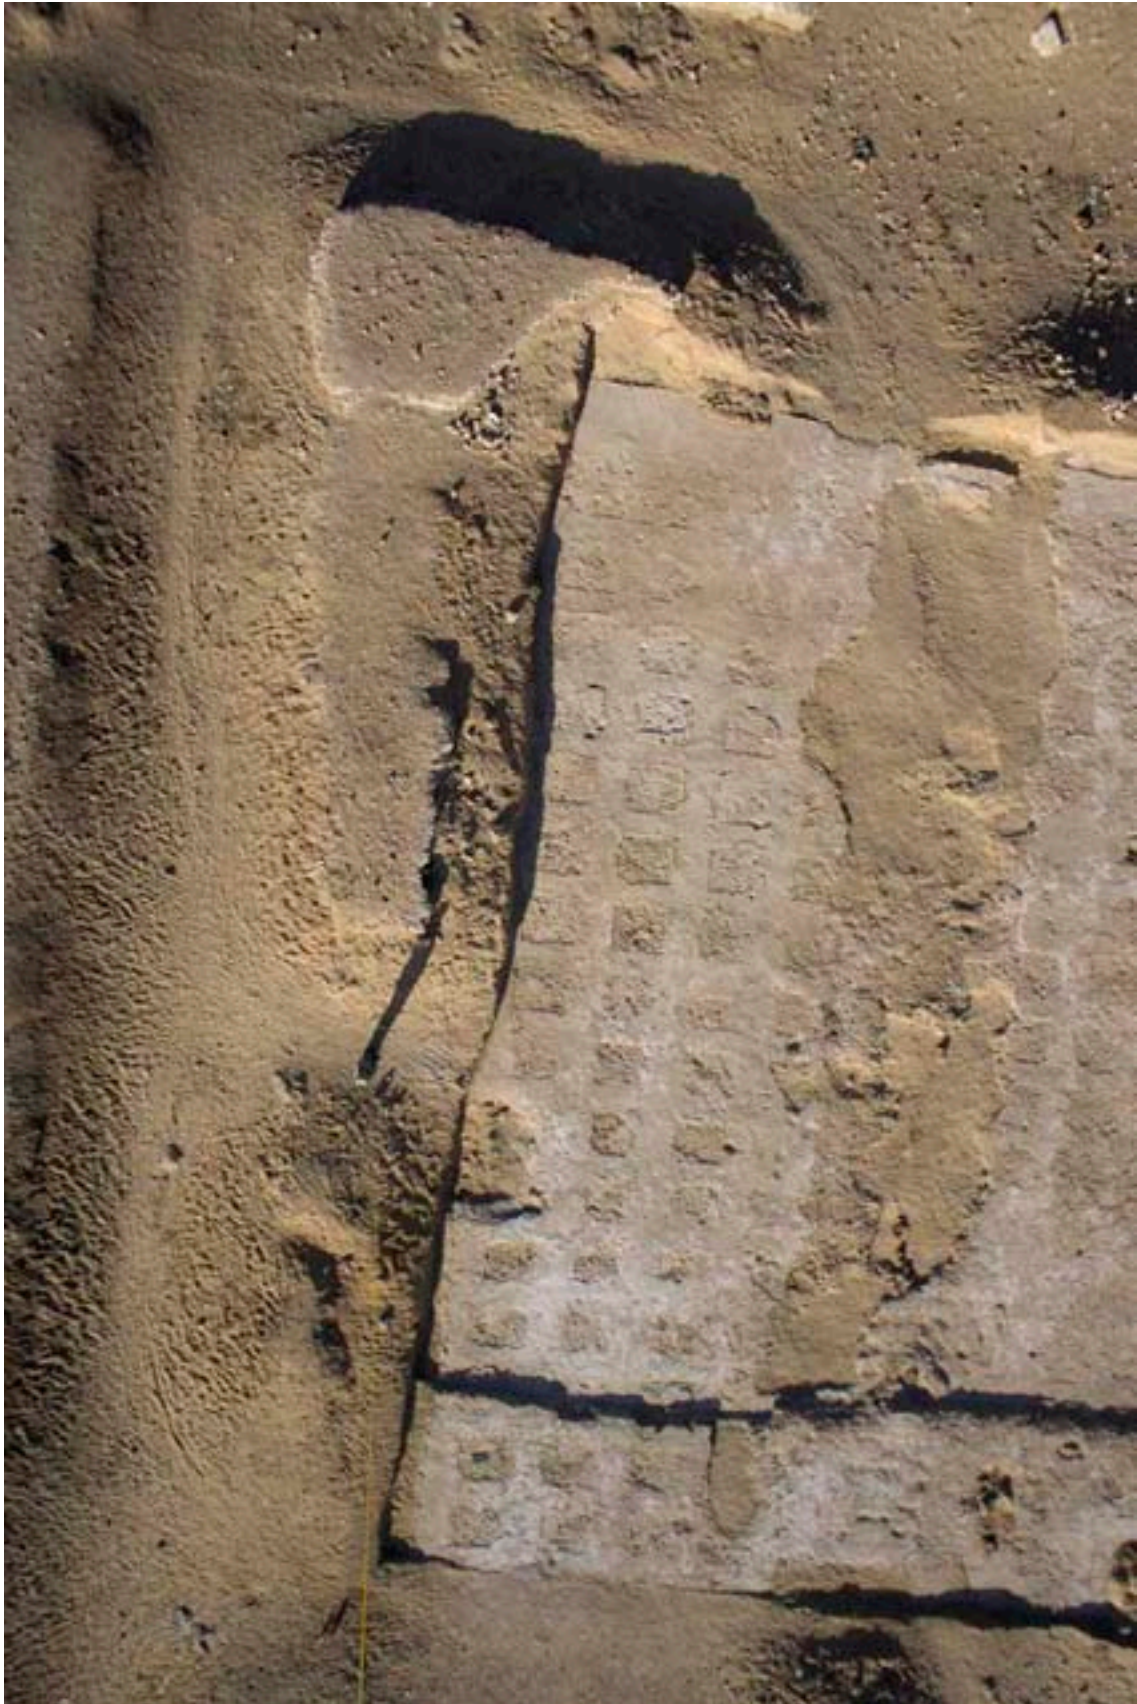
*Figure 11. Aerial view of the offering-table outlines at the end of the season (photo by Miriam Bertram and Sue Kelly). North is towards the right of the picture.*

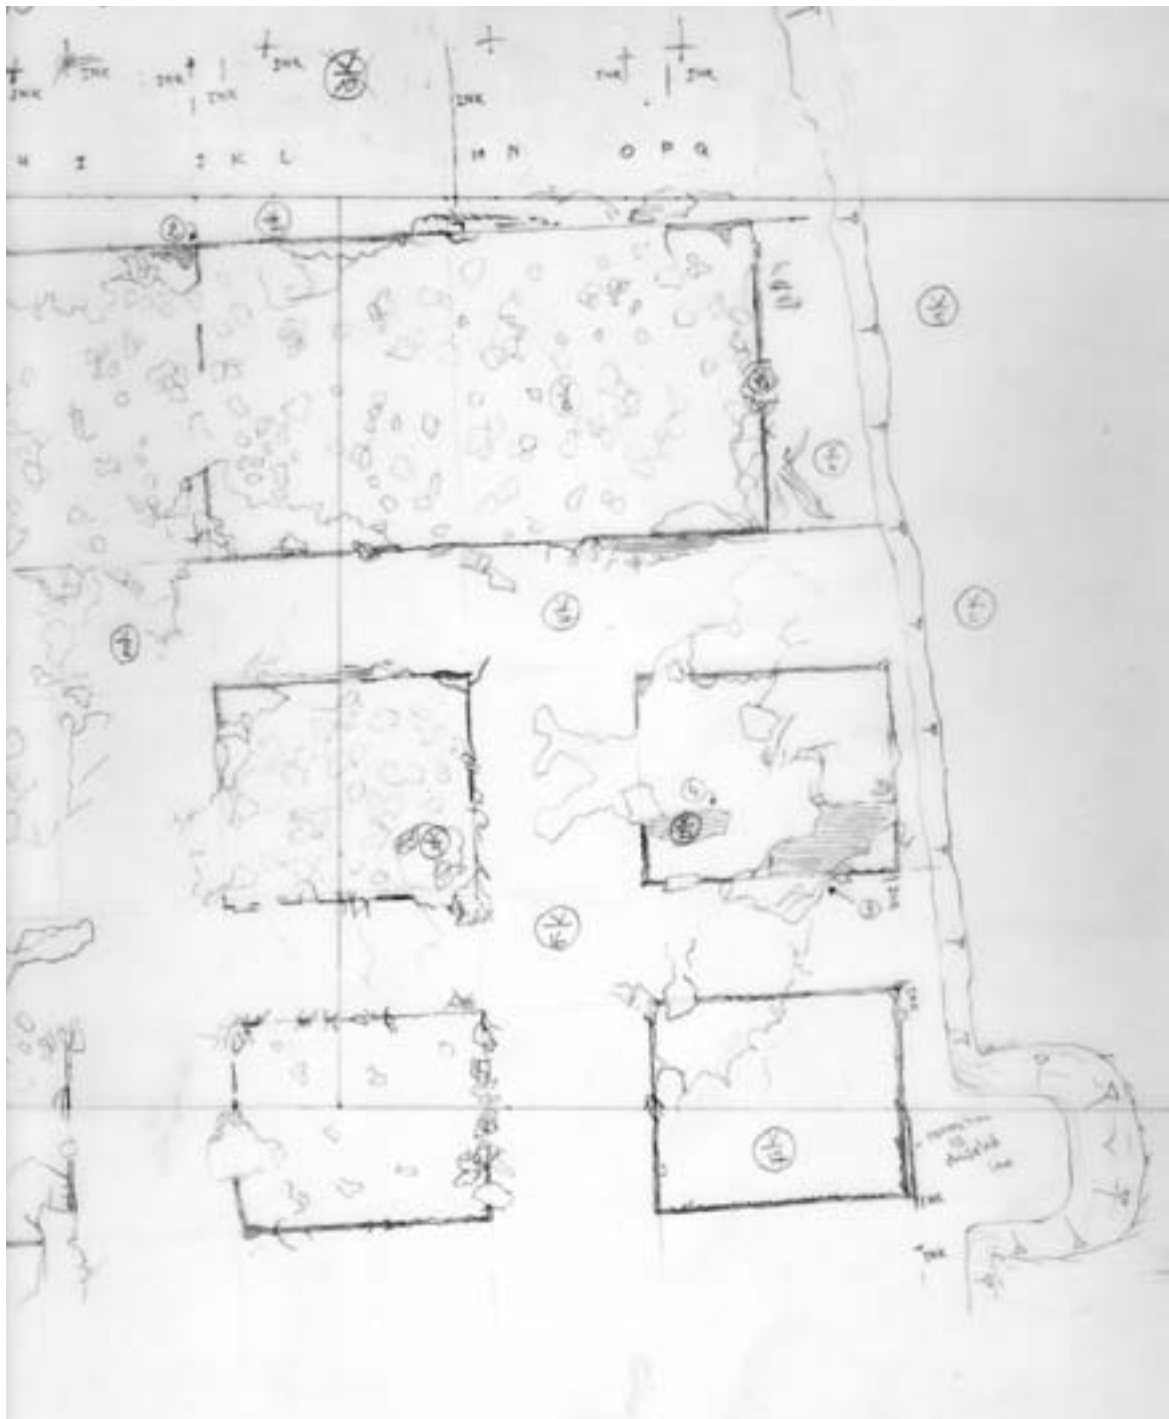
*Figure 12. Sample of 1:25 plan of the gypsum foundation platform (original by Juan Friedrichs).*

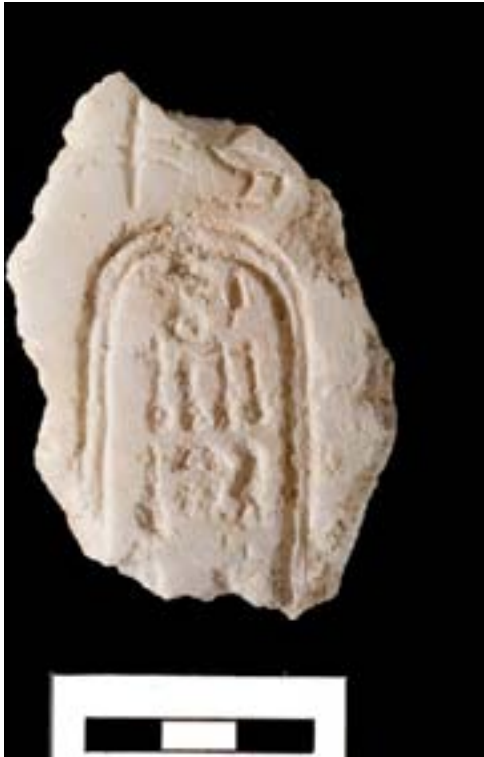
Figure 13. Fragment S7720. Travertine (alabaster) fragment with cartouche of Nefertiti.

The fragments came primarily from architectural elements in travertine (alabaster) (Figures 13, 16), indurated limestone, conventional limestone and granite (Figure 14). There were also inlays in grano-diorite and red quartzite, mostly from a large cavetto cornice the background of which was made from indurated limestone. One or two pieces (one of them made from basalt) seemed to come from balustrades (Figure 15).

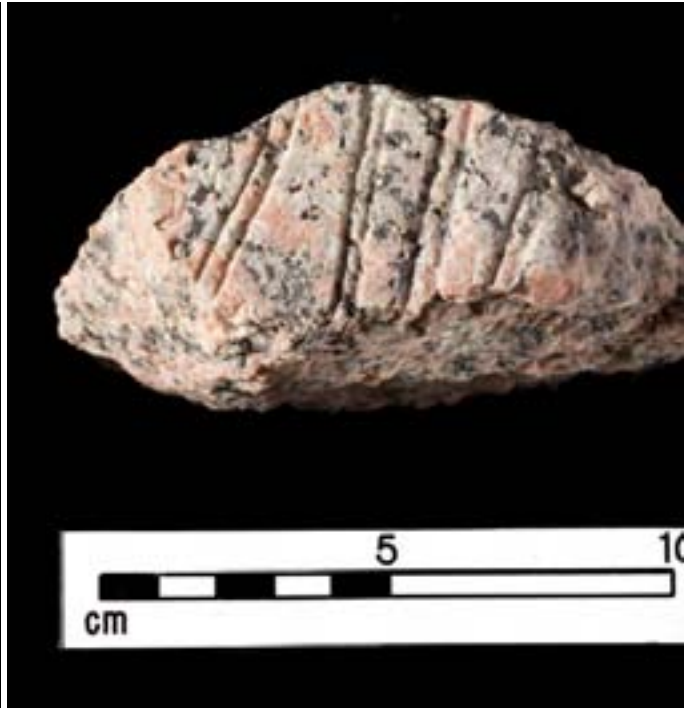
Figure 14. Fragment S7733. Red granite, with edge of cartouche and Aten rays.

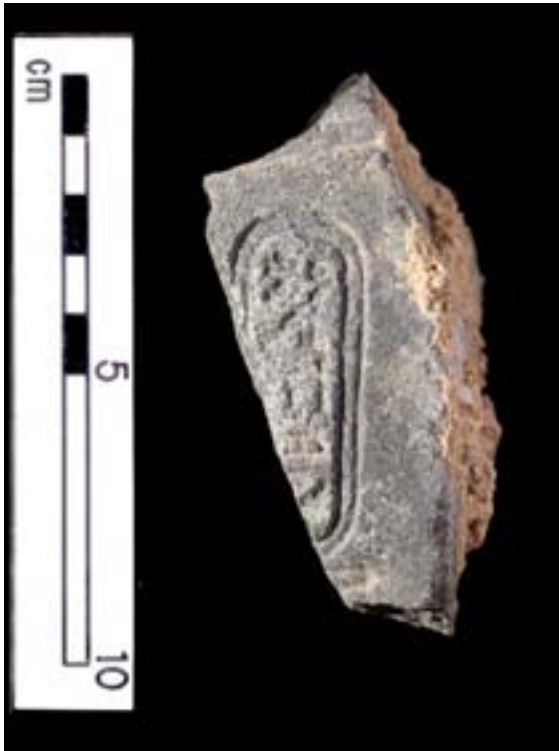
Figure 15. Fragment S7734. Basalt, with cartouche of the Aten. The slightly sloping line above suggests that it comes from a balustrade.

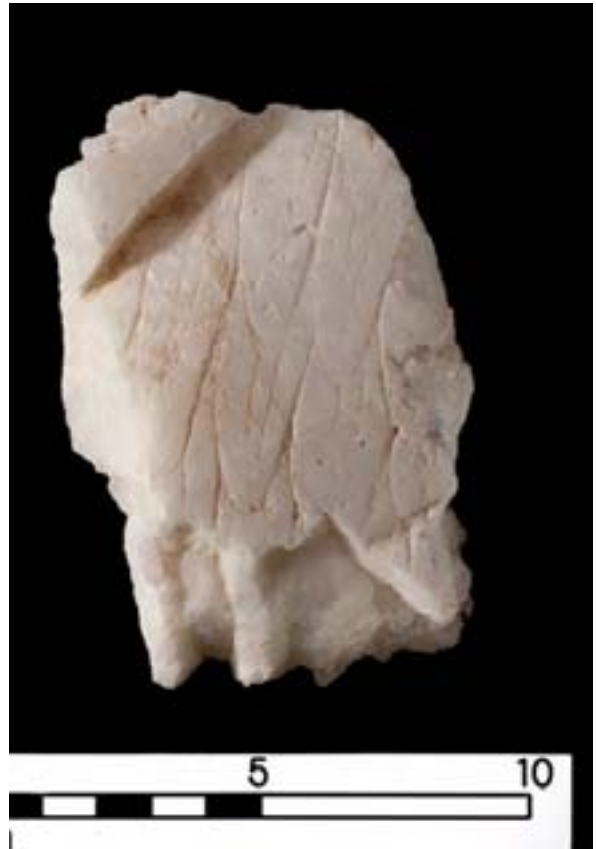
Figure 16. Fragment S7741. Travertine (alabaster) with a feather design.

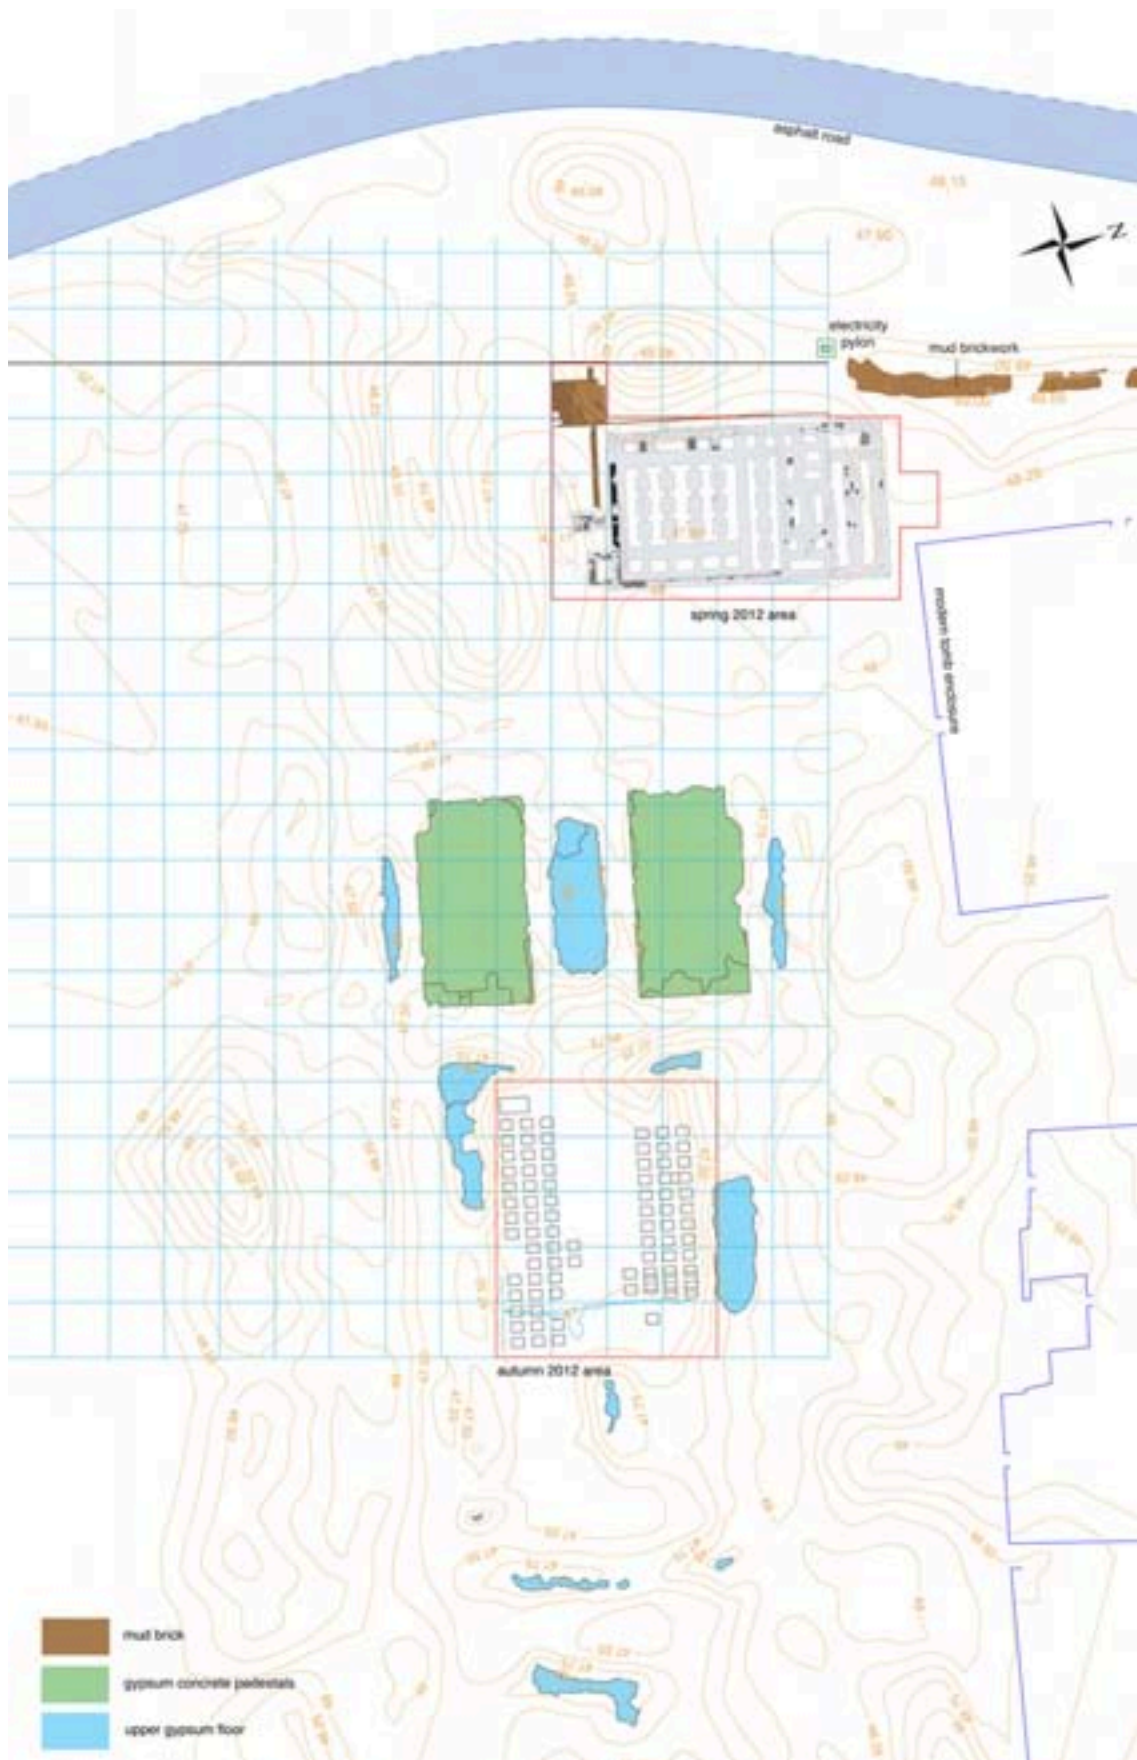
*Figure 18. Survey plan (by Hans Barnard) of the front part of the Great Aten Temple over which have been laid the outlines of the areas cleared and planned in the spring and autumn of 2012.*
