British Mission to Tell el-Amarna

Great Aten Temple Spring 2015 Season

Preliminary Report

Barry Kemp

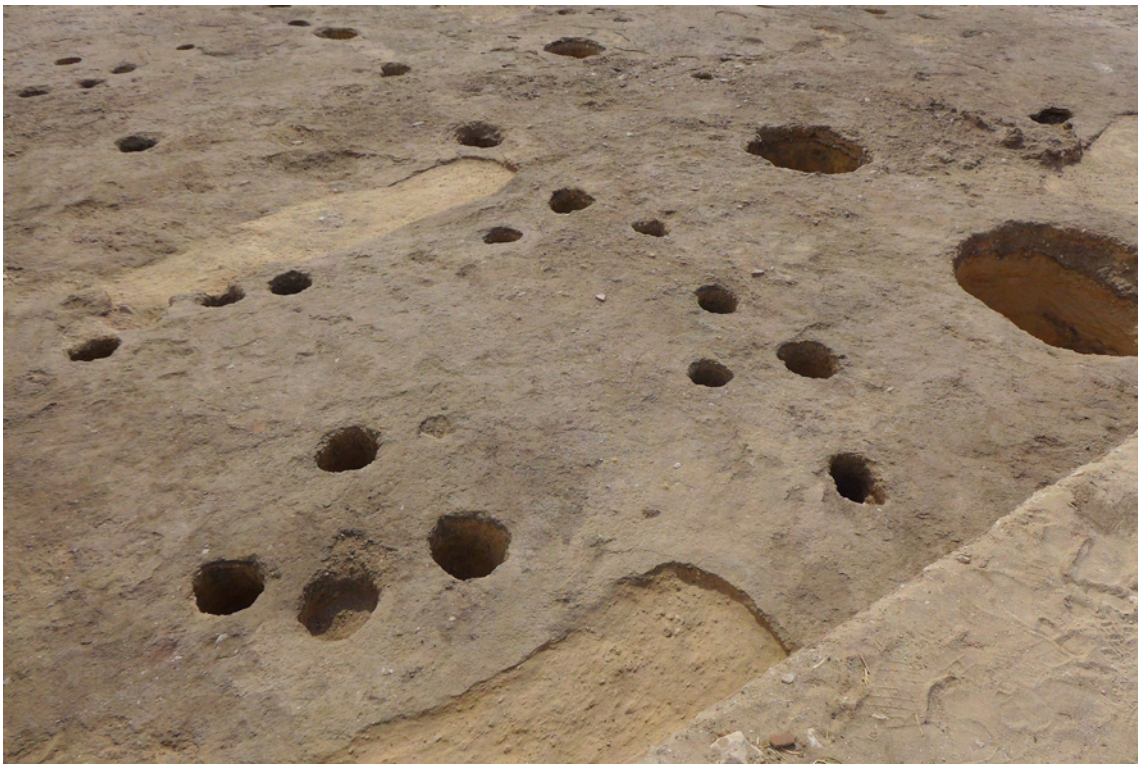
Post holes and (towards the top right) larger pits for buried pots, all dug into the mud floor of the early temple phase in Area E. The longer pits filled with sand are modern graves. View to the south-west.

Across the floor were small and roughly circular depressions with a diameter of between 15 and 20 cm (Figures 12, 13). When examined further they were identified as circular holes with generally vertical sides. They appear to be more numerous in S35 and S36, but the examination of all of the possible holes in R35 and R36 was not completed. Many are likely to be post holes. Squares S35 and S36 are crossed by perhaps ten holes in what is close to a single N–S line. Towards its southern end the holes correspond with a strip where the upper layer of mud floor has been worn away. A similar though not so well defined strip occurs to the west, along the western edge of S35, where a group of four holes occurs.

A second group of three much larger and deeper holes forms a line parallel to the main line of smaller holes in S35 and S36, and about 1 m to the west. They have depths of 1.01, 0.74 and 0.52 m. Traces of mud line the sides, especially in the case of the largest and northernmost. There can be little doubt that these holes were dug to receive pottery jars which were then fixed in place with mud mortar, their mouths flush with the mud floor. The northernmost would have suited one of the large, wide-bellied storage jars sometimes referred to as ‘meat jars’ although they served as general storage jars and were not only for meat.

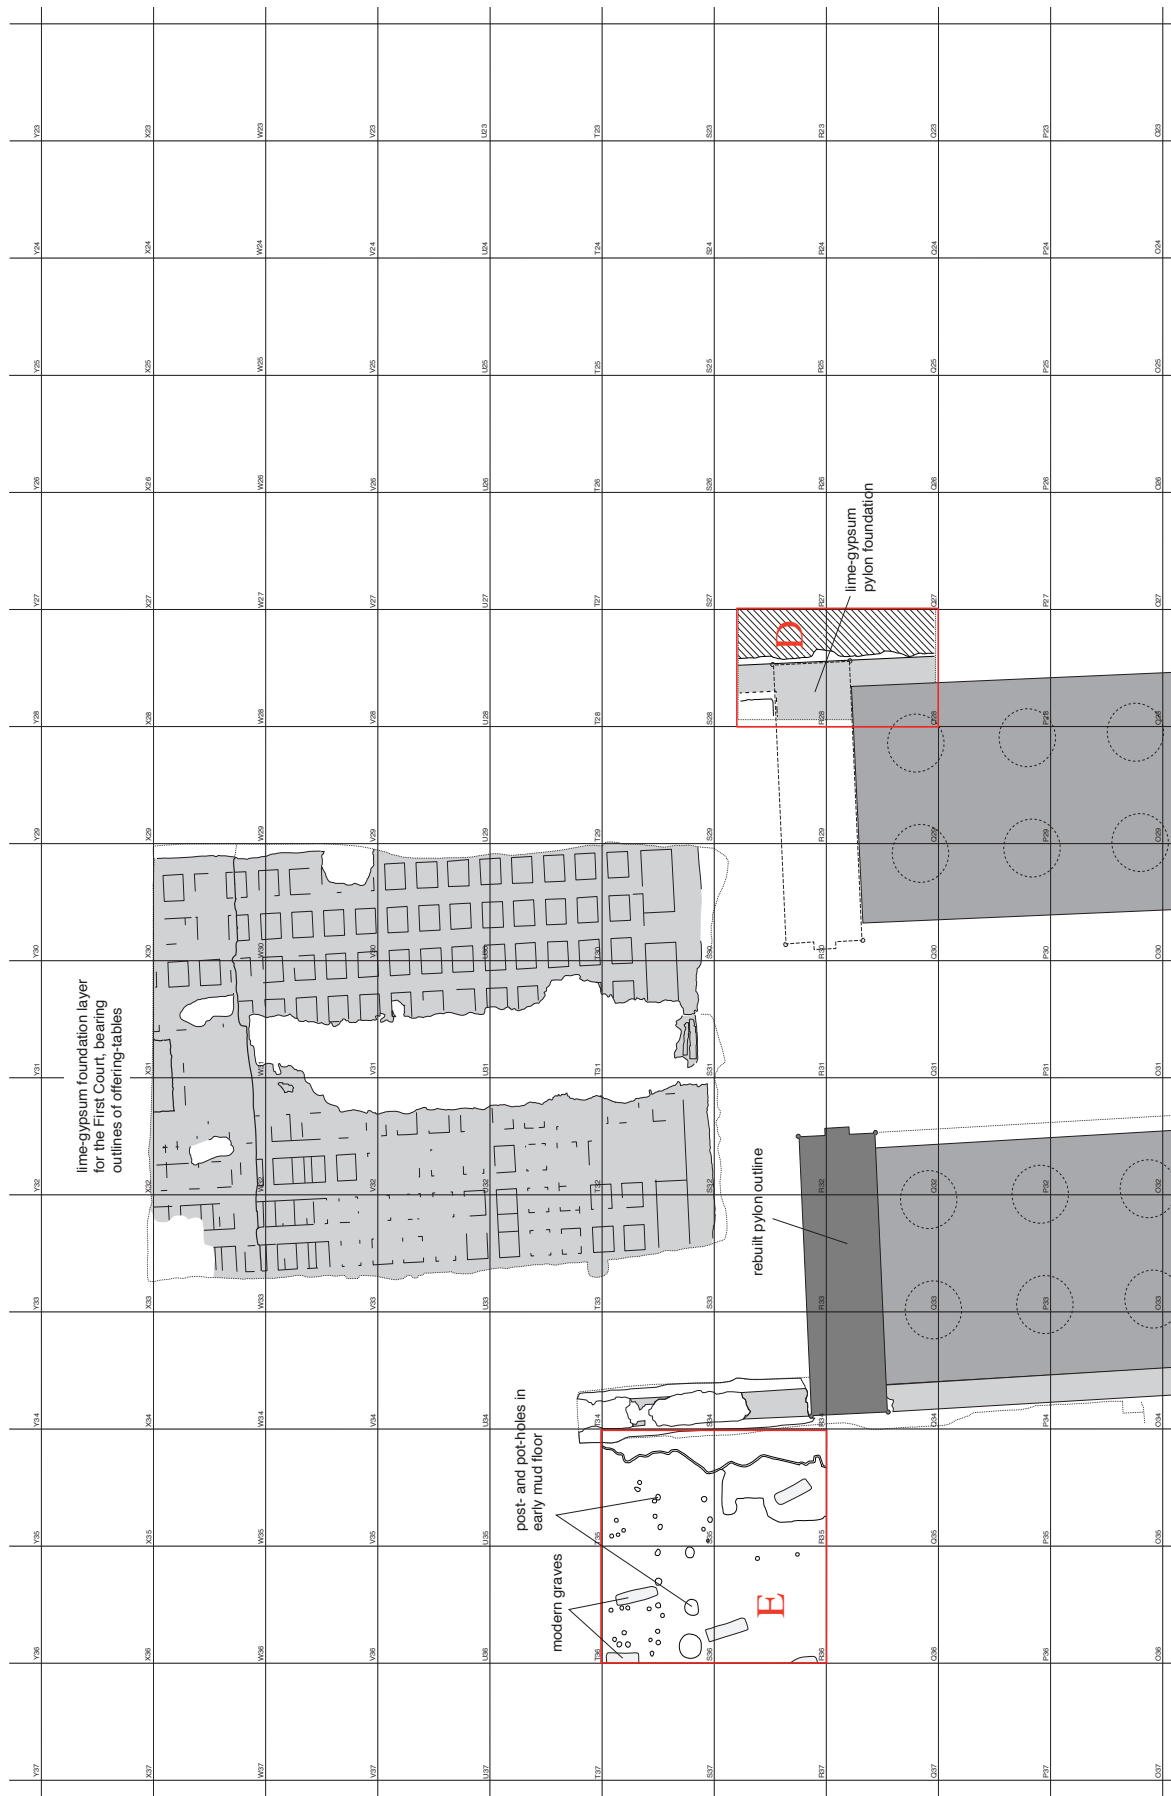
Figure 1. Plan of the eastern half of the excavation, showing the results of work carried out between 2012 and 2015.

The maps (Figures 1 and 2) indicate the location of each area. The excavation was conducted within a grid of 5 x 5 metre squares.

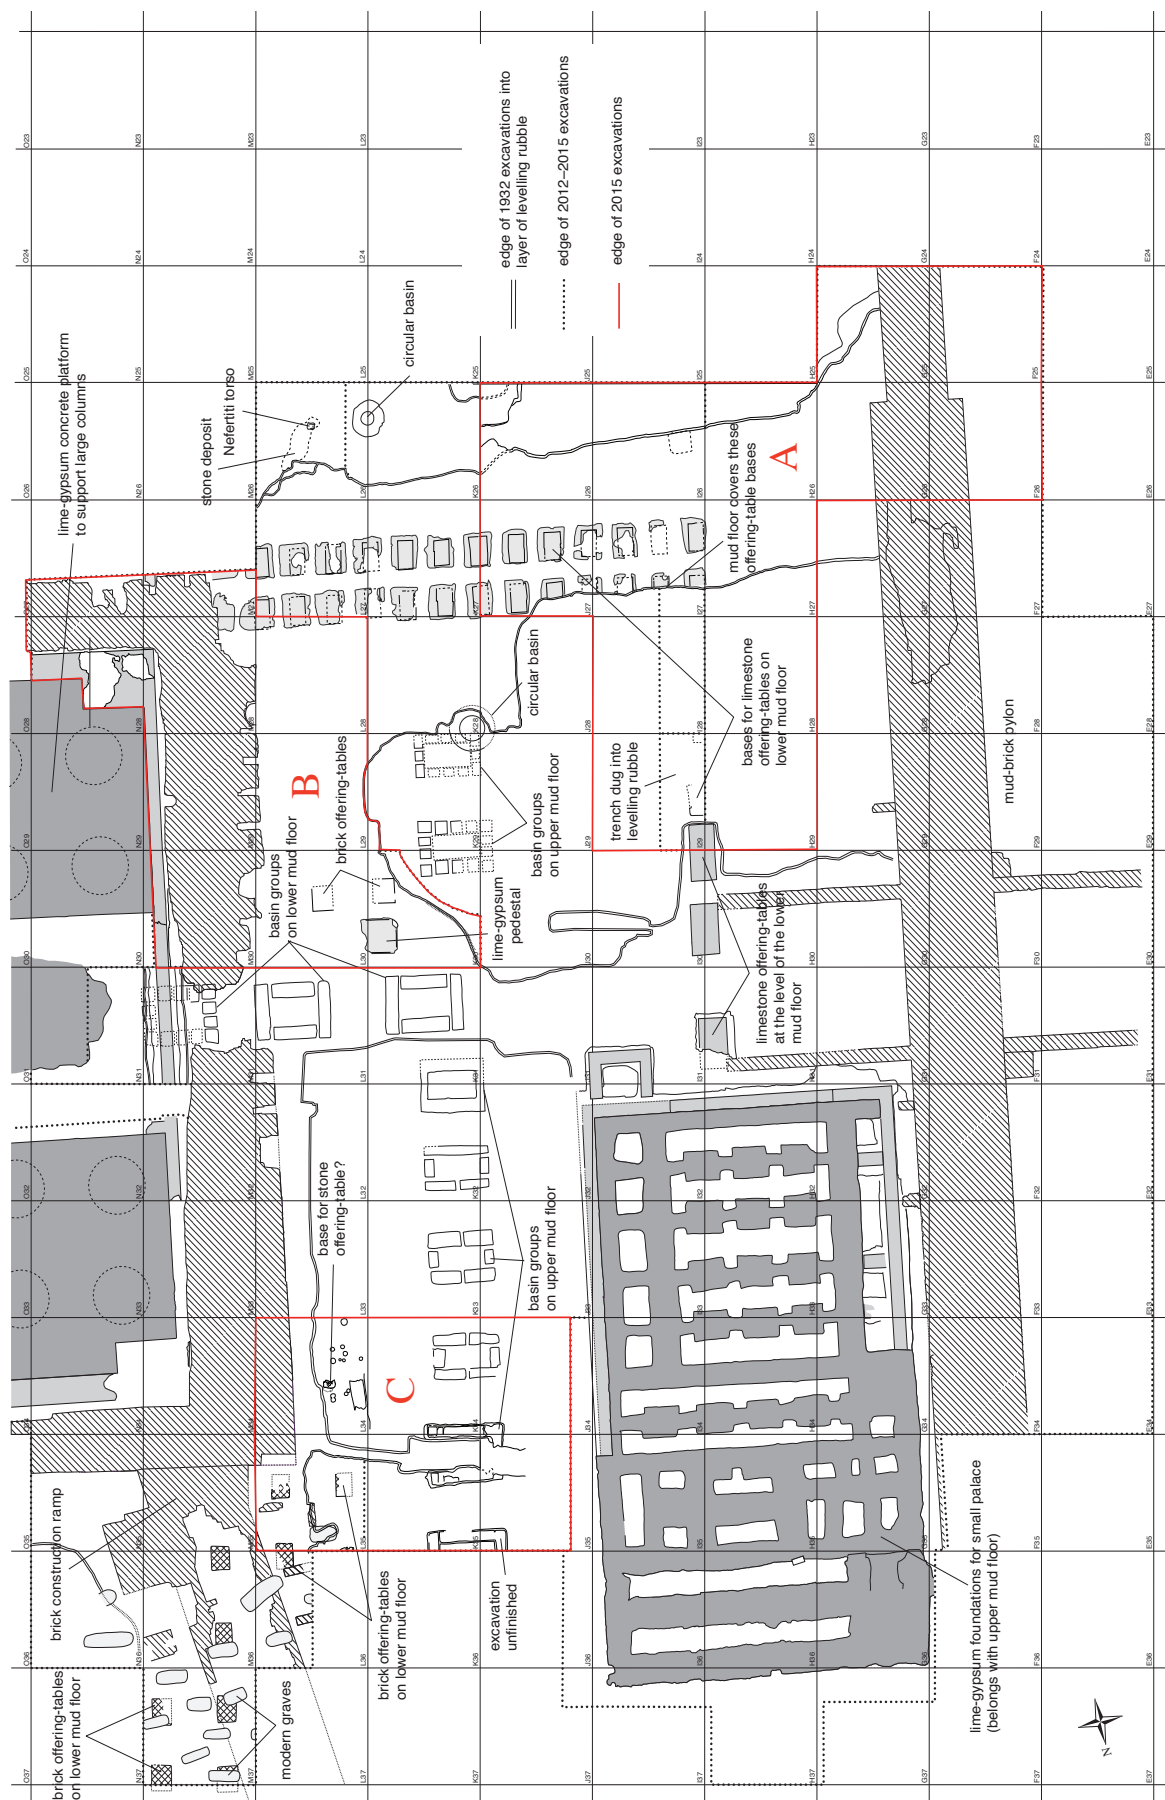
Figure 2. Plan of the western half of the excavation, showing the results of work carried out between 2012 and 2015.

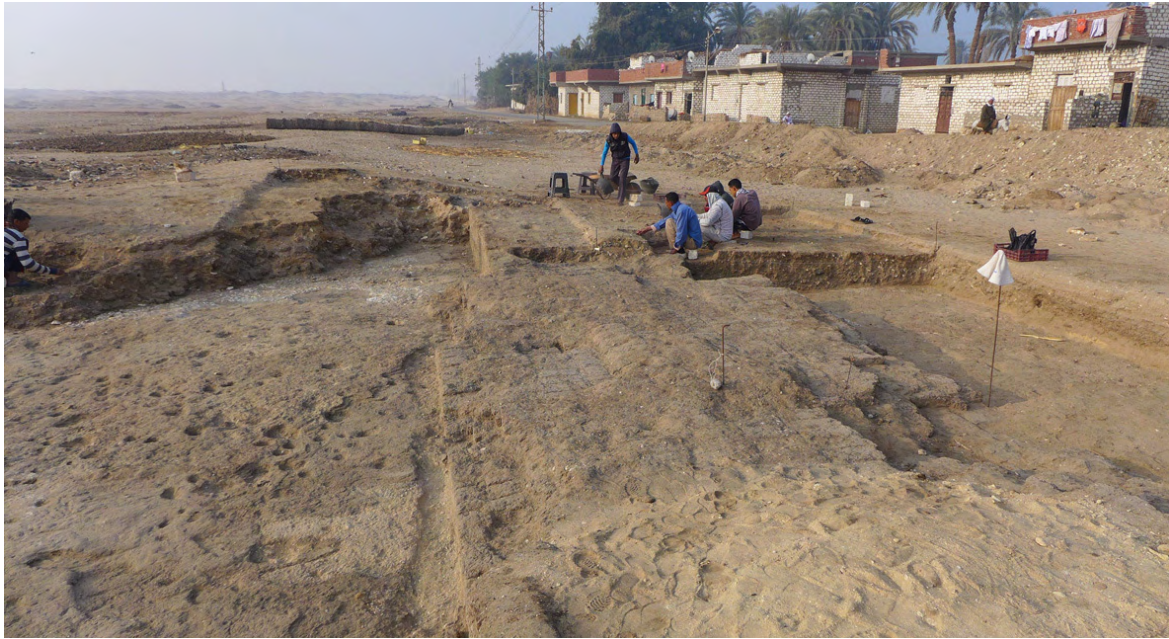
Figure 3. Area A: the southern mud-brick pylon. View to the south. The end of the pylon has been reached, leading to a narrowing of the brickwork as it becomes the temenos wall. The south edge of the excavation is the south edge of the 1932 trench.

During the seasons of 2012, 2013 and 2014 the areas of work included most of the extent of the two pylons. This year, the southern end of the south pylon was finally reached and exposed, along with a 5.50/5.70-m length of the wall itself (Figure 3). Whereas the pylon had a width of 4.3 m, the wall had a width of 2.3 m. The outer face preserved areas of mud plaster coated with whitewash; but the corners of the pylon were square, with no trace of a torus moulding. On both sides of both pylon and wall the outlines of construction cuts into the existing mud-coated floor were visible.

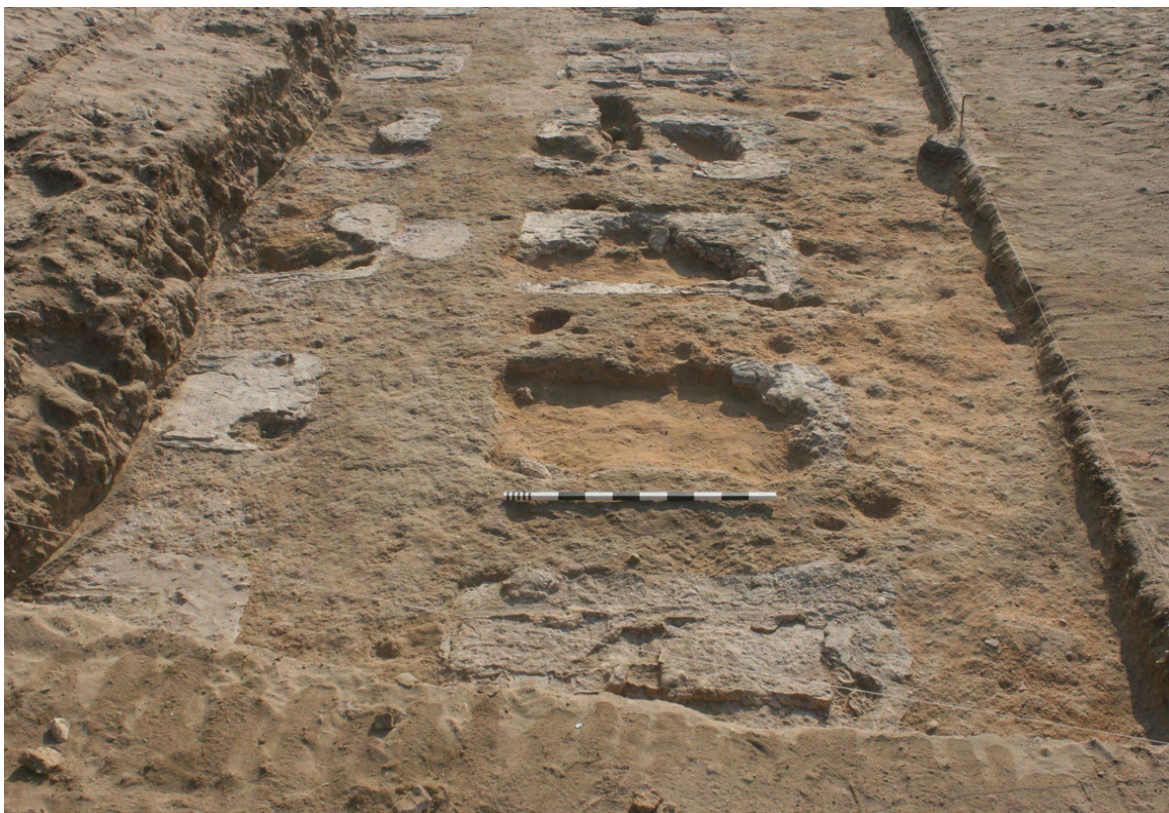
Figure 4. Area A: the lines of lime-gypsum foundation bases for stone offering-tables. View to the east. The left edge of the excavation is the edge of the 1932 trench. Near the left-hand corner, remains of the mud-plaster floor can be seen covering the bases. Photo by Anna Hodgkinson.

As in the previous season, the lime-gypsum platforms were found to be cut into individual shallow trenches in the natural desert surface. They had then been topped with a layer of lime-gypsum-lime, into which the talatat blocks had been set. None of these survived (except in three cases where just fragments of limestone remained), the mortar usually bearing only the impressions of these blocks and their chisel-marks (indicating that they were roughly-hewn), and finger-marks around the block impressions, where the mortar had been smoothed out. The block pattern already found in place during the previous season was repeated: two sets of N-S orientated blocks, with space for a smaller, either $\frac{1}{2}$ or $\frac{1}{3}$ sized block in between. No linear string marks in ink to guide the builders

were visible on the lower lime-gypsum platforms, and the block impressions do not all appear to be exactly aligned, indicating a rather hasty style of working. The blocks may have been coated by a layer of whitewash in order to hide any imperfections, although no archaeological evidence of this has been found. Presumably, the outer lips of the lower lime-gypsum platforms, where not covered by blocks, would have been covered with a mud floor, which was then covered with a layer of whitewash, though evidence of this, too, is scarce. Although patches of mud floor and whitewash have been found surrounding the lime-gypsum platforms, there is little evidence of this floor having covered the platforms themselves.

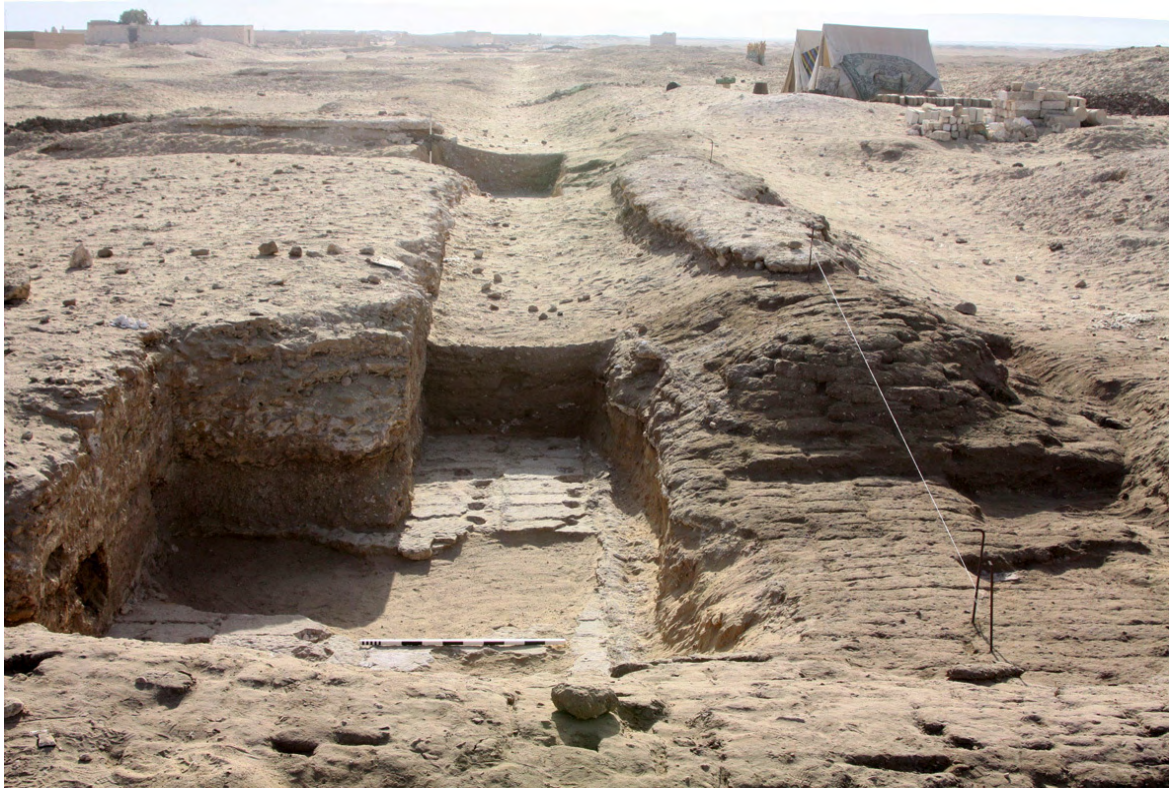
Figure 5. Area B: the line of the southern wall of the temple recedes eastwards into the distance. Mostly it is a straight trench filled with sand. In the foreground the sand has been excavated, revealing the lime-gypsum foundation layer for stone blocks and the south-west corner of the temple. Photo by Juan Friedrichs.

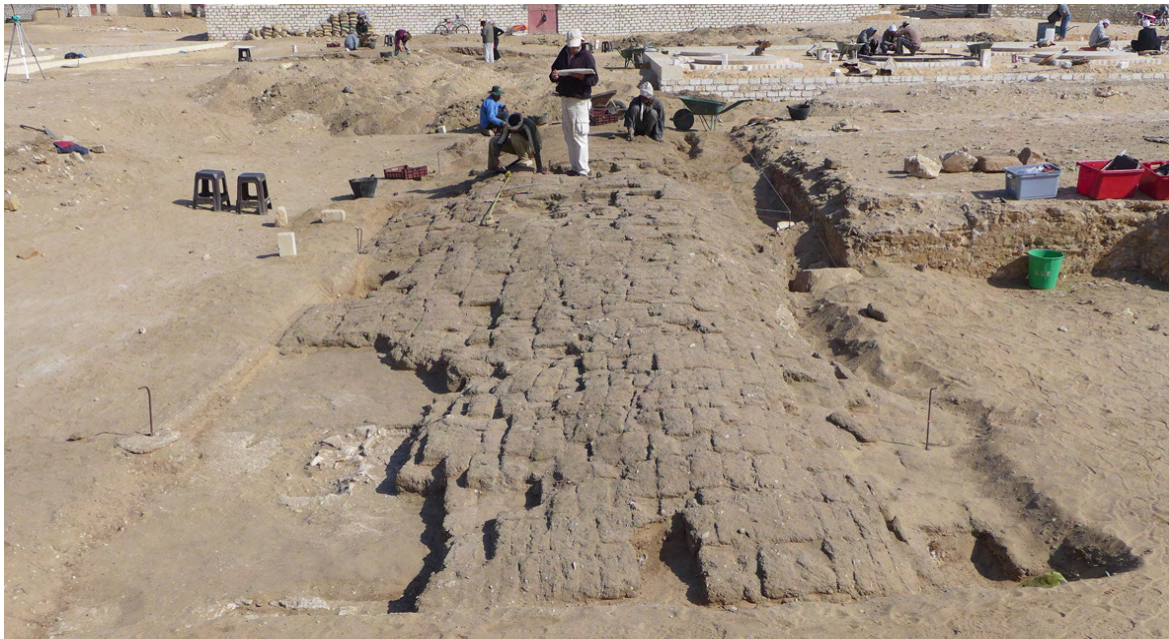
Figure 6. Area B: planning the surface of the brick revetment wall around the south-west corner of the temple. View to the north. Juan Friedrich is the planner.

The flat desert which supported this extensive scatter of offering-tables ends to the east with the wide mass of mud brickwork which is probably a temporary revetment to contain the sand which acted as a working surface during the erection of the large columns which stood on the concrete platforms. Last year the northern part of the brickwork was cleaned and planned. This year the southern part was similarly cleaned and planned (Figure 6), together with the part of the brickwork which runs around the southern part of the platform in square N28.

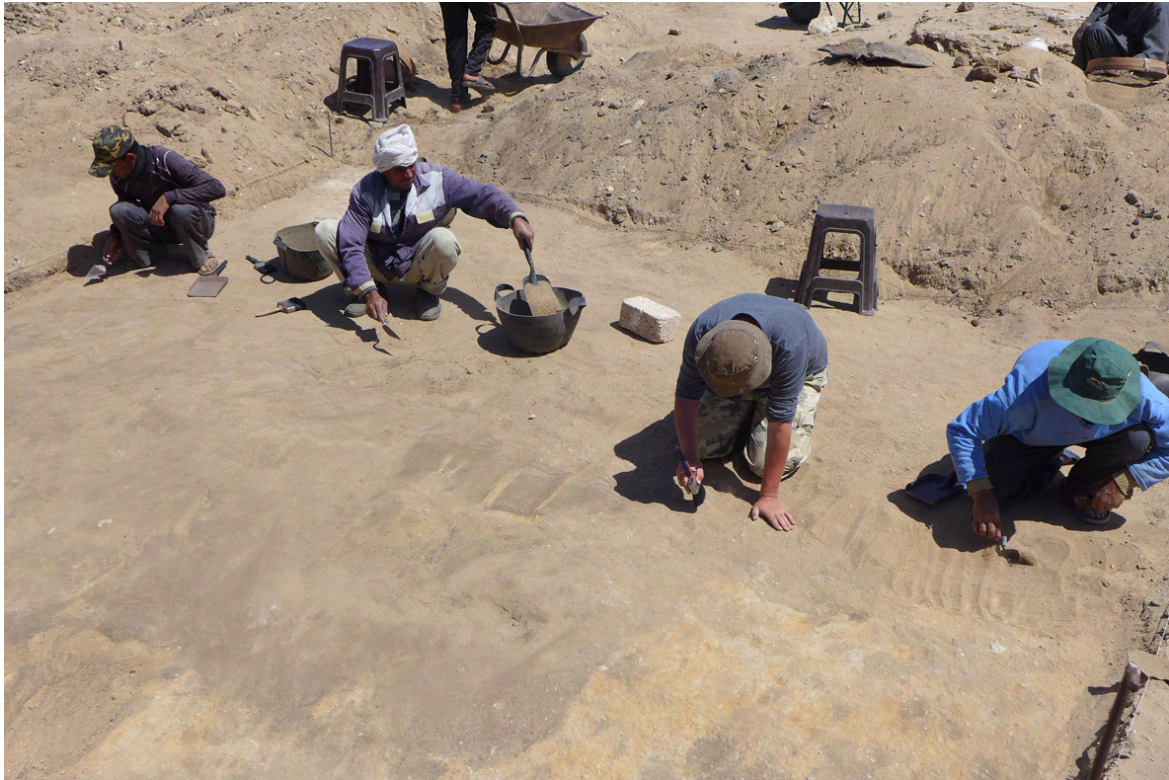
Figure 7. Area B: final examination of the earlier mud floor. The outlines of mud bricks which belong to an offering-table are emerging to the right of the central digger, Slawomir Jedraszek. View to the north-east.

Close to the south of the pedestal traces were discovered of a mud-brick offering-table which had been built directly on the desert surface and then surrounded by the early mud floor. A thick patch of white plaster lay against the southern side. Further to the east traces were also found of a second mud-brick offering-table, its remains reduced to a thin layer of mud dust (Figure 7). It is clear that, towards the south, they are not part of an E–W line of offering-tables, whilst to the north this line is crossed by the line of gypsum-lined basins of the early period. Only the excavation of the levelling rubble to the north of the basins will show if a corresponding set lies here.

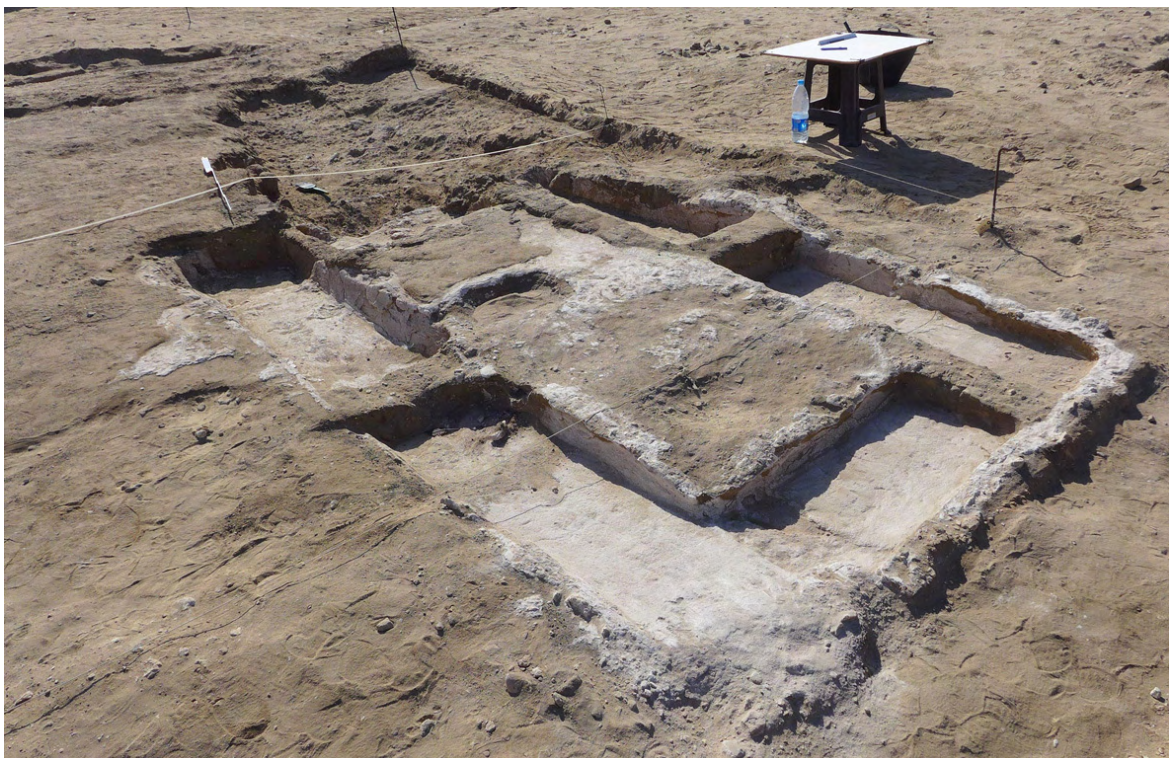
Figure 8. Area C: a set of basins surrounding a mud platform or pedestal newly excavated in 2015. The basin dividers were in the course of being replaced when the site was abandoned. View to the south-east.

This year three more such sets of basins were located, continuing the N-S line. The southernmost one continued the same pattern as the others but, when the temple was abandoned, was in the process of being altered by the renewal of the basin dividers, which had not yet been coated with lime-gypsum plaster (Figure 8).

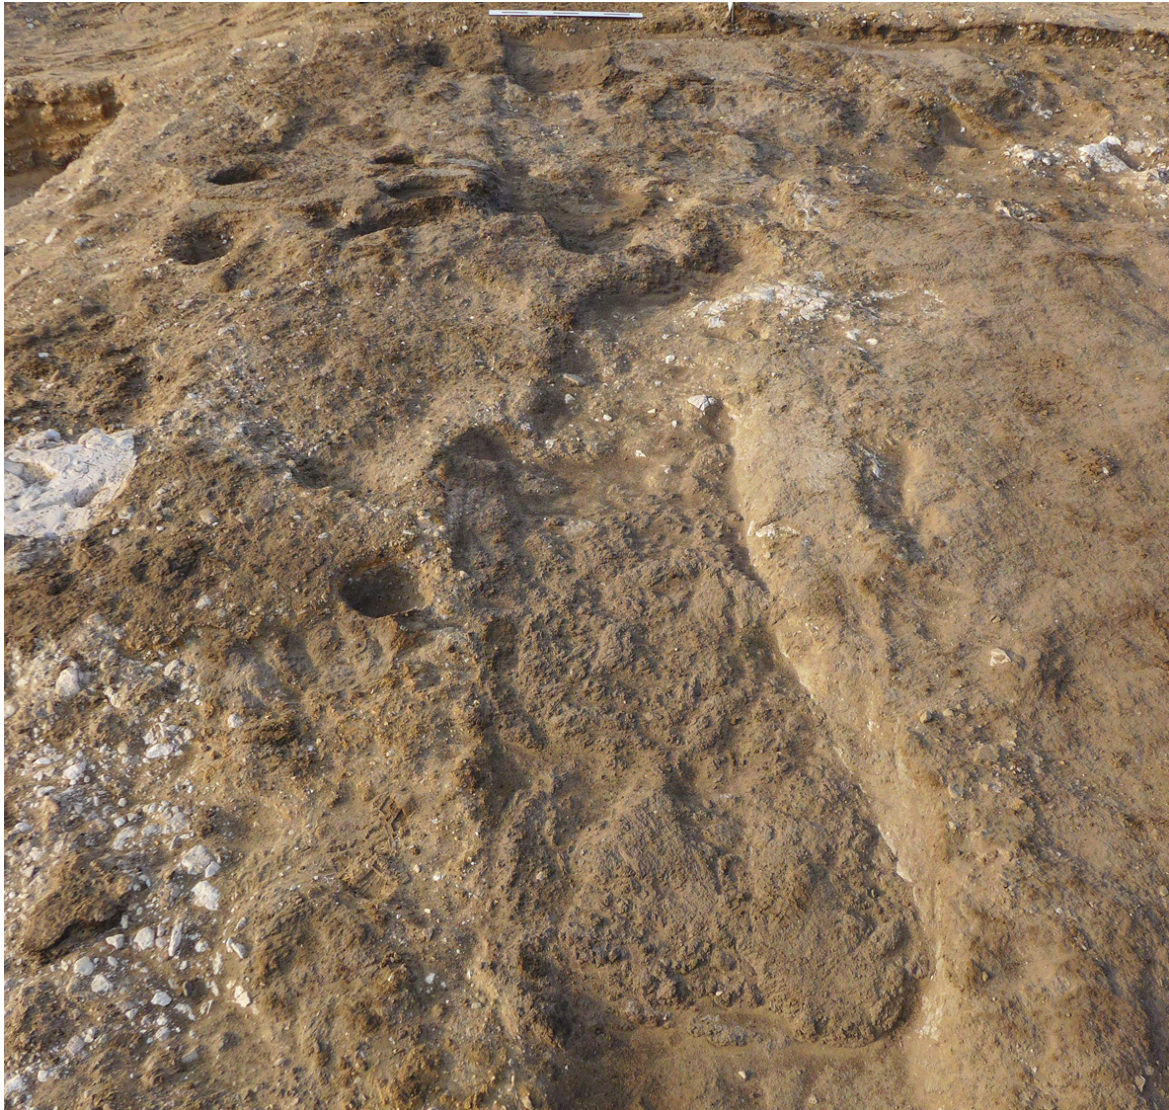
Figure 9. Area C: patch of ground to the east of the newly discovered set of basins. On the left edge of the picture is the remains of a lime-gypsum foundation for a stone block. Beyond are small holes probably to hold small storage jars upright. The mud-filled shallow trench in the foreground is of uncertain purpose. View to the south.

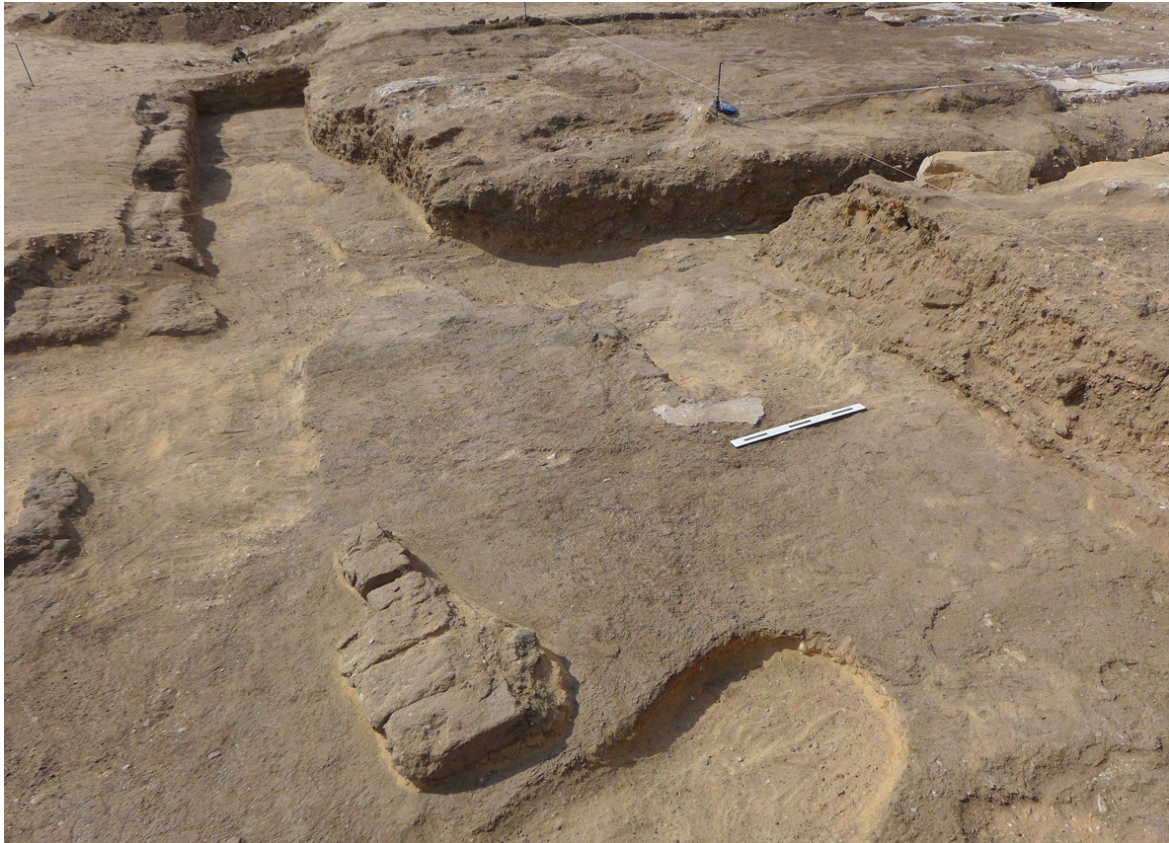
Figure 10. Area C: square L35, excavated by the team of four MSA inspectors as part of their training. The mud-brickwork in the foreground is the remains of a short-lived construction associated with the long building ramp found last year. Beside it is the outline of a modern grave. Just beyond the photographic scale are the remains of an early offering-table made from mud-bricks. A patch of white plaster follows the nearer edge. View to the south.

In square L35, excavated by the trainees, the levelling rubble occupied the western half of the square but little of the original surface remained. The rubble consisted of loose mud bricks, mud rubble, broken pieces of gypsum and a few potsherds. The eastern half of the square had previously been dug in 1932 and it was from this excavation that the trench westwards had been dug, through the middle of the gypsum-lined basin in K35.

On the floor of the eastern half, beneath a layer of sand containing limestone chippings, gypsum fragments and mud-brick rubble, several architectural features were found. They included the remains of two mud-brick offering-tables. Of the northern one, only a part one-brick wide could be seen, the remainder having been found in 2014 in the next square to the north. It lay close to the edge of an angled wall which belongs to a wide ramp also excavated in 2014. The second offering-table showed more of its method of construction. It had been built on the desert surface by laying out a rectangle of mud bricks to form the edge, and a single row across the middle. The mud floor of the early temple was then added and smeared against the edges of the bricks.

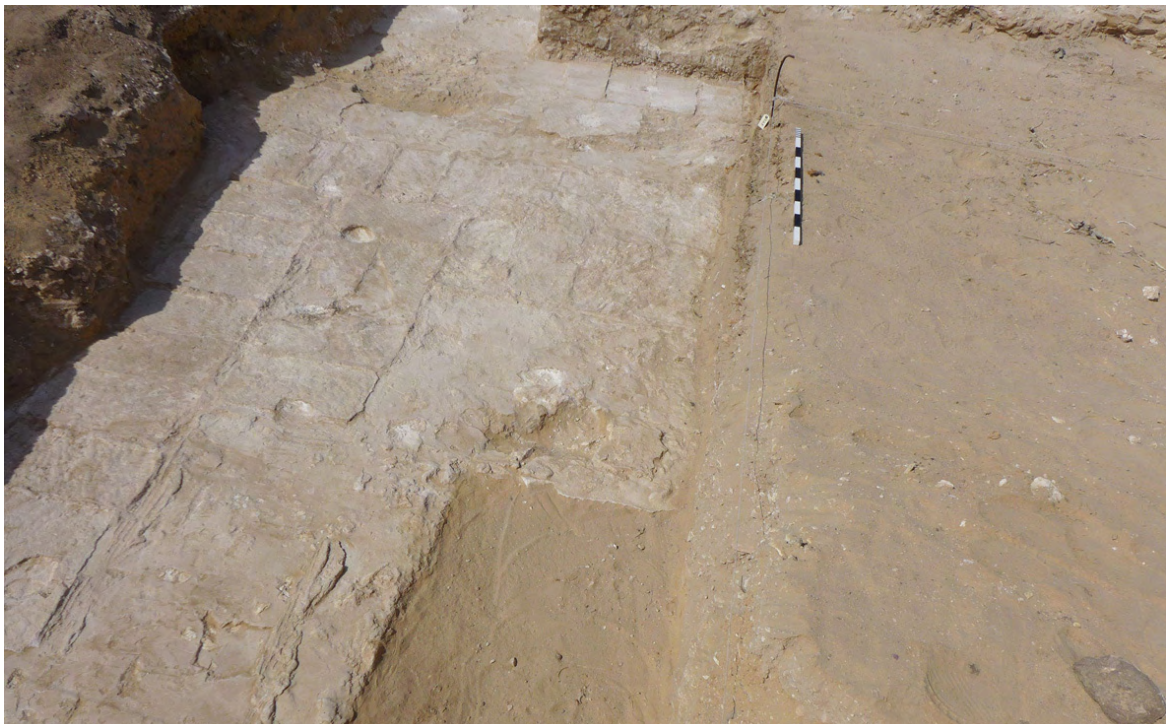
Figure 11. Area D: the full width of the stone pylon is here revealed, from the well preserved lime-gypsum foundation platform. View to the west.

Area D lies at the south-east corner of the southern lime-gypsum concrete platform for large columns. The purpose of excavating across two 5 x 5 m squares was to determine the exact width of the stone pylons which flanked the main entrance to the stone temple. Where the north pylon had stood all trace of the foundations had been destroyed before the 1932 excavation took place. The foundations for the south pylon had, however, remained intact at the southern end, where it joined the south wall of the temple. The sand and dust which had gathered since 1932 were removed, exposing a well preserved area of lime-gypsum concrete on which were marked the impressions of many of the talatat blocks which had formed the lowest course of stones (Figure 11). The width of the pylon could then be fixed as 3.37 m. This measurement was used when setting out the lines for the builders to follow as they reconstructed the north pylon.

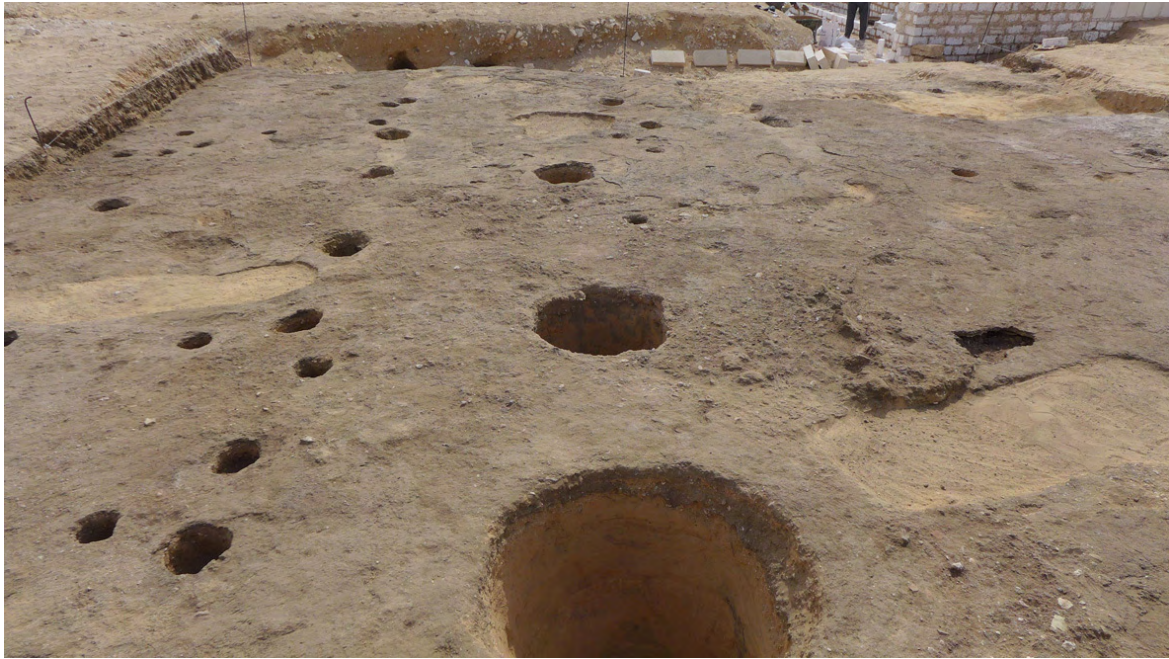
Figure 12. Area E: the early mud floor and its pattern of post-holes (mainly on the left) and holes for large pots (centre). The full investigation of the right side has not been completed. The sand-filled pits are modern graves. View to the south.

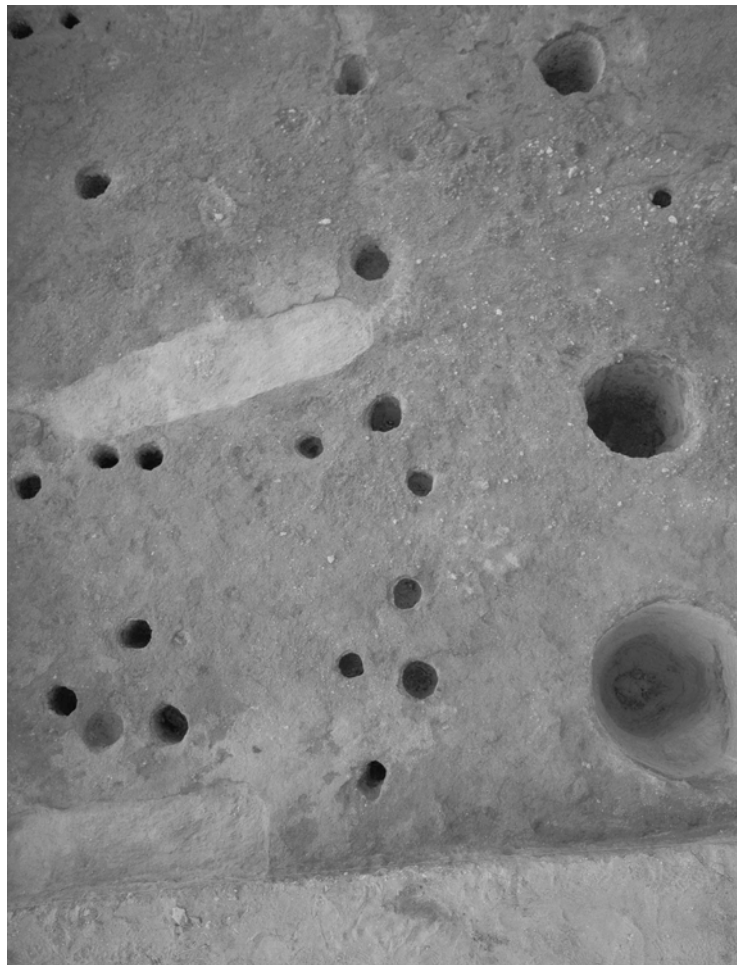
Figure 13. Area E: vertical photograph of much of the same area as shown in Figure 12. Photo by A. Hodgkinson and M. Bertram.

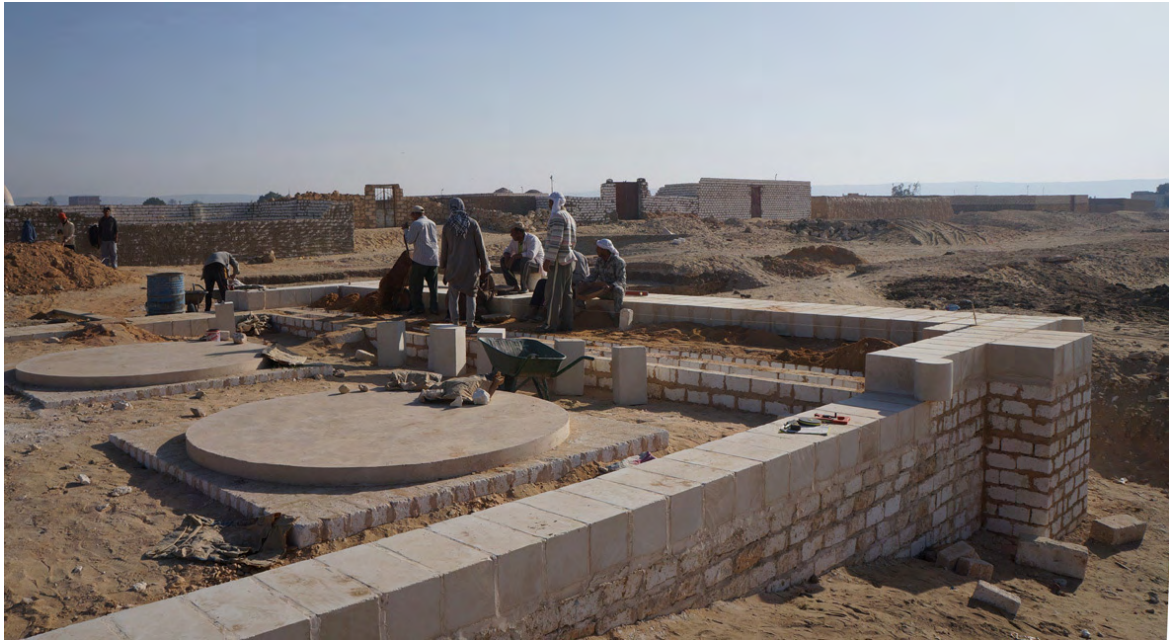
Figure 14. The recreation of the northern half of the monumental front to the temple in a late stage. The easternmost pair of the circular pads (2.5 m in dia.) which mark the positions of large column bases have been laid down. The builders are now laying the blocks of fine Tura limestone to create the shape of the pylon itself. A future stage will be to bury the foundation of small local limestone blocks completely. View to the north-east. Photo by Marsha Hill.

In 2015 the scheme for this part of the temple was completed. The internal structure of the north platform had already revealed that eight large columns had stood on it, in two rows of four running E–W. To begin with, therefore, the position of each of the columns was laid out as a square foundation of small limestone blocks figure 14). A circular pad of white cement reinforced with iron rods was created on each of these foundations, using a circular iron mould, 2.5 m in diameter. As they dried, the builders sprinkled damp orange sand over the surface to have a mellowing effect on the colour of the cement so that it matched the colour of the Tura limestone. At the end of the season, a layer of this sand was also spread around each column base, hiding the square foundations (Figure 15).

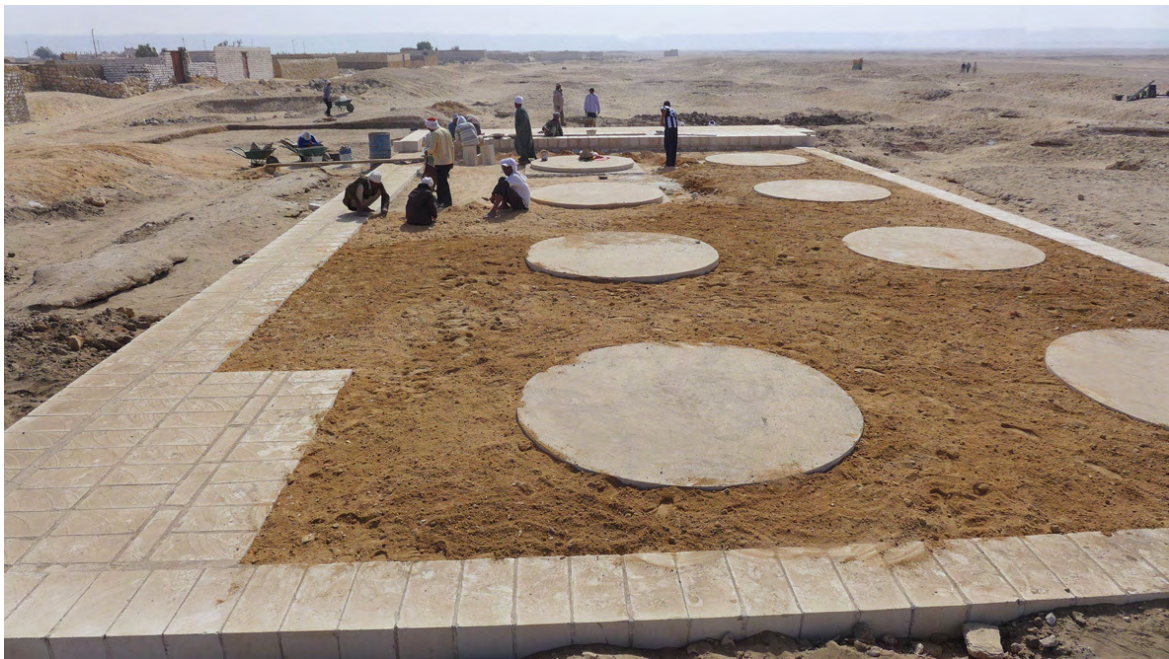
Figure 15. The final stage in the recreation of the northern pylon and its colonnade was to level up the surface with a layer of sand. View to the east.

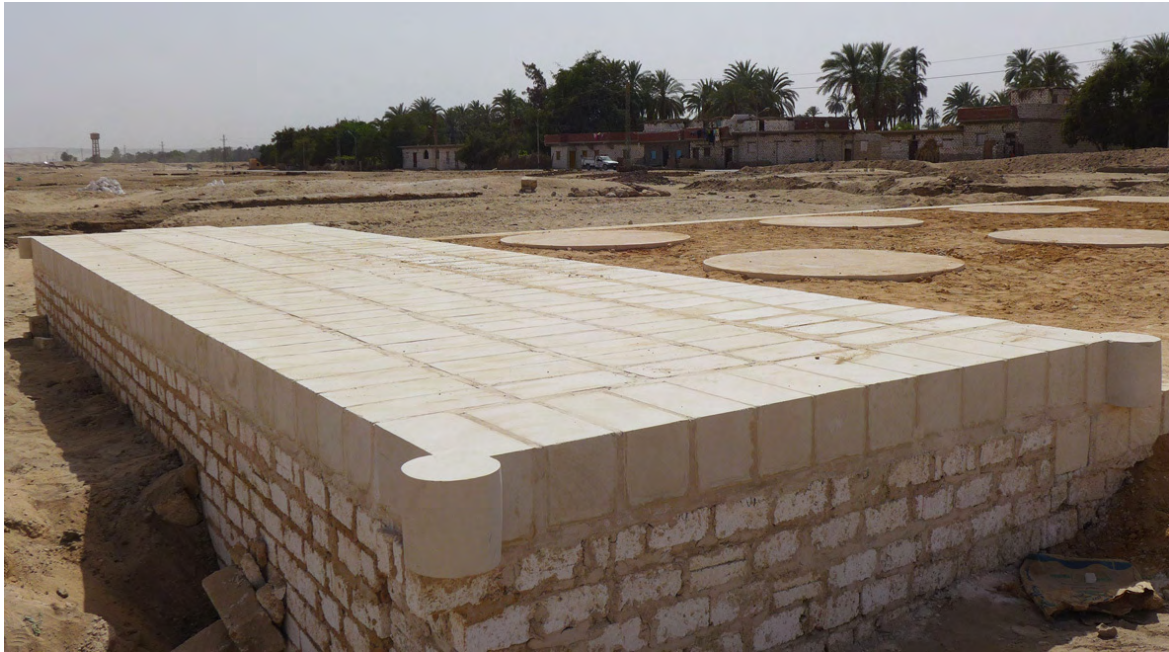
Figure 16. The north pylon as finished. The rough foundation blocks will be completely buried in the future.

Using the Small Aten Temple as a guide, and preferring the simplest solution, the pylon was built as a rectangle, 3.37 m wide and to the full length of the platform (including outside walls), 12 m. A block with a circular moulding on the outer corner was set at each corner, and a small projecting 'nib' added to the middle of the south face. The foundation of the pylon, built as a network of walls of small local limestone blocks, was raised to the same height as the top of the layer of Tura blocks around the other three sides of the platform. The course of Tura blocks outlining the pylon was then built as the next course up, so that it rises above the outline of the platform (Figure 16). As the work progresses, these foundations of rather unsightly local limestone blocks will be entirely buried. This work was completed on the last day of the season (March 26th).

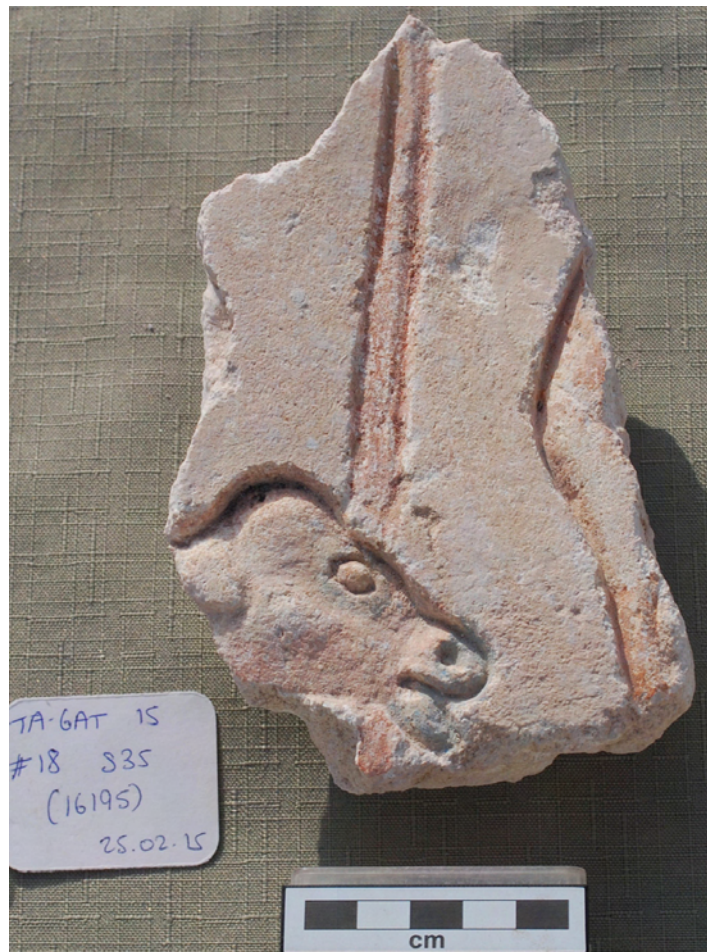
Figure 17. Fragment of limestone block with the head of a calf, an Aten ray behind it. Photo by Miriam Bertram and Anna Hodgkinson.

The last of the 1932 dumps and our own cuttings into the levelling rubble produced many fragments of decorated stonework (Figures 17, 18) and the feet of a statue (Figure 19). Marsha Hill continued her study of stone fragments, both groups from the 2012 season and certain pieces from the current season. Her report is given separately, below.

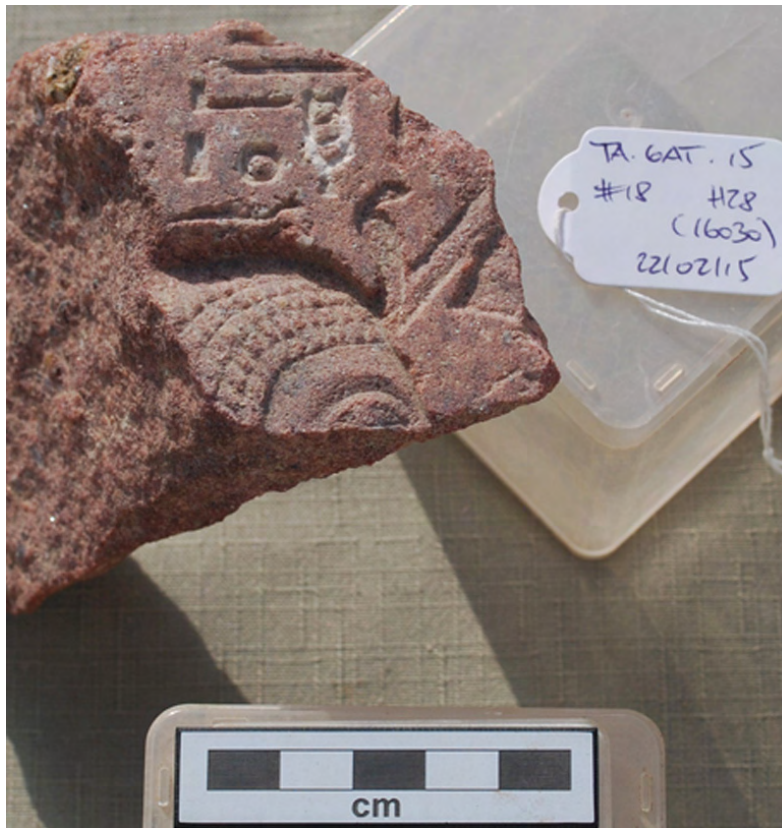
Figure 18. Fragment of relief carved into red quartzite, showing part of a royal face, an Aten ray behind it. The triangular shape below the Aten ray to the right could be a ribbon worn by a king. If that is the case then the head could be that of Nefertiti standing behind Akhenaten. Photo by Miriam Bertram and Anna Hodgkinson.
