British Mission to Tell el-Amarna

Great Aten Temple Spring 2015 Season

Preliminary Report

Barry Kemp

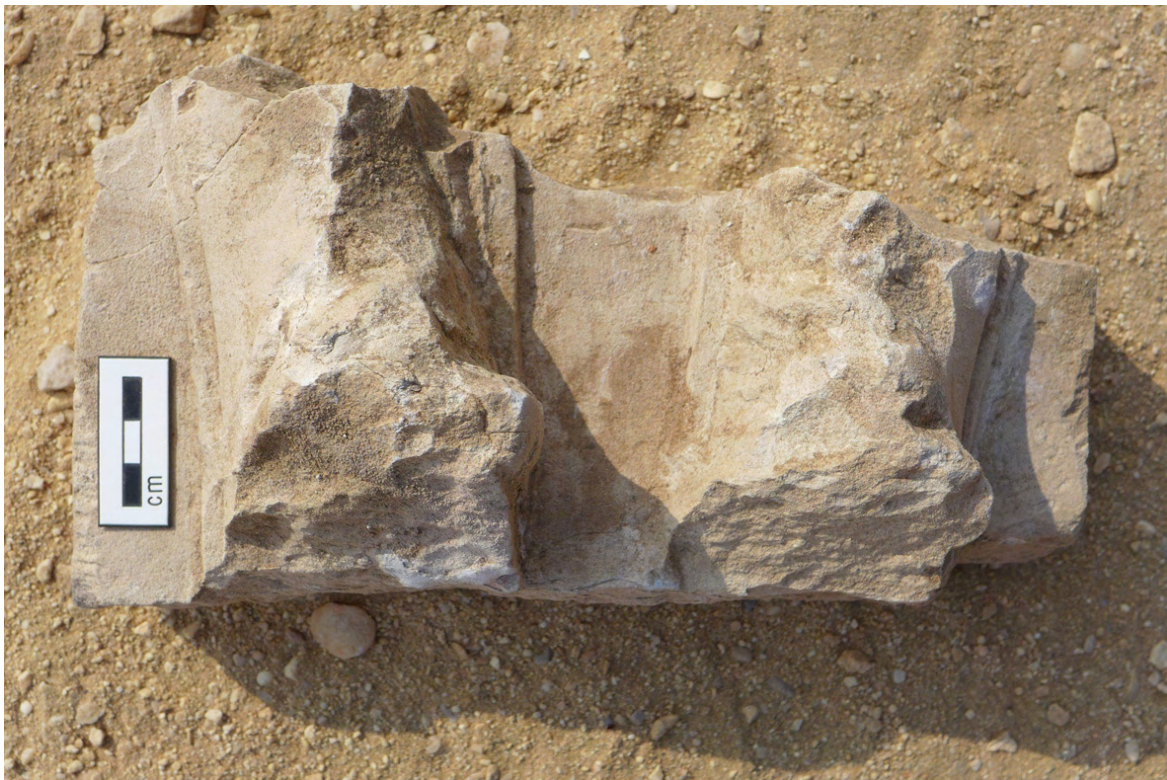
Figure 19. The feet and part of the base of a limestone statue (S-8351).

The last of the 1932 dumps and our own cuttings into the levelling rubble produced many fragments of decorated stonework (Figures 17, 18) and the feet of a statue (Figure 19). Marsha Hill continued her study of stone fragments, both groups from the 2012 season and certain pieces from the current season. Her report is given separately, below.

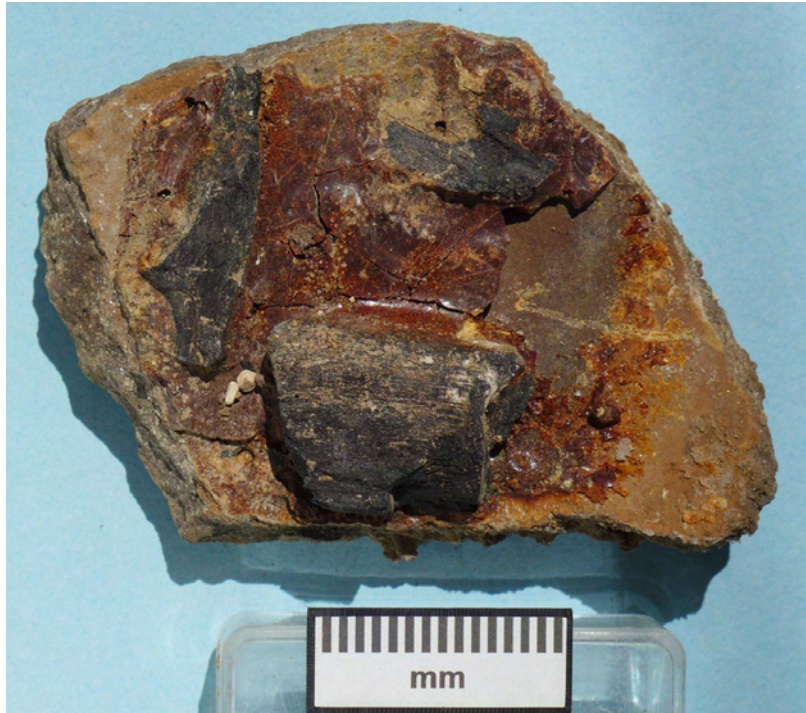
Figure 20. Potsherd bearing pieces of charcoal embedded in incense.

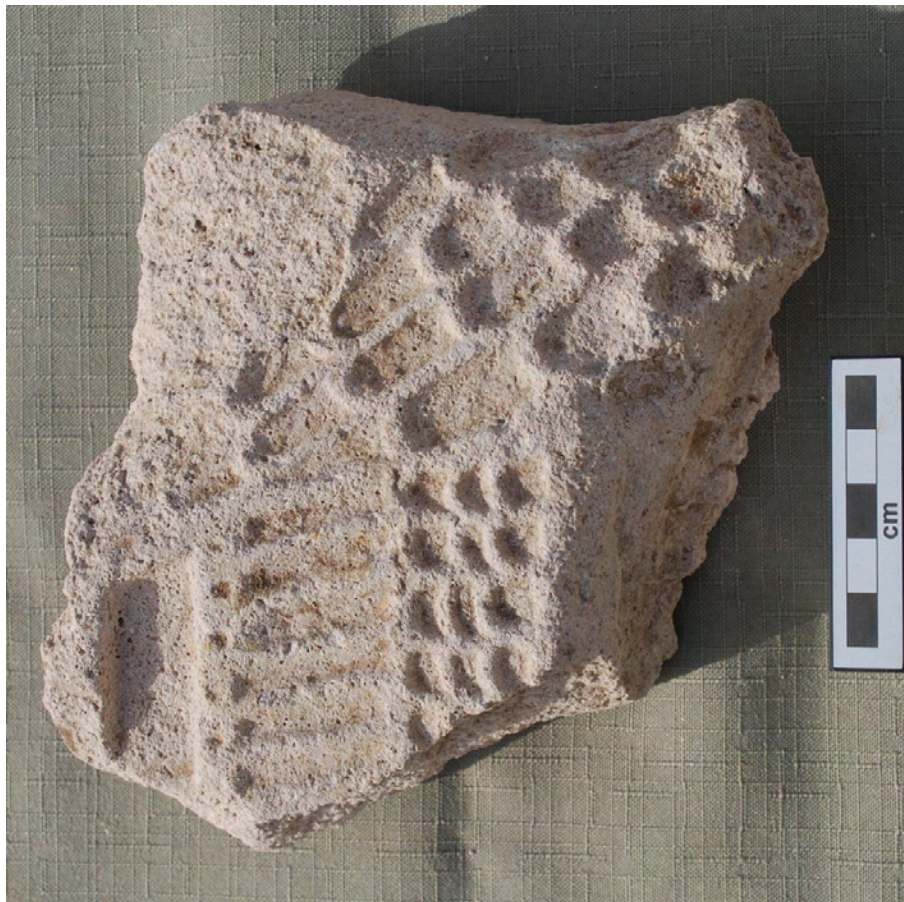
Figure 21. Piece of gypsum mixed with grit, made into a low mound on one side and top of which the feathering of a vulture has been shaped. The surfaces have suffered some wear. Photo by Miriam Bertram and Anna Hodgkinson.

Also notable were pieces of gypsum cement mixed with grit or sand on which designs had been incised and which do not seem to be pieces of architectural decoration themselves. One appears to have the shape of part of a vulture headdress (Figure 21). It is hoped that further study will lead to an explanation as to what they were.
