British Mission to Tell el-Amarna

**Great Aten Temple
Report on Recent Work
(Autumn 2017, Spring and Autumn 2018)**

Barry Kemp and Miriam Bertram
December 4th, 2018

Great Aten Temple, Report on Recent Work

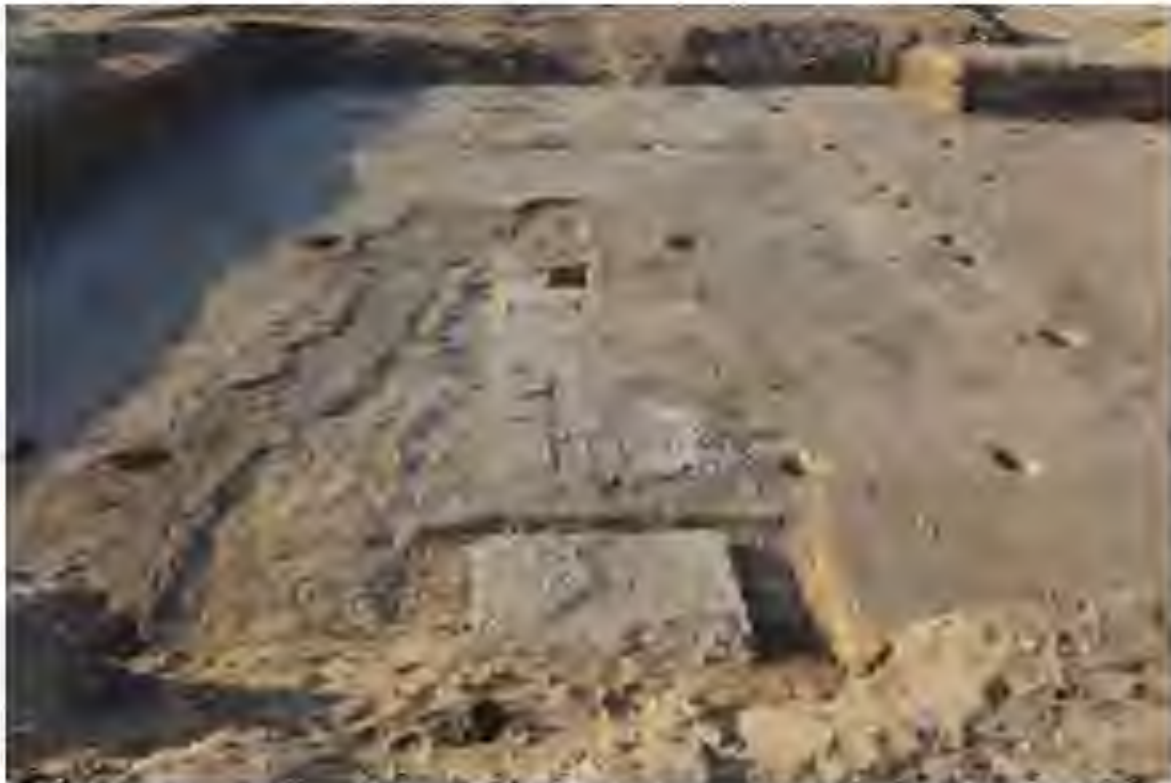
Figure 3. Mud floor showing the lines of post holes from a wood-framed building, with parts of earlier stone bases exposed (the nearer one in 1932). View to the south.

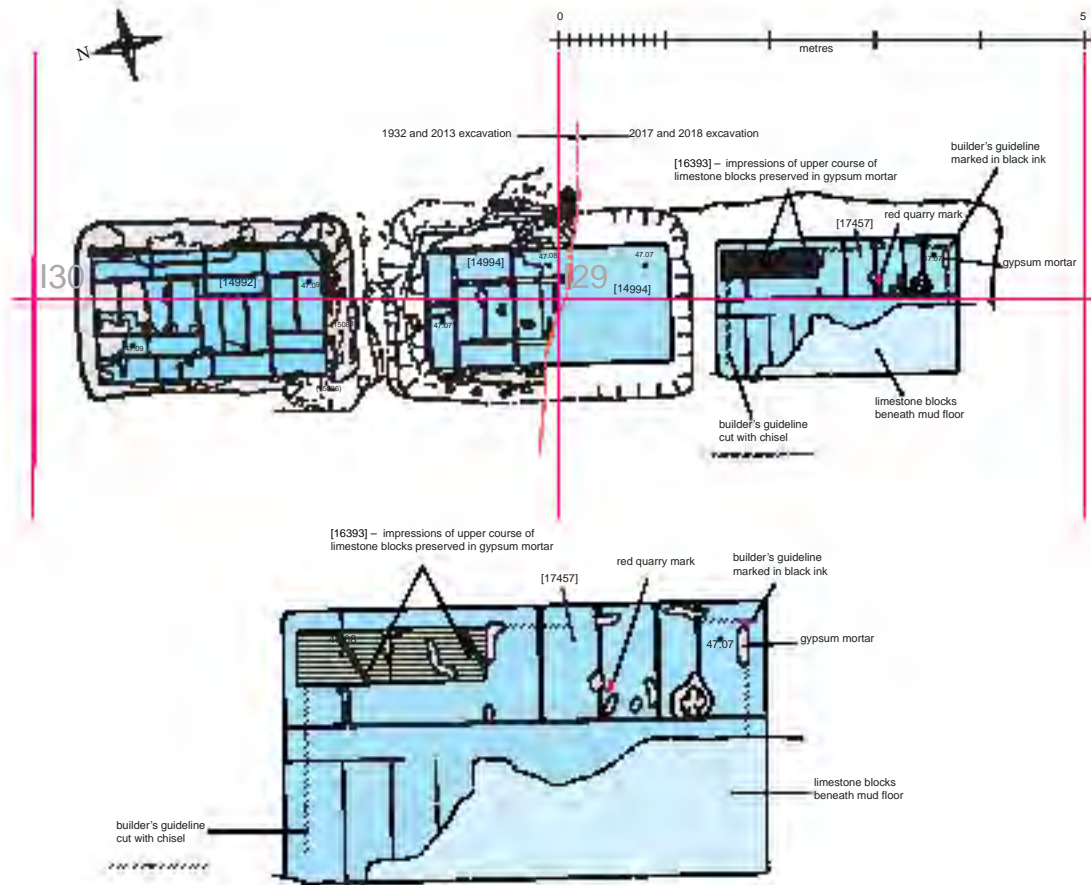
Figure 4. Plan of three earlier stone bases beneath the later mud floor. The left half of the plan is an area exposed in 1932. The right-hand base is shown below at twice the scale.

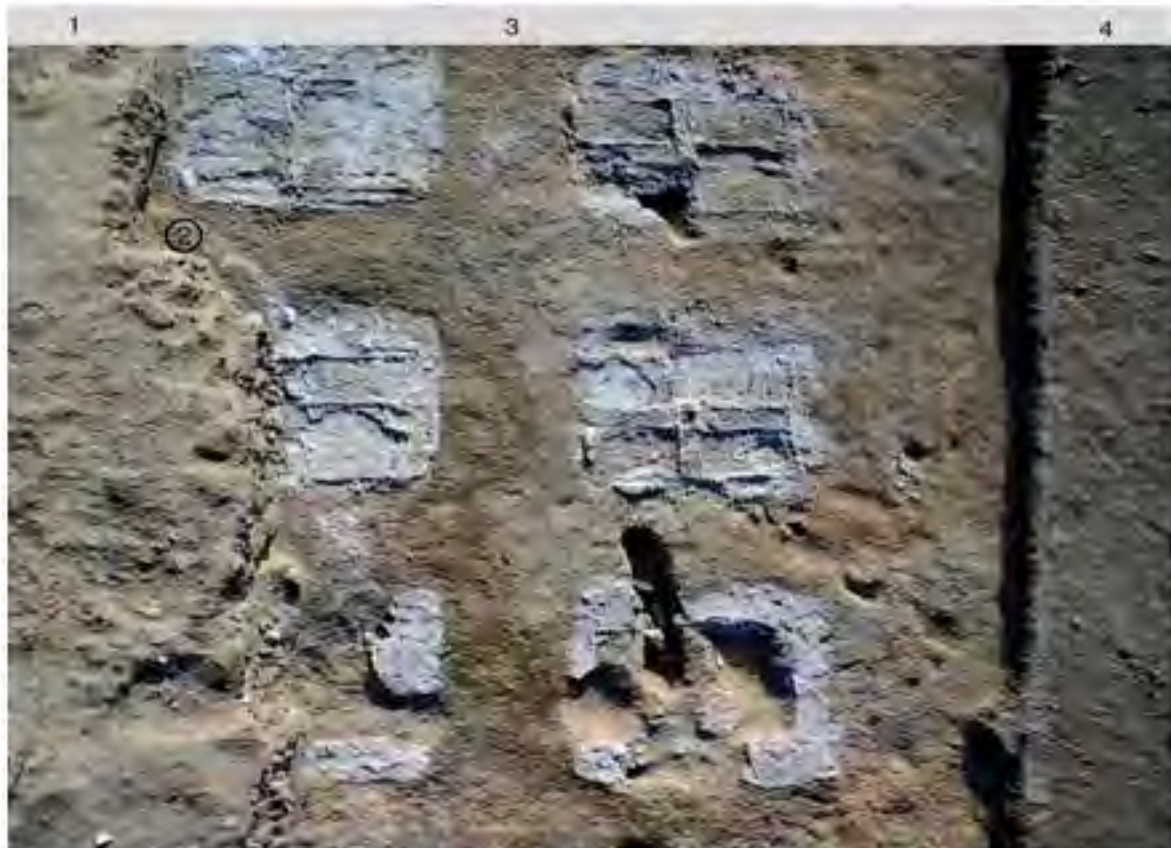
Figure 5. Part of the double row of foundations for offering-tables made from limestone blocks built on a foundation of gypsum concrete. North is towards the left. 1: levelling-rubble cut by the edge of a 1932 excavation trench. 2: patch of the mud floor on which the wooden palace was erected. It had originally covered the entire area of the photograph until cut away in 1932. 3: floor of the 1932 trench newly cleaned, bearing the remains of the gypsum-concrete foundation for offering-tables, each one made from a group of four talatat-blocks. 4: thin coating of dust and organic debris accumulated since 1932. Photograph by Anna Hodgkinson.

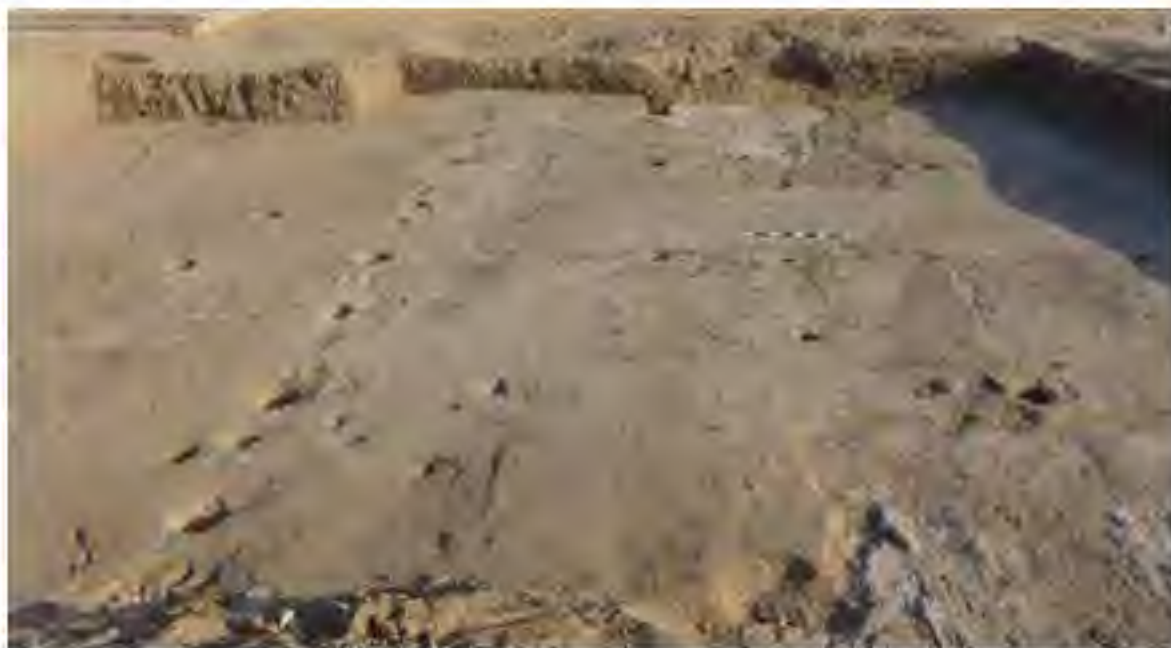
Figure 6. The mud floor into which lines of holes for wooden posts have been cut. The rectangular foundations of limestone blocks which had been covered by the floor are at the further end. In the foreground are two of the foundations for limestone offering-tables which had also been covered by the floor. View to the north.

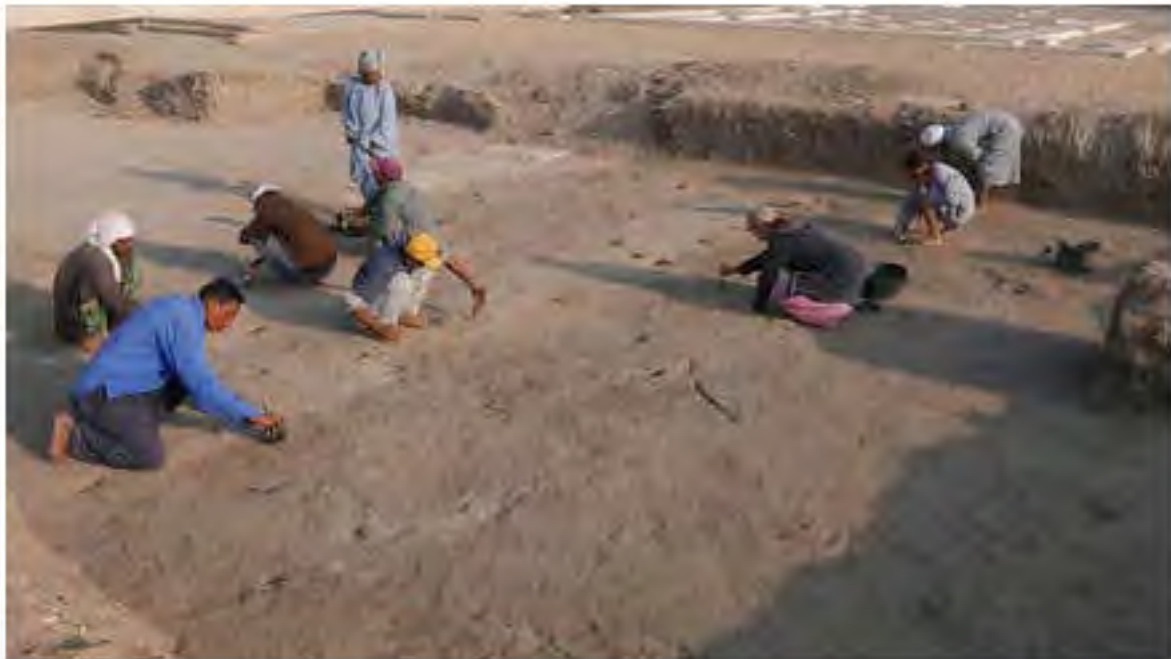
Figure 7. Cleaning the mud floor which had been buried beneath the levelling rubble (visible in the background). The post holes are becoming visible. View to the north-east.

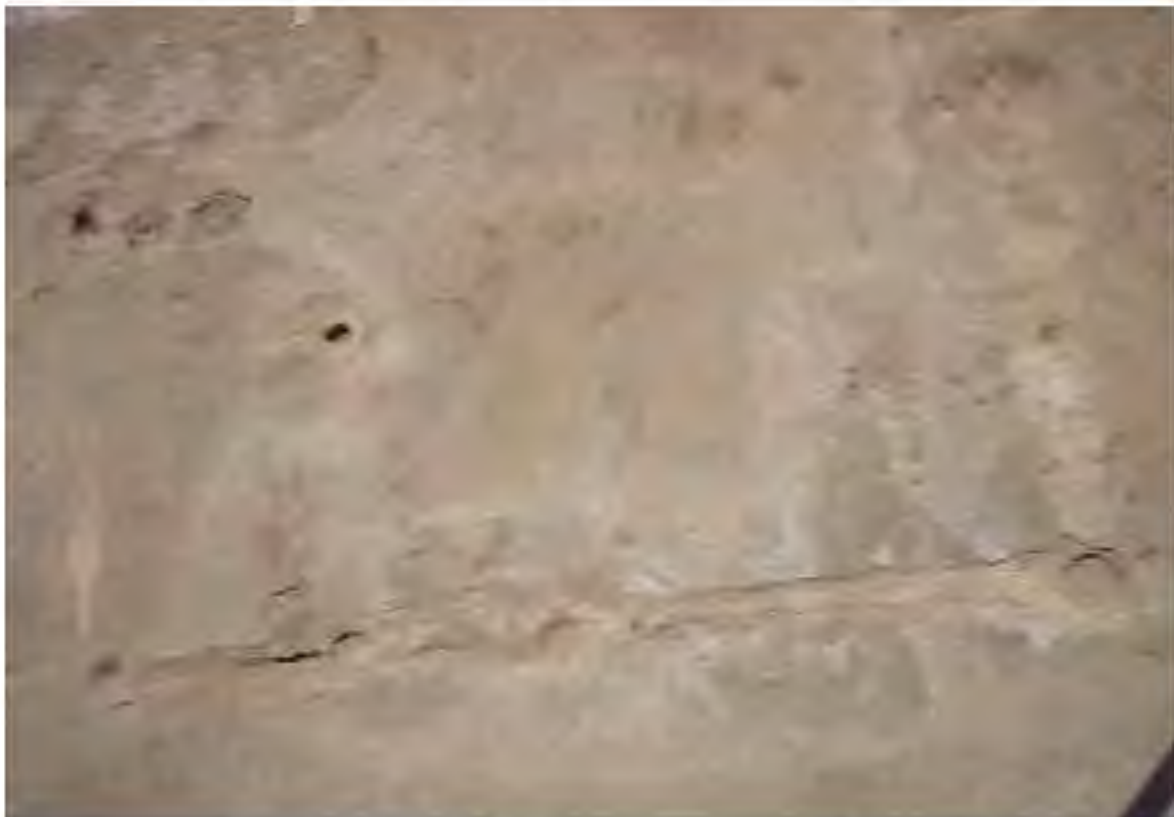
Figure 8. Part of the mud floor shortly after first exposure, before the post holes had been cleaned. Note the patches of linear wear between some of the holes, presumed to mark the presence of connecting screens. North is towards the bottom. The prominent line of post holes and shallow wear lines are those of the east-west 'wall' that runs across the middle of the building. Photo by Anna Hodgkinson.

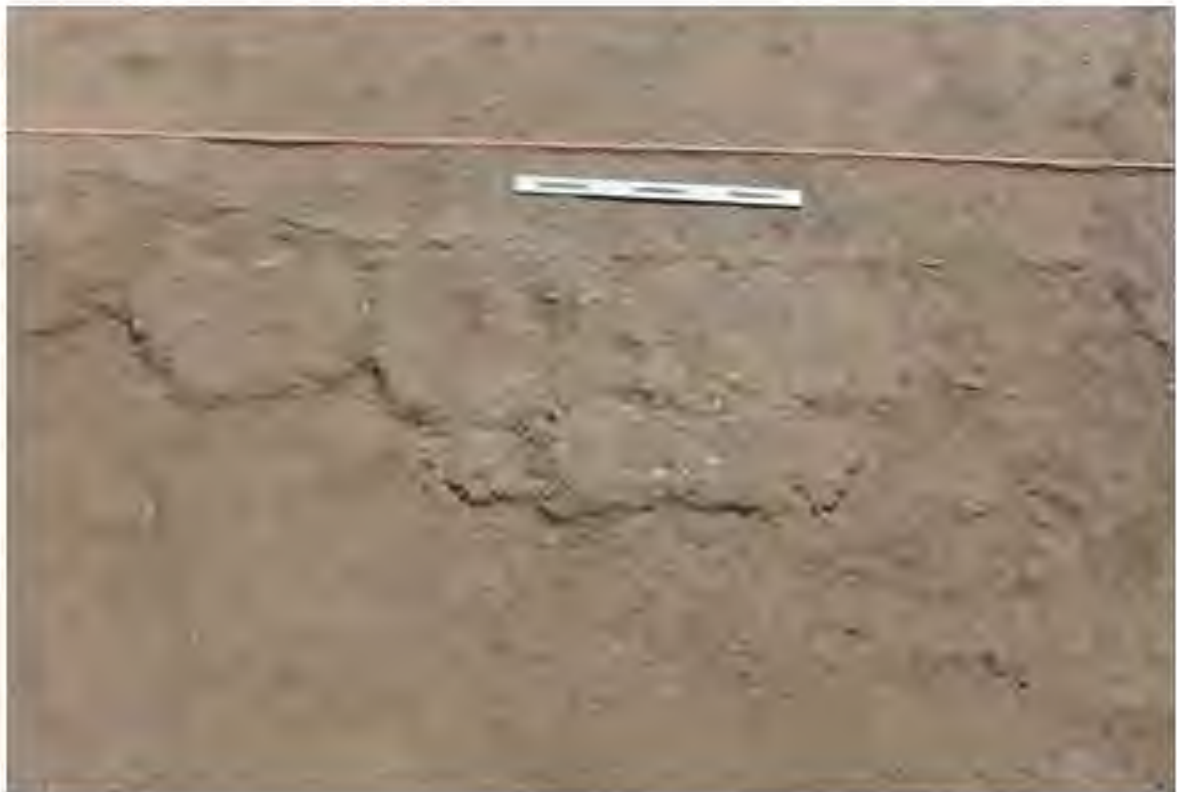
Figure 9. Mud mortar from beneath a layer of mud bricks, and the line which marks the edge of the mud floor, where it lapped up against the mud-brick platform. North is towards the left. Photograph by Miriam Bertram.

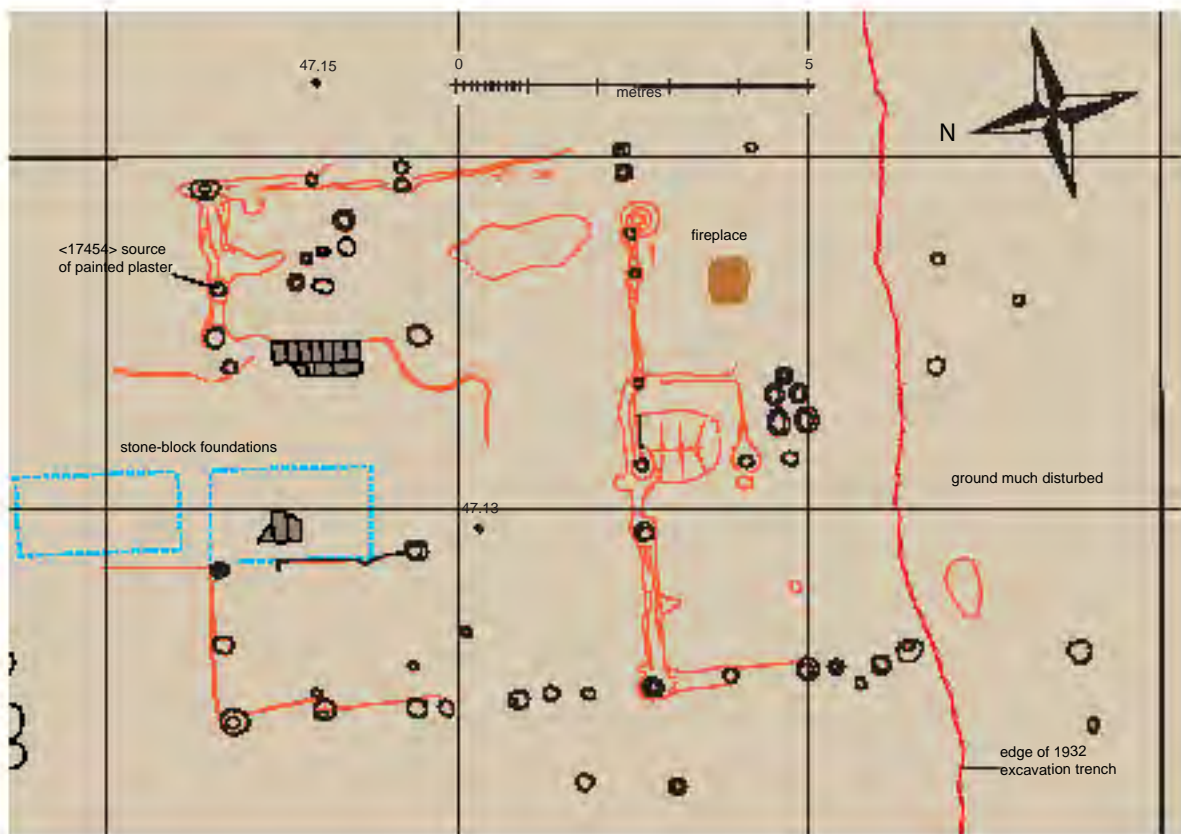
Figure 10. Plan of the mud surface and post holes. Red lines are the edges of linear grooves in the floor and of separate mud layers. Beyond the edge of the 1932 excavation trench the mud floor is not preserved. Original by Miriam Bertram.

The plan resolves itself into a building measuring 10.5 m north–south, and 7.5 m east–west (Figures 10 and 12). It is divided approximately mid-way by an internal wall running east–west (Figure 8). This is interrupted by what might have been a doorway behind which is a small rectangular area defined by posts and an uneven surface, behind which again is a group of four shallow circular depressions where jars had probably stood (Figure 11). To one side, a patch of brownish-black on the mud floor probably shows where one of the standard large pottery bowls or hearths had stood, of the kind commonly used to warm the interiors of houses.

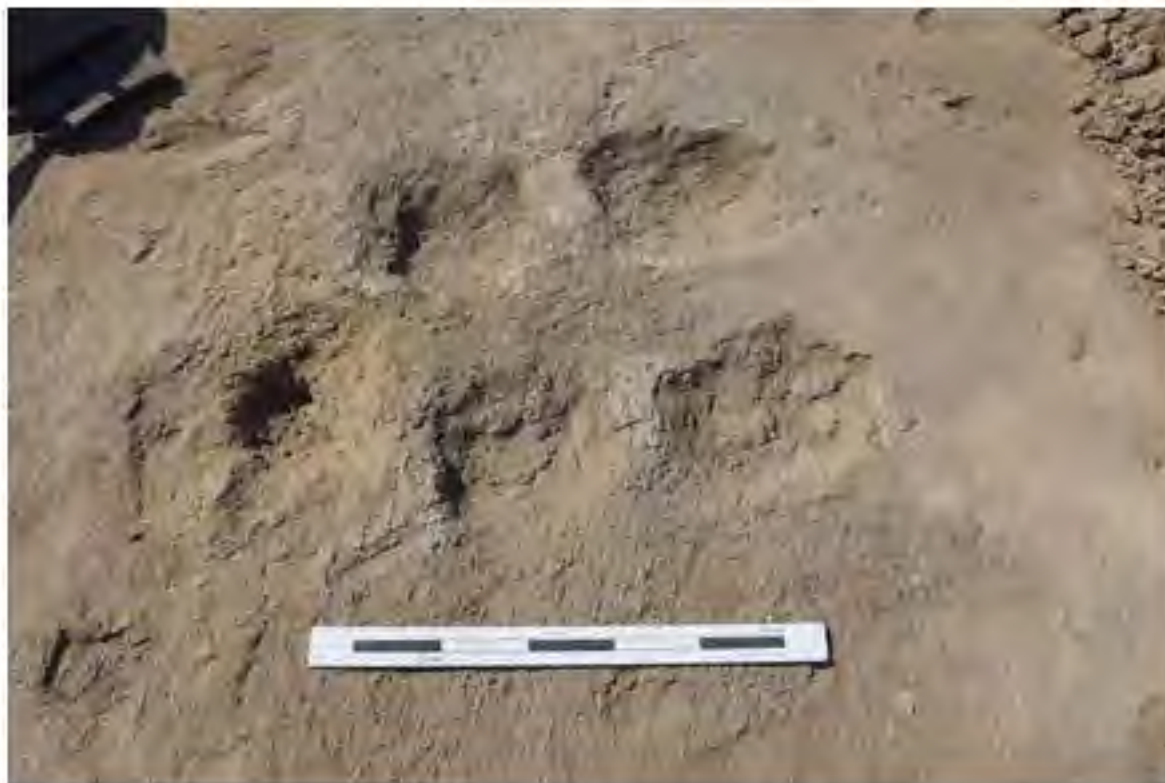
Figure 11. Square G29. Five depressions in the mud floor (<17453>). The group of four was probably to support pottery jars; the fifth (on the left) is more likely a post hole. View to the south. Photograph by Miriam Bertram.

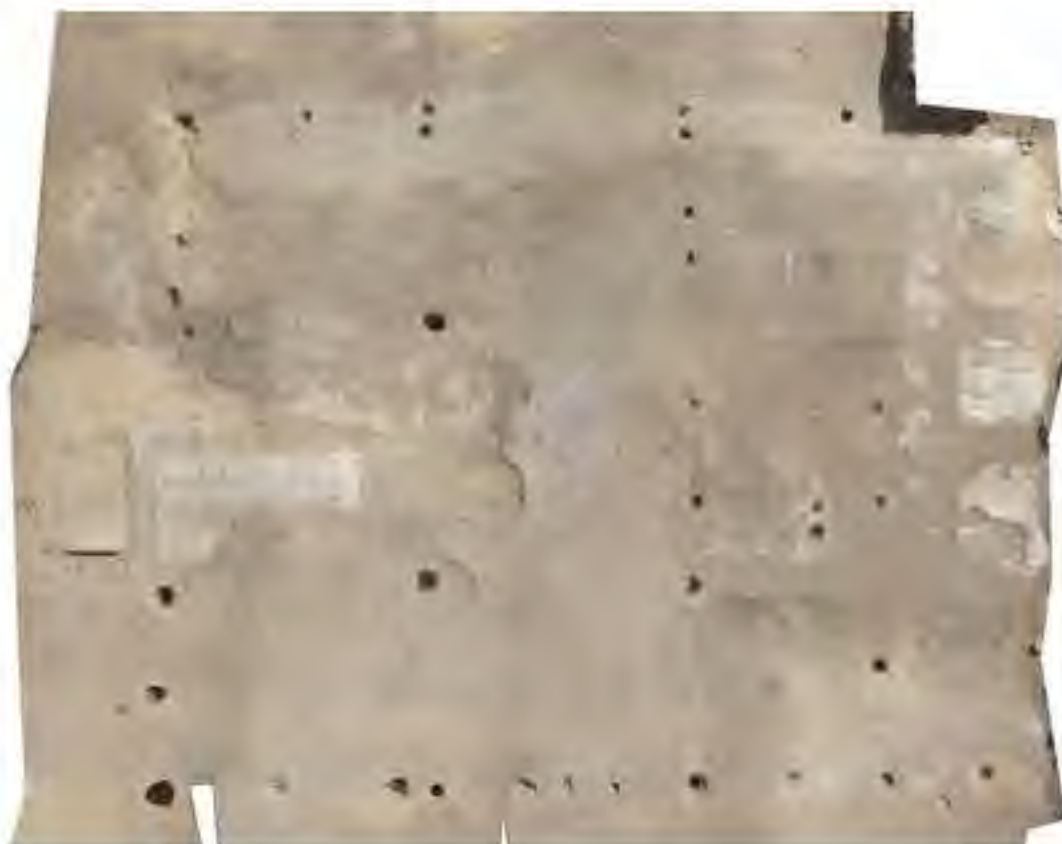
Figure 12. Aerial view of the mud floor, showing the post holes of the wooden building. North is towards the left. Photographic mosaic by Anna Hodgkinson.

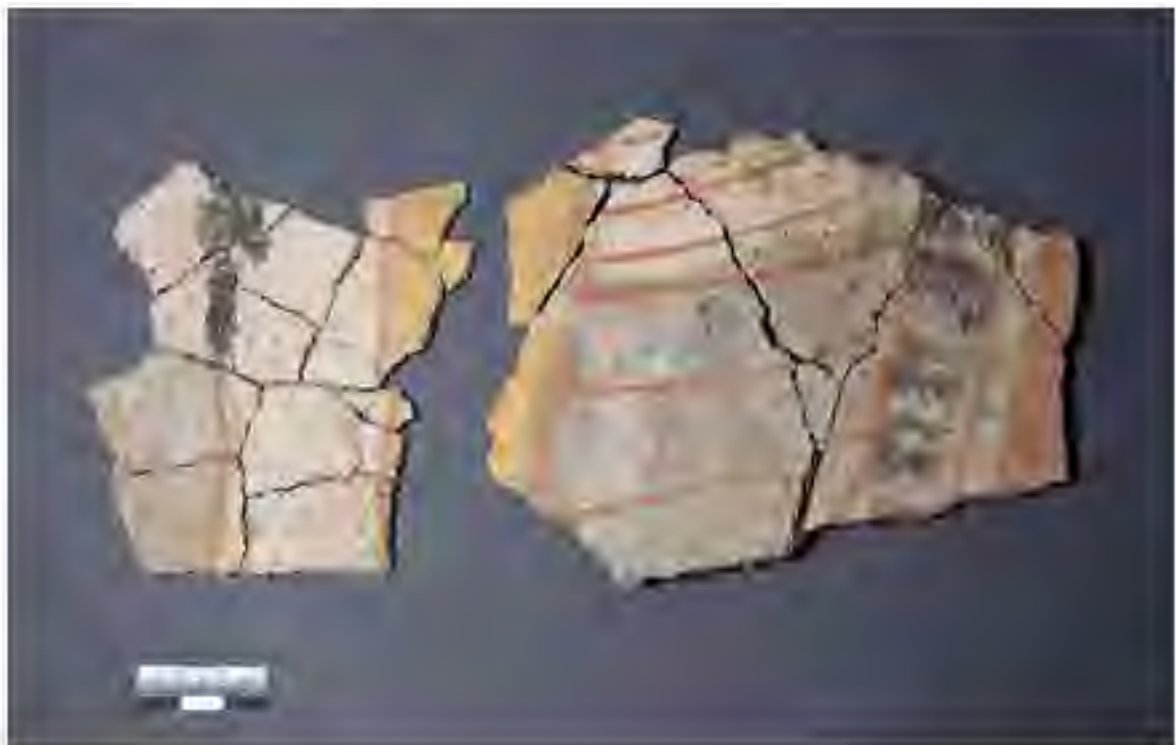
Figure 13. Fragments of painted gypsum plaster, recovered from post hole <17454> in grid square I29. Object no 41900. Fragments prepared and photographed by Alexandra Winkels and Miriam Bertram.

The archaeologist responsible for this area of the excavation, Miriam Bertram, subsequently reassembled the main fragments (which were also cleaned, conserved and photographed by conservator Alexandra Winkels) to form two groups which might not originally have been far apart (Figures 13 and 14). In each the dominant colours are white and pale blue, the areas partly defined by red lines, which also subdivide the pale blue area on the larger group of fragments. Other areas of patterning are formed from irregular black patches. One edge of each group is yellow, a common background colour for paintings at this period. Marsha Hill suggested a plausible explanation for the source of the fragments: they belong to the figure of a foreign captive. The reconstruction offered here is based upon part of a sheet of painted rushwork which had formed the seat of a chair found in Tutankhamun's tomb (Figure 15). Figure 16 is a rendering of the Nubian prisoner, its direction reversed to match the direction of our own painted fragments. The archer's bow which stands close to the front of the figure and at the same height has been omitted.

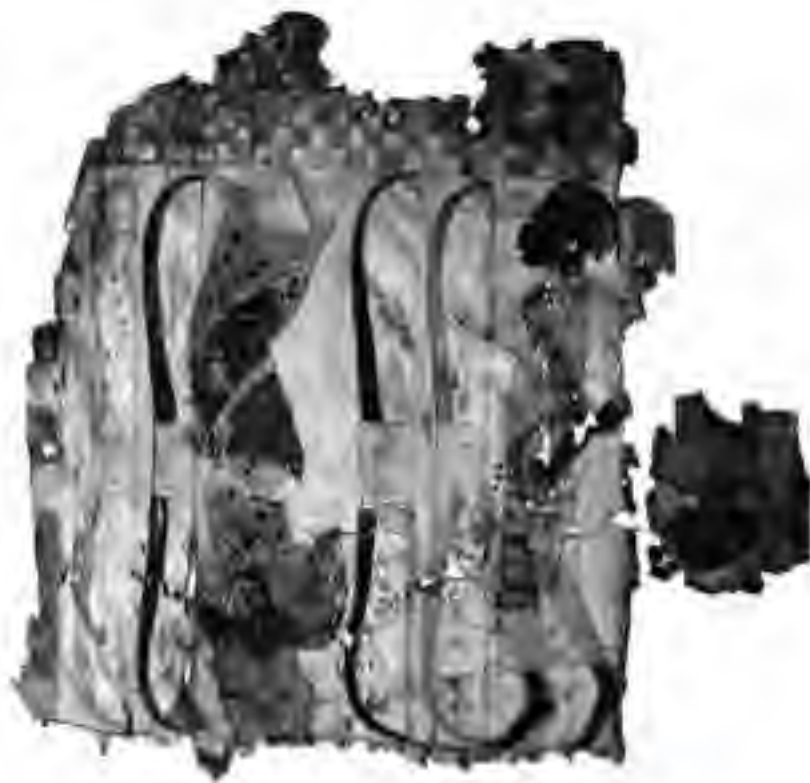
Figure 15. The painted rushwork seat of a chair found in Tutankhamun's tomb, now in the Egyptian Museum, Cairo (JE 62042; Carter no. 457). The height of the Nubian figure can be calculated from the given dimensions of the painted sheet to be c. 34.7 cm. Burton photograph, copyright Griffith Institute.

A valuable supplement to the Burton photograph of the decorated chair seat from the tomb of Tutankhamun (Figure 15) is Moamen M. Othman, Mohamed Abd El-Rahman, Eid Mertah, Eslam Shaheen, Mohamed Ibrahim and Ahmed Tarek, 'Il papiro nascosto di Tutankhamon. Indagine Diagnostica Multispettrale sul papiro dipinto della sedia di Tutankhamon.' *Analecta Papyrologica* 29 (2017), 183–98. Thanks to Marsha Hill for bringing this to my attention.

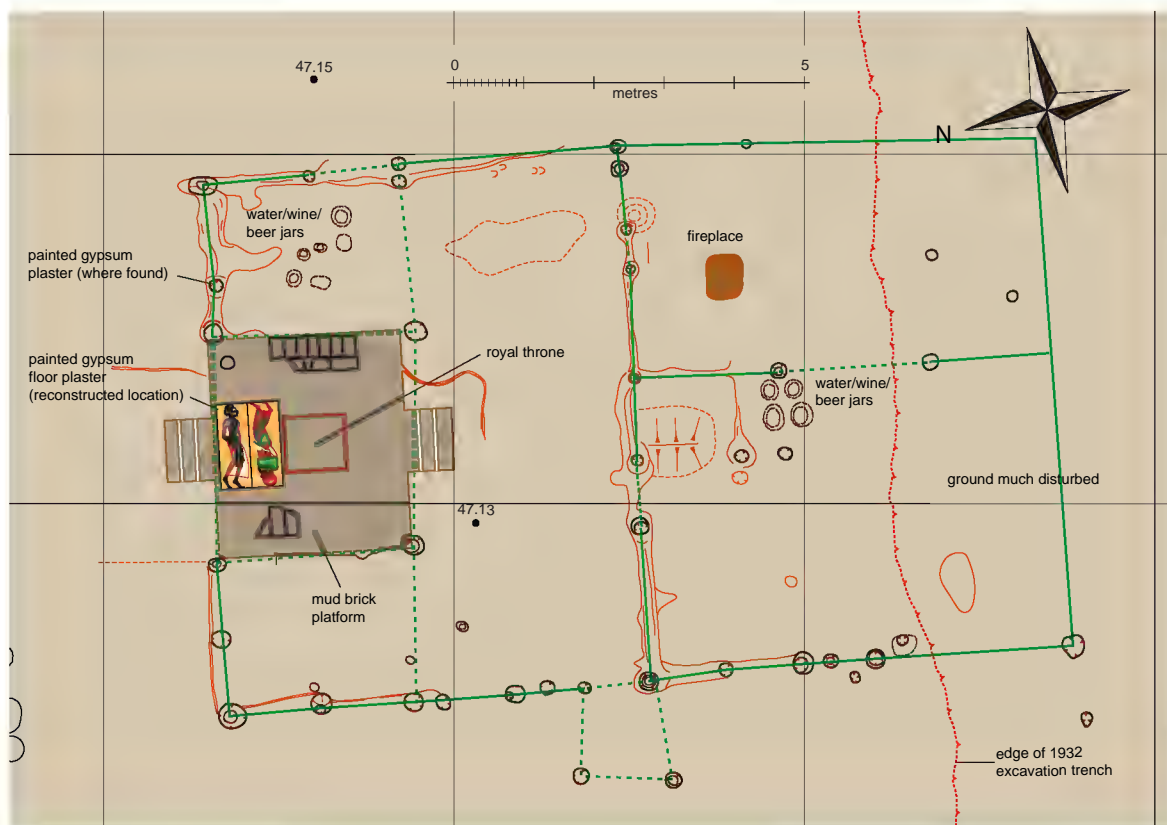
Figure 17. Reconstructed plan of the building above the post holes. The green lines show where wooden beams might have joined the vertical wooden posts. Those with broken lines are those only at roof level. Based on an original by Miriam Bertram.

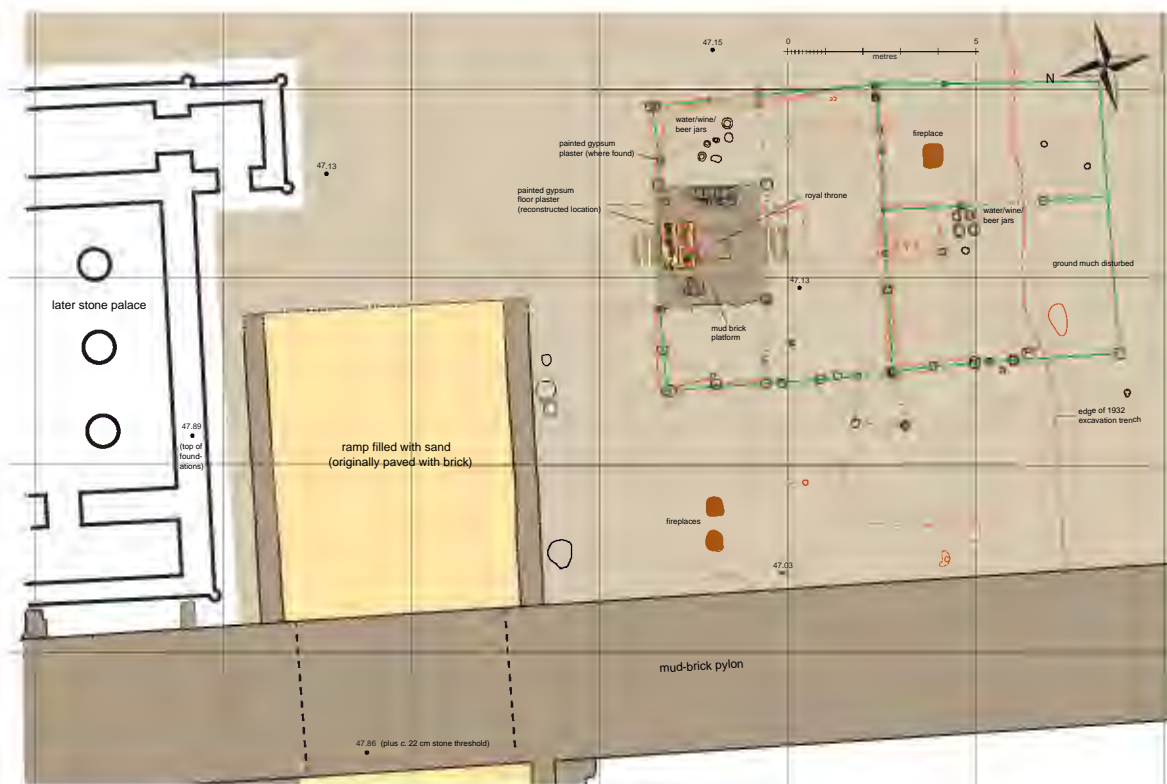
Figure 18. Plan of the area beside the main gateway into the temple enclosure. The wooden palace lies to the right of the entrance ramp. The plan of the later stone palace (left edge) is a reconstruction based on the evidence of the foundation platform.

Imagine standing on the threshold at this time, facing east along the temple axis (Figure 18). The mud surface of the earlier period would be almost a metre below, although the ground in front of you was now covered by the ramp. On the left the builders would have started to create the concrete foundations for the small stone palace, building them up to the same height as the entrance threshold on which you are standing. To your right, at the lower level, the wood-framed building has been set up, facing the site of the stone palace-to-be. Suppose — and here we come to a probably unprovable assumption — that the stone palace was replacing one that had been there from the beginning, built either from brick or stone and now demolished. The temple site continues to be used despite the building work. Some provision is needed for the king's presence. The wood-framed palace, hastily erected, is the answer.

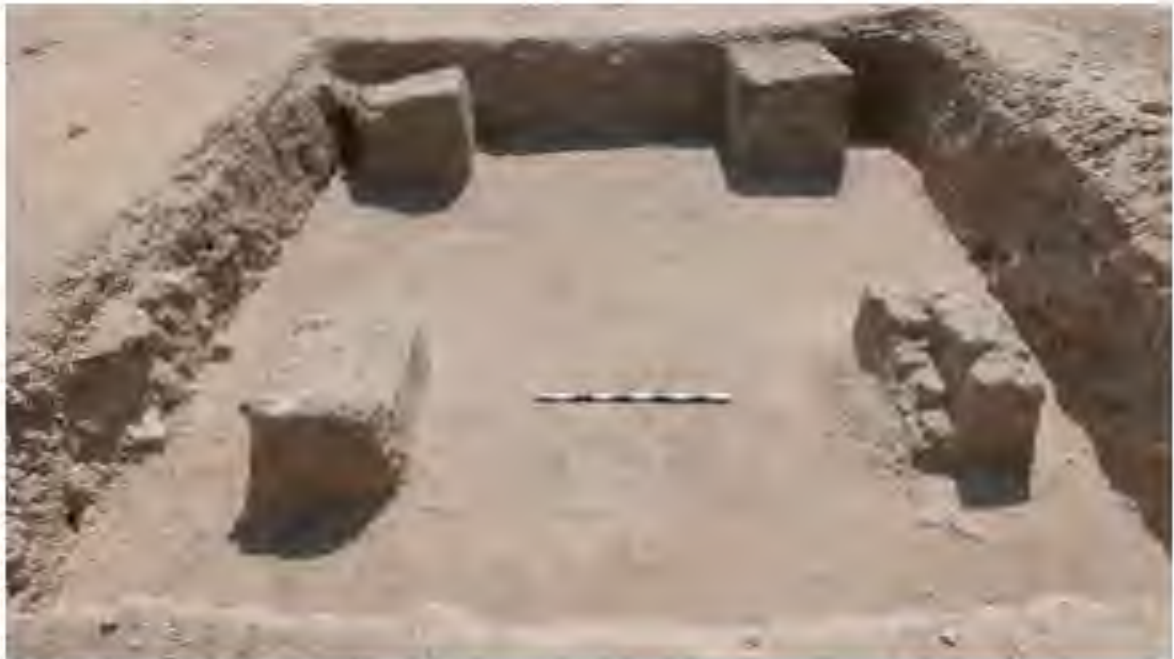
Figure 20. Four mud-brick offering-tables in square I24. View to the south.

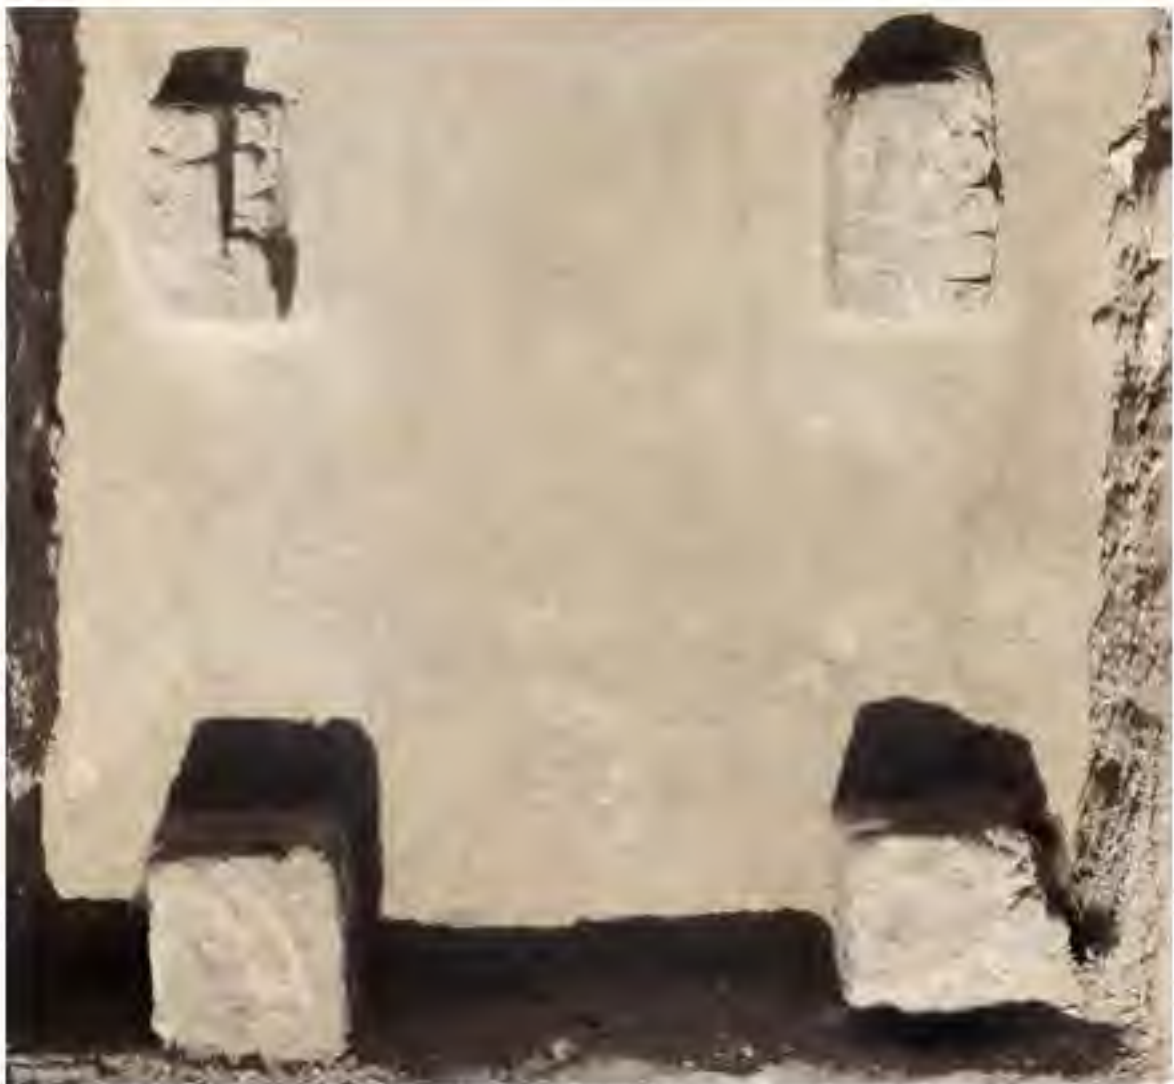
Figure 21. Four mud-brick offering-tables in square I24, seen from above. North is towards the top.

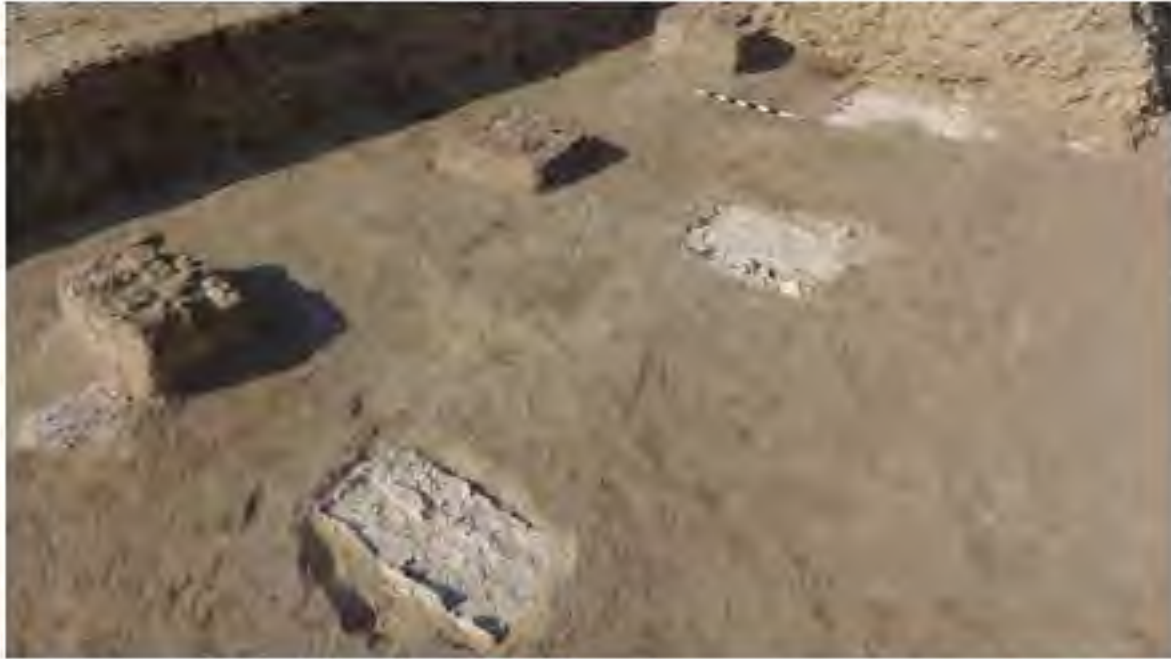
(Above) Figure 22. Parallel rows of offering-tables at the southern limit of the excavations. The further row of three (a fourth is off the picture to the left) is made from mud bricks. The nearer row had been made from stone blocks on gypsum concrete foundations. The stones had been removed before the levelling rubble had been laid down. The furthest stonework that is visible is a base made of limestone blocks which had later been covered by a mud floor and is not yet fully exposed. View to the south-west.

The archaeological context across the area so far investigated (2017, 2018) is fairly straightforward. Mud-brick offering-tables (where not damaged or largely destroyed as a result of having been left exposed by the older excavations) lie buried in the levelling-rubble to a maximum height of 74 cm, probably not far short of their original height (Figures 20, 21). They rise from a floor of mud plaster, generally in good condition, which rests on the natural desert surface. So far, we have exposed parts of two east–west rows (Figures 1, 20). According to the excavation plan of 1932 there should have been a further row to the north, the final one of the large area of offering-tables. Instead we find that the final row had been built from limestone blocks set on individual foundations of gypsum concrete. They have the same distances between them as the adjacent mud-brick offering-tables (and so further apart than the limestone offering-tables which appear, after a gap, to the north). Whereas the limestone offering-tables to the north had been removed before the later mud floor was laid down, the row to the south had been left to stand until the levelling rubble was laid down. Then, presumably so as to save good building-blocks for re-use, the stones were prised up, leaving the raw foundations (Figure 22).

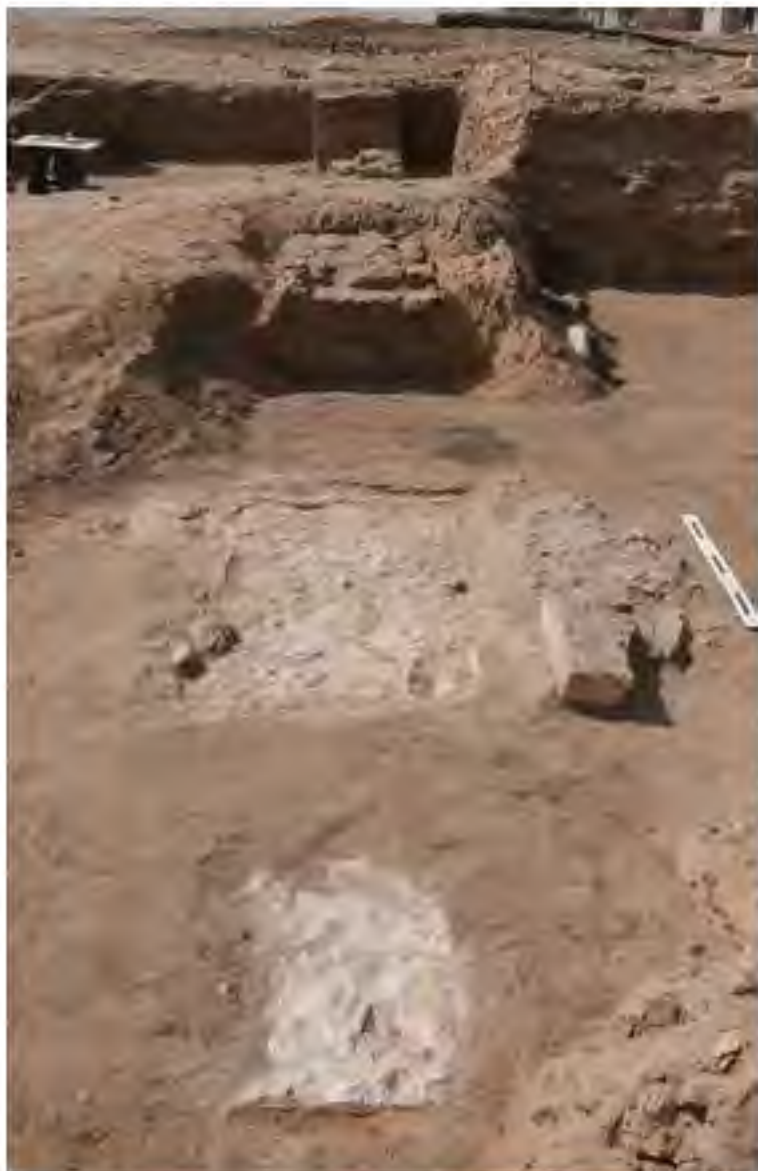
(Right) Figure 23. View to the south along the westernmost row of offering-tables in squares I24 and I25. The third offering-table from the viewer has been partly uncovered from the sand and dust which was put down to protect it in 2017. The fourth is still covered. In the foreground is the still only partially exposed stone foundation later covered with mud plaster.

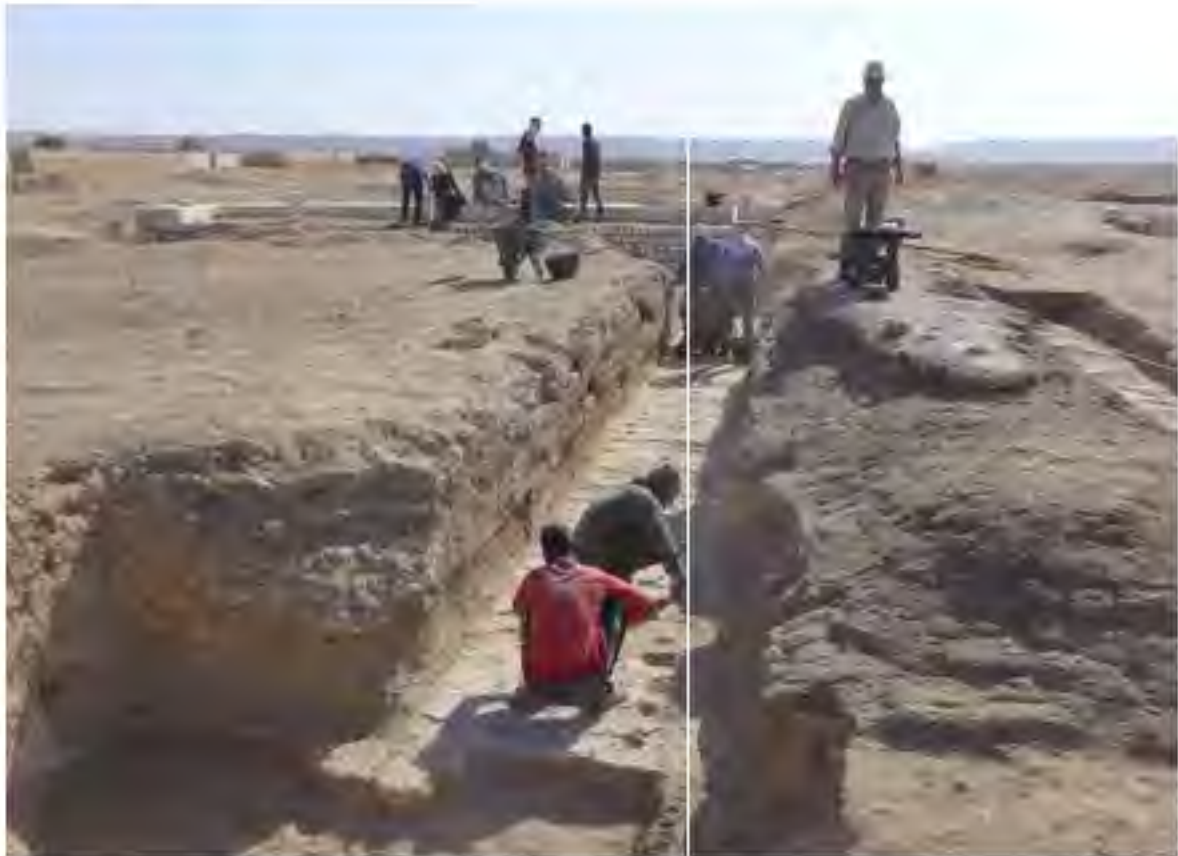
Figure 24. In the background the team of builders works on the south pylon. The wall trench that runs towards the viewer is being brushed as a detailed plan is made, prior to covering the floor with sand, and filling the trench with stone foundations. View to the east.

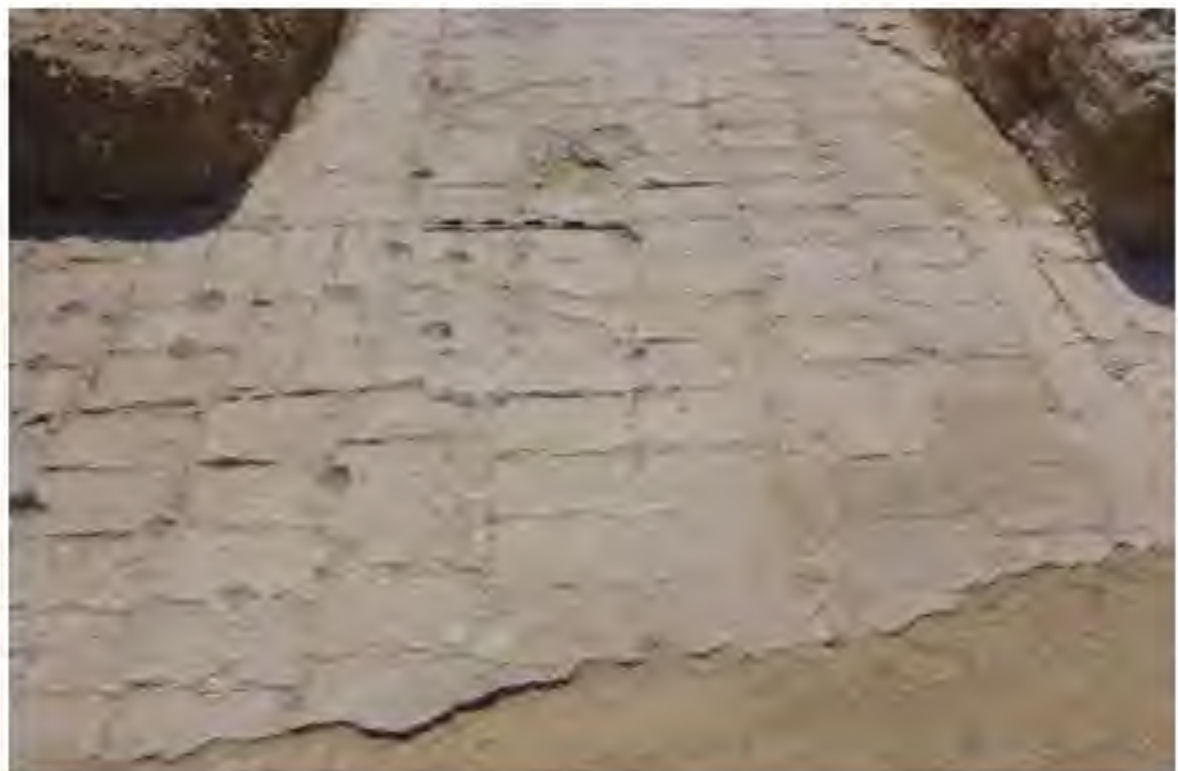
Figure 25. The foundation bed for the southern pylon, showing the impressions of talatat-blocks. View to the south.

At the west end of the temple the lower concrete foundation layer extended beneath a pair of relatively narrow pylons each with a width of 3.30 m (Figure 25). The ground to the west was then developed in a different way. Was a different group of builders responsible? The plan was to erect two sets of eight gigantic columns on either side of a wide paved area, 8.48 m across. The existing ground here must have lain outside the front of the earlier temple. The mud floor of the earlier period runs beneath the central paved area and, more or less at its eastern end, the remains of at least one mud-brick offering-table are recognisable standing on it (Figures 34, 35). The builders dug trenches down roughly to the same level reached in creating the foundations for the temple itself (Figure 24), cutting into the earlier mud floor (Figure 41). The trenches defined two large rectangles, each in front of one of the pylons to be built and where the columns were to be erected. They were joined by the wall which defined the western edge of the central paved area to come. Walls of stone blocks were built in the trenches, creating three adjacent box-like spaces. In the two larger ones where the columns were to rise, measuring 18.95 x 10.10 m (Figures 26, 27), the mud floor and underlying *gebel* were removed. The space so created was filled with foundations for the huge columns. Where each column was to stand, stiff concrete was heaped up (not poured) in the form of a square support (Figure 30). Their size suggests a diameter of column base of c. 2.5 m. The sides of the square supports, where not against the surrounding wall, were linked with short walls made in the same way. The tops of these constructions were, here and there, still traceable when we cleaned the tops of the platforms. Small stones were then used to fill the intervening spaces for around half the depth. The remaining depth was filled with more concrete. Over the whole surface a layer of paving-stones was laid, the pattern of the stones reflecting the locations of the buried supports for the columns which were laid over the paving-stones. (The impressions from those on the southern platform have remained fairly clear whereas those on the northern platform have been extensively weathered.) The height of this floor was the same as the top of the levelling-rubble outside the temple and as the paving-stones inside the temple.
