British Mission to Tell el-Amarna

**Great Aten Temple
Report on Recent Work
(Autumn 2017, Spring and Autumn 2018)**

Barry Kemp and Miriam Bertram
December 4th, 2018

Great Aten Temple, Report on Recent Work

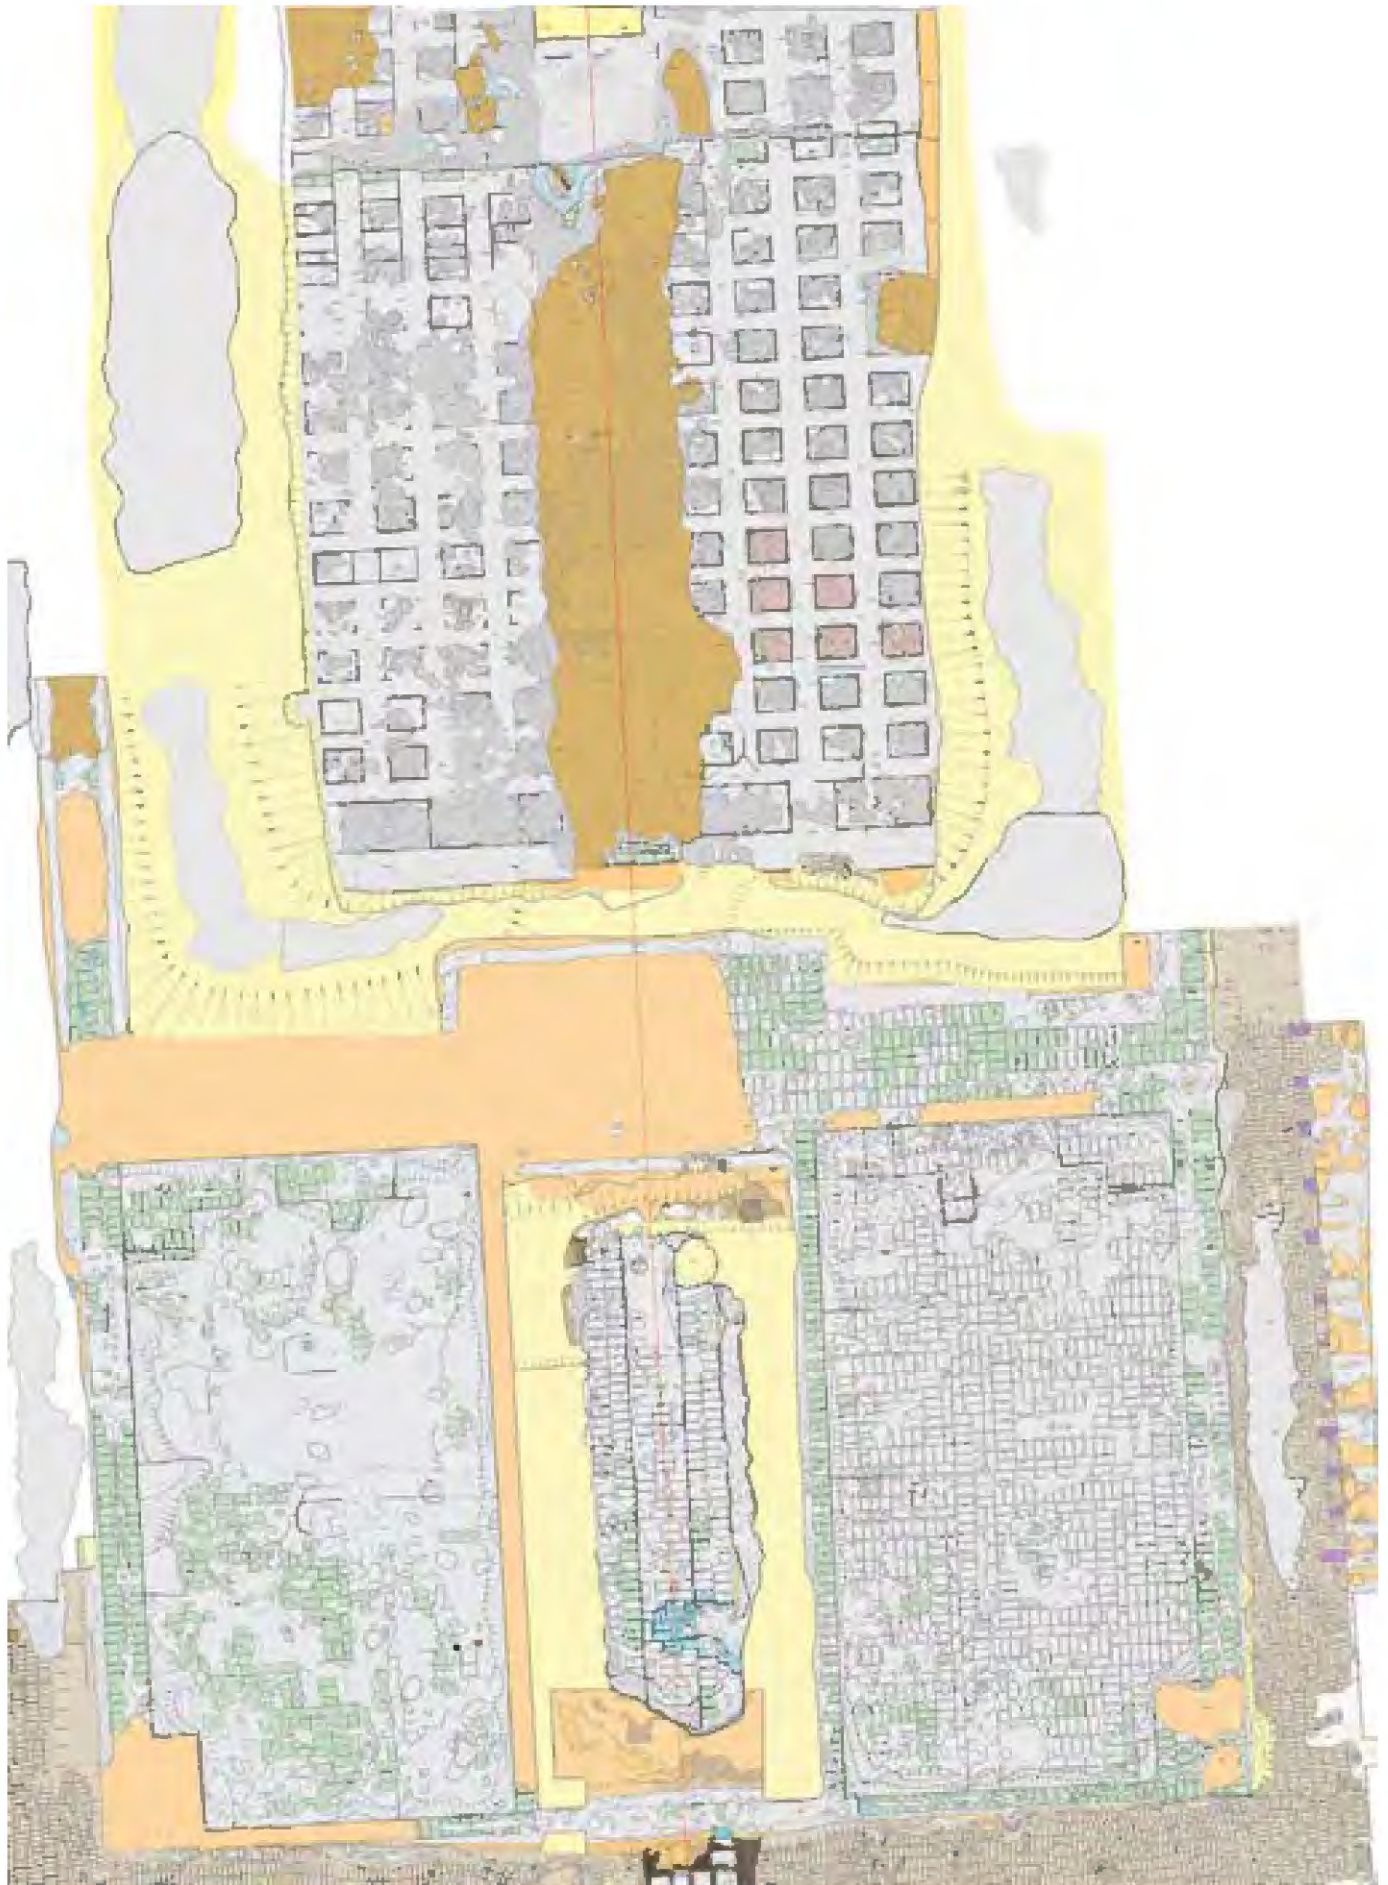
Figure 26. A portion of the excavation plan of the Great Aten Temple. It shows (at the top) the west half of the first court of offering-tables; below is the site of the pylon-flanked entrance and foundation platforms for the two sets of eight large columns.

When the stonework of the temple was methodically removed after the end of the Amarna Period, the blocks of the foundations were dug out, and for this the upper concrete layer must have been broken up where stonework occurred. Around the edges of the courts, however, it was not necessary to do this and, although the paving-stones were removed, the concrete foundation was left. Extensive areas of it still survive along the north and south sides of the first court (Figure 26).

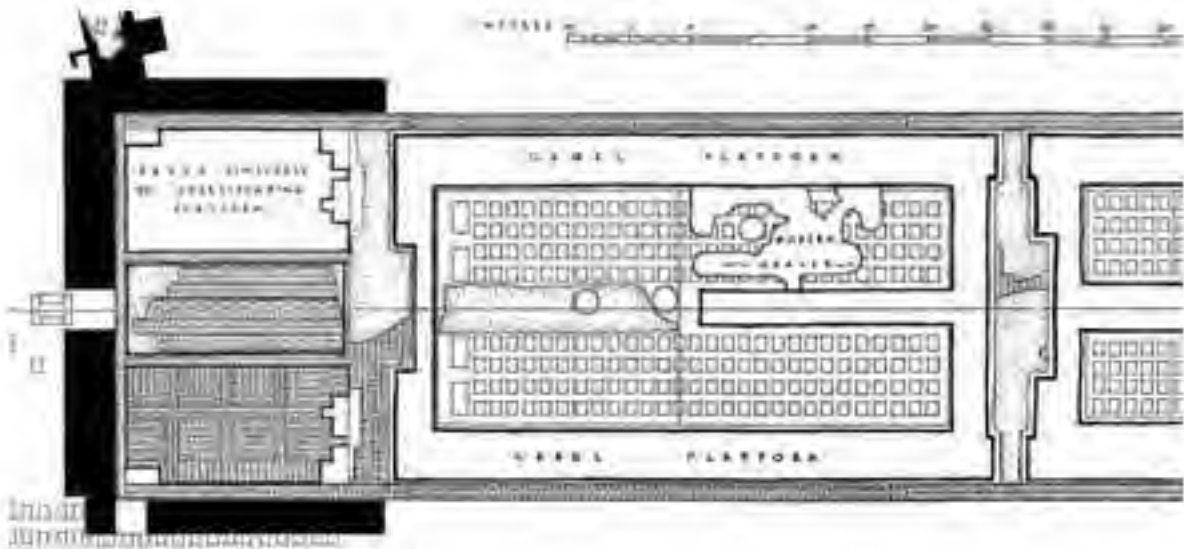
Figure 28. Lavers' plan of the front part of the Great Aten Temple. The offering-tables inside the temple lay not on a sunken floor surrounded by platforms (each marked 'gebel platform' on the plan) but on a floor at the same level as the rest of the temple. Lavers' plan is in *City of Akhenaten III*, Pl. III.

Pendlebury and Lavers, in 1932, misinterpreted the remains. Lavers marks on his plan (Figure 28) the surviving areas of the sand, with concrete covering, as areas of 'gebel platform'. In his reconstruction drawing (Figure 29) the offering-tables sit on the floor of large pits surrounded by raised walkways (the 'gebel platforms') including a central raised avenue. In fact, although the rear courts of the temple might, as a whole, have risen a little, everything within the temple boundary wall was at the same paved level from side to side. Lavers' sunk areas are foundation pits which had actually been filled in with sand and paved over. The reason for being confident in this conclusion is that where we have removed the sand fill beneath the upper concrete layer, or where it has slumped since 1932 as a result of weathering, pieces of worked stone and fragments of broken gypsum concrete and mortar from an earlier building regularly appear. They have included the legs from a small granite statue of a princess. Lavers' 'gebel' is actually redeposited sand used to build up the floor level and is the equivalent to the levelling-rubble outside the temple. Inside and outside the temple the ground and floor level was the same.

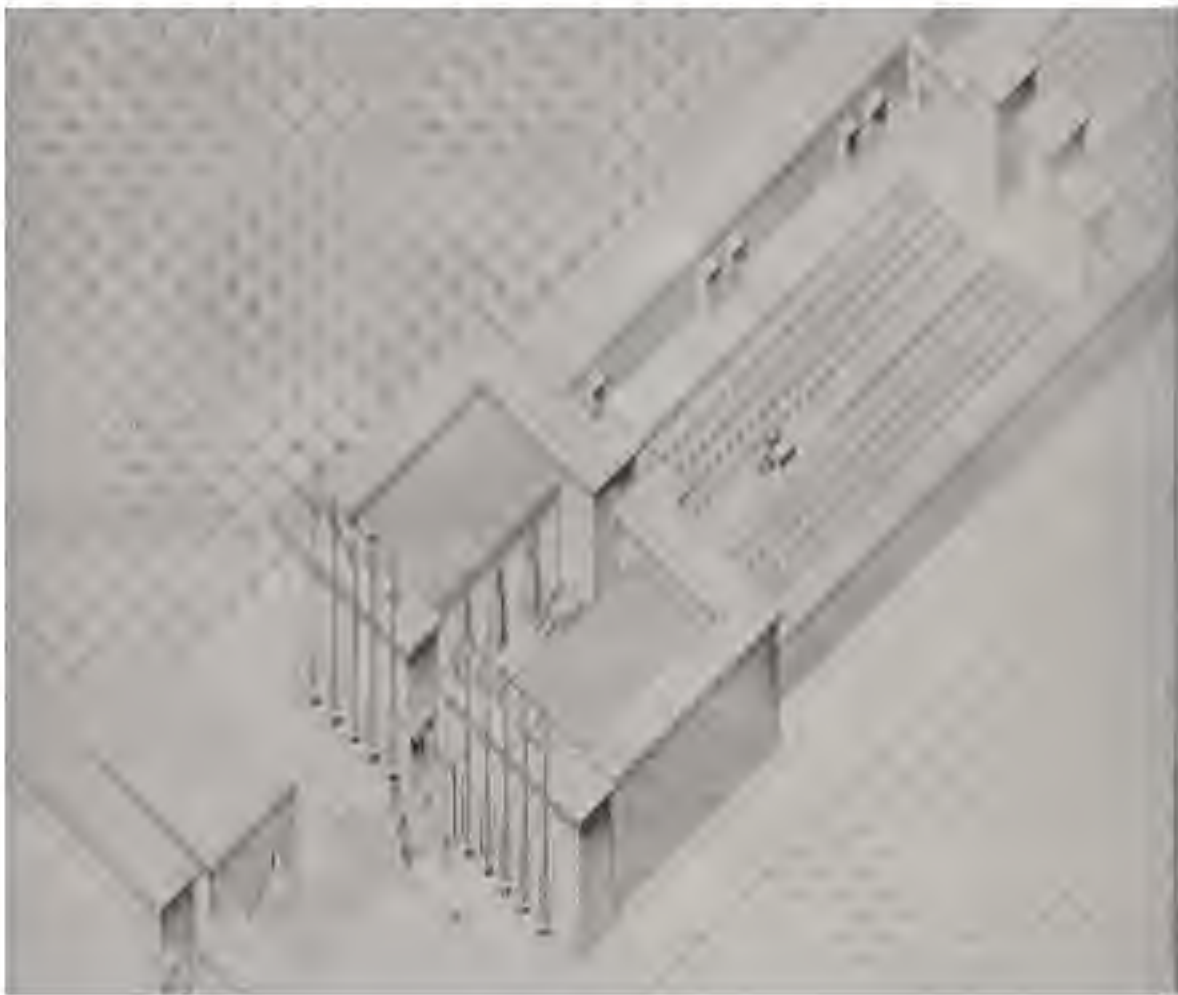
Figure 29. Lavers' reconstruction of the front part of the Great Aten Temple. For the presentation of the twin colonnades as the sides of a single hall with pylons Lavers assumed that the thick brick walls around the three sides of this front portion rose as full-height walls, whereas they were a temporary construction not visible when the temple was finished. The offering-tables inside the temple lay not on a sunken floor surrounded by platforms but on a floor at the same level as the 'platforms'. Lavers' reconstruction is in *City of Akhenaten III*, Pl. VIA.

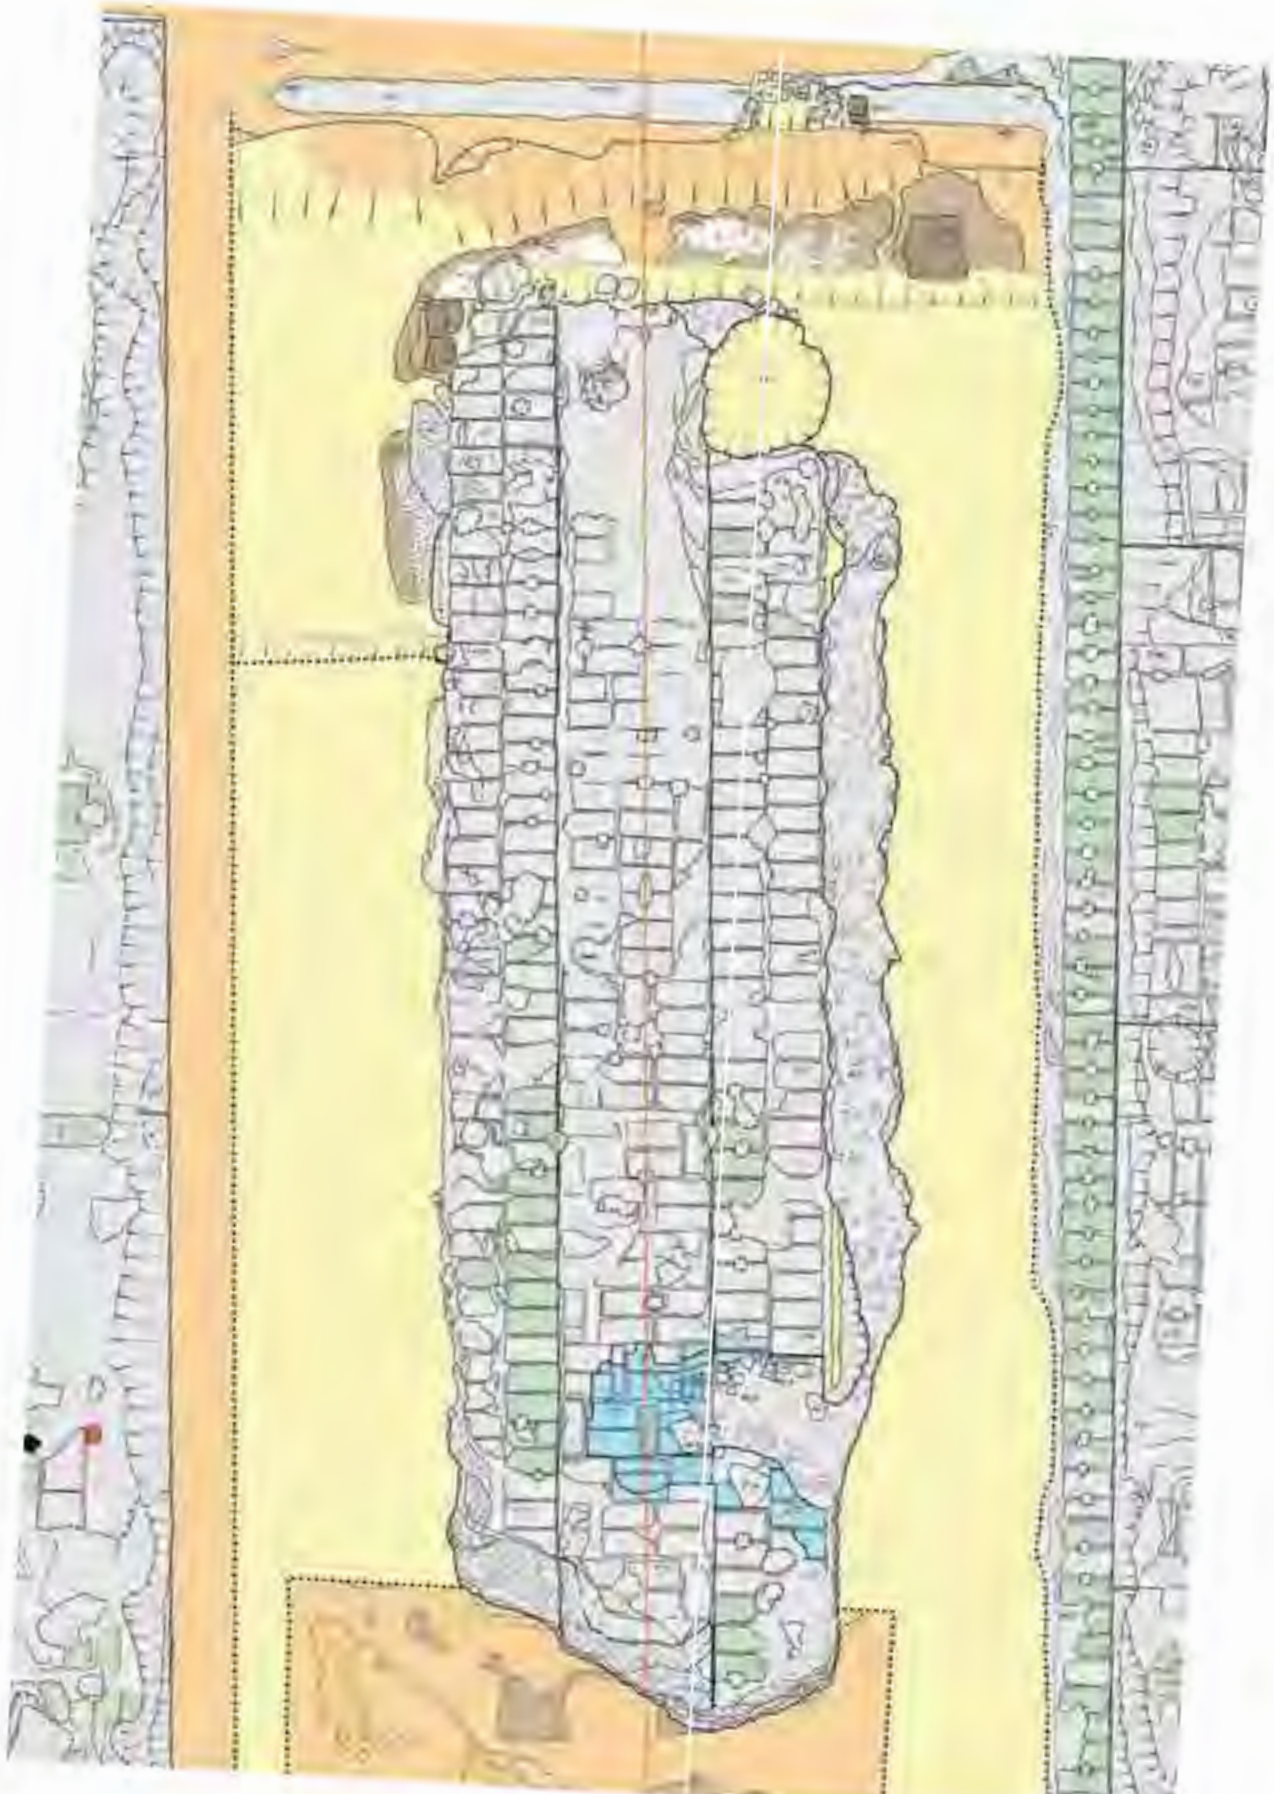
Figure 31. Plan of the foundations for the pavement to cover the space between the two platforms which supported the large columns in front of the pylons. The plan is also part of Figure 26. Original by Juan Friedrichs.

The central compartment, where the paved approach to the pylons was to go, was prepared differently (Figures 31, 33–42). The mud floor (supporting the stump of at least one mud-brick offering-table) was left in place. This earlier mud floor was, of course, lower than the top of the levelling-rubble which was to be laid down outside the stone temple. A layer of sand, c. 30 cm deep, was used to cover it. Over this came foundations made from gypsum concrete for the pavement which, at a higher level, continued the pavement beneath the nearby columns. Instead of it being a single layer as found elsewhere in the temple, however, it has an internal structure of its own. The results of the 1932 excavation were recorded by the architect Lavers (Figure 32). His plan of the general outline and the layout of the block-marks is reasonably accurate and also shows that wide strips along both the north and south edges have been lost since then. What the *City of Akhenaten III* publication does not communicate is that the concrete incorporates a separately made structure at the lower level, resting on the 30 cm bed of sand.

A concrete foundation bed [17498], 3.7 m wide, was laid along the axis on this sand bed (Figures 31, 41, 42). Two parallel rows of limestone blocks, each with a width of two blocks end-to-end as headers, were laid on this, leaving a gap of 1.5 m between them. The builders then added a further 10 cm or more of concrete in the intervening space to create a thicker foundation bed [17878] for a central strip of blocks. This pattern of construction extended for the full length of the paved area (a distance of 19 m, although both ends had been lost by the time that Lavers planned it). Another 30 cm of sand was now added, and a further bed of gypsum concrete [17876] laid over it, covering the side strips and joining the foundations for the large columns. Paving-stones were laid on this. Of this bed nothing now survives on the north side, but a narrow strip is preserved on the south. A small patch of the mortar for one of the slabs is preserved at the eastern end, at a level of 48.11.

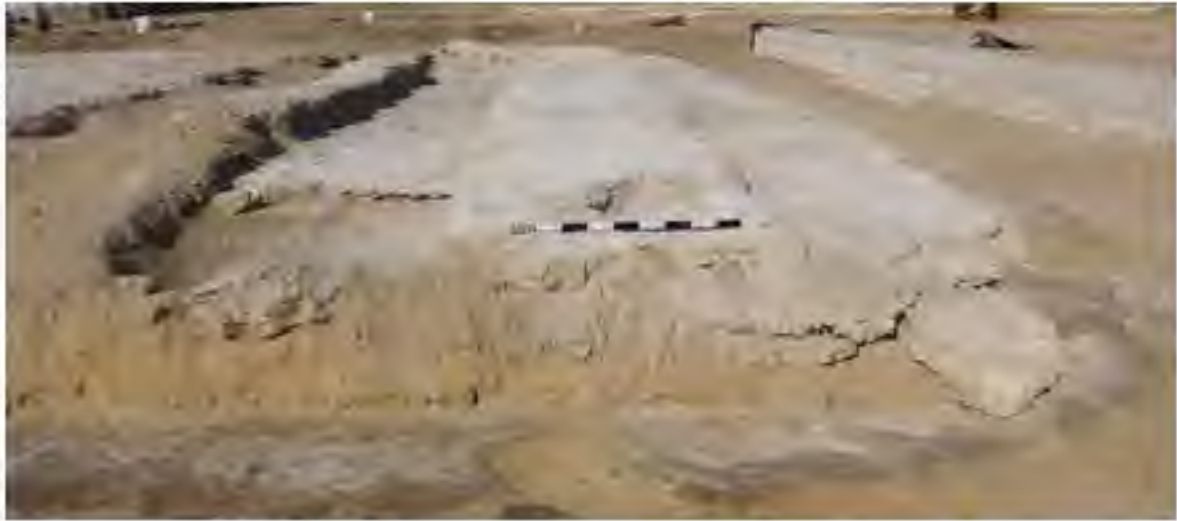
Figure 33. View westwards along the axis of the staircase foundation in front of the temple entrance. In the low foreground the earlier mud floor is visible, separate from the gypsum concrete by c. 30 cm of sand.

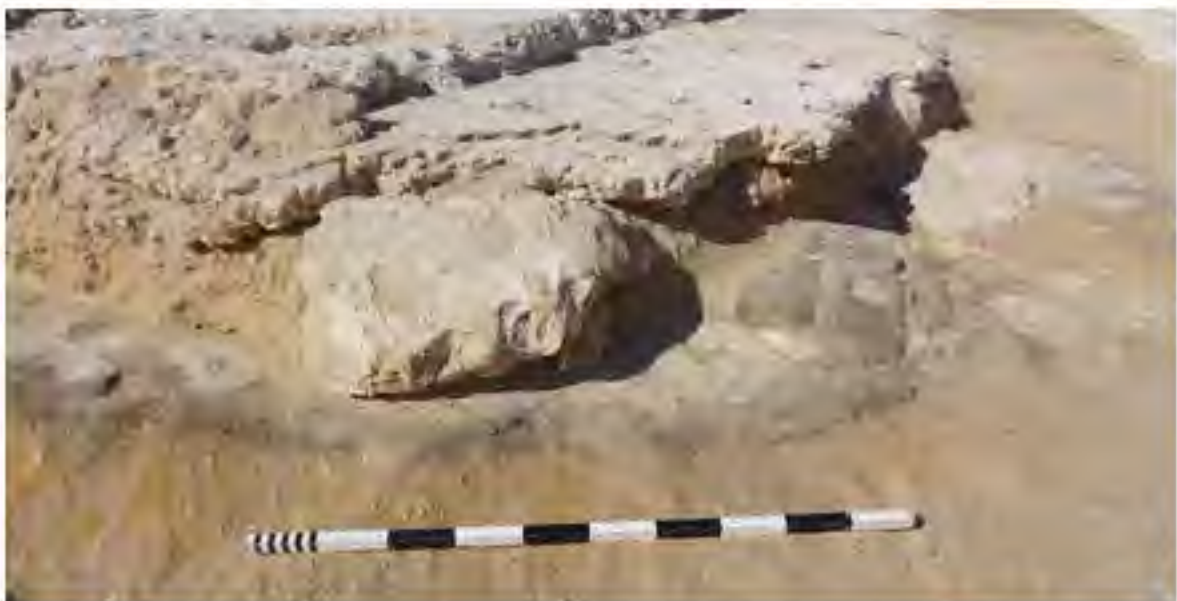
Figure 34. North-east corner of the staircase foundation in front of the temple entrance. Loss of sand beneath the gypsum concrete foundation has led to a large fragment of the latter breaking off. It lies on the earlier mud floor. To the right are the remains of a mud-brick offering-table which belongs with the earlier mud floor.

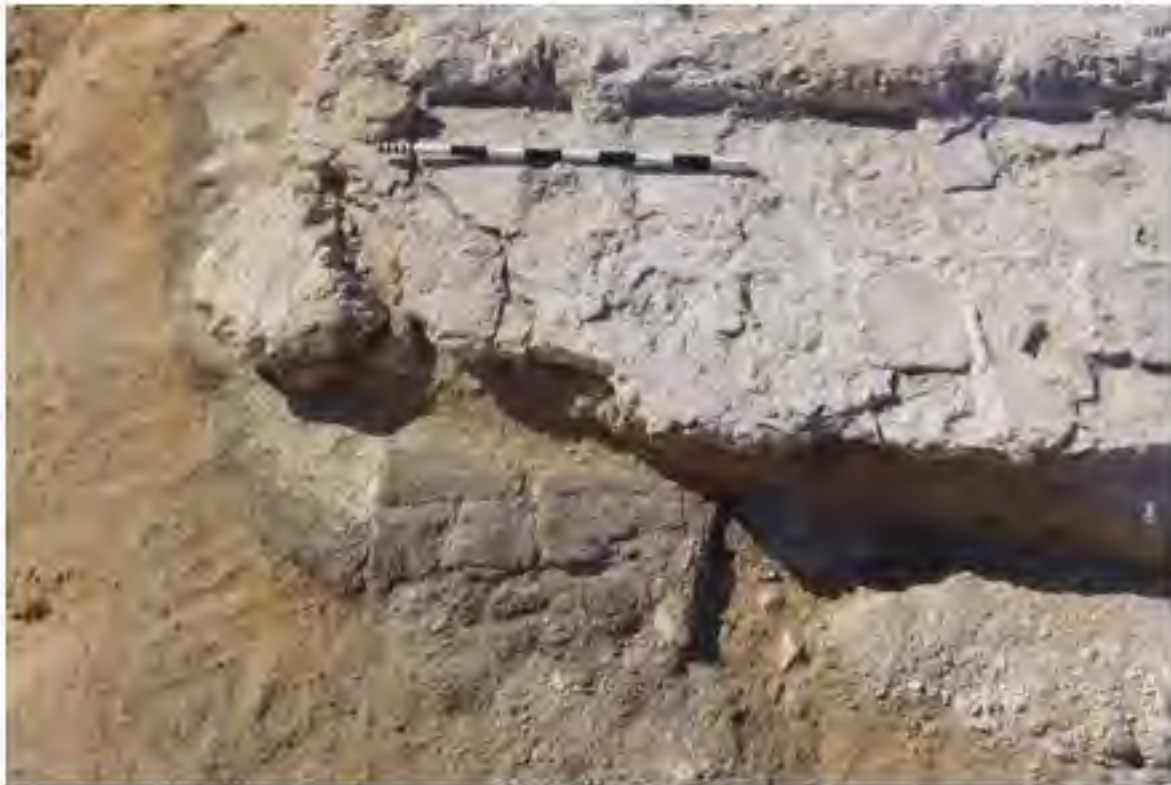
Figure 35. North-east corner of the staircase foundation in front of the temple entrance, viewed to the south. The earlier mud-brick offering-table and adjacent mud floor and remains of white covering are emerging from beneath the covering of sand and gypsum concrete foundations.

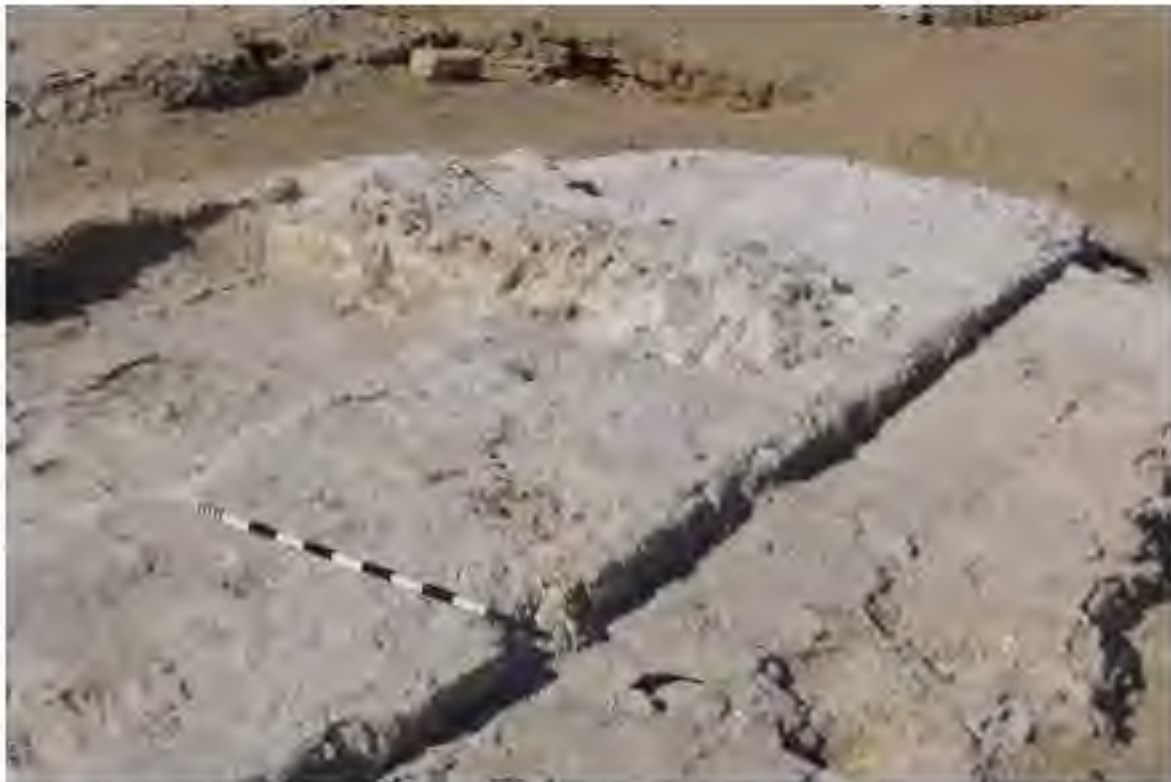
Figure 36. The western end of the staircase foundation in front of the temple entrance. The low mound in the middle consists of the remains of limestone blocks still in their original place. View to the south-west.

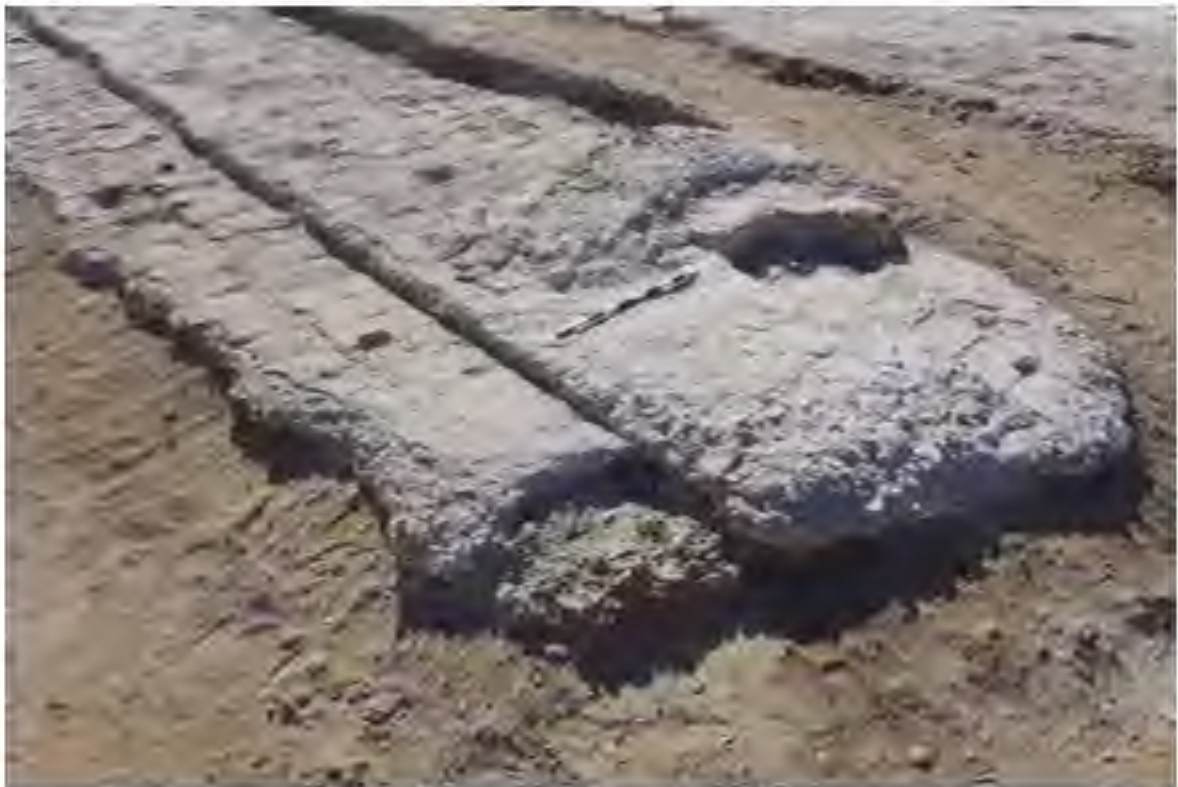
Figure 37. The western end of the staircase foundation in front of the temple entrance. The low mound in the middle consists of the remains of limestone blocks still in their original place. View to the south-east.

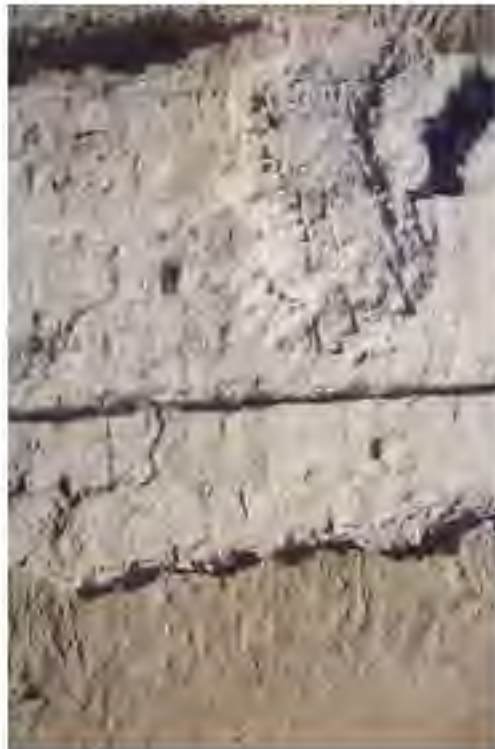
Figure 38. Vertical view of the mixture of limestone blocks still in their original position and surrounding gypsum concrete from beneath the upper pavement. South is towards the top.

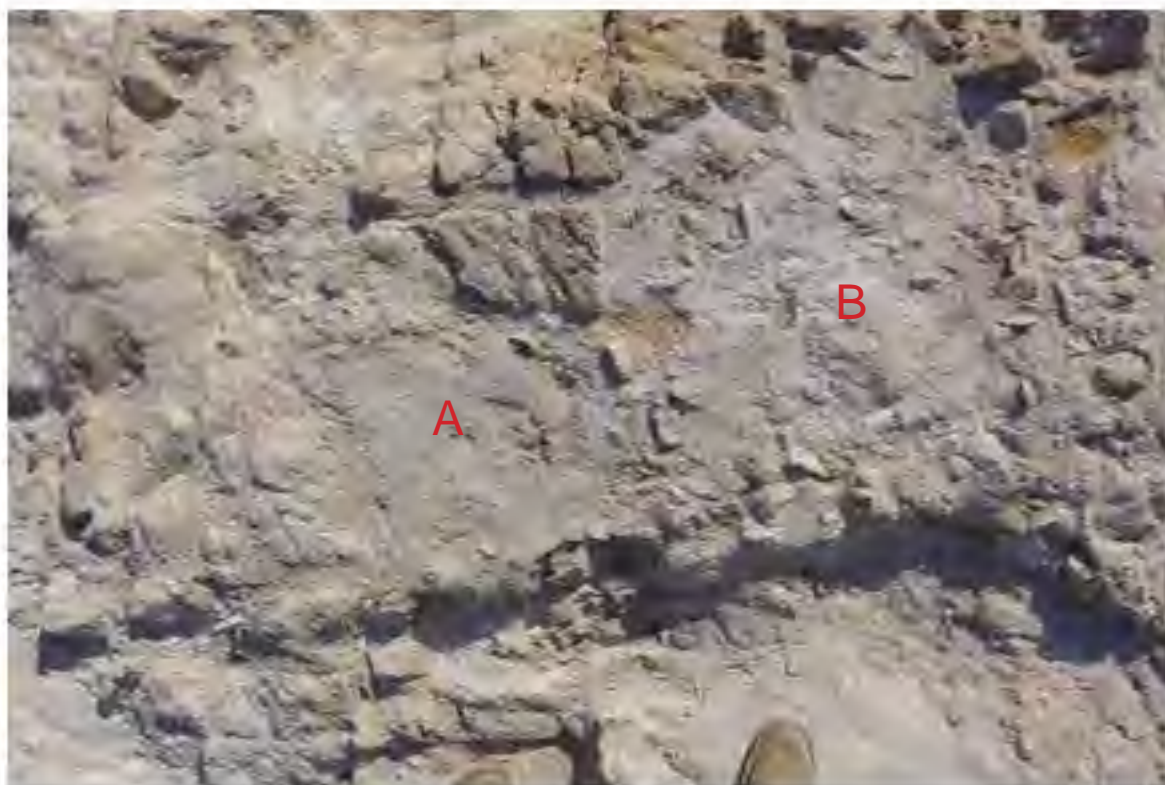
Figure 39. Vertical view of the limestone blocks of the staircase foundation still in their original position (A) and the adjacent surviving extra layer of concrete foundation (B) over the blocks of the balustrade foundations. East is towards the top.

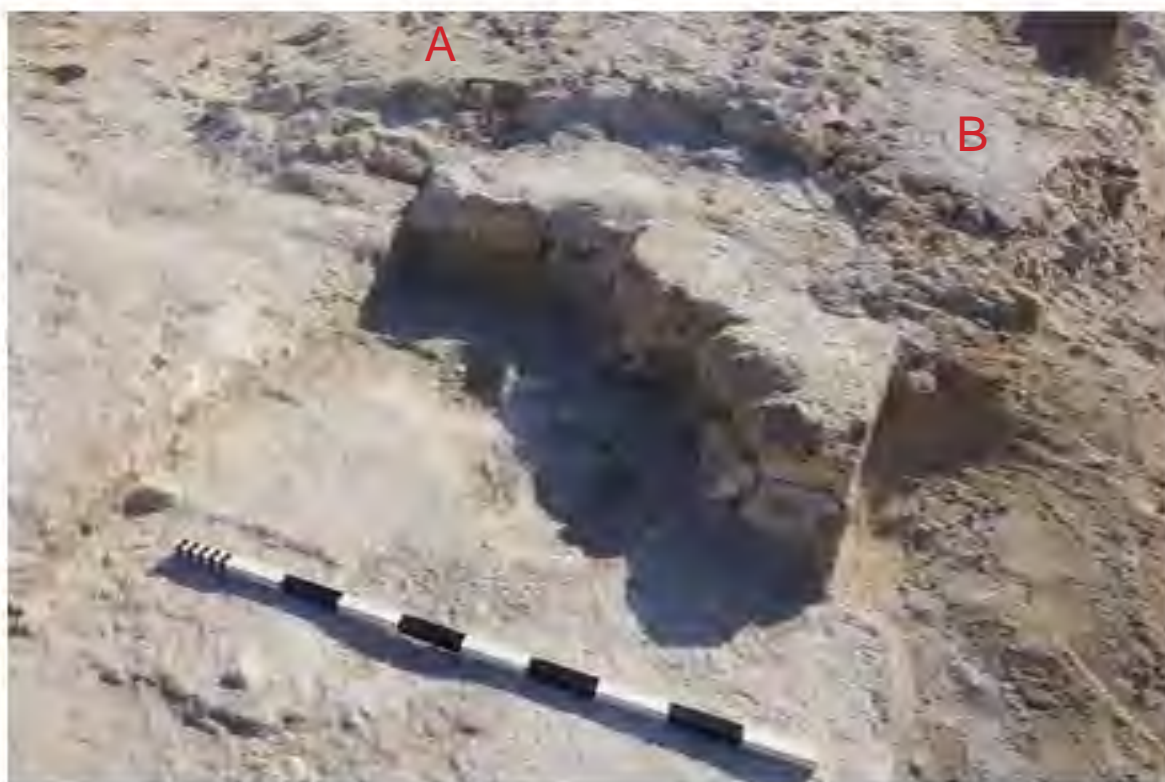
Figure 40. View to the east of original limestone blocks still in place towards the west end of the staircase foundation in front of the temple entrance.

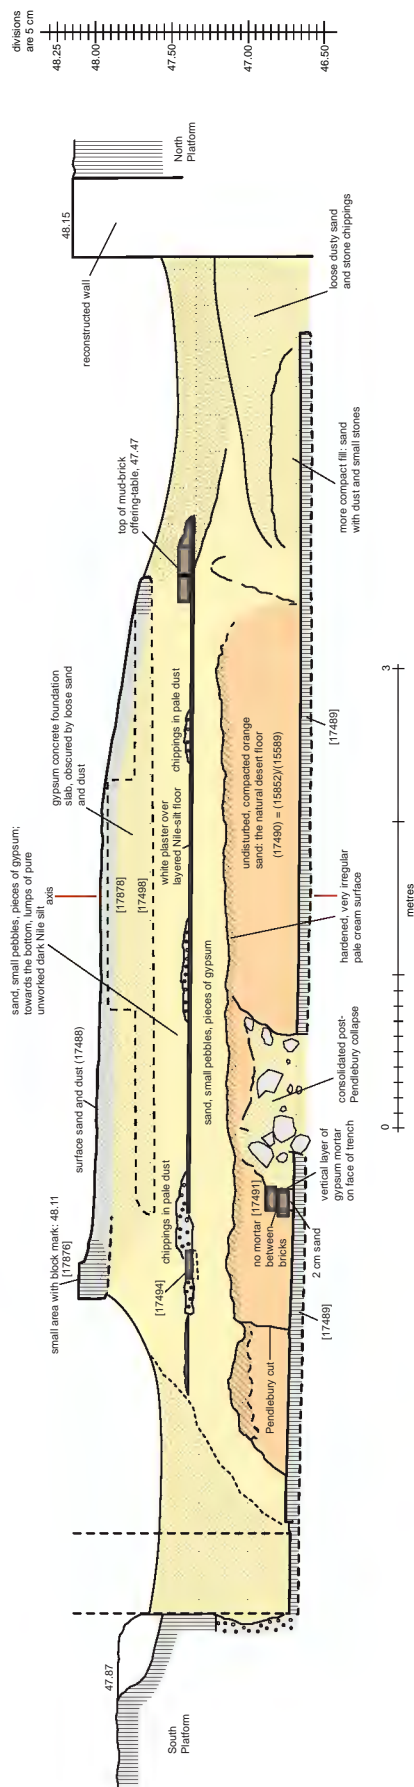
Figure 41. Section across the staircase foundation at the east end, where it rises above the foundation trench cut into the natural desert floor to receive the foundations for the stone pylons.

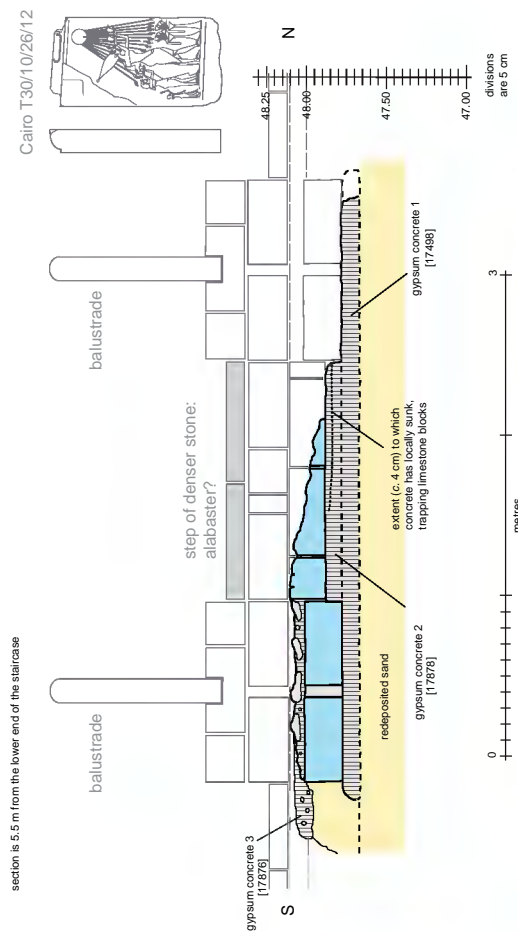
Figure 42. Section across the staircase foundation, showing how the masonry might have risen above the existing foundations.

masonry is a rare (and very minor) case of structural failure. The stone blocks over this patch had been laid either before the lowest layer of concrete [17498] had properly dried or because the deep sand on which it rested had settled slightly. As a result, the weight of the blocks had caused them to sink a little into the concrete foundation layer, which had also sagged slightly. This had increased the difficulty of lifting them when the time came for the building to be demolished after the end of the Amarna Period. As a result, the blocks had been left behind. In consequence this area fortuitously preserves a thicker section of the construction system (Figure 42), which had been followed for the entire length of this area of pavement.

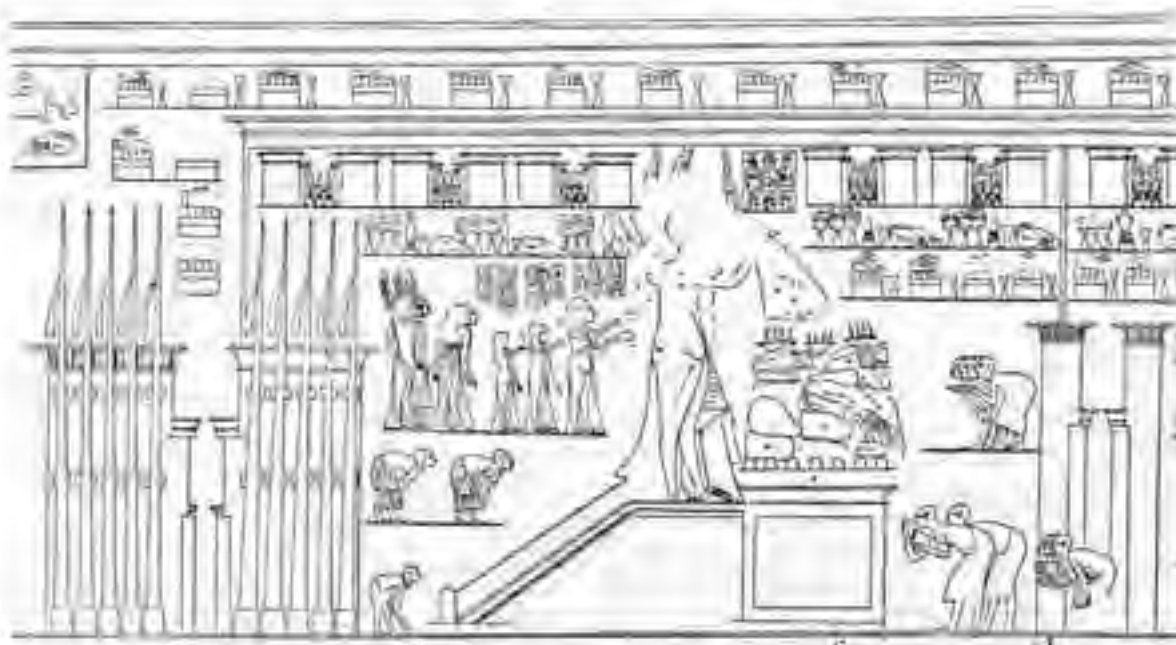
Figure 43. Two pictures in Amarna tombs of the main offering-place in the House of the Aten. Above: in the tomb of Panehsy (after Davies, *The Rock Tombs of El Amarna II*, Pl. XVIII). Below: in the tomb of Meryra (after Davies, *The Rock Tombs of El Amarna I*, Pl. XII).

The pictures of the temple in the tombs of Meryra (where it is shown twice) and Panehsy give prominence to a platform on which Akhenaten and Nefertiti stand to make offerings to the Aten (Figure 43). In one of the two versions in the tomb of Meryra the means of access is shown as being a flight of steps rather than a ramp. In all three cases the platform is shown on the far side of the pylon entrance, within the first court of small offering-tables. The foundations we are considering are consistent with an ascending approach to a platform located between the pylons. The central reinforced strip would represent the line of the staircase, and the wide, flanking stonework the foundations for a narrow balustrade on either side, giving a total width of 3.7 m. Such side walls, of double header-blocks, have the thickness of the side walls to several ramps or staircases at the Great Palace (although the ramps were up to 6 m wide). With a low angle of ascent, similar to the angle of the brick and sand ramp east of the brick enclosure wall, the slope would have reached a height of around 2 m, which would have been the floor of the platform. This would have had the character of an observation platform from which the sun could have been observed appearing above the line of the horizon to the east. To judge from the tomb pictures it was also provided with a table on which offerings of food, bouquets of flowers and bowls of incense could be placed. (It should be noted that the large and equally detailed picture of the temple which occurs twice, on opposite walls, in the Royal Tomb (chamber alpha) does not show an offering-platform, although the picture was probably completed before work had progressed far on the rebuilding of the temple.)

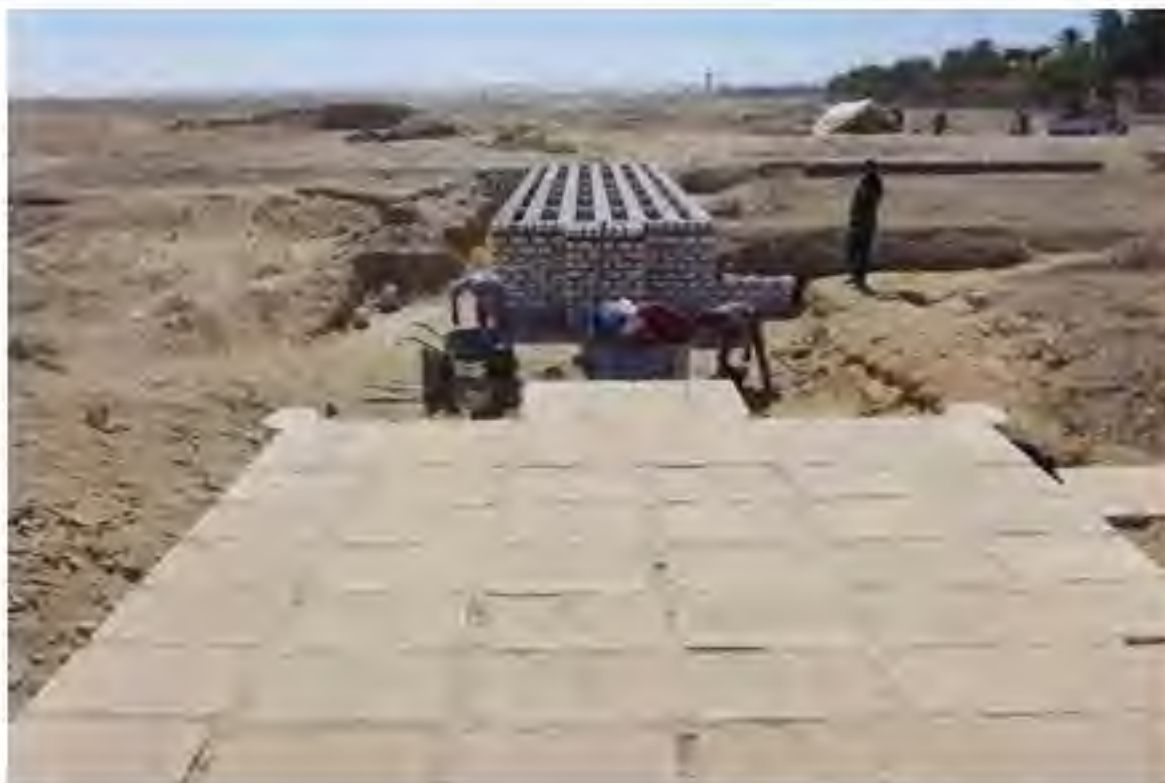
Figure 45. In the foreground is the North Pylon, reconstructed in 2015. Beyond are the foundations for the South Pylon, completed this year (2018). View to the south.

By the end of 2018 they had completed the reconstruction of the north and south pylons, most of the surrounding walls for the north and south platforms on each of which eight large columns had been originally set up, the eight circular pads of white concrete (2.5 m in diameter) to mark the positions of the northern set of columns and the square foundations for the southern set. The pylons are separated by a wide gap, of 8.4 m. This would have supported a threshold of stone paving slabs at the same slightly raised level (30 cm) as the pavement on which the staircase stood. This elevation is preserved by a small patch of concrete ([17876] at height 48.11) beside the foundations for the staircase. As a preparation for the threshold, the builders created a network of narrow rectangular compartments built from small limestone blocks from local quarries and laid in normal cement. They were built so that the walls between them could support paving slabs of the same length (52 cm) as the main building stones and also cut from Tura limestone. The compartments themselves have been filled with sand to provide a solid support.

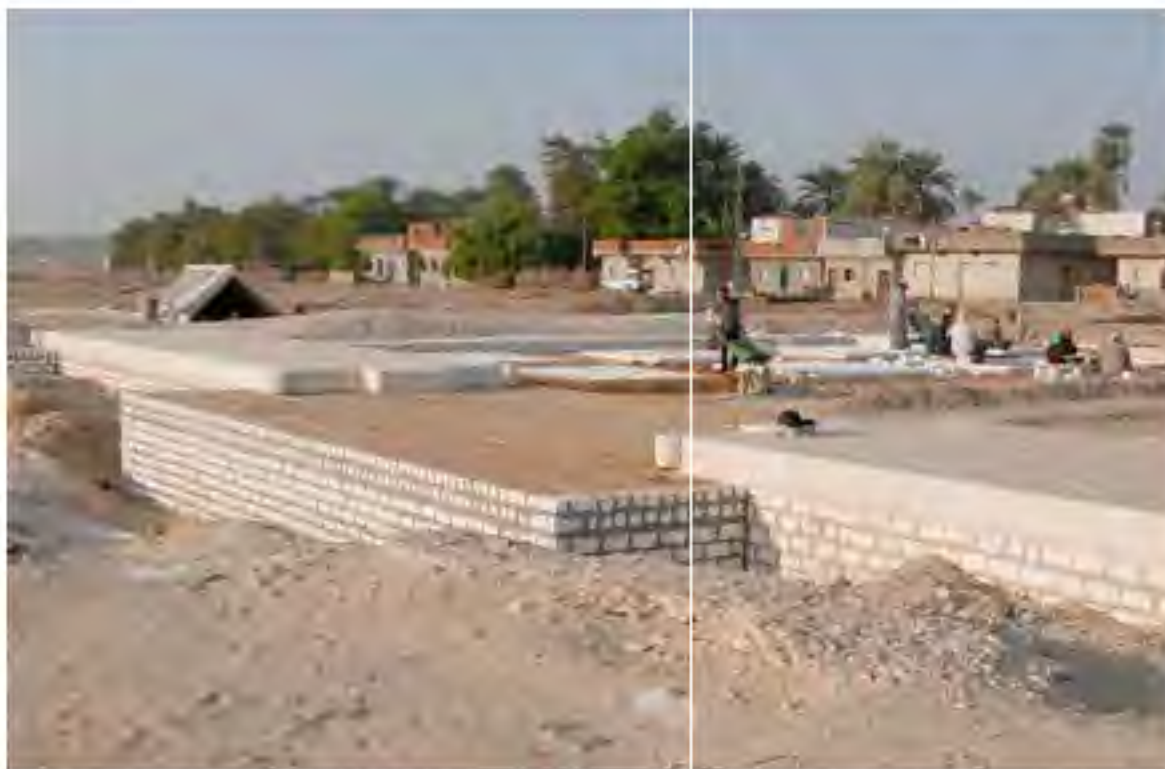
Figure 47. Foundations for the pavement between the pylons. The compartments have been filled with sand ready for the paving stones (of Tura limestone) to be laid over the top.

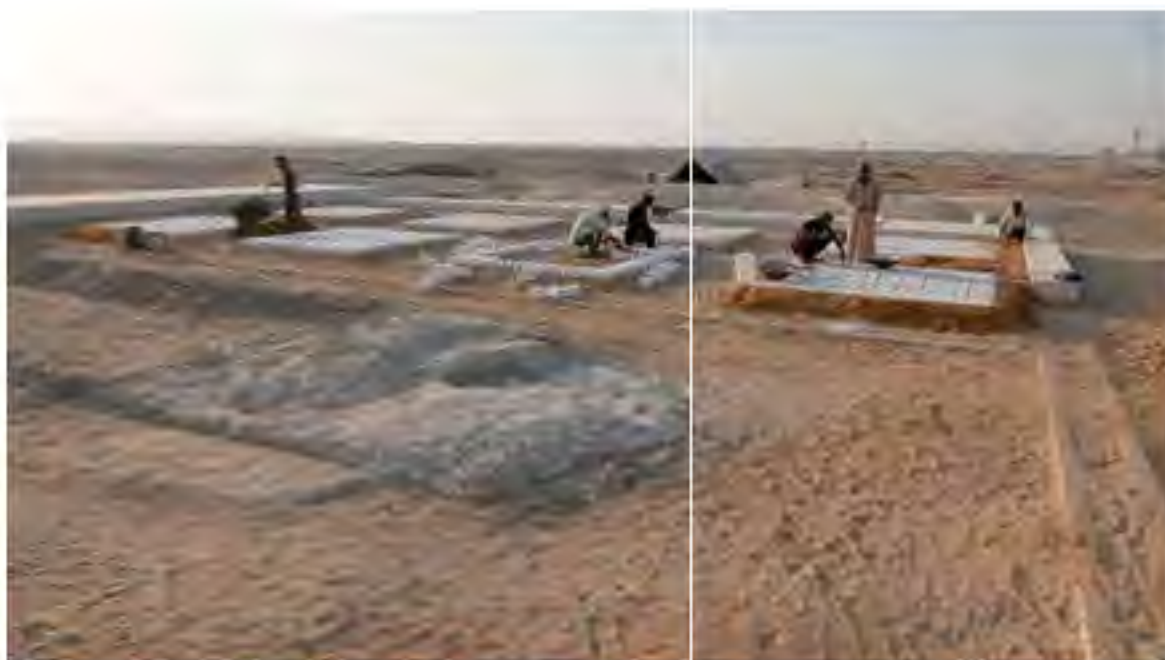
Figure 48. Work carried out on the southern half of the temple entrance system. The squares made from small limestone blocks are foundations (which will be covered with sand) for circular pads of white cement, each one 2.5 m in diameter, which will represent the eight large columns which originally stood here.

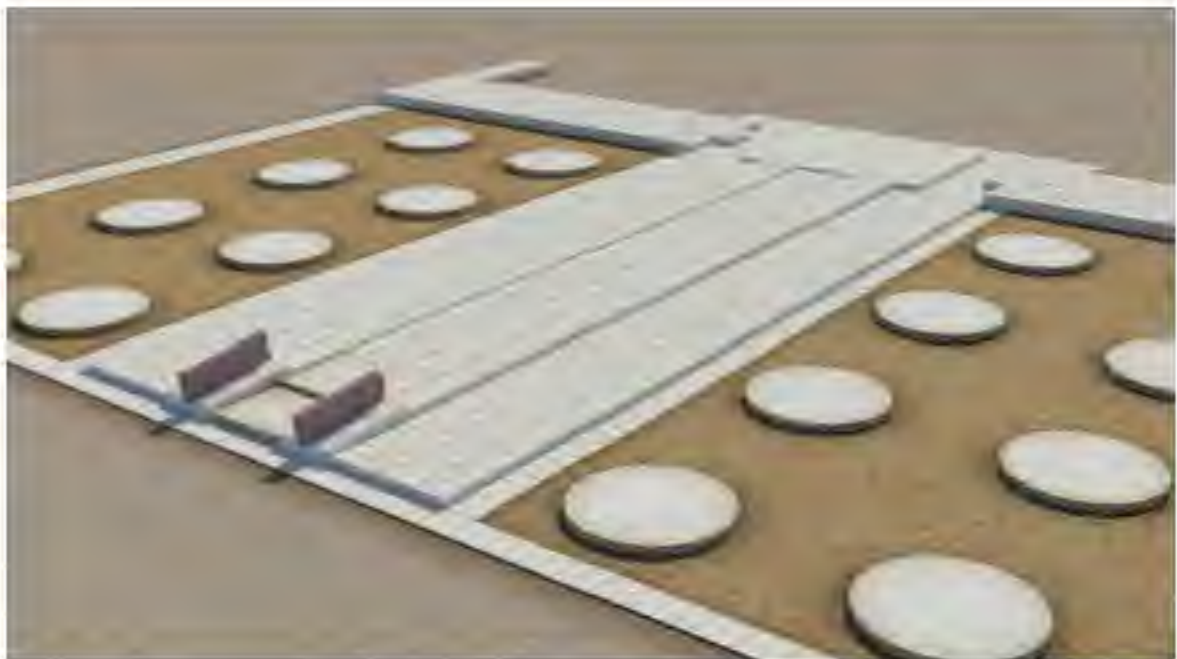
Figure 50. Visualisation of how the reconstruction scheme at the Great Aten Temple will look when completed. Artwork by Paul S. Docherty, www.amarna3d.com.

The expedition has been fortunate this year to have the assistance of Paul Docherty (of www.amarna3d.com) who provided a series of visualisations of both the current new stonework being laid and of the likely original appearance of the staircase and platform (Figures 49–52). A key source for the original appearance is the small shrine found (in 1926) in the northern house of Panehsy, itself close to the southern boundary wall of the Great Aten Temple (Figures 53, 54). The decorated stonework from the shrine is in the Egyptian Museum, Cairo. When discovered, the stones which formed the beginning of the access staircase were still in place, but seem not to have been kept and do not appear in the museum display (they are no longer in the ruins of the house). Their importance is that they preserved the beginnings of the balustrades which had run along the centre of the wide stonework which ran on either side of the staircase. This is the basis for Paul's reconstructions of the balustrades at the Great Aten Temple. Balustrades made from granite, quartzite, indurated limestone and basalt were used at Amarna, many fragments having been found at several of the most important buildings at Amarna (including in all these materials at the Great Aten Temple). The Panehsy shrine provides the basis for the design of the specially cut blocks which will mark the beginning of the staircase in our reconstruction.

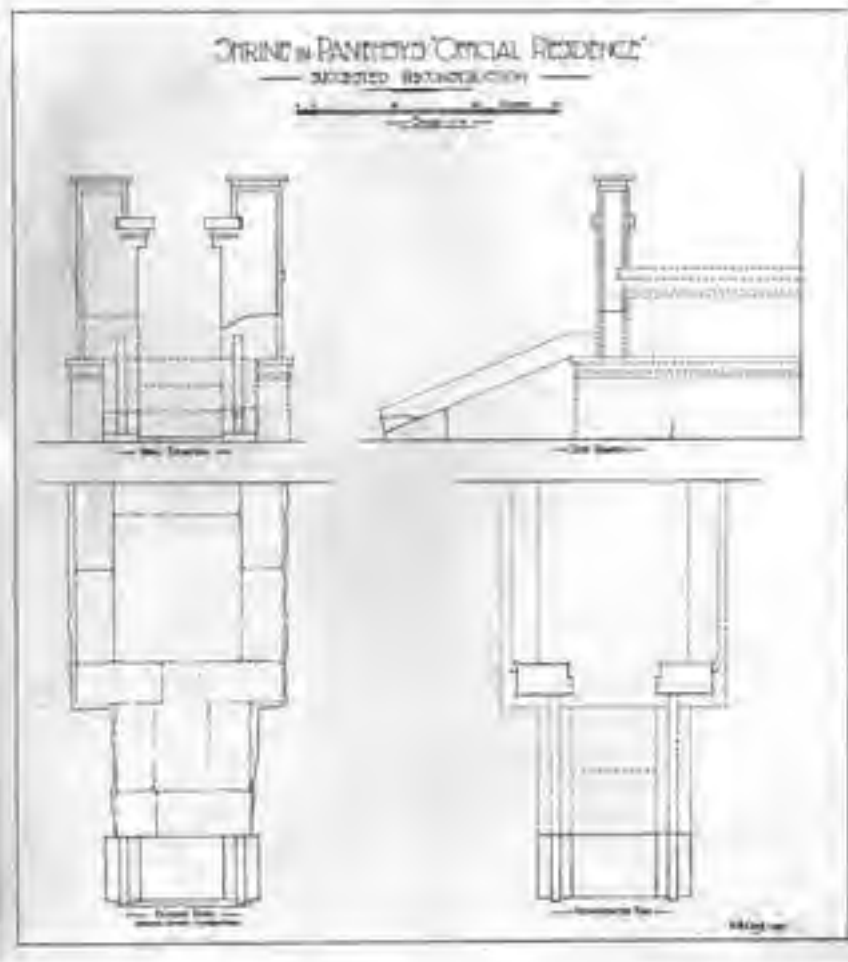
Figure 53, Plan and elevation drawings of the shrine in the northern house of Panehsy, made by H.B Clark, 1927. EES archive negative 26/108.
