British Mission to Tell el-Amarna

**Great Aten Temple
Report on Recent Work
(Autumn 2017, Spring and Autumn 2018)**

Barry Kemp and Miriam Bertram
December 4th, 2018

Great Aten Temple, Report on Recent Work

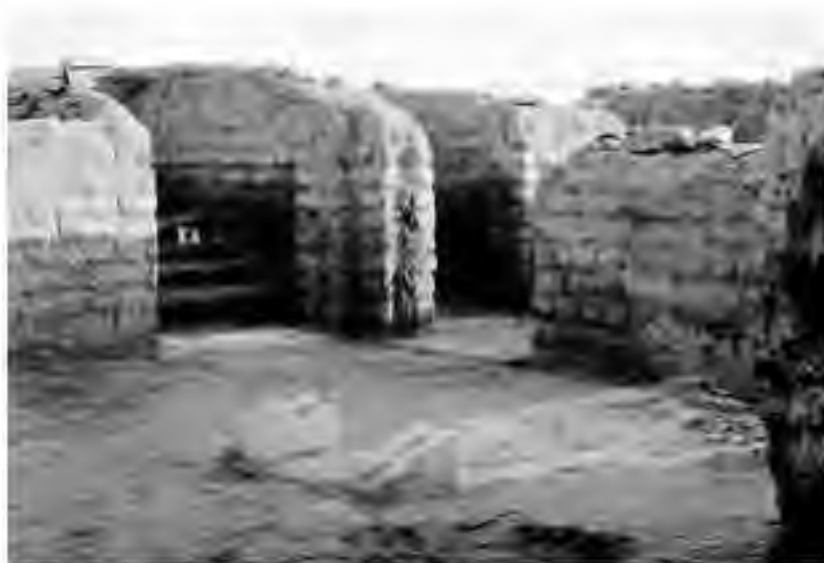
Figure 54. Photograph of the remains of the shrine in the northern house of Panehsy. Note the blocks at the beginning of the staircase which still preserved the beginnings of the balustrade. EES archive negative 26/06.

Panehsy's shrine, as found, with evidence for its balustrades, is published in *City of Akhenaten* III, 26–7, Fig. 6, Pl. XXX.1. Unpublished EES archive photographs (1926/04, /05, /06) clarify the construction of the balustrade block. For balustrades see I. Shaw, 'Balustrades, stairs and altars in the cult of the Aten at el-Amarna.' *JEA* 80 (1994), 109–27; J. Wegner, *The Sunshade Chapel of Meritaten from the House-of-Waenre of Akhenaten*. Philadelphia, Pennsylvania 2017, 67–76.

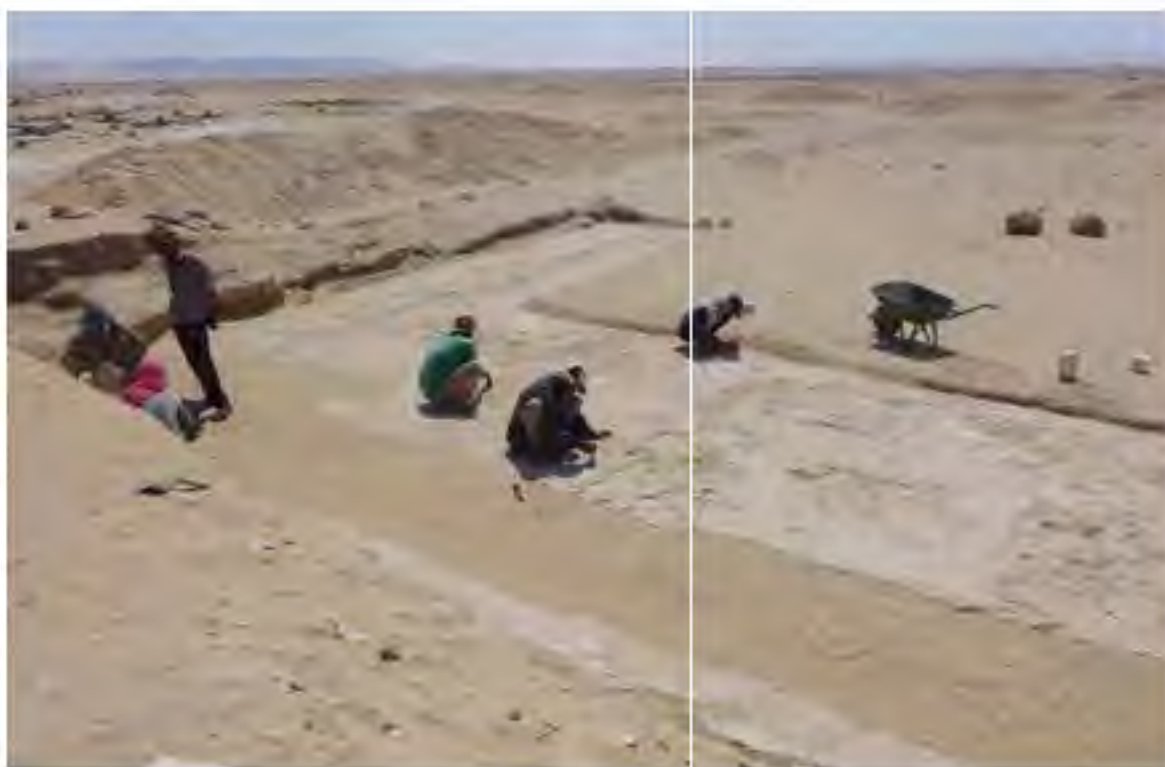
Figure 55. North-east corner of the temple: cleaning sand from the original gypsum foundation layer.

Another active part of the programme is to mark the line, to a similar height, of the entire north wall of the temple, a length of c. 200 m. The north-west end, where it leaves the north pylon, has been started. In order to ensure that it follows a straight course, the north-east corner was also located in 2017. Much of the original foundation layer of gypsum concrete was cleaned and a new plan made (Figure 55). Following this, the lines of the east and north walls and of the intersecting corner were established. Because the ground rises around the corner, the Tura blocks were laid at a level equivalent to a second course as they approached the corner (Figure 56). Newly-dug sand was heaped against the inside face of the walls, to a level approximating to that of the original floor level.

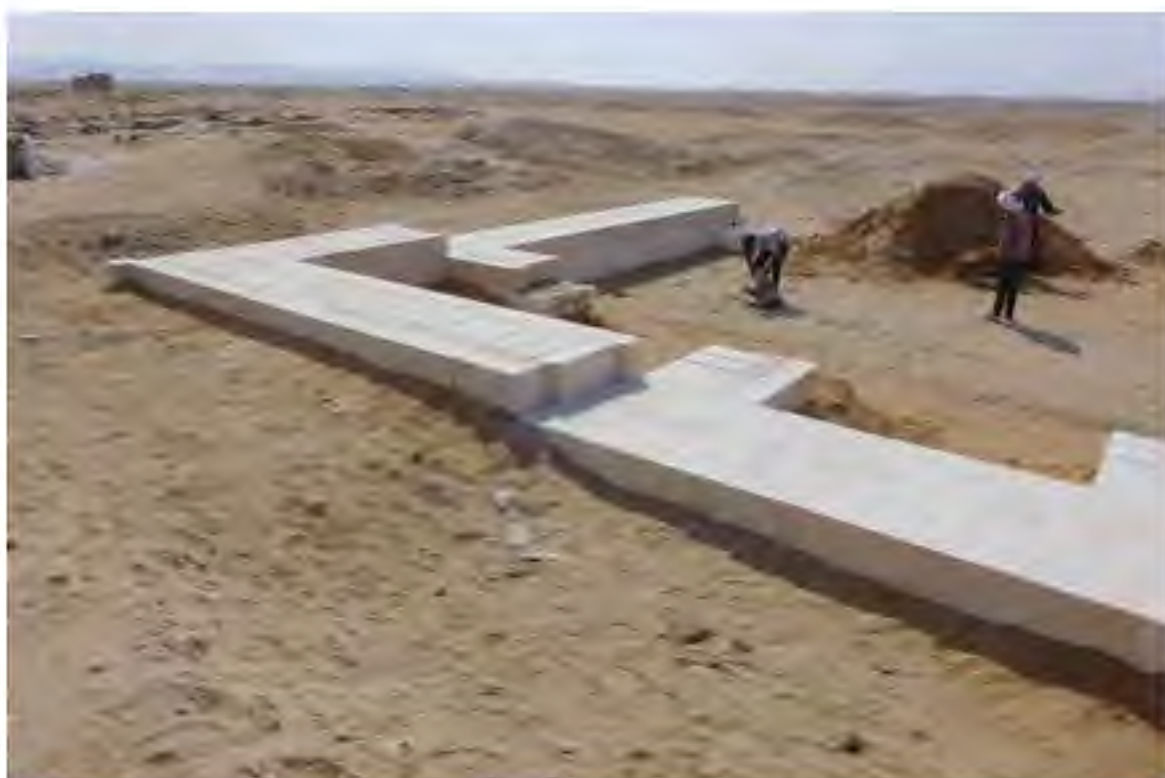
Figure 56. North-east corner of the temple: the corner recreated in new stone blocks. The sand is being added to build up the ground level to the bottom of the top layer of Tura-limestone blocks.
