British Mission to Tell el-Amarna

## Great Aten Temple Spring 2014 Season

### Preliminary Report

Barry Kemp

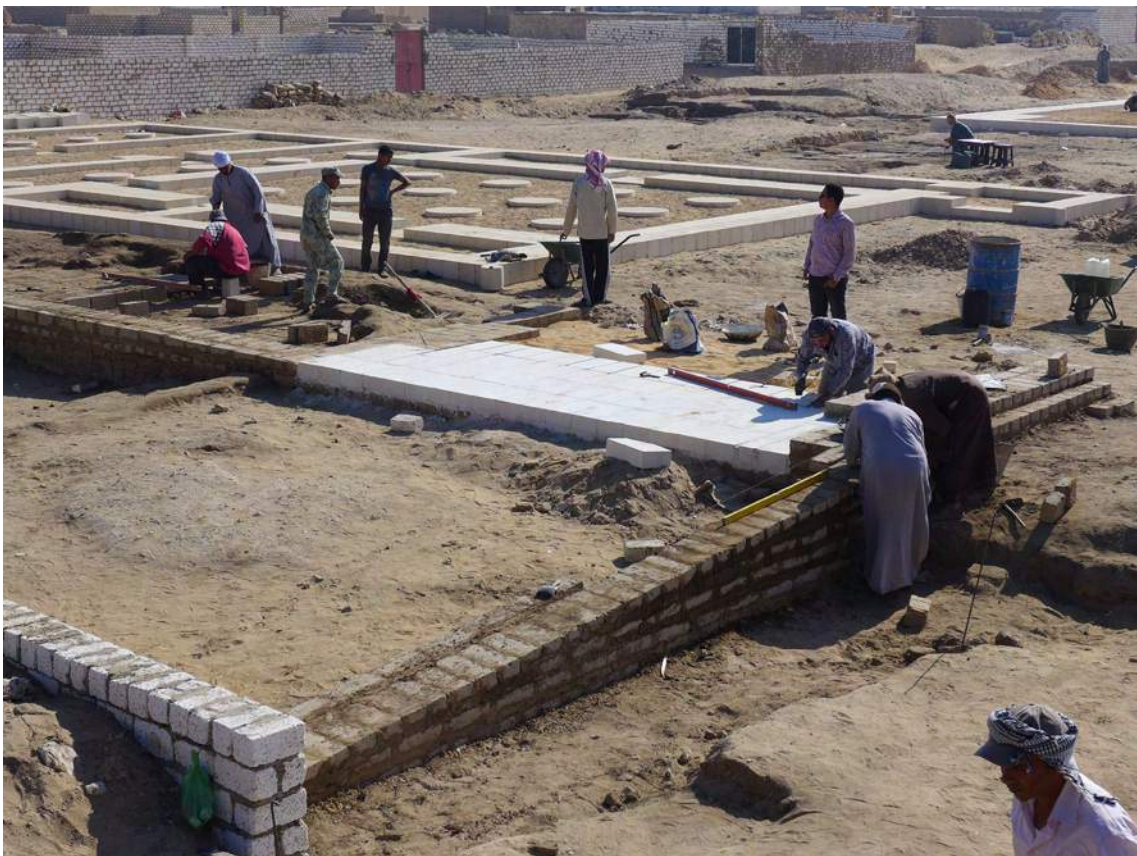
*Repairs to the mud-brick pylon of the temple, with recreation of the limestone threshold.*

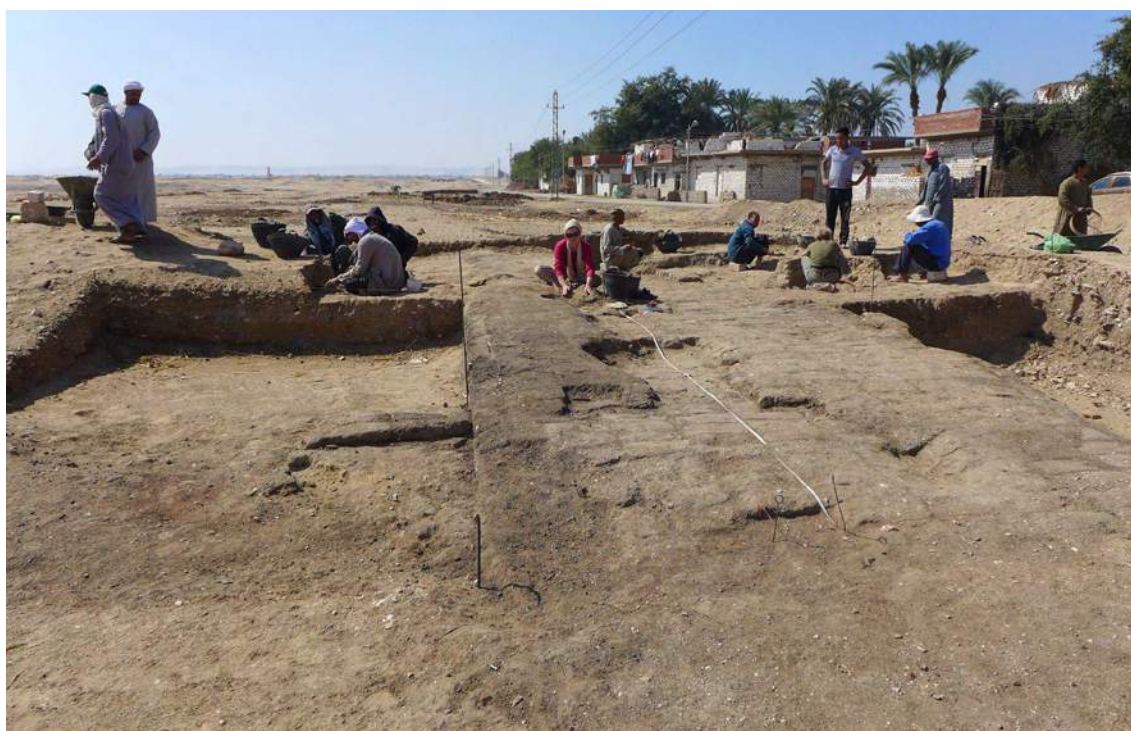
*Figure 2. View, to the south, of the mud-brick southern pylon in the course of excavation.*

A large spoil heap that had buried the southerly of the two mud-brick outer pylons was removed, exposing the remains of the pylon itself. This was 4.25 m thick and reached a length of at least 15 m (the southern end has not been reached this season). At some time in the past the bricks of the pylon have been extensively robbed, and what looks like a long mixing pit made in the middle, in which bricks have been turned into a mud mix, perhaps for the making of newer bricks at a more convenient size. On the east side, the spoil heap also covered a firm floor of trampled earth and mud. This is probably the original floor surface that belongs to the second phase of the temple's history. A vertical section cut through this by the Pendlebury expedition had left the mud floor of the earlier temple visible. Where it joins the base of the pylon, a narrow foundation trench was discovered in which the mud bricks of the pylon had been laid.

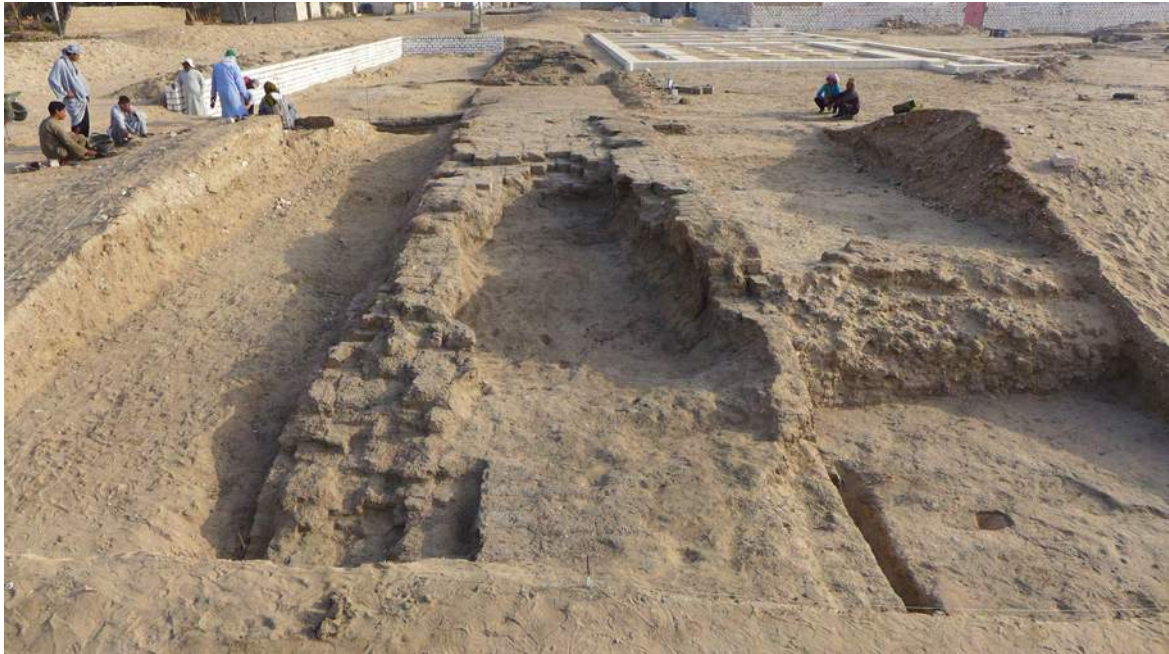
**Figure 3.** The south pylon tower of the mud-brick pylon, fully excavated, showing the large mixing pit made within it. View to the north.

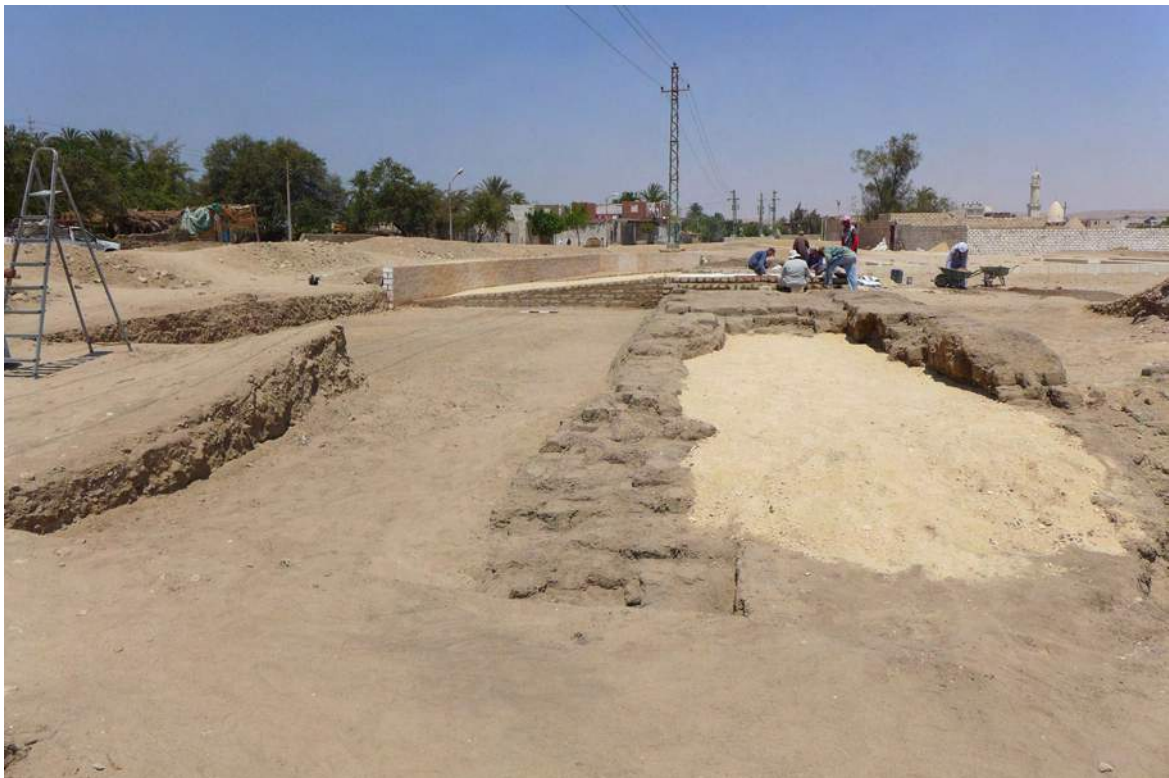
**Figure 4.** The south pylon tower at the end of the excavation, with the mixing pit filled with rubble and sand ready for final layers of mud brick planned for next year.

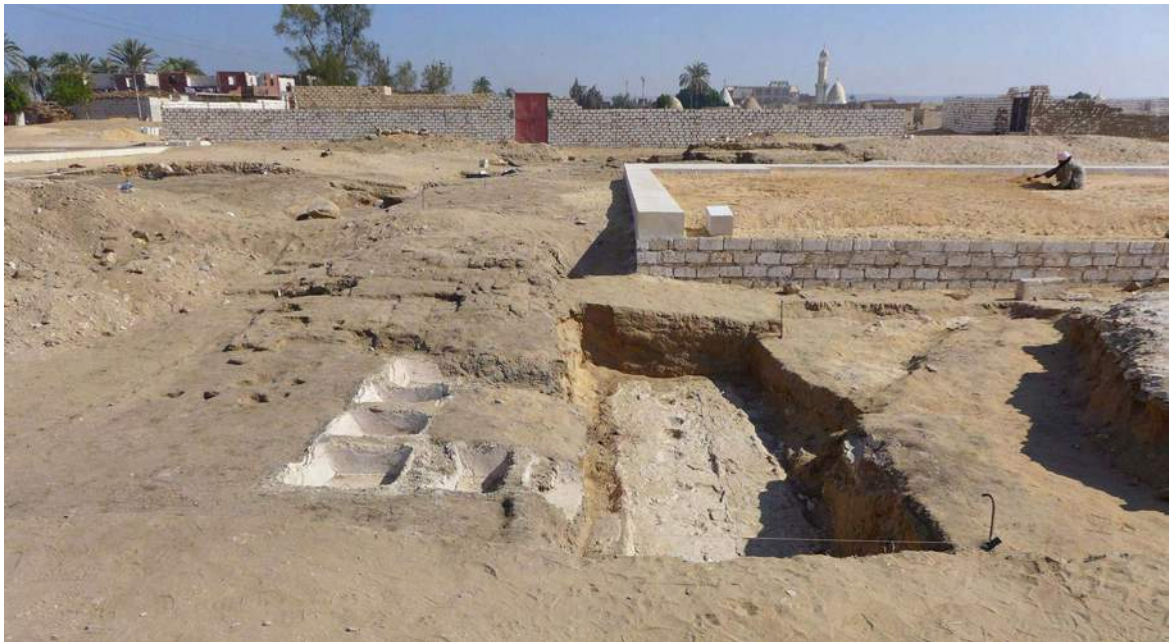
*Figure 5.* In the centre of the picture (and looking to the north) is the foundation trench for the stone wall of the second temple. It has cut through a set of basins lined with gypsum, which lie on the left. In the background is the North Pedestal (Area F), a set of foundations made to support the northern colonnade of the portico.

This area lies along the original axis of the temple. All that survives is the mud floor of the first temple. A set of rectangular basins was discovered, cut into the floor and lined with a thick layer of white gypsum plaster.

They had been arranged around the four sides of a rectangular pedestal made of mud and also coated with gypsum plaster. It had been 1.10 m wide, but along its length only around half survived. The remainder had been destroyed in the Amarna Period when the second temple was built. Then a deep trench had been dug through it, to contain the foundations for a stone wall. Before this had happened, the basins had been completely filled with mud and made invisible.

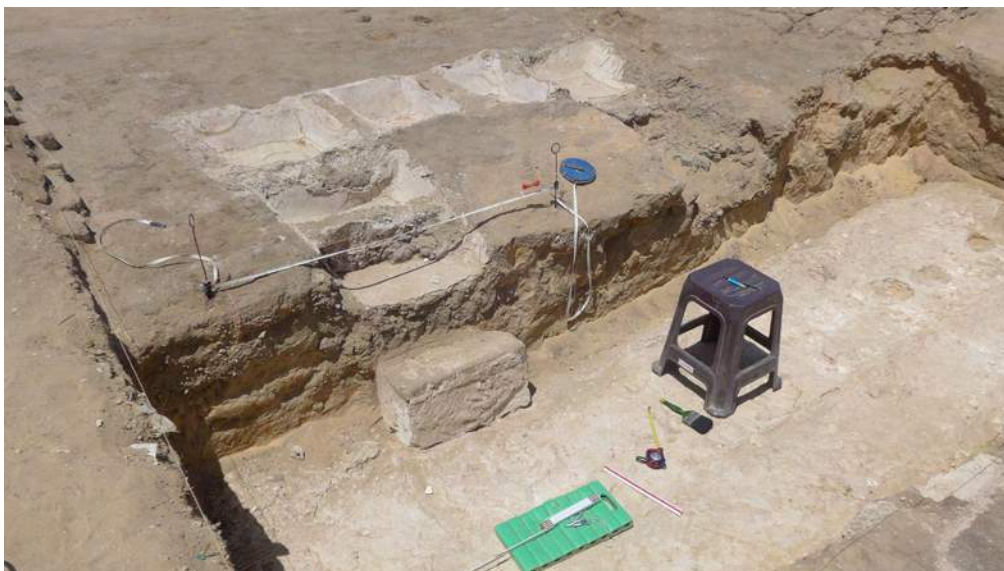
*Figure 6.* The set of basins, lined with gypsum, that have been cut through by the trench for the second temple. View to the north-west.

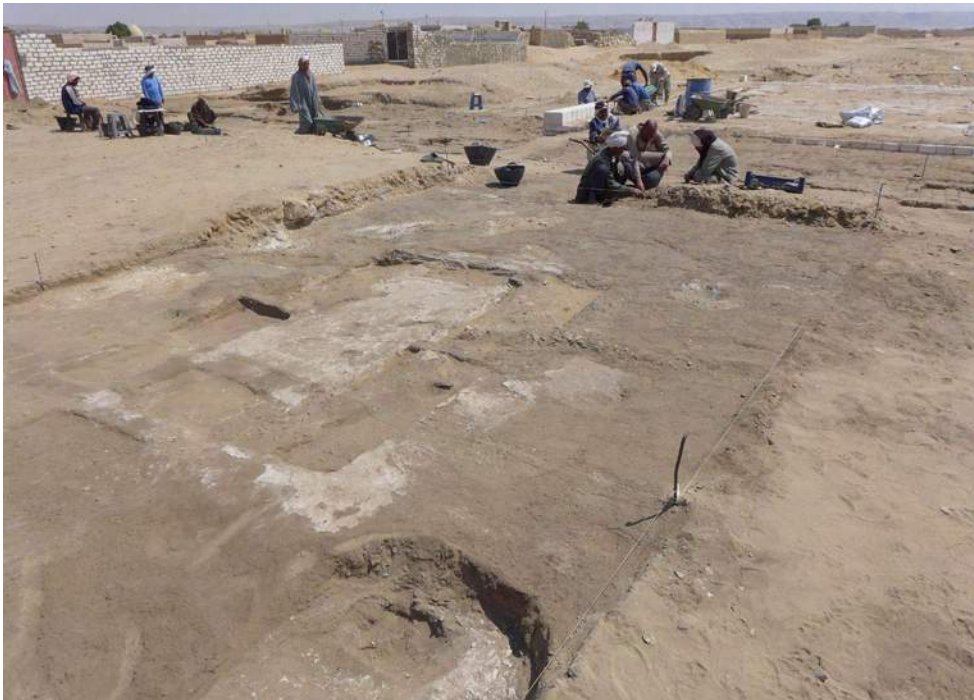
**Figure 7.** An east-west strip between the Small Palace and the North Platform (Area F) was surfaced with a thick mud floor. A set of rectangular basins, lined with gypsum plaster, had been made within this floor. View to the north-east. At this stage in the excavation the basins were still filled with sand.

This strip of ground is next to a 5-metre wide strip excavated last year. Within it, a further set of rectangular basins lined with gypsum plaster has been revealed, surrounding a rectangular platform of mud coated with gypsum, measuring 1 x 2 m.

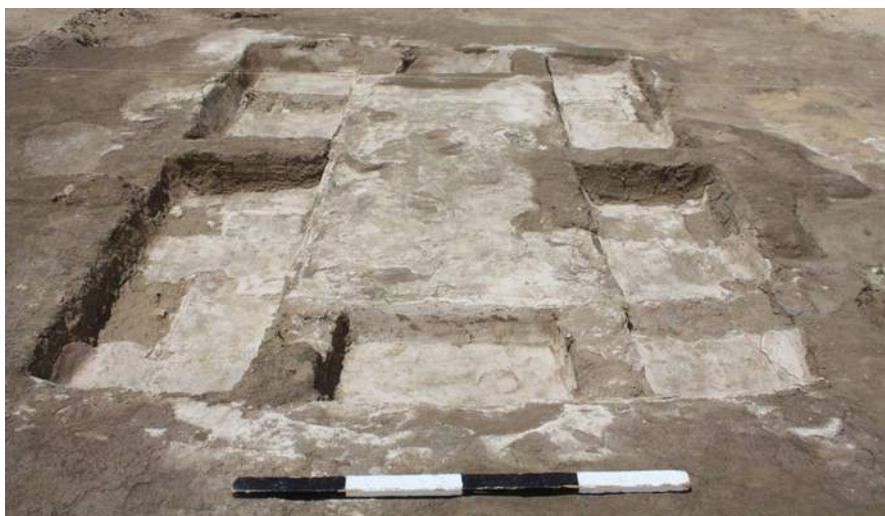
**Figure 8.** The set of gypsum-lined basins in Area C, viewed to the east. The basins were being renovated when the temple was abandoned. The renovation was making the basins wider. The dividing walls had not yet been plastered.

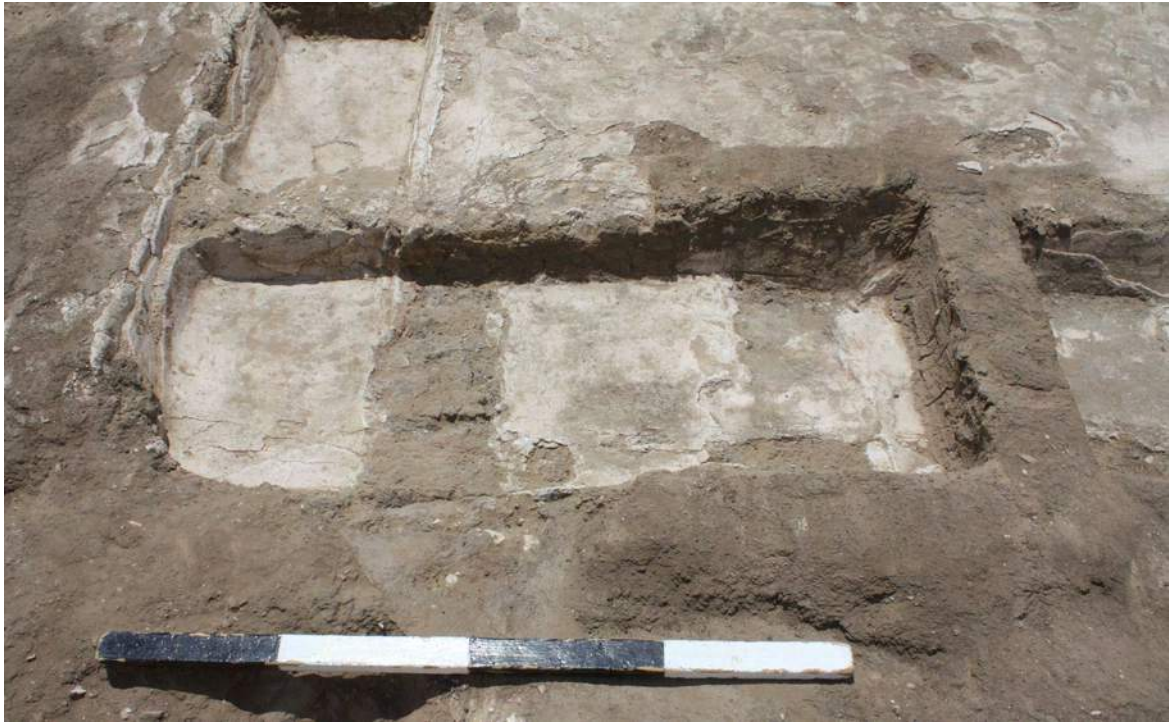
*Figure 9. Detailed view, looking to the south, of the gypsum-lined basins that were in the process of renovation when the temple was abandoned. This basin was being widened and lengthened at the same time.*

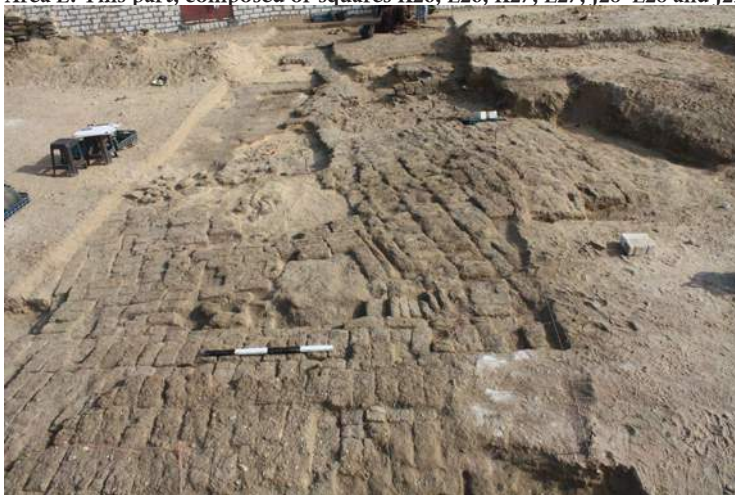
*Figure 10. View to the north along the brick wall and foundation for a construction ramp at the north-west corner of the second temple.*

Here the brickwork turns the corner of the large gypsum platform to run eastwards, and also puts out an extension to the north, at an angle to the temple axis. Our interpretation is that this is the remains of a ramp that allowed the large stones that were to form the columns on the concrete platform to be dragged upwards on to a bank of sand kept in place by the thick wall. After the columns had been erected, wall and ramp were demolished. They had originally been built over a thin layer of sand that had covered the mud floor of the first temple. Traces were found of an original cover of white plaster and of several mud-brick offering-tables that also belonged to the first period of temple building.

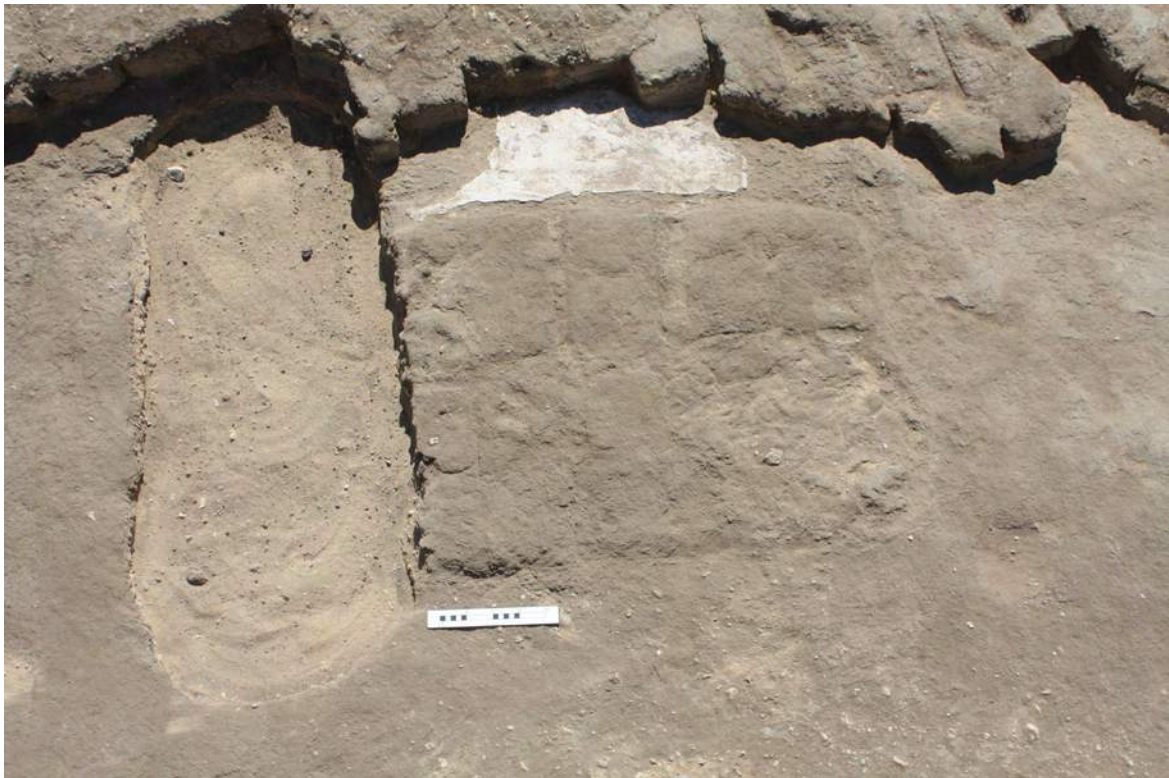
**Figure 12.** At the top runs the brickwork of the construction ramp of the second temple. Beneath it is an area of white-plastered earlier mud floor, on which lie the remains of a rectangular offering-table of mud brick. An early modern grave pit is to the left. View to the east.

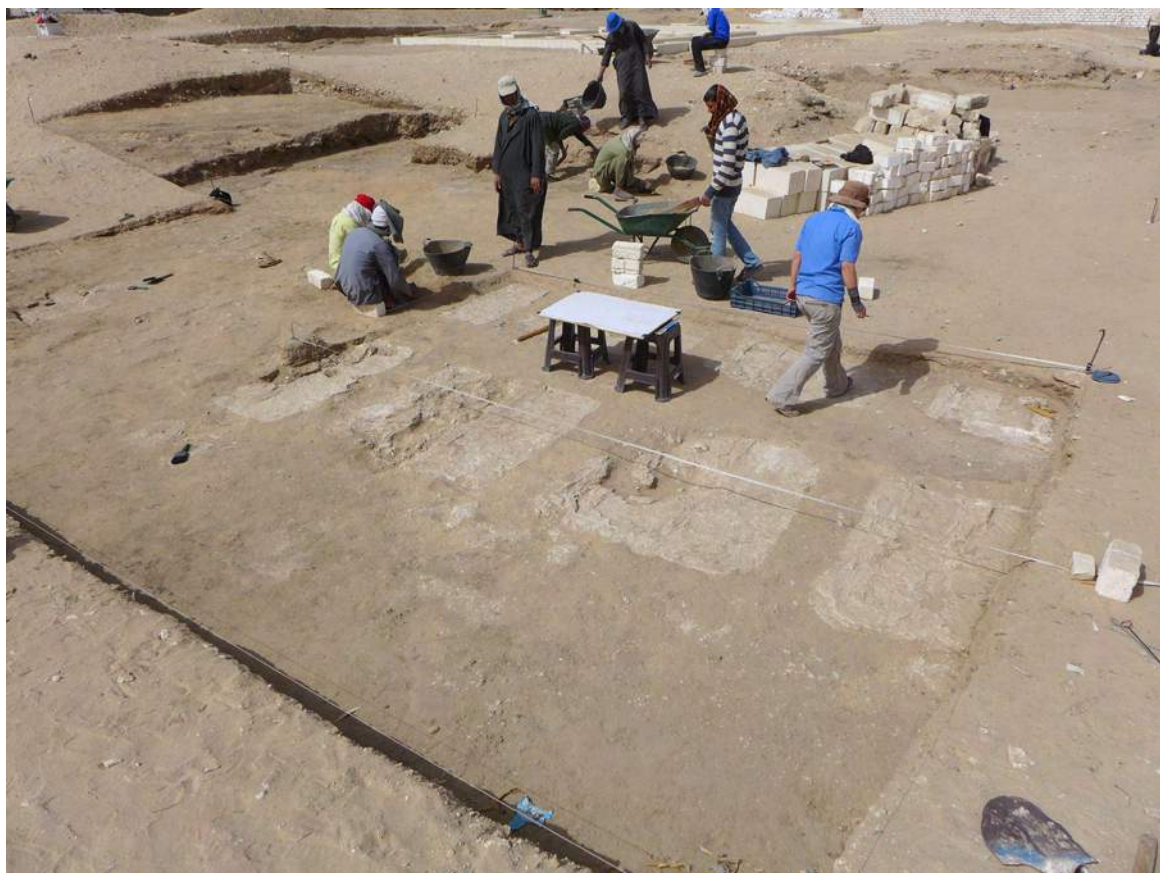
**Figure 13.** Central zone of Area E. Part of two rows of rectangular foundations, made from gypsum concrete, for offering-tables made from limestone blocks. They belong to the first temple and were either demolished or buried when the temple was rebuilt. View to the north west.

The central zone is the remains of a wide trench excavated in 1932. This had removed the sand and rubble levelling layer completely, so that the mud floor of the first temple lay close beneath the surface. In squares L27 and K27 two lines of rectangular gypsum foundations (1.40 x 1.10 m) were found, each intended to support the stones of offering-tables. These had been first discovered in 1932. Seven of the foundations were uncovered in each of the rows.

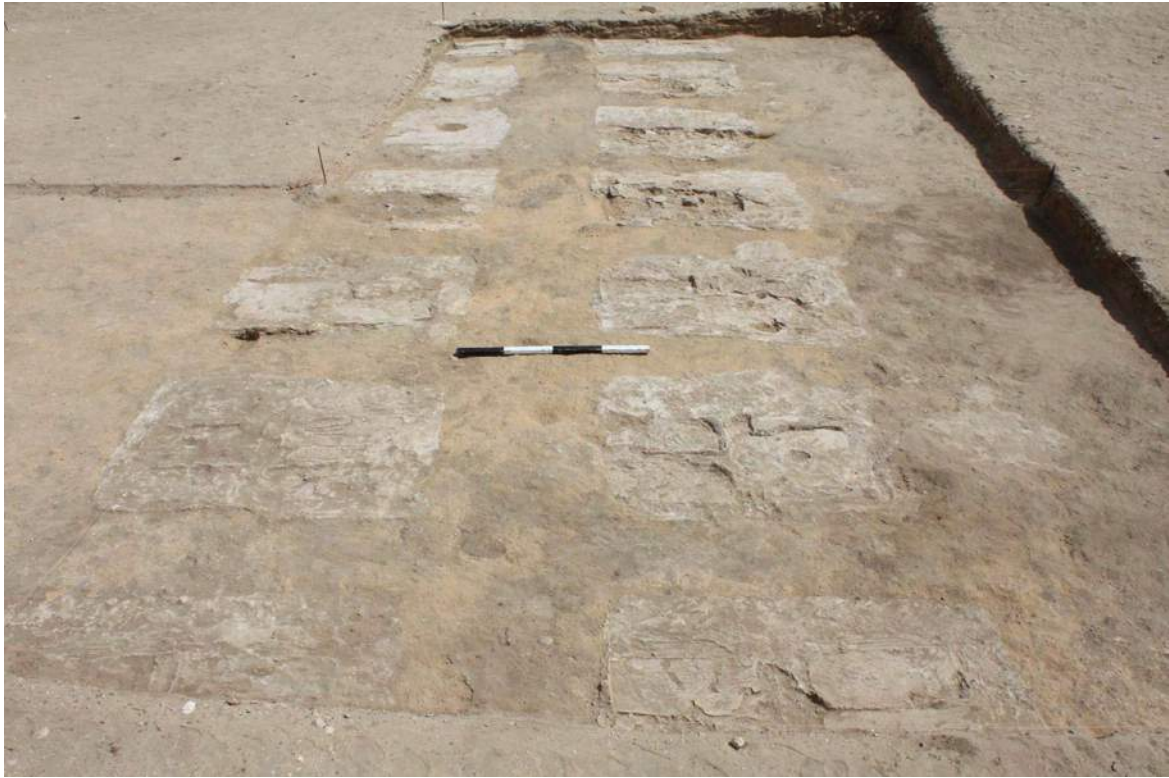
**Figure 14.** Central zone of Area E, the two rows of bases for stone offering-tables belonging to the first temple. Viewed to the east.

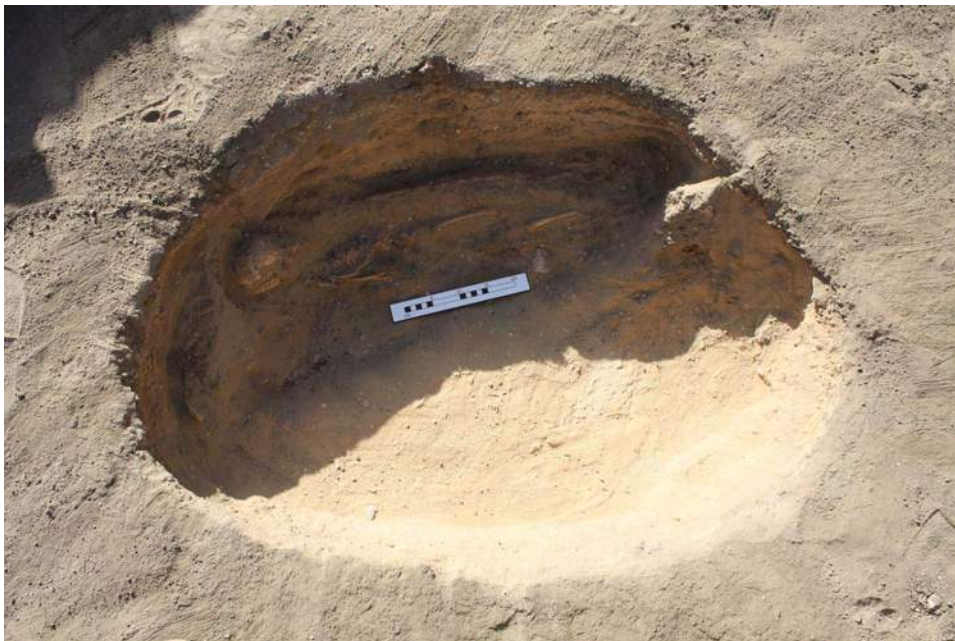
**Figure 15.** Southern zone of Area E. The burial of a child, made before the deposition of the layer of rubble on which the floor of the second temple was made. View to the south-east.

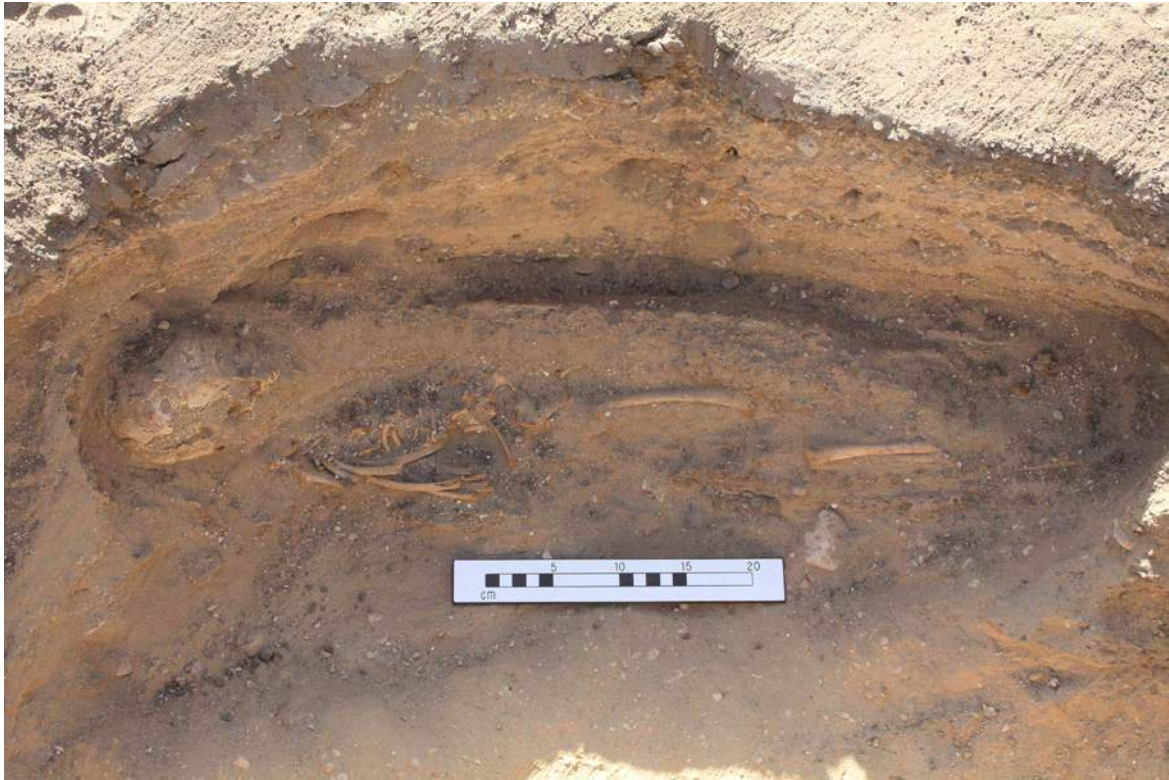
**Figure 16.** The child burial, in the remains of a simple stick coffin. The burial had been slightly disturbed.

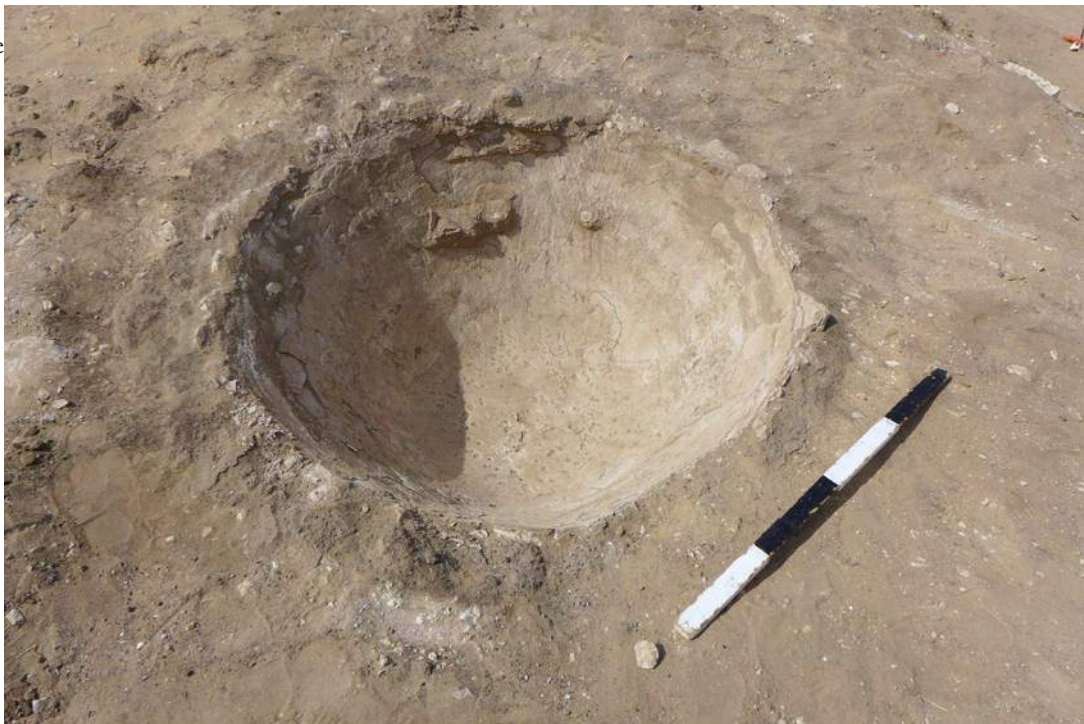
**Figure 17.** Southern zone of Area E. Gypsum-lined basin of the second temple, dug into the layer of levelling rubble that covered the first temple. View to the north-west.

The southern zone (squares K26, L26) was largely occupied by the layer of sand and rubble that had separated the two temple levels. A second deep circular basin, lined with gypsum plaster, had been cut into the upper surface. The rubble was completely excavated only in a space, 3 m wide, in L26. Beneath it ran the well preserved mud floor of the first temple. A small grave, containing the bones of a child within the remains of a simple coffin made of sticks, had been cut into the floor to a depth of only 30 cm. Beneath the jaw was a small and poorly made faience amulet of a god, perhaps Ptah or Isis. The layer of rubble that covered it had included many large pieces of stone, and there was no sign that the grave had been cut down through it. It does appear that the burial is of the Amarna Period.

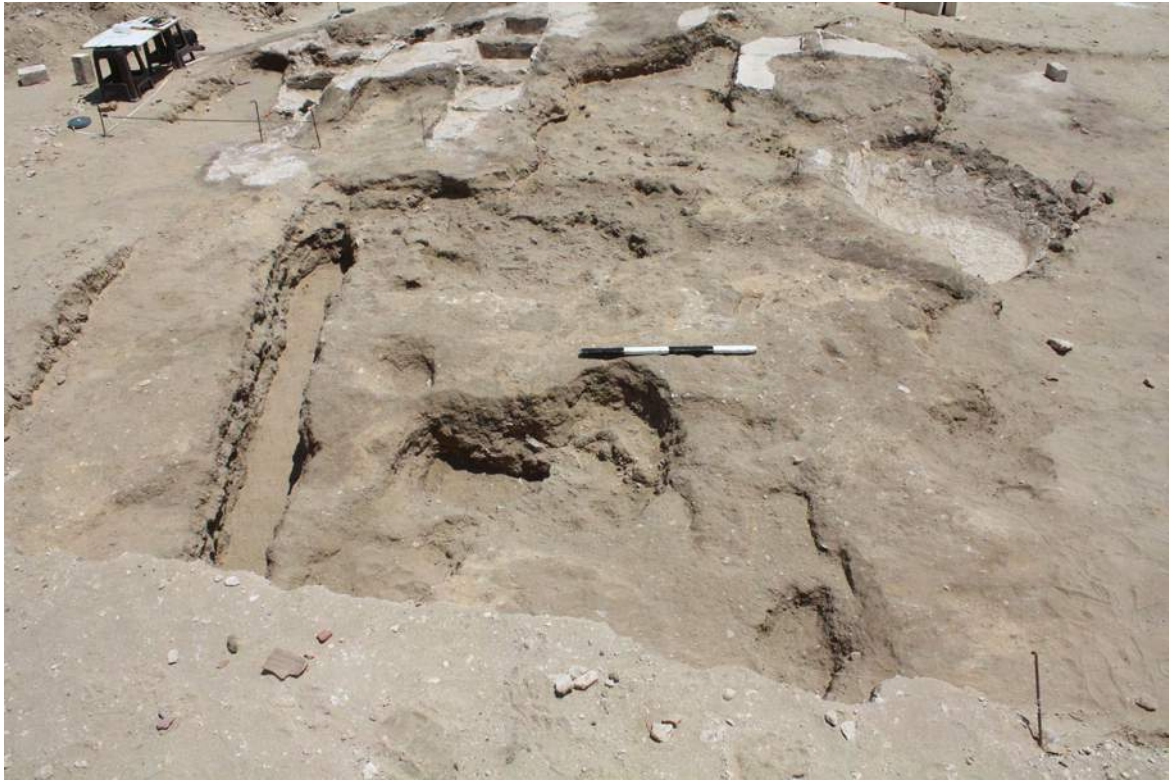
**Figure 18.** Northern zone of Area E. In the foreground the surface of the ground of the second temple has been partly destroyed by the trenches of the 1932 excavation. In the background are the remains of a set of gypsum-lined rectangular basins. View to the east.

The northern zone is a low mound made from the sand and rubble layer that separates the floors of the first and second temples, partly covered by spoil from the 1932 excavation. Excavation revealed two more sets of gypsum-lined basins surrounding rectangular platforms. They had, however, been badly damaged by earlier digging into the surface. A short distance to the south was the remains of a large circular basin, 1.7 m in diameter, also lined with gypsum plaster.

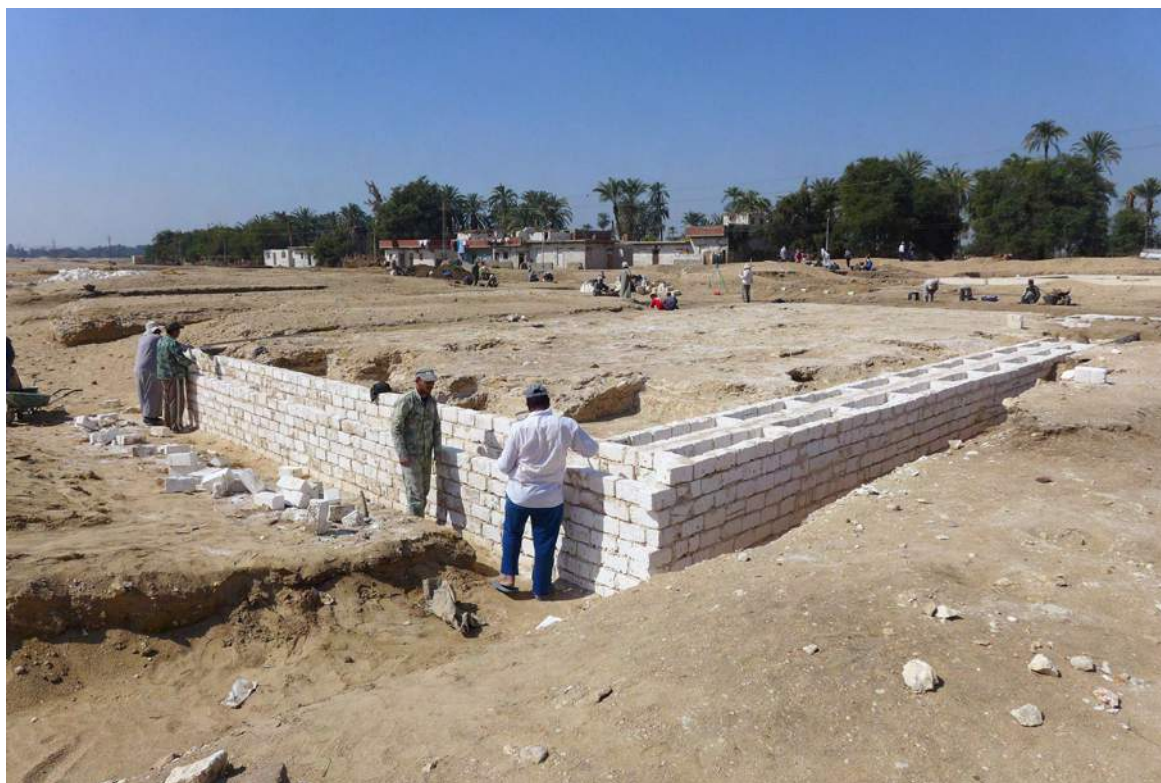
*Figure 20. Area F: the northernmost of the pair of gypsum-concrete foundations for large columns. Here the foundations are being laid for a row of limestone blocks that will recreate the original surrounding wall. View to the south-west.*

As the re-examination of the temple has continued, the team of builders has worked on repair and reconstruction. One job has been the laying out at ground level of the northern set of large column bases on their foundation platform of gypsum concrete (Area F). To achieve this, the deep foundation trenches have been filled with a network of walls of small local limestone blocks. These have provided a solid foundation for a final layer of Tura-limestone blocks cut to *talatat* size. This has been put in place on the north and west sides, the plan being to add the south and east sides next year. The upper surface of the whole rectangle has been filled with a layer of clean sand. The intention is to create on top of this eight circular pads of white cement with a diameter of 2.50 m, occupying the positions of eight huge column bases that stood there originally.

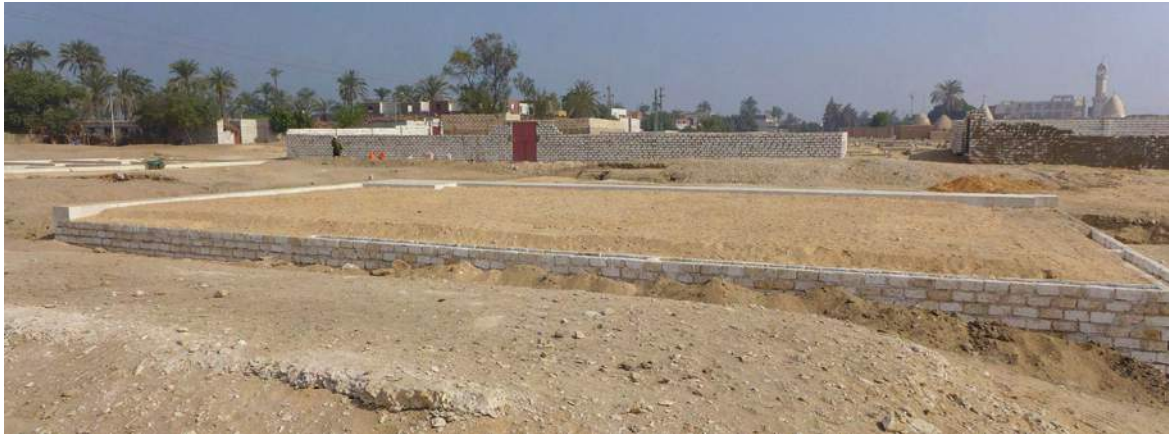
*Figure 21. View northwards of the North Platform at the end of the season. The top layer of fine stone has been laid on the north and west. It remains to do the same on the east and south. The positions of the large columns (eight of them) also need to be marked.*

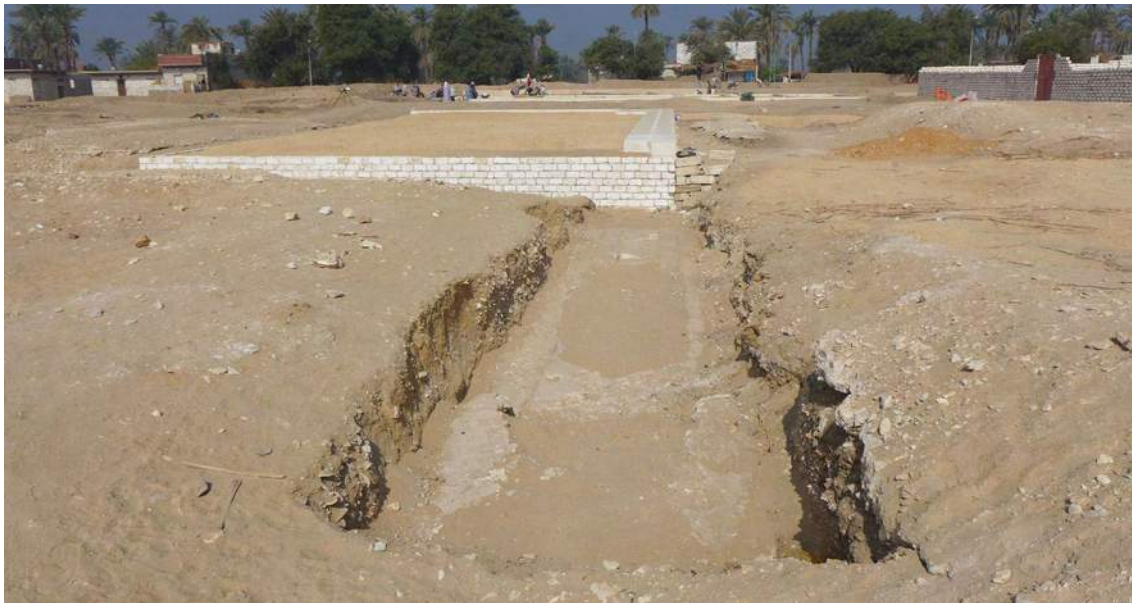
*Figure 22. The North Platform at the end of the season with, in the foreground, a length of the northern temple enclosure wall foundations exposed. In the future this will be filled with stone support for a final layer of fine limestone blocks.*

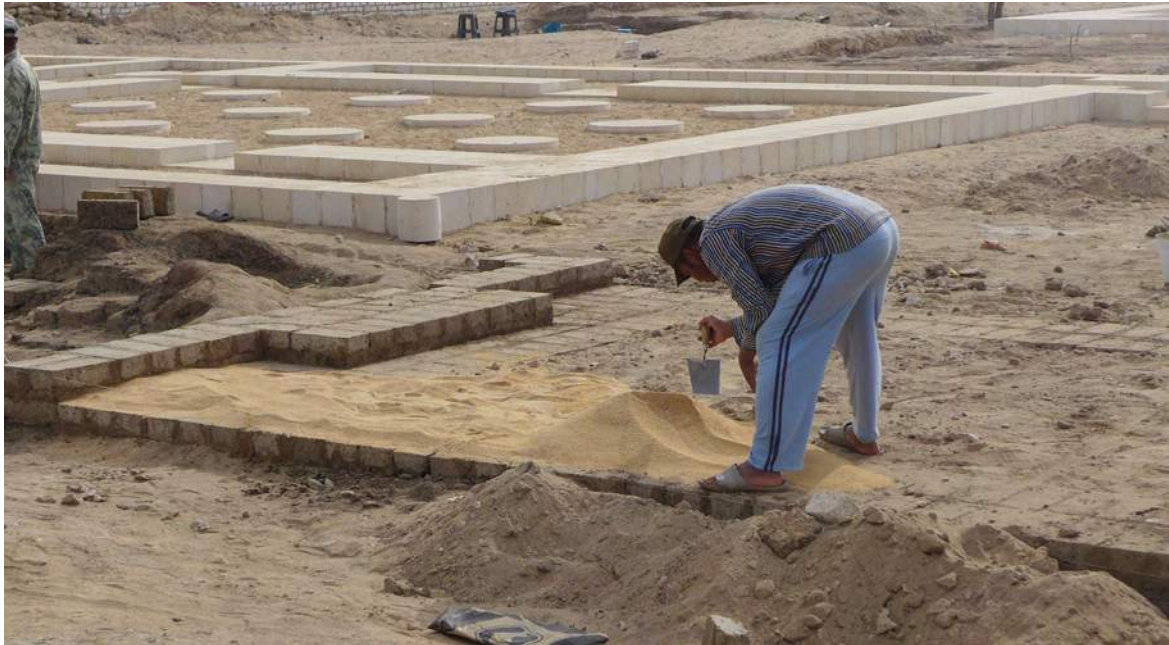
**Figure 24.** The first steps in recreating the threshold between the mud-brick pylons. Laying down a bed of clean sand over a layer of new bricks and pieces of brick rubble. The northern edge of the doorway has been remade in new bricks. View to the north-east.

Repairs have also been done to the mud-brick pylon. We have concentrated on the northern pylon tower, capping the ancient brickwork with newly-made bricks that have also filled deep holes that had been dug into the brickwork in the past. The entrance through the pylon towers is marked by the walls of an approach ramp. This shows that the threshold of the pylon entrance was 6.16 m wide. This surface has been protected with a layer of sand, and over it a single course of Tura-limestone slabs has been laid. At the same time, the sloping side walls of the ramp have been repaired with new courses of bricks, and the surface of the ramp given a layer of clean sand.

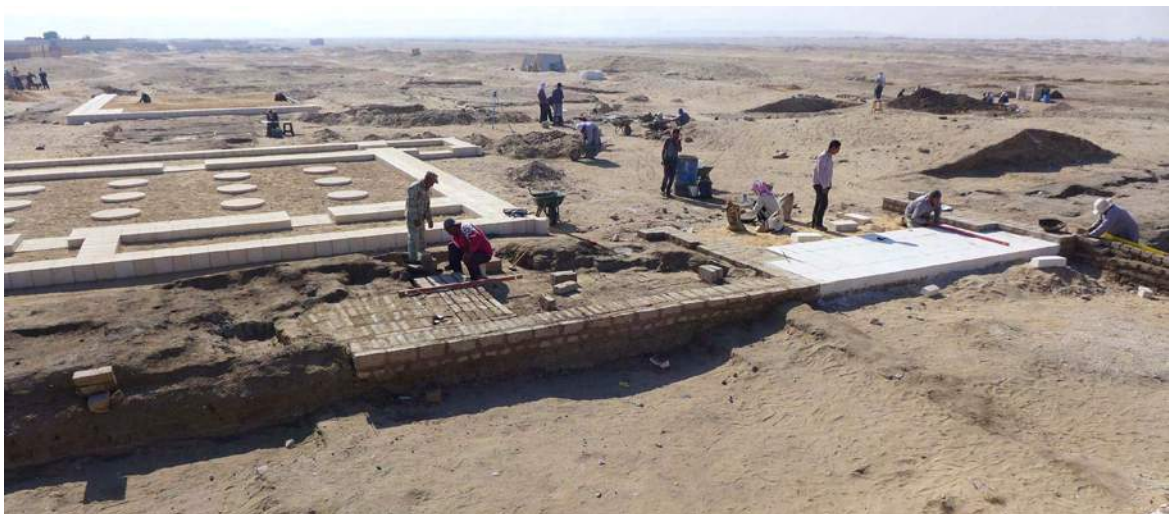
**Figure 25.** Repairing the brickwork of the north pylon tower and laying a new layer of limestone blocks to recreate the threshold of the entrance. View to the east.

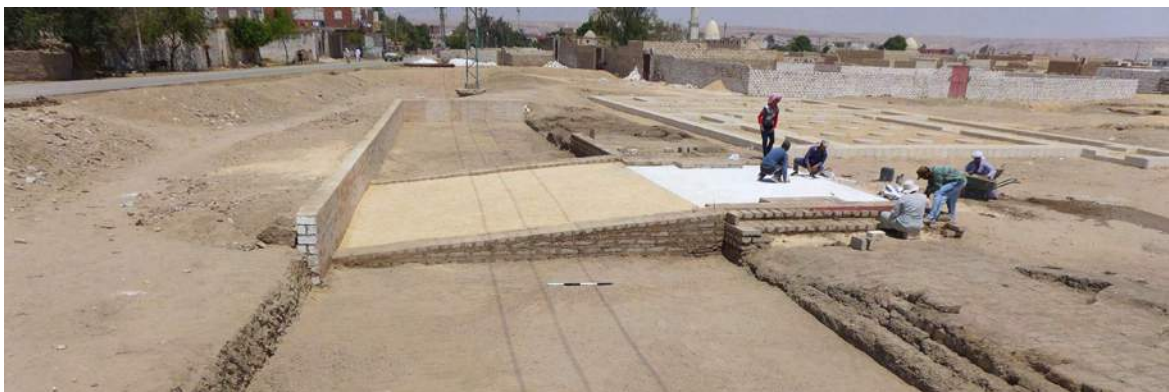
**Figure 26.** The mud-brick pylons and temple entrance, at the end of the season. View to the north.

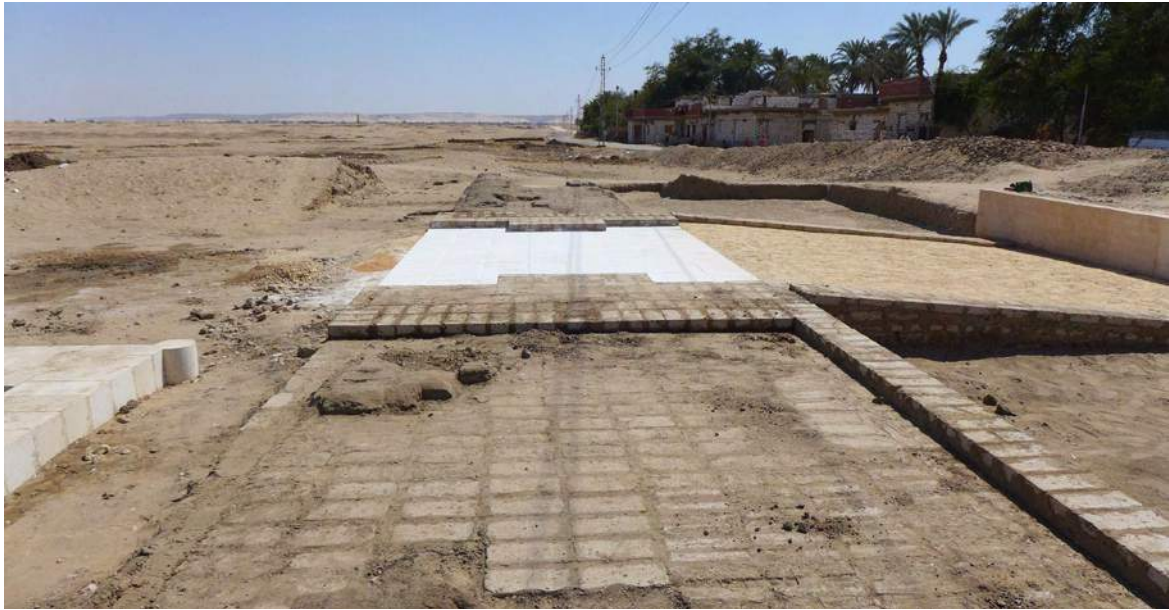
*Figure 27. The mud-brick pylons and temple entrance, with approach ramp, at the end of the 2014 season. View to the south.*

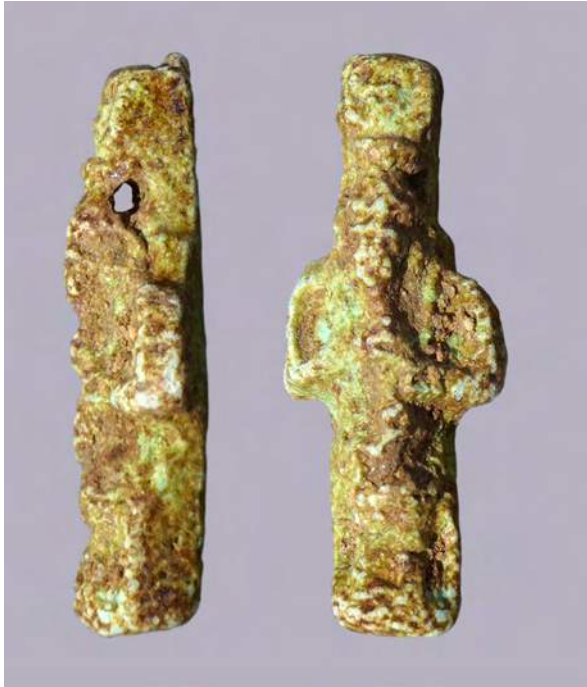
*Figure 28. A faience amulet, perhaps of the god Ptah, perhaps of the goddess Isis, found at the neck of the child burial in Area E, southern zone. Height 3.5 cm. Object no. 40256.*

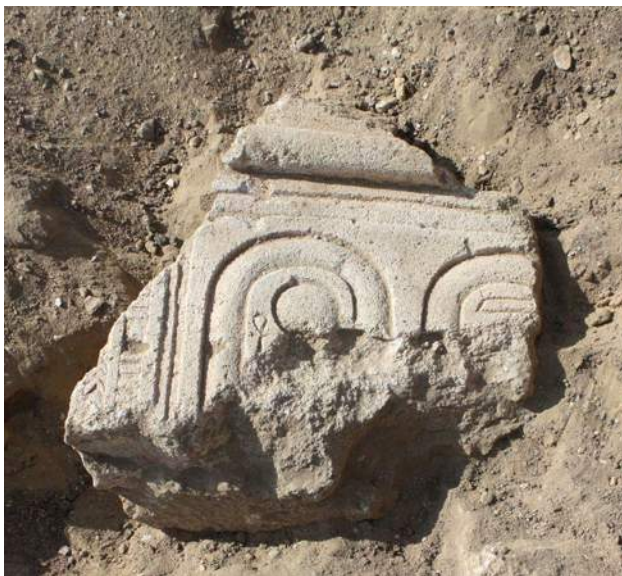
*Figure 29. Fragment of limestone cornice or lintel bearing the names of the Aten, probably in their later form. Area E, southern zone.*

Within the rubble, in addition to mud bricks, lay pieces from sandstone columns of large diameter, part of a limestone cornice or architrave bearing the cartouches of the Aten (probably the later version), a piece of balustrade carved in indurated limestone and the mid-part of a limestone statue, roughly two-thirds life size, of a royal woman clad in an elaborately pleated garment.

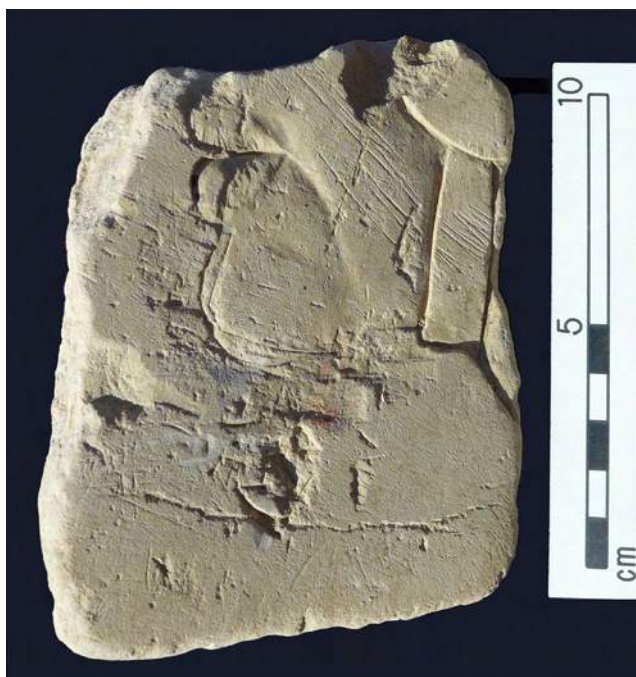
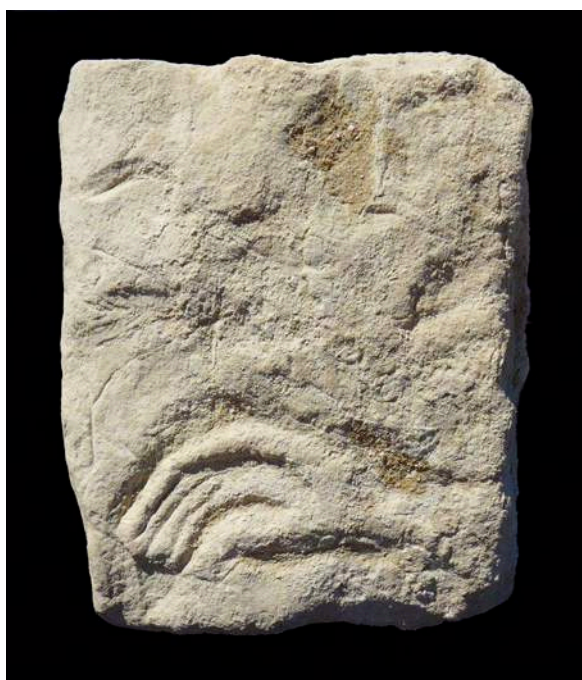
*Figure 30. Limestone trial piece, object no. 40257. On one side is a carving, in sunk relief, of the chin and lips of a man wearing either a helmet or an unusual style of hair. On the other side is a rough carving of a human hand and wrist, perhaps the end of an Aten ray.*
