British Mission to Tell el-Amarna

## Great Aten Temple Spring 2014 Season

### Preliminary Report

Barry Kemp

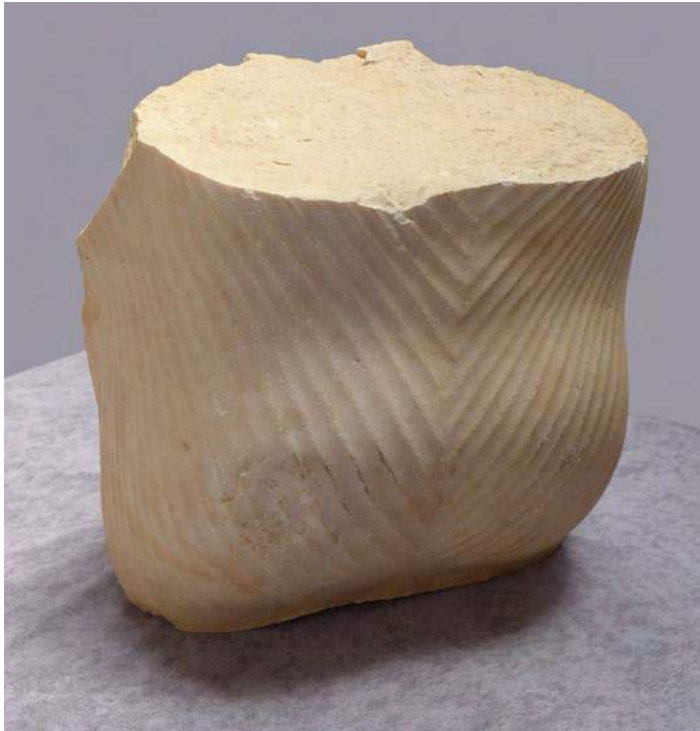
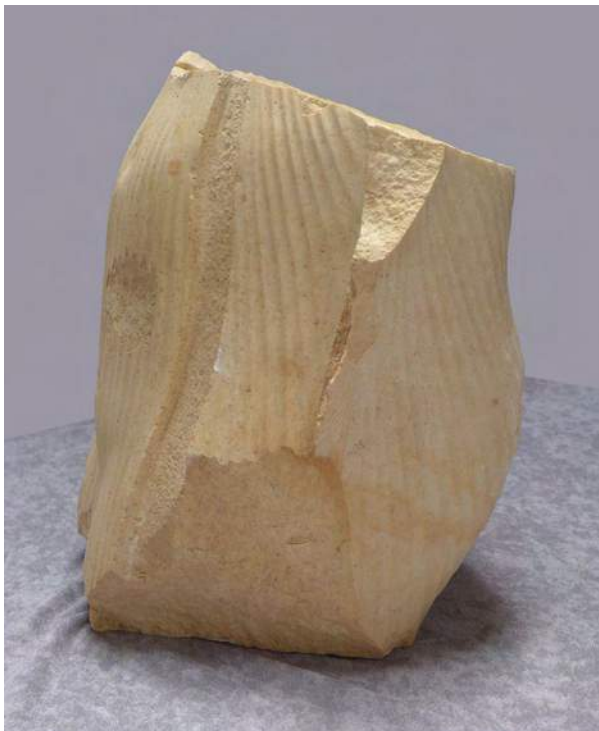
*Figure 31. Limestone torso of a female figure draped in linen. The deep groove visible on the left side was originally filled with red pigment, to depict a long red sash. Height 30 cm. Sculpture no. S-8264.*

Within the rubble, in addition to mud bricks, lay pieces from sandstone columns of large diameter, part of a limestone cornice or architrave bearing the cartouches of the Aten (probably the later version), a piece of balustrade carved in indurated limestone and the mid-part of a limestone statue, roughly two-thirds life size, of a royal woman clad in an elaborately pleated garment.

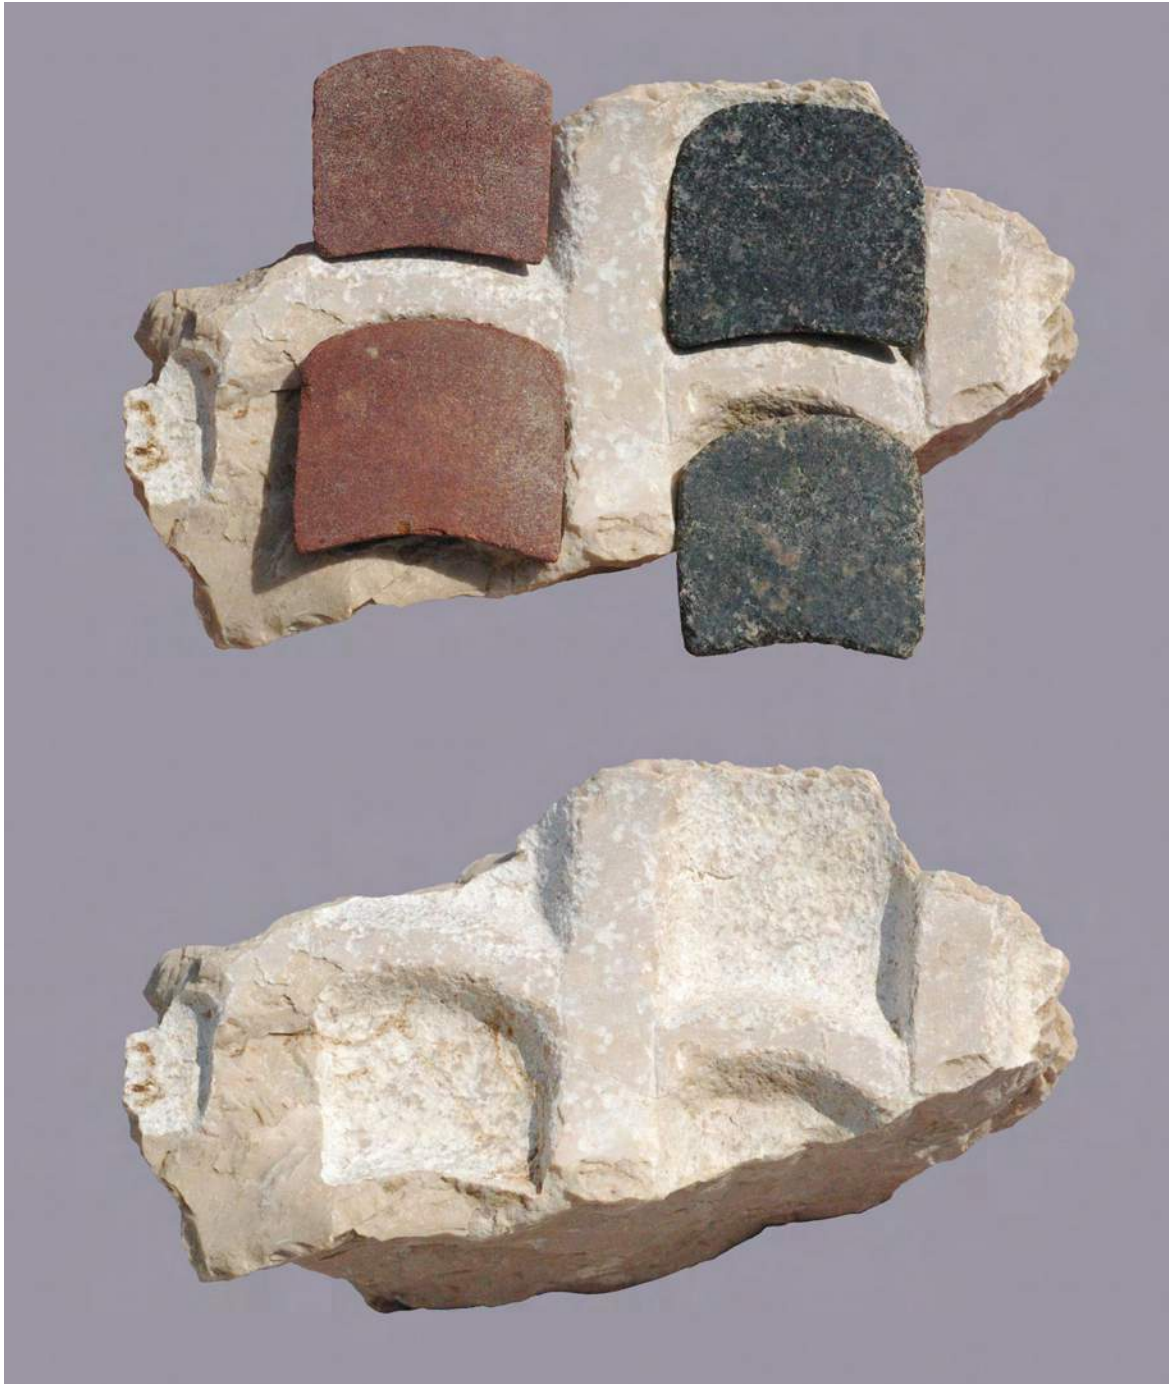
**Figure 32.** Fragment of cornice or lintel made from indurated limestone, S-8326. The spaces cut into the surface were for inlaid pieces cut from quartzite and grano-diorite, of which several examples have been found individually. In the top picture a selection of four has been inserted to illustrate the style of decoration.
