British Mission to Tell el-Amarna

Great Aten Temple Spring 2014 Season

Preliminary Report

Repairs to the mud-brick pylon of the temple, with recreation of the limestone threshold.

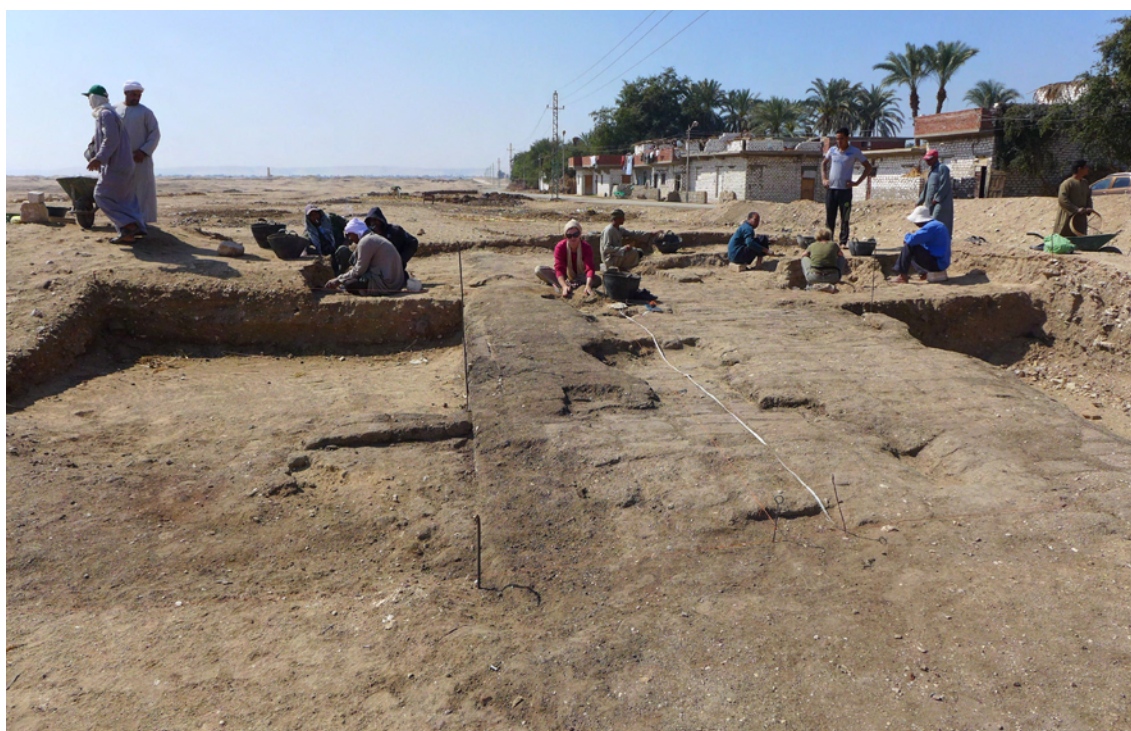
Figure 2. View, to the south, of the mud-brick southern pylon in the course of excavation.

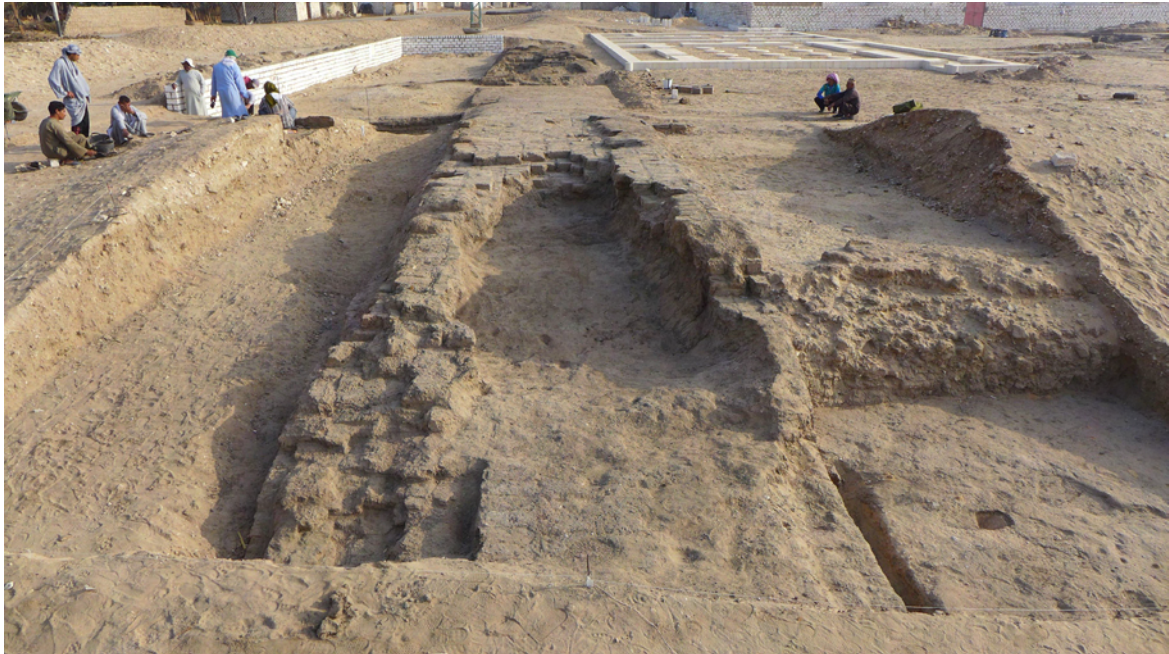
Figure 3. The south pylon tower of the mud-brick pylon, fully excavated, showing the large mixing pit made within it. View to the north.

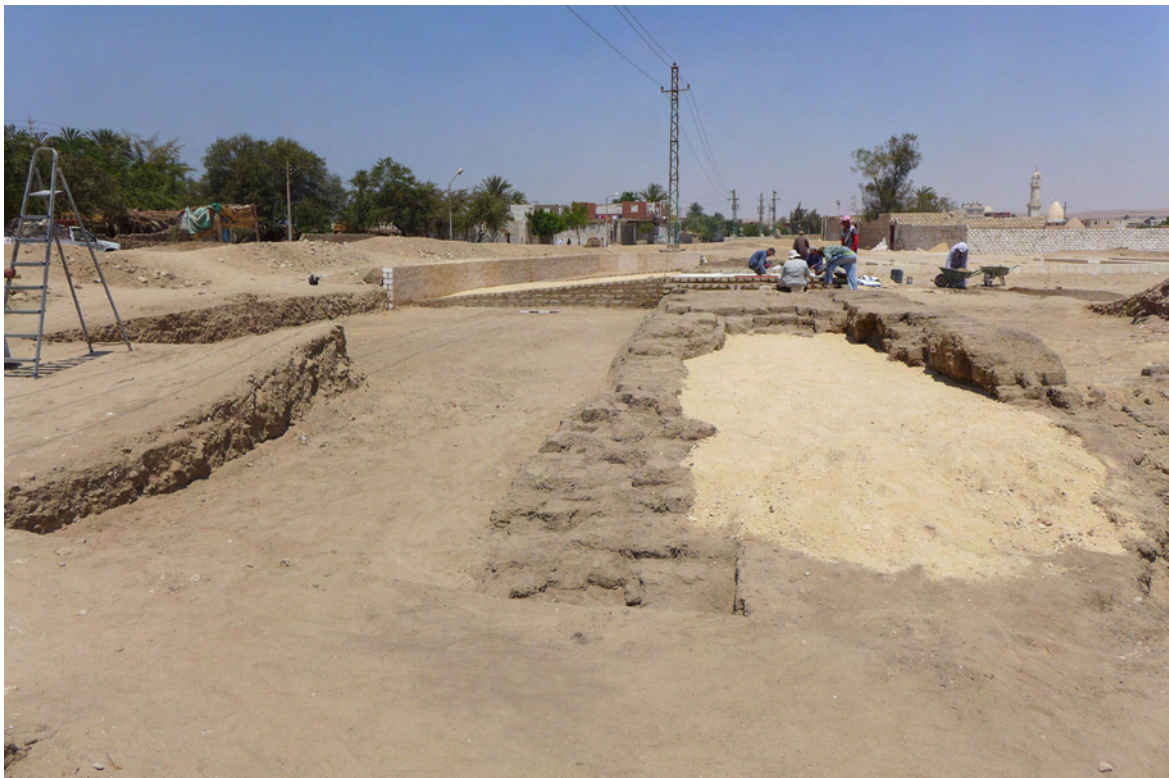
Figure 4. The south pylon tower at the end of the excavation, with the mixing pit filled with rubble and sand ready for final layers of mud brick planned for next year.

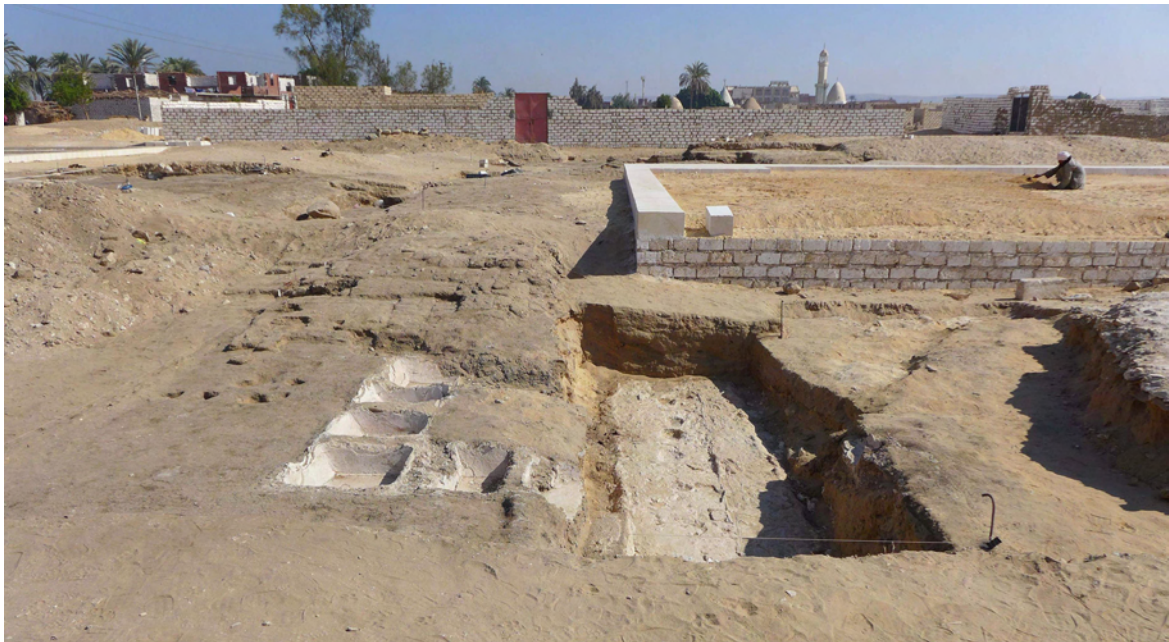
Figure 5. In the centre of the picture (and looking to the north) is the foundation trench for the stone wall of the second temple. It has cut through a set of basins lined with gypsum, which lie on the left. In the background is the North Pedestal (Area F), a set of foundations made to support the northern colonnade of the portico.

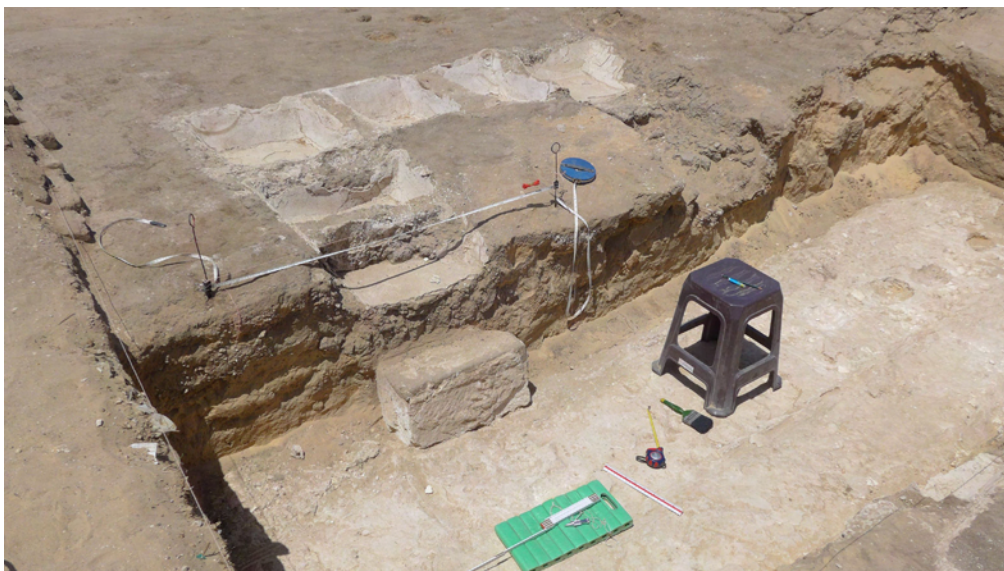
Figure 6. The set of basins, lined with gypsum, that have been cut through by the trench for the second temple. View to the north-west.

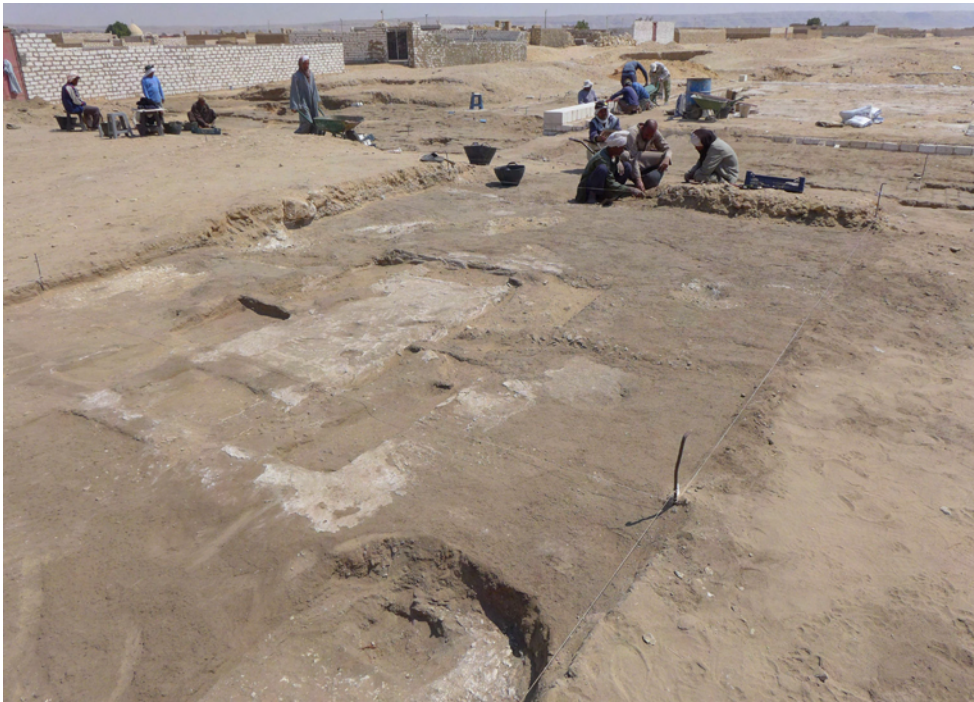
Figure 7. An east-west strip between the Small Palace and the North Platform (Area F) was surfaced with a thick mud floor. A set of rectangular basins, lined with gypsum plaster, had been made within this floor. View to the north-east. At this stage in the excavation the basins were still filled with sand.

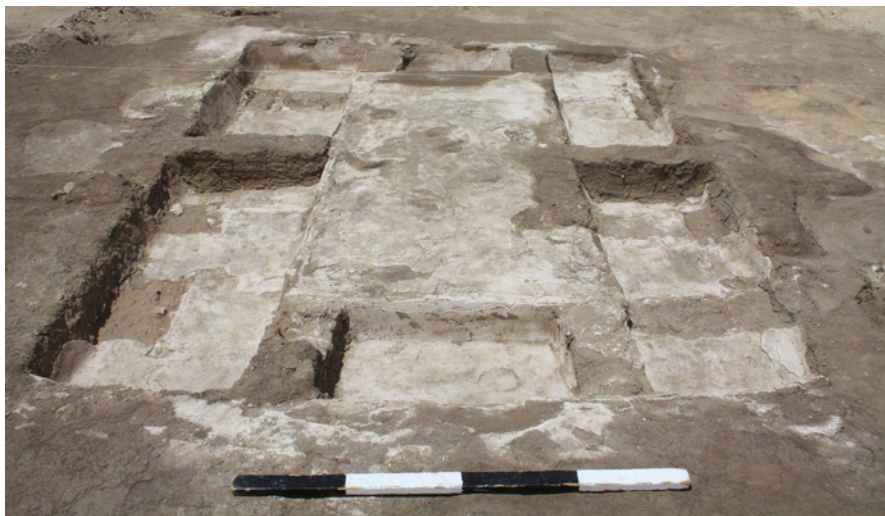
Figure 8. The set of gypsum-lined basins in Area C, viewed to the east. The basins were being renovated when the temple was abandoned. The renovation was making the basins wider. The dividing walls had not yet been plastered.

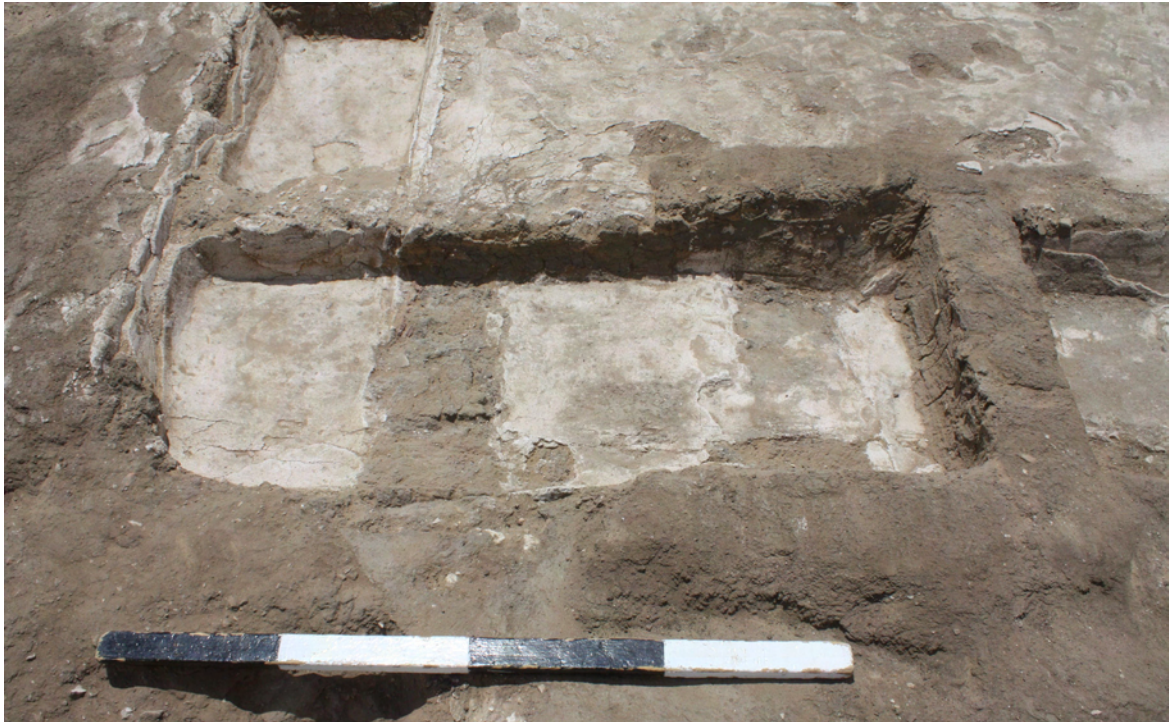
Figure 9. Detailed view, looking to the south, of the gypsum-lined basins that were in the process of renovation when the temple was abandoned. This basin was being widened and lengthened at the same time.

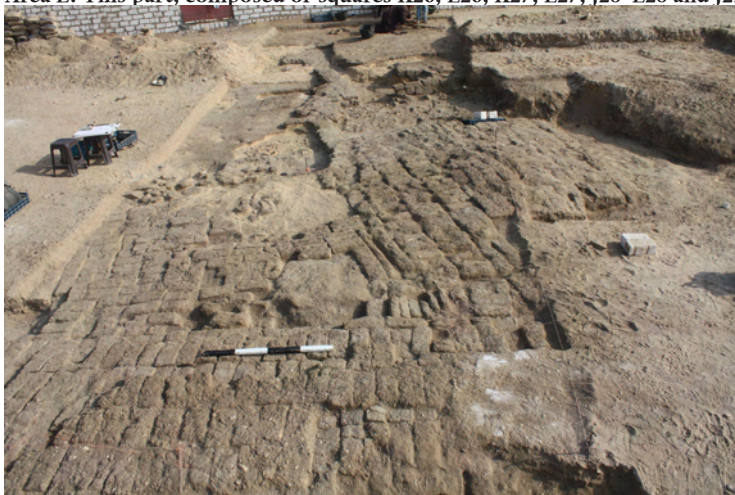
Figure 10. View to the north along the brick wall and foundation for a construction ramp at the north-west corner of the second temple.

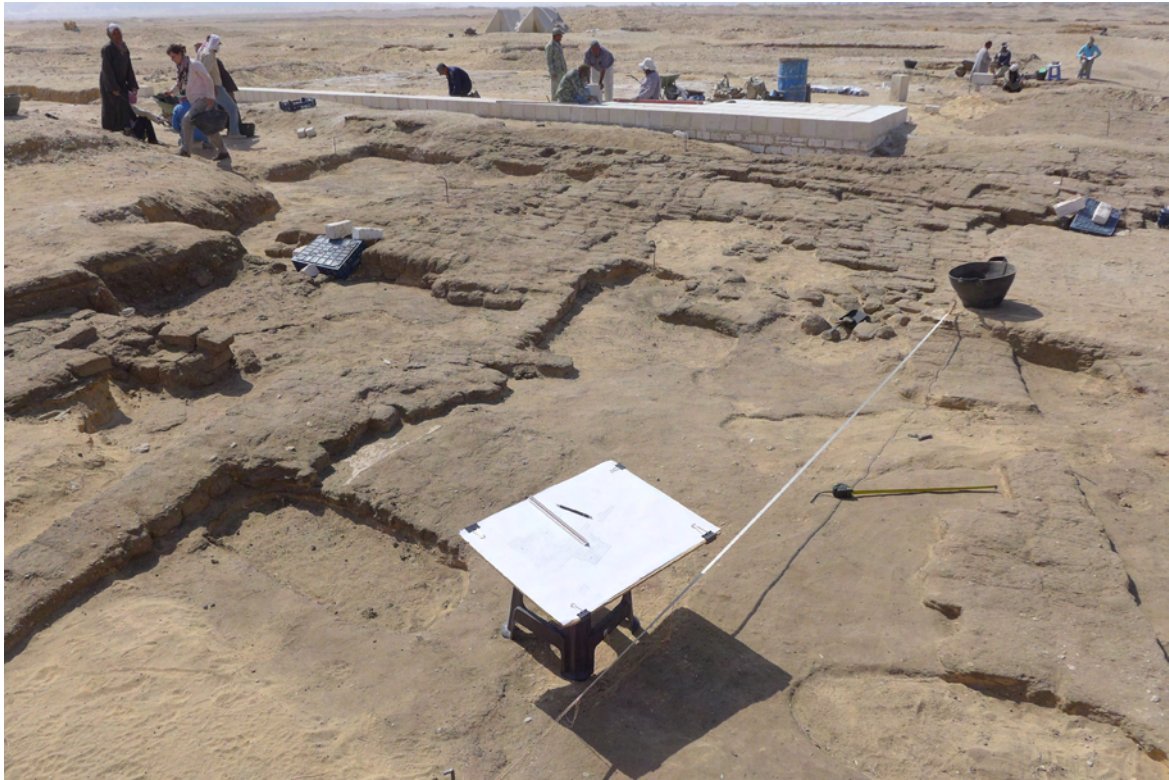
Figure 11. View southwards across Area D. Most of the brickwork belongs to the construction ramp and wall of the second temple. Early modern grave pits are visible, as is a single mud-brick offering-table from the earlier layout and an adjacent patch of white floor.

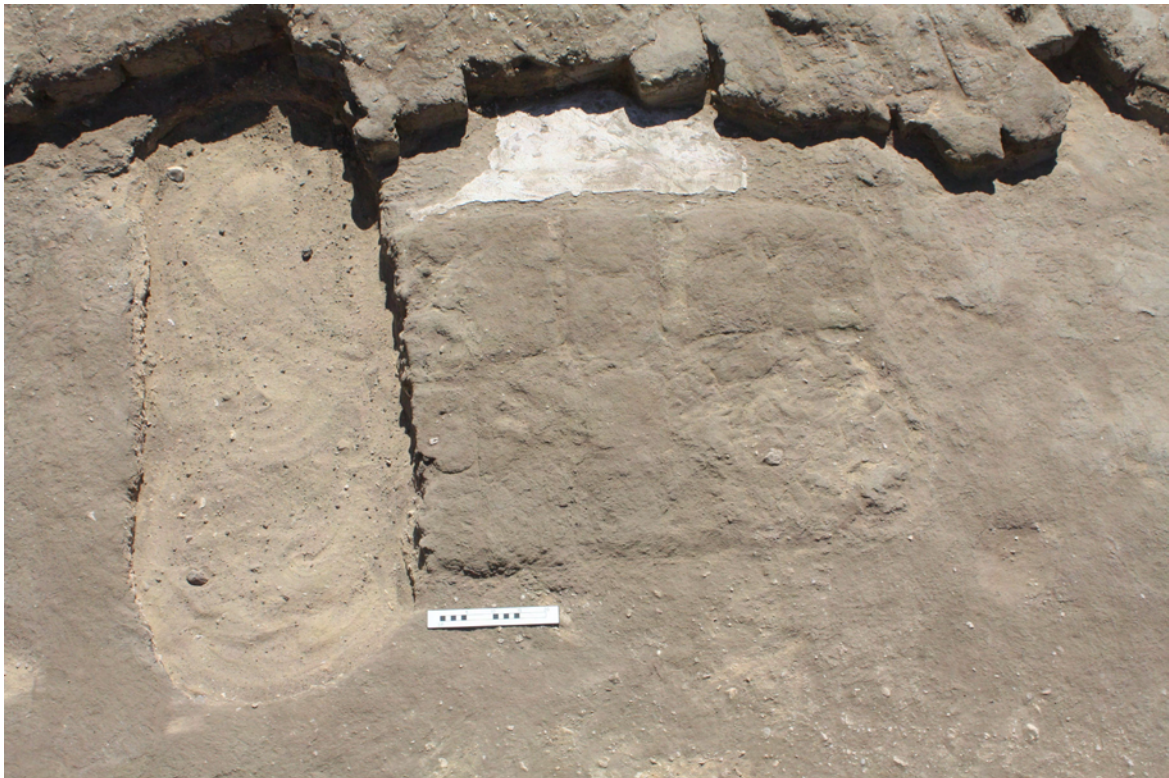
Figure 12. At the top runs the brickwork of the construction ramp of the second temple. Beneath it is an area of white-plastered earlier mud floor, on which lie the remains of a rectangular offering-table of mud brick. An early modern grave pit is to the left. View to the east.

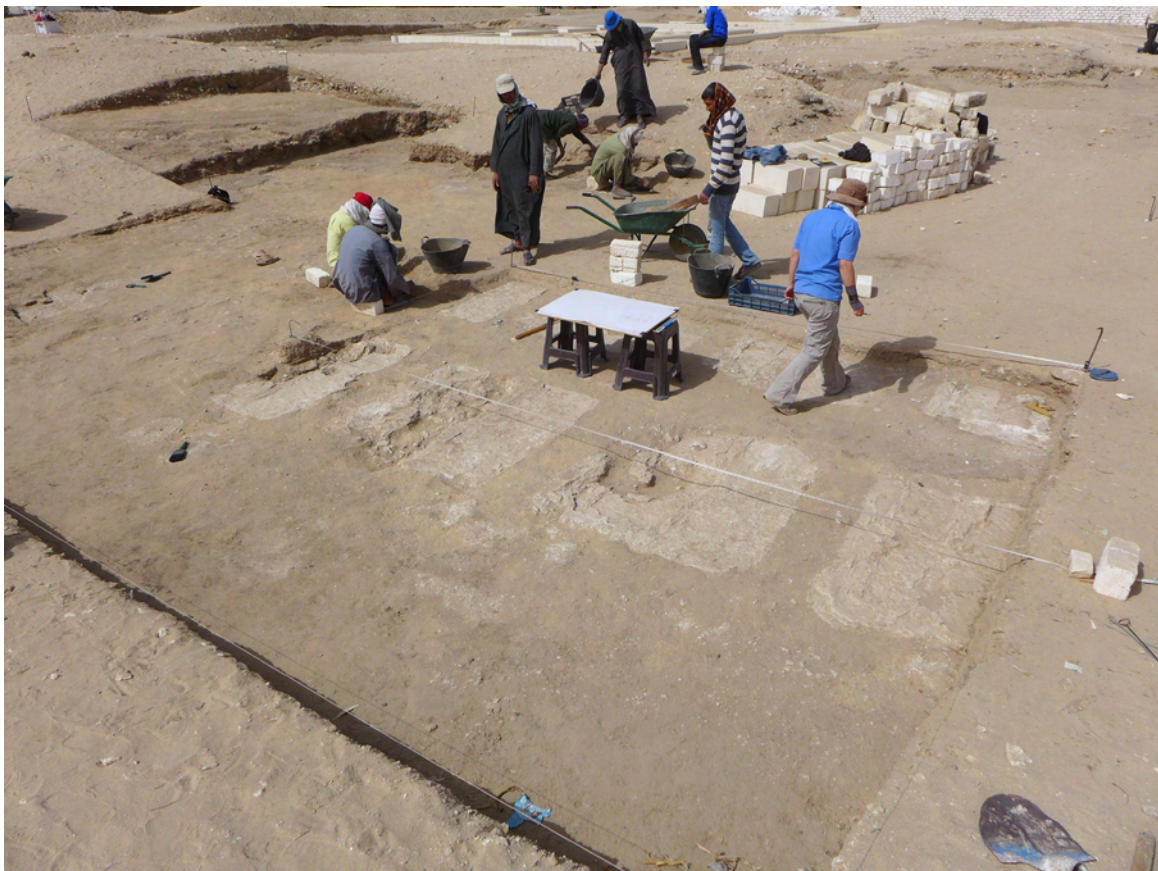
Figure 13. Central zone of Area E. Part of two rows of rectangular foundations, made from gypsum concrete, for offering-tables made from limestone blocks. They belong to the first temple and were either demolished or buried when the temple was rebuilt. View to the north west.

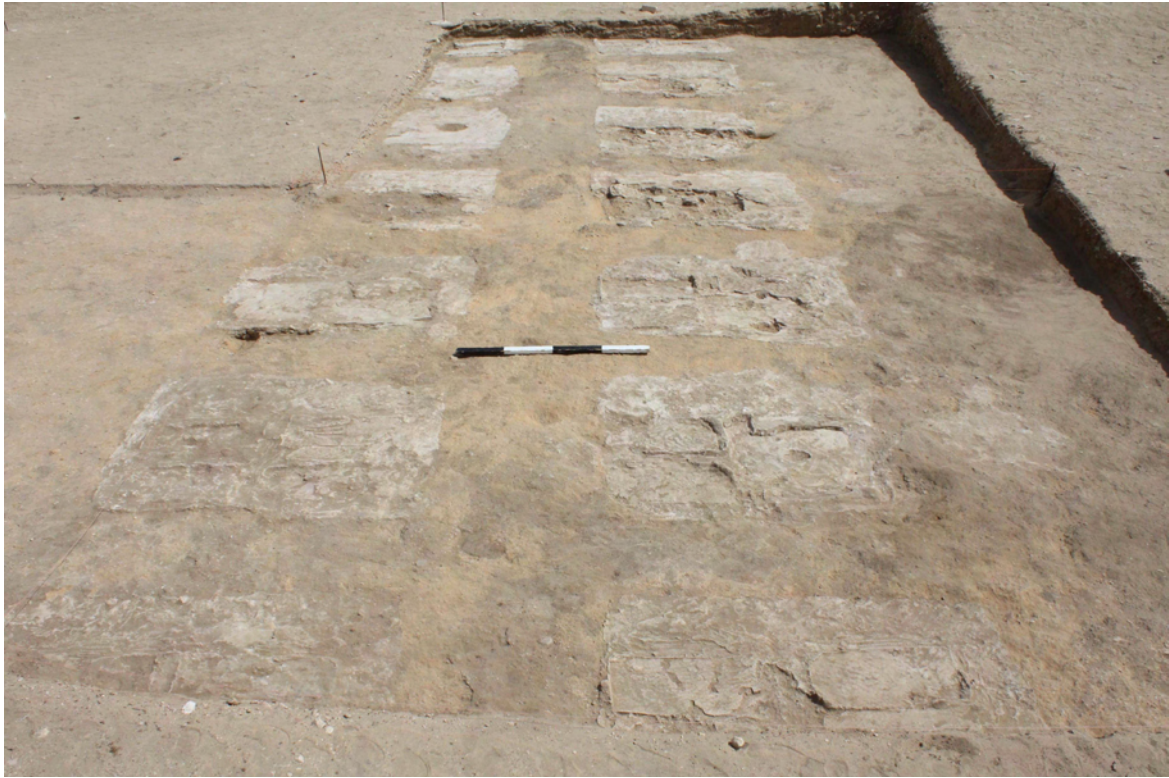
Figure 14. Central zone of Area E, the two rows of bases for stone offering-tables belonging to the first temple. Viewed to the east.

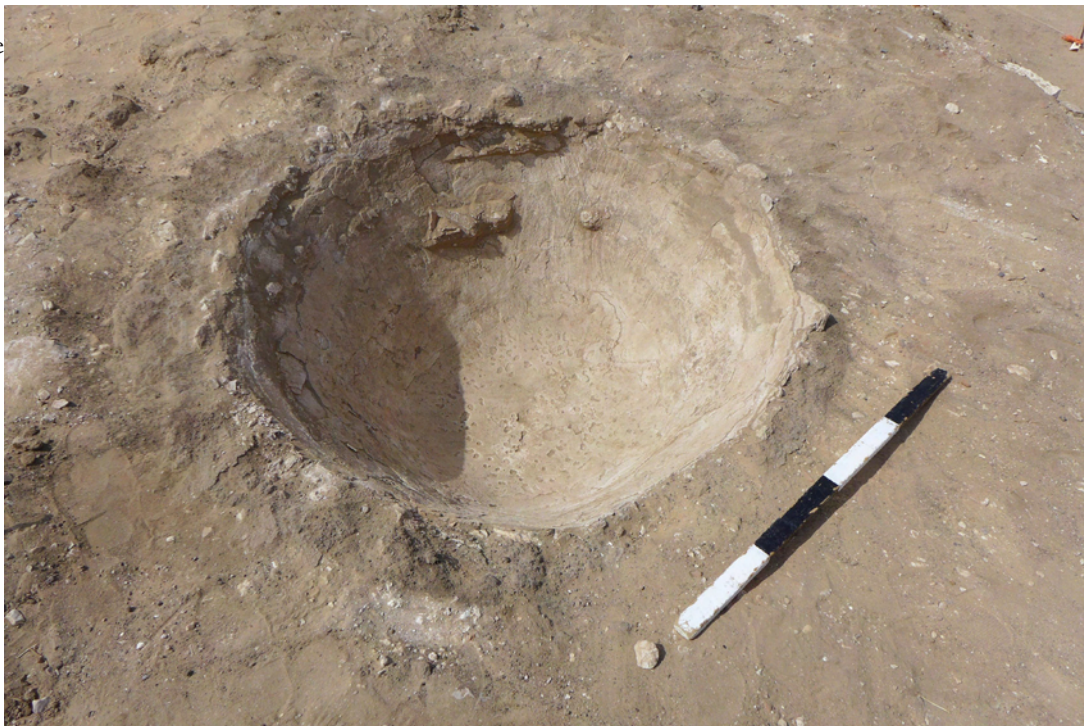
Figure 17. Southern zone of Area E. Gypsum-lined basin of the second temple, dug into the layer of levelling rubble that covered the first temple. View to the north-west.

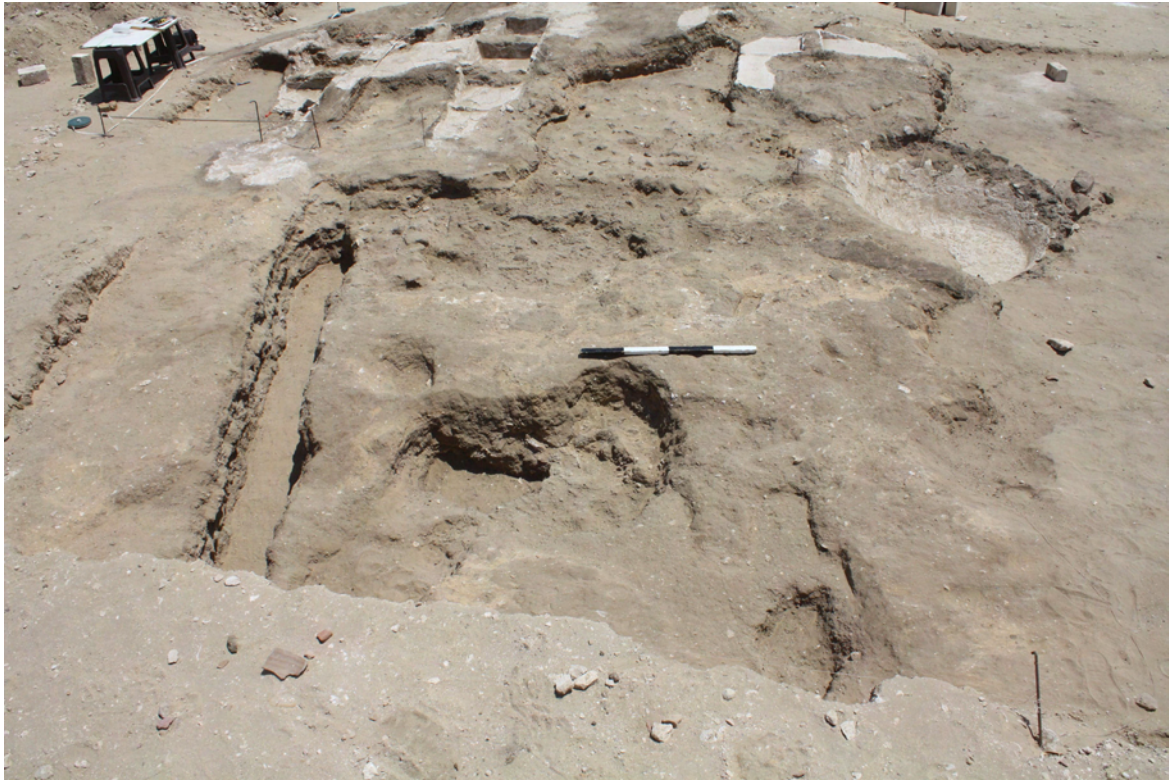
Figure 18. Northern zone of Area E. In the foreground the surface of the ground of the second temple has been partly destroyed by the trenches of the 1932 excavation. In the background are the remains of a set of gypsum-lined rectangular basins. View to the east.

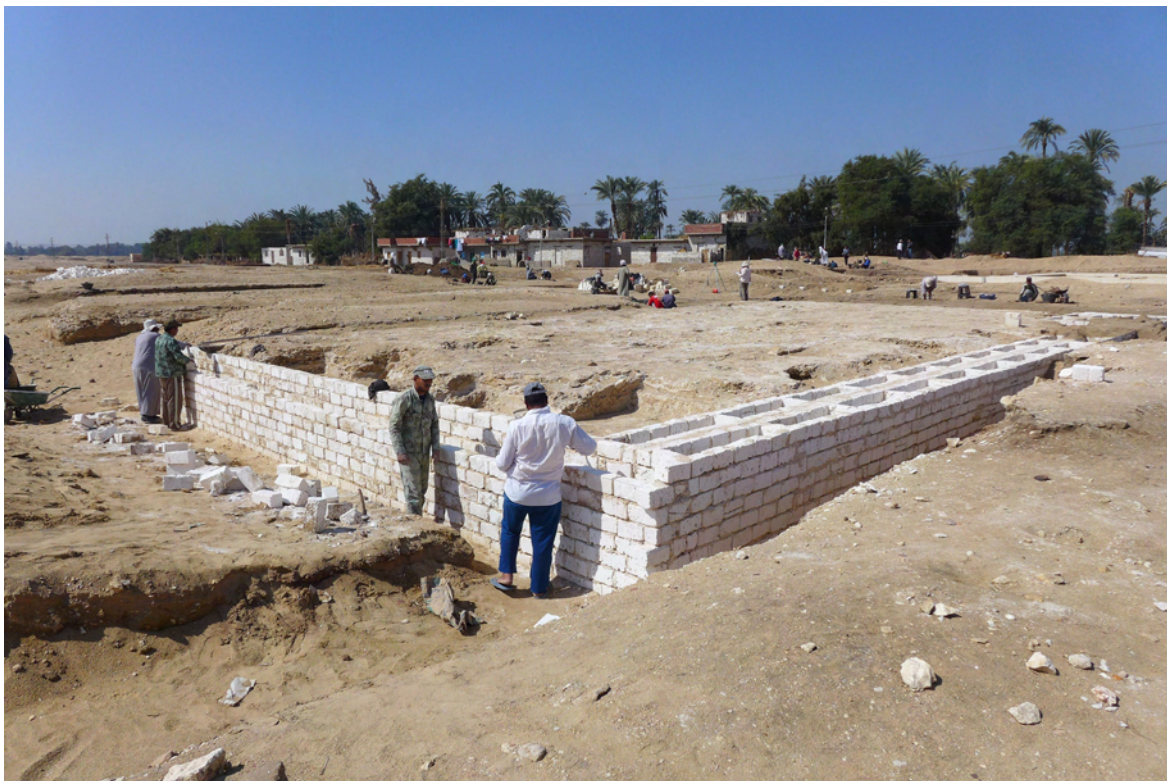
Figure 20. Area F: the northernmost of the pair of gypsum-concrete foundations for large columns. Here the foundations are being laid for a row of limestone blocks that will recreate the original surrounding wall. View to the south-west.

As the re-examination of the temple has continued, the team of builders has worked on repair and reconstruction. One job has been the laying out at ground level of the northern set of large column bases on their foundation platform of gypsum concrete (Area F). To achieve this, the deep foundation trenches have been filled with a network of walls of small local limestone blocks. These have provided a solid foundation for a final layer of Tura-limestone blocks cut to *talatat* size. This has been put in place on the north and west sides, the plan being to add the south and east sides next year. The upper surface of the whole rectangle has been filled with a layer of clean sand. The intention is to create on top of this eight circular pads of white cement with a diameter of 2.50 m, occupying the positions of eight huge column bases that stood there originally.

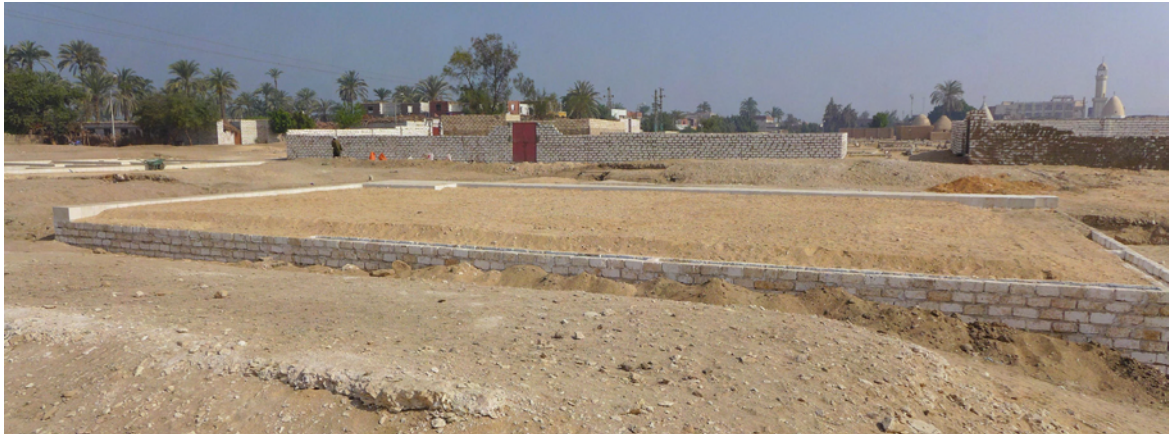
Figure 21. View northwards of the North Platform at the end of the season. The top layer of fine stone has been laid on the north and west. It remains to do the same on the east and south. The positions of the large columns (eight of them) also need to be marked.

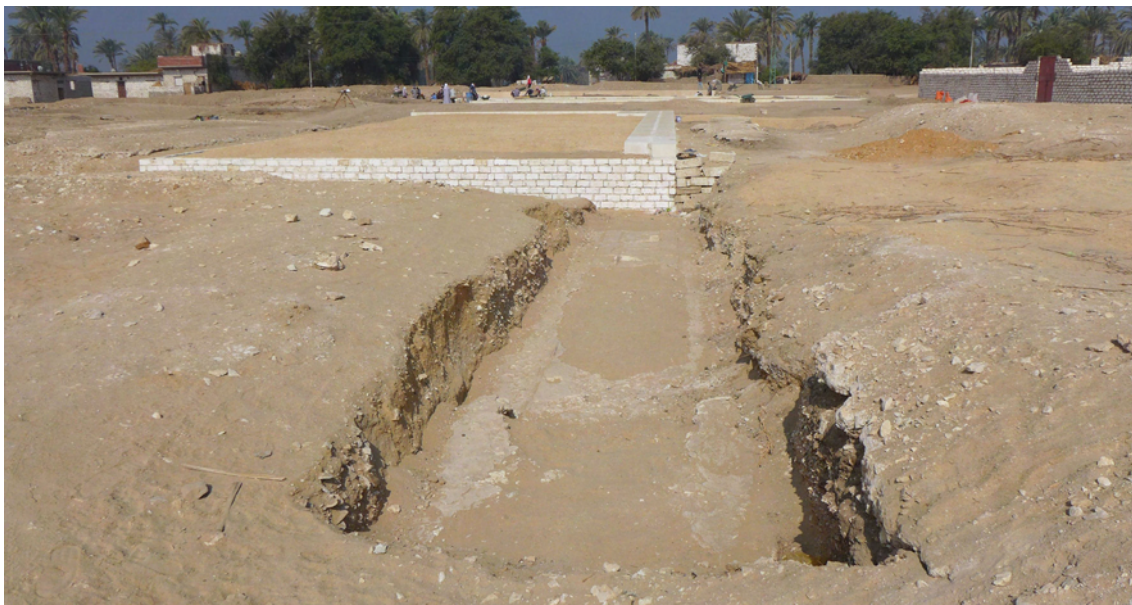
Figure 22. The North Platform at the end of the season with, in the foreground, a length of the northern temple enclosure wall foundations exposed. In the future this will be filled with stone support for a final layer of fine limestone blocks.

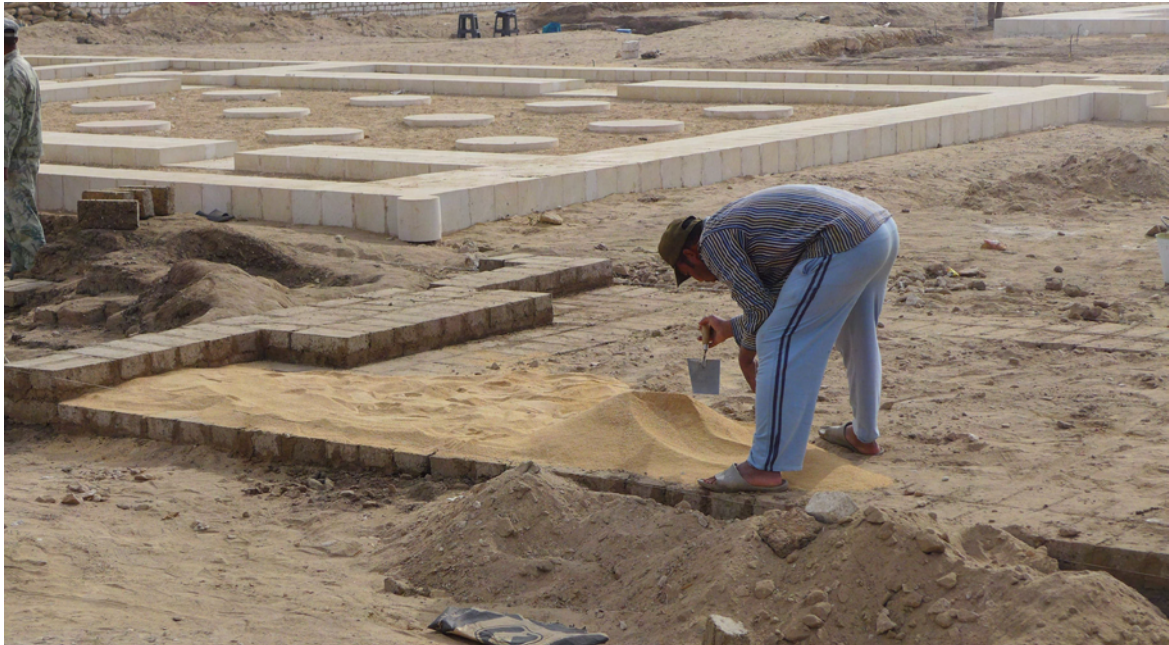
Figure 24. The first steps in recreating the threshold between the mud-brick pylons. Laying down a bed of clean sand over a layer of new bricks and pieces of brick rubble. The northern edge of the doorway has been remade in new bricks. View to the north-east.

Repairs have also been done to the mud-brick pylon. We have concentrated on the northern pylon tower, capping the ancient brickwork with newly-made bricks that have also filled deep holes that had been dug into the brickwork in the past. The entrance through the pylon towers is marked by the walls of an approach ramp. This shows that the threshold of the pylon entrance was 6.16 m wide. This surface has been protected with a layer of sand, and over it a single course of Tura-limestone slabs has been laid. At the same time, the sloping side walls of the ramp have been repaired with new courses of bricks, and the surface of the ramp given a layer of clean sand.

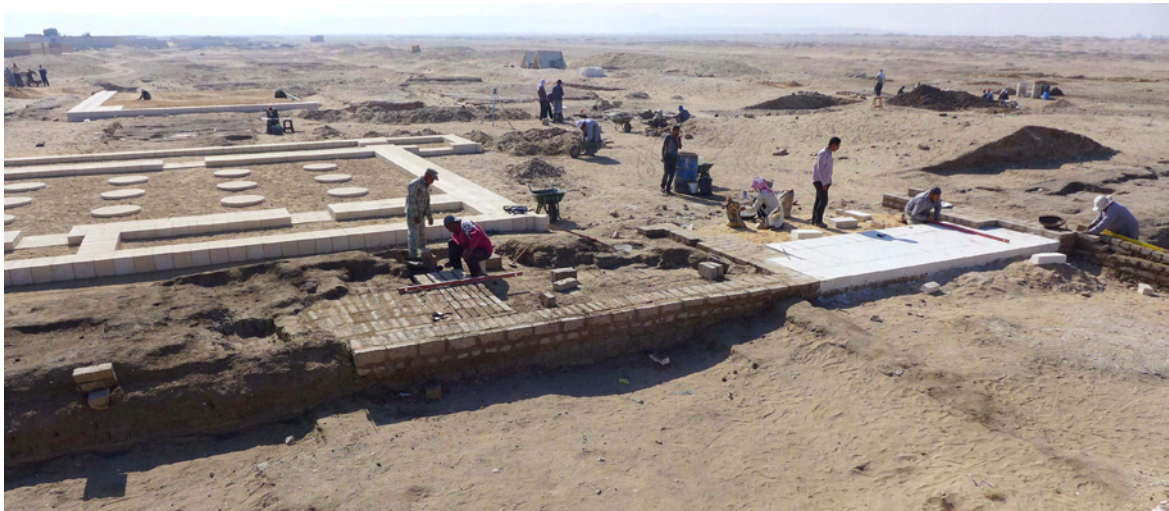
Figure 25. Repairing the brickwork of the north pylon tower and laying a new layer of limestone blocks to recreate the threshold of the entrance. View to the east.

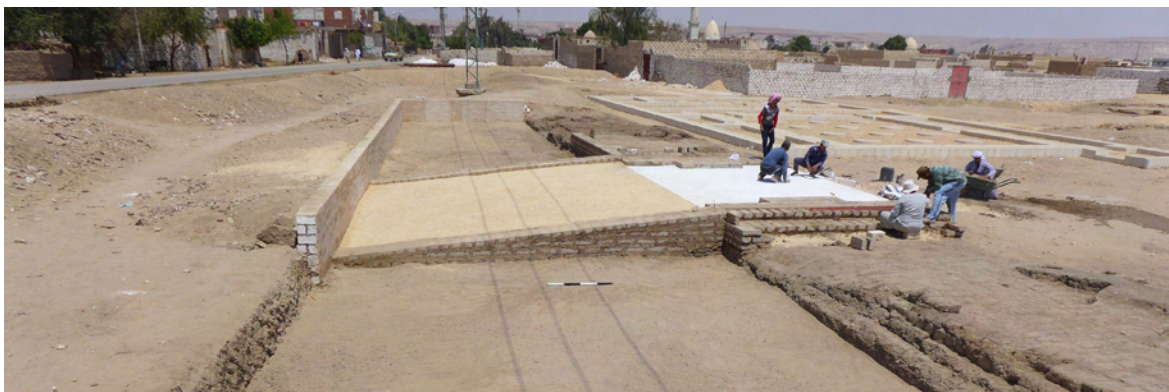
Figure 26. The mud-brick pylons and temple entrance, at the end of the season. View to the north.

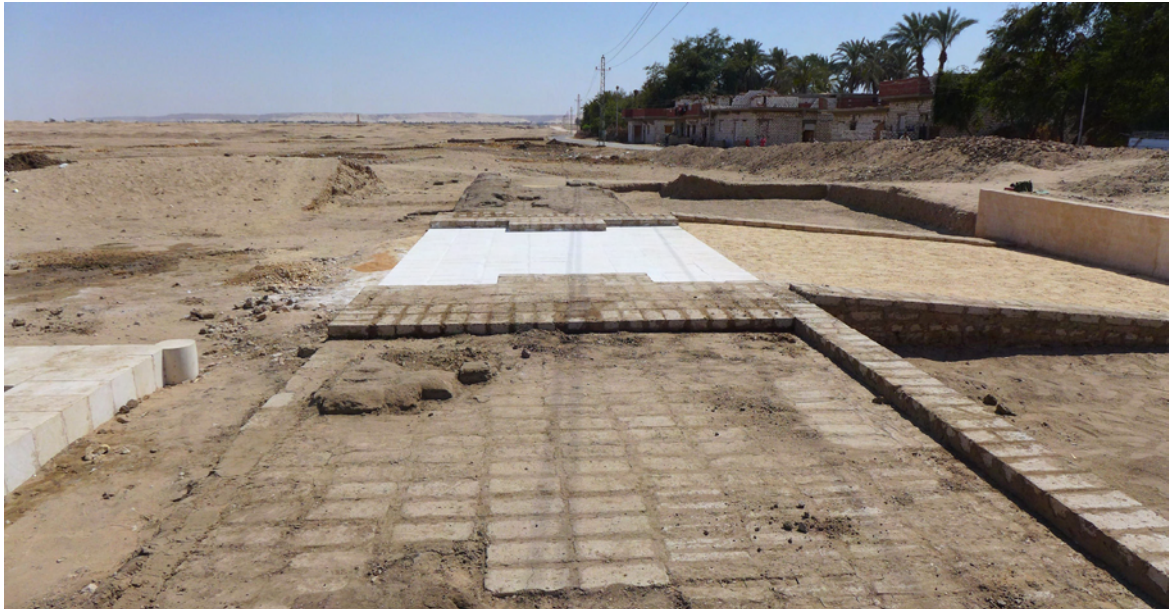
Figure 27. The mud-brick pylons and temple entrance, with approach ramp, at the end of the 2014 season. View to the south.
