CHAPTER 2

REPORT ON THE 1987 EXCAVATIONS THE EXCAVATION OF Q48.4

Christopher Kirby
(in association with Angela M.J. Tooley)

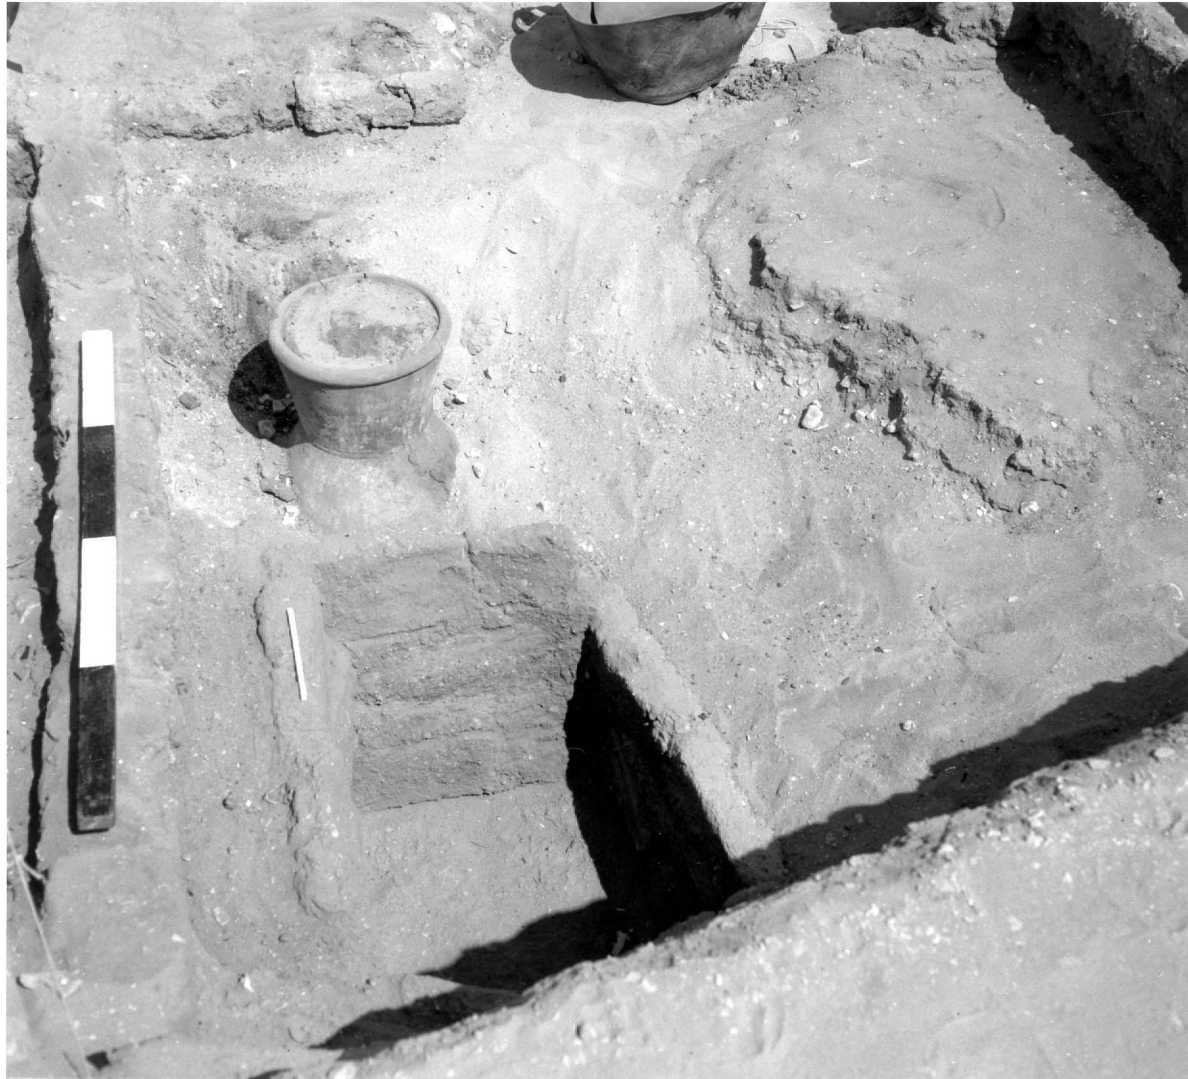
Figure 2.5. A view of Area 12, at Phase I level, looking north, showing the brick-lined pit [3046] and buried *zir* [3113].

Directly to the north of the bin was the sunken *zir* [3113]. Mud brick had been packed around the neck to secure it in the *gebel*. A small pottery incense burner was found close by. On excavation, the *zir* was found to be full of large pieces of mud brick deliberately placed inside. It seems likely that this was done by the Phase II builders in order to consolidate the *zir* beneath the new Phase II floor. Part of the shoulder of the *zir* had been plastered with mud, presumably to repair a crack in the fabric. Both the *zir* and the bin were difficult to associate with a floor level, since the floor around them had crumbled away leaving a dark brown, sandy fill [3036]. Other parts of the workshop preserved patches of two floors [3119, 3120].

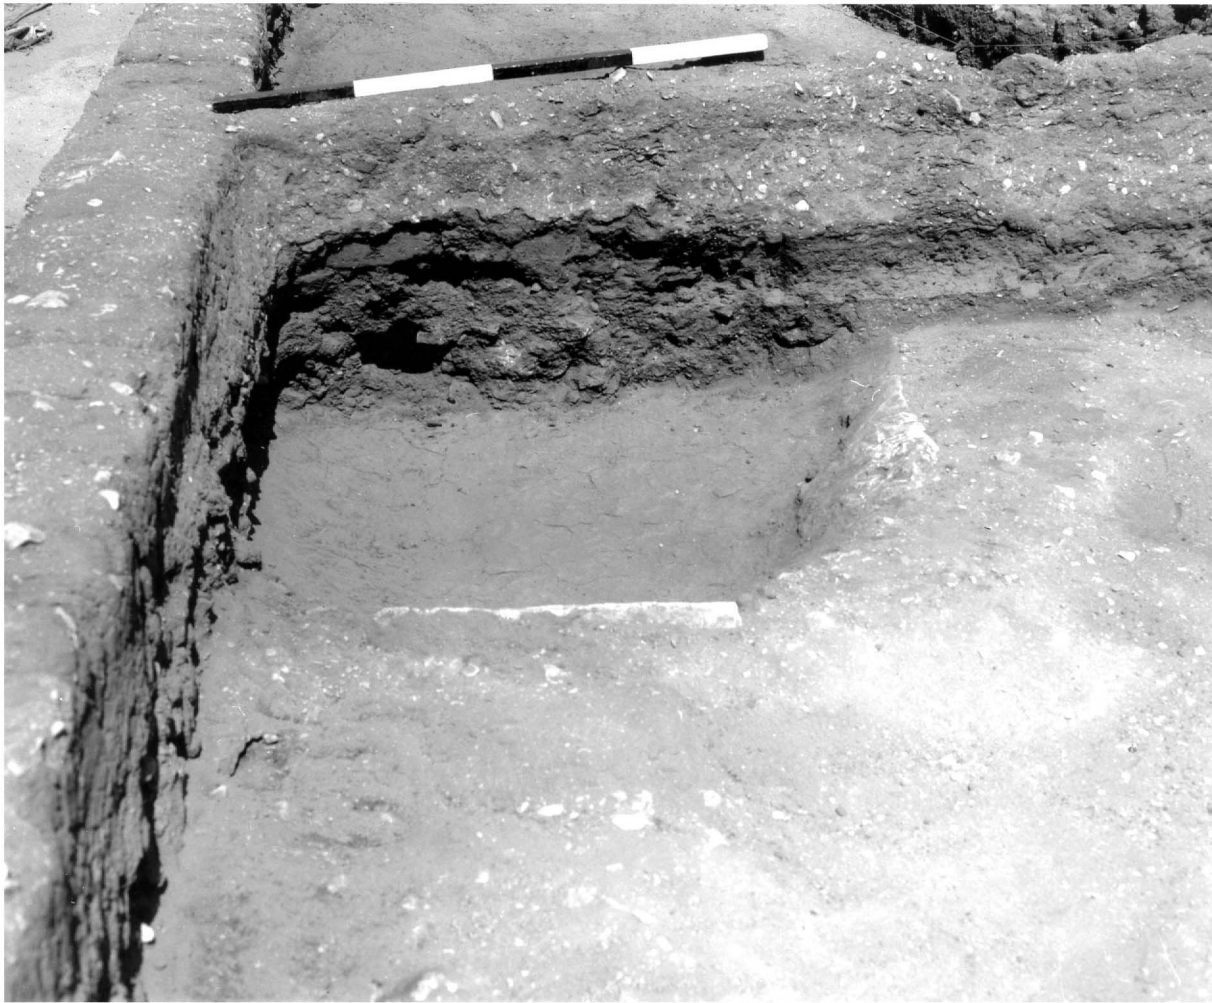
Figure 2.8. Puddling pit [3166], looking north. The pit is crossed by the Phase II wall [2908], and by a section of debris which includes the sterile sand layer [2918 = 3011], see Figures 2.19, 2.25, no. 5.

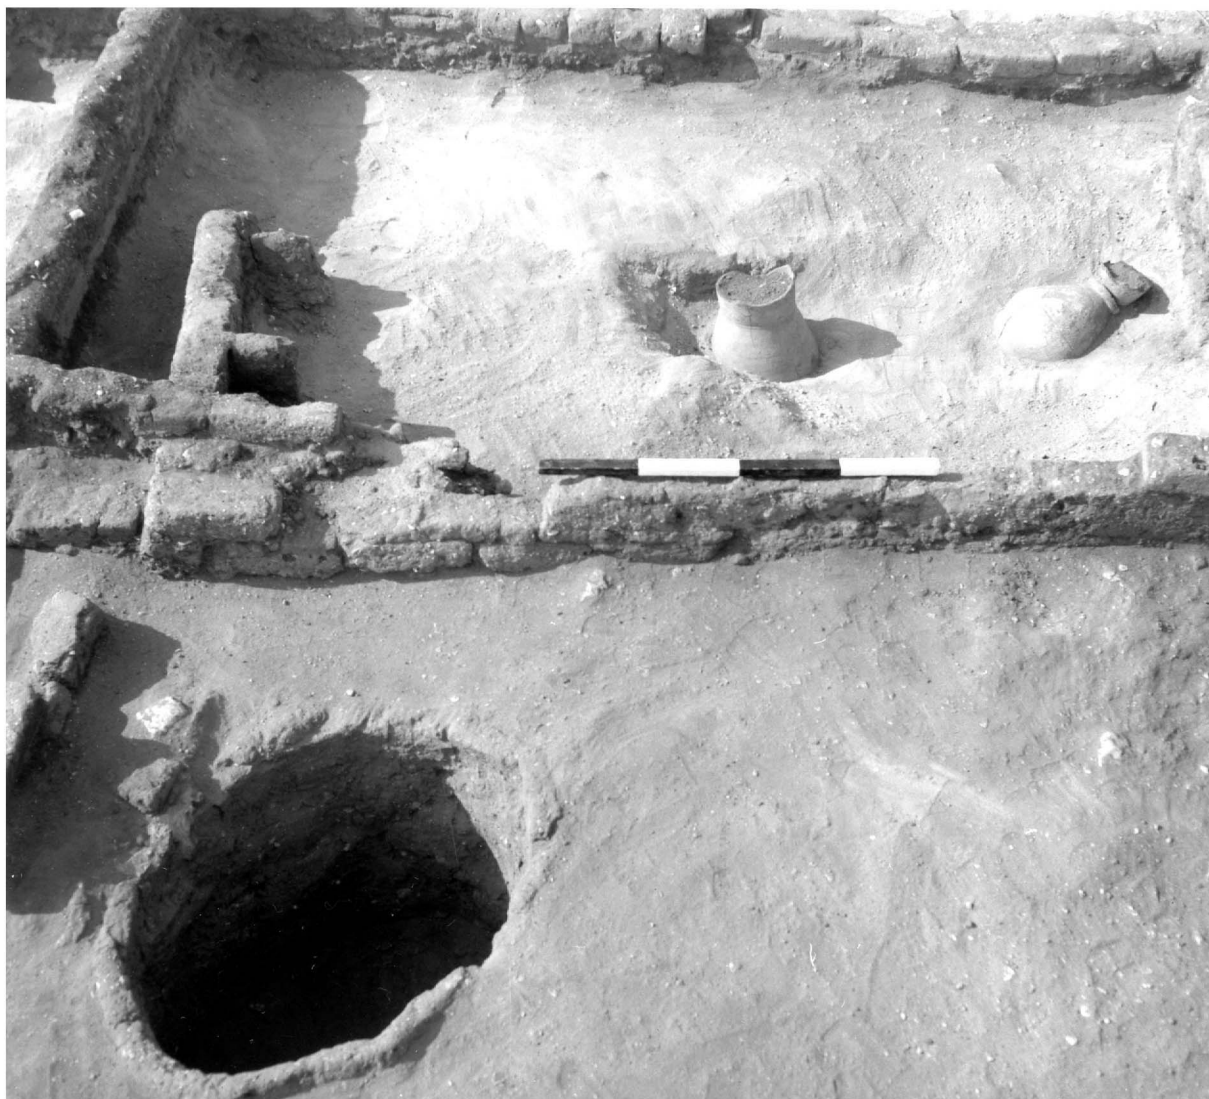
Figure 2.9. View, to the south, of Phase I features in square D3.

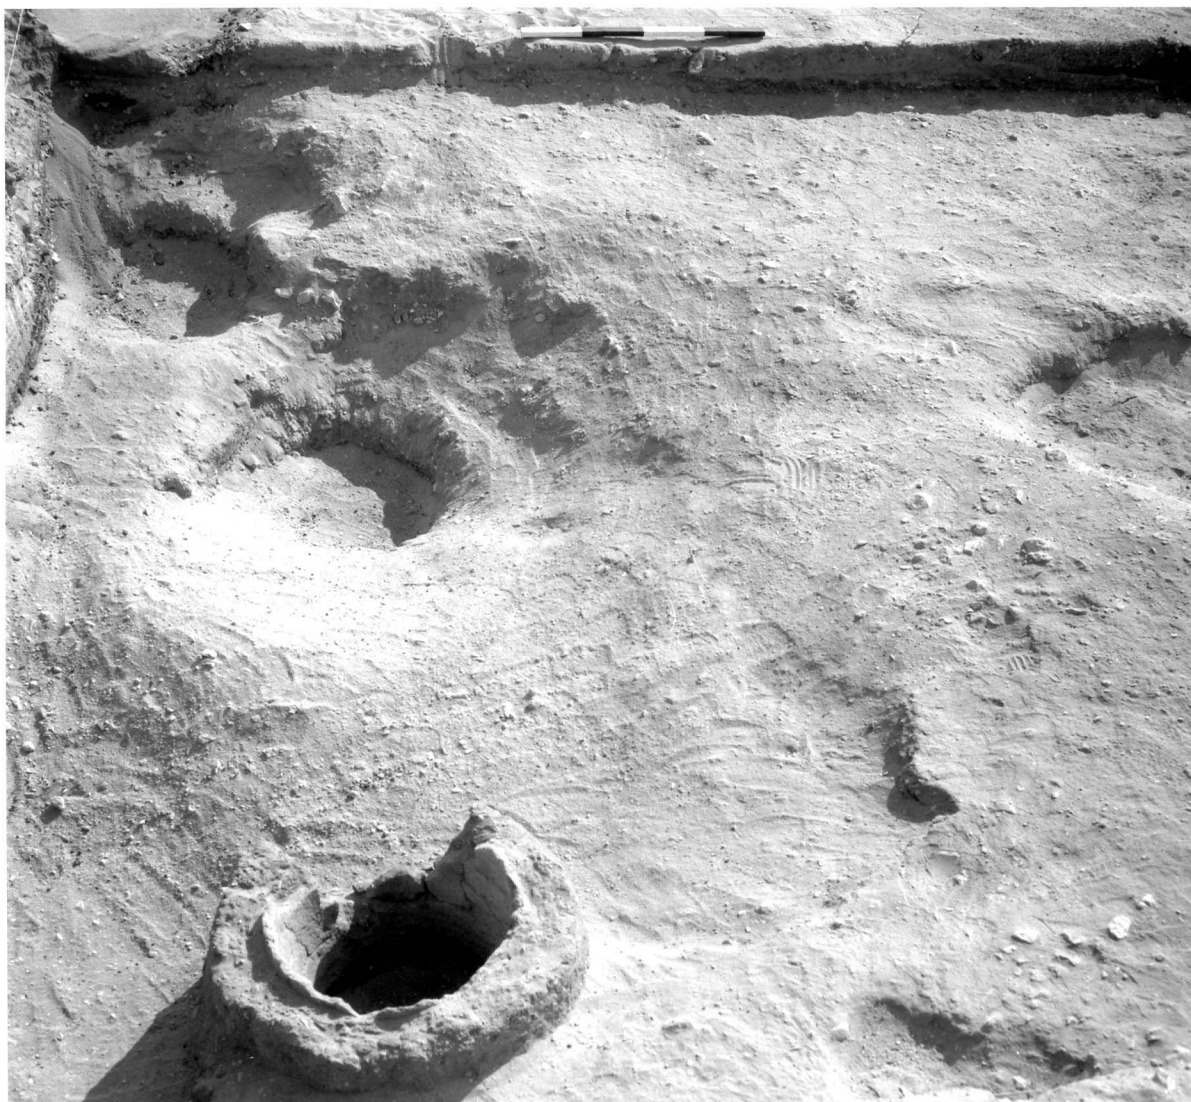
Figure 2.10. Square F5, looking south, showing the west half of Area 27.

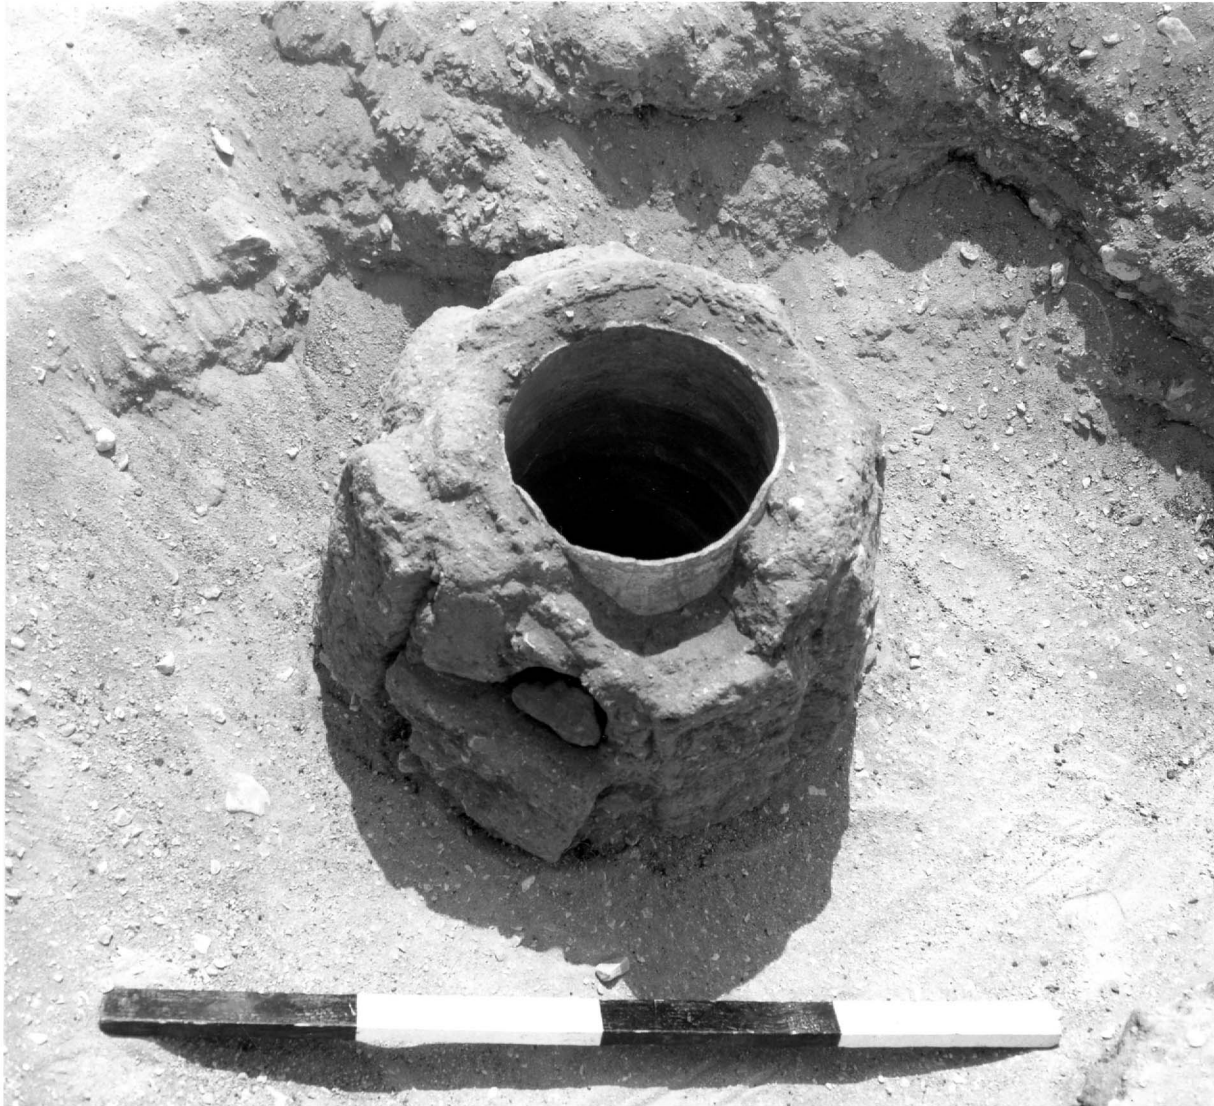
Figure 2.12. View of the oven/kiln in square G5, looking south-east.

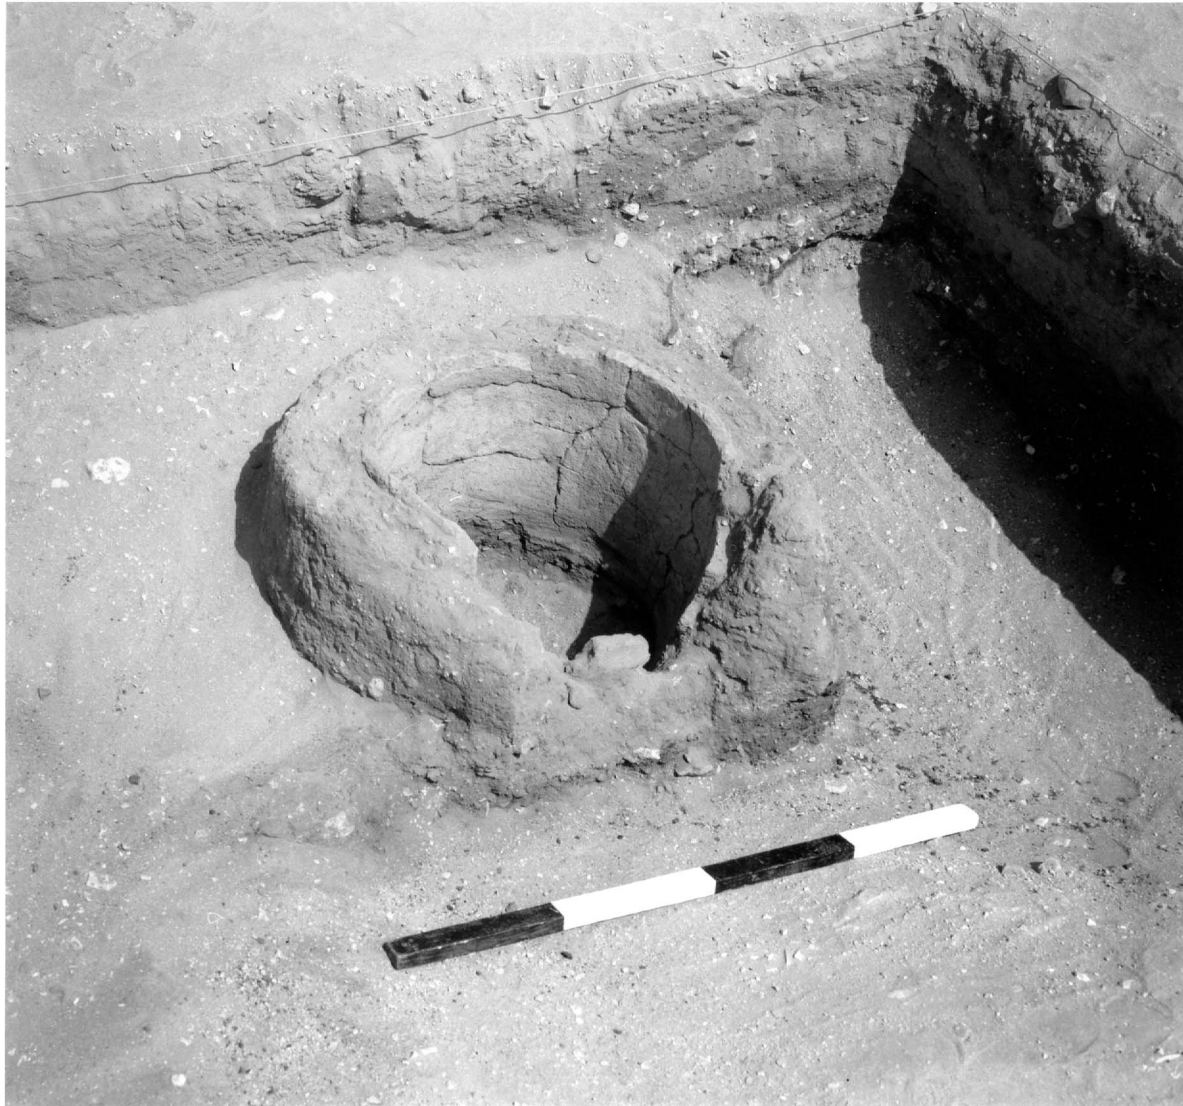
Figure 2.13. View of oven/kiln [2993] in square F5, looking north-east. Note the dark ashy layer beginning to rise in the section at the north-east corner of the square.

A second oven lay on the opposite side of **Area 27**. It consisted of a cylindrical baked clay liner [2993], 56 cm in diameter, 3 cm thick, and preserved to a height of 41–42 cm, with damage on the south side, around the stoke hole. Around it was a 12–13 cm thick jacket of mud [2994]. The fill [3056] consisted of clean, loose sand, some sherds and stones, but none of the expected ash. This raises the possibility that, like pottery kiln [3052], it had not been used. Immediately to

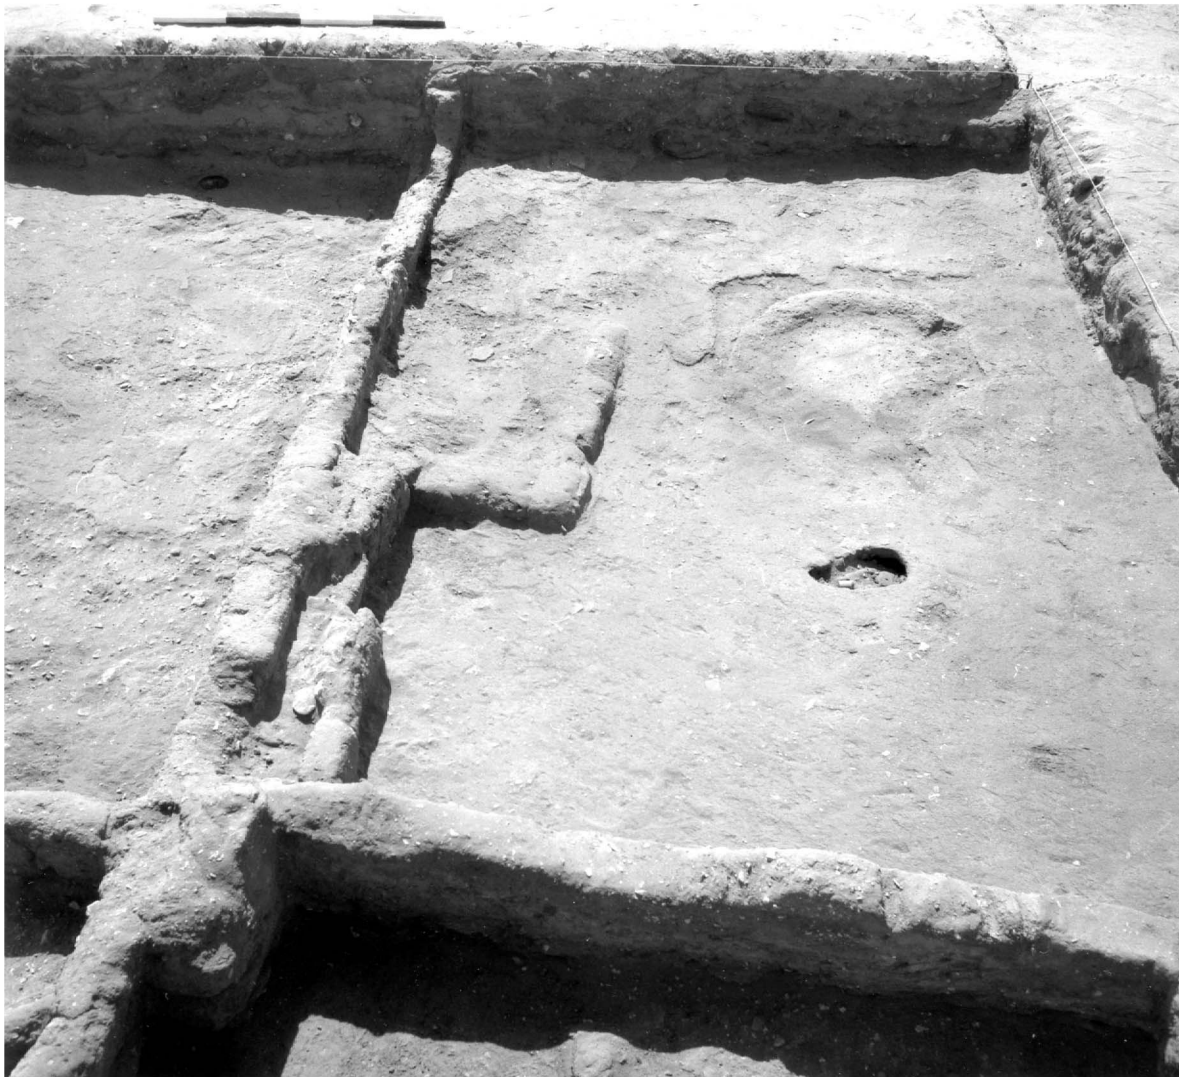
Figure 2.14. Square E6, looking south, at Phase II level, showing the bench and hearth in **Area 12**.

The original northern pottery workshop and its related courtyard (**Area 12**) showed particularly clear evidence of a change of use, having been completely covered over by a single mud floor [3038=3122]. Excavation of the *zir*, as mentioned above, showed it to be full of mud bricks placed there presumably in order to consolidate the vessel beneath the new floor. The *zir* actually

lay beneath a circular hearth [3027] in the Phase II floor filled with burnt sand [3028], which overlay a dark brown silty deposit containing some heavily burnt organic material [3036] deposited in the workshop beneath. On the east wall of the new Phase II room was a low bench or *mastaba* [3041] with the hearth in front of it (Figure 2.14). The other three rooms in square E6, Areas 13 to 15, also had good mud floors which must also belong to this phase [3005, 3121, 3012]. However, these floors had little beneath them to represent the Phase I occupation except relatively shallow rubbish deposits [3745, 3746, 3721]. Both the north-east room (Area 15) and south-east room (Area 13) had pots sunk into the floors [3006, 3013], perhaps for storage.

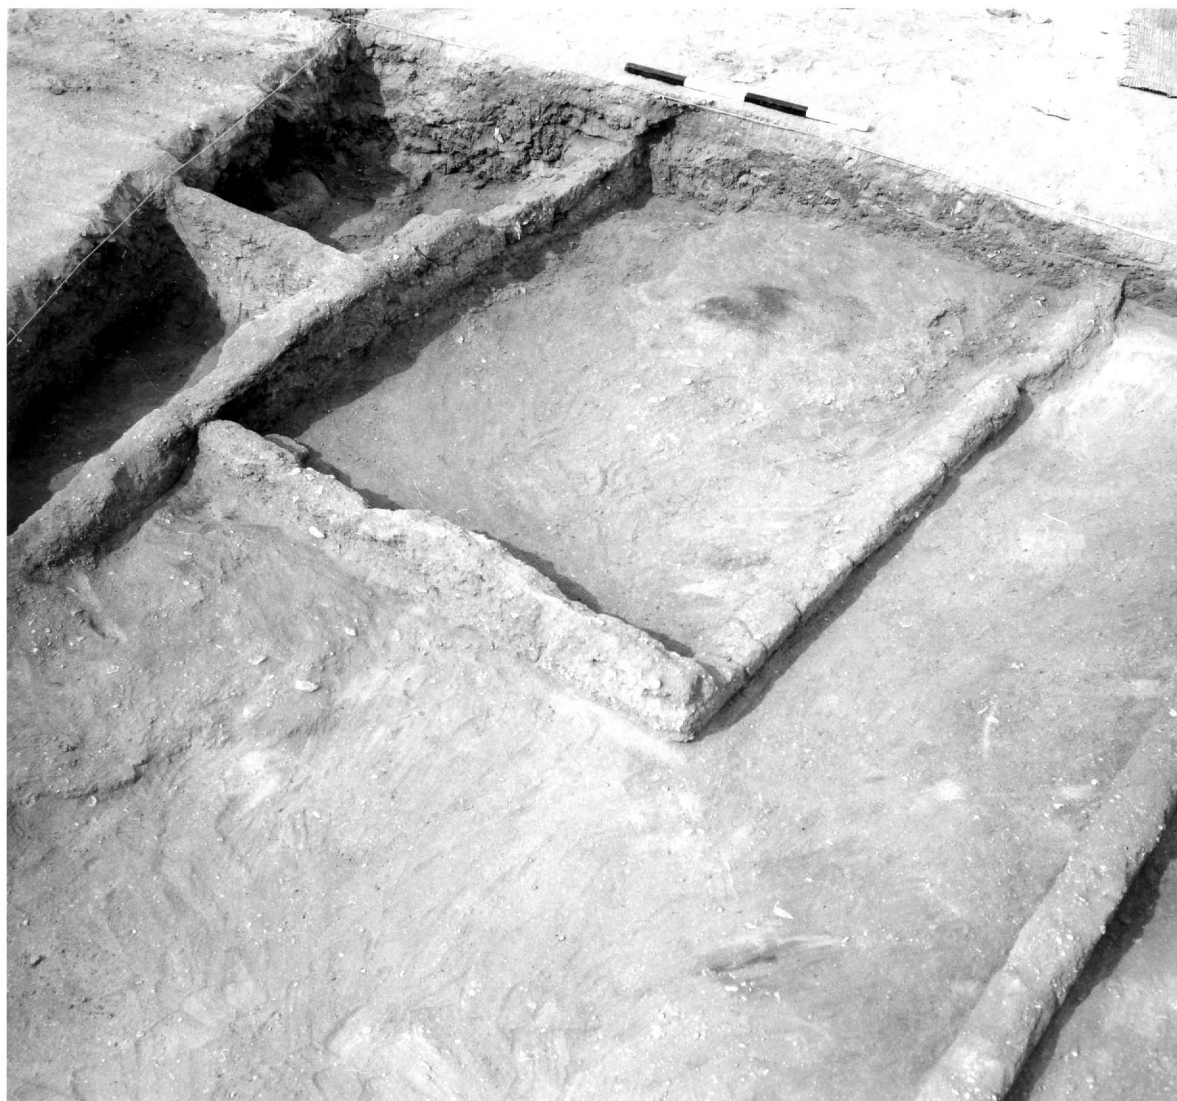
Figure 2.15. Square E4 at Phase II level, looking north-west. The southern part of Area 9 occupies the centre of the picture.

running continuously beneath it, and was also almost flush with the modern surface and therefore very vulnerable to destruction or robbery, explains why so often in small buildings where only one or two courses of bricks are preserved no doorways can be detected. Beyond this doorway, to the south, was a small room (Area 6), with secondary buttressing wall [3127] similar in nature to the one noted in Area 12. This room presumably gave access to a second small room (Area 7) by means of a doorway in wall [3128] no longer detectable. The “house” was probably completed by a fourth room on the east, Area 9, a long, rectangular room, again with a badly preserved floor [3019, 3024], which had been laid over a stratified sequence consisting of a rubbish deposit [3010], a layer of fine sand deposit [3011] (part of the sand over the Phase I floor mentioned above), and another rubbish deposit lying on *gebel* [3014], a sequence which illustrates again two distinct phases of dumping before the construction of the Phase II building. In the north-west corner of this room was a limestone door socket [3837] set into a thickening of the wall, showing the presence of a doorway leading into Area 8. An important missing element is the position of the outside entrance to the “house” itself. The most likely position, on the parallel provided by the northern “house”, is in the east wall of Area 9 [3003], towards the south end. Of this wall only the bottom course survived (Figure 2.15).

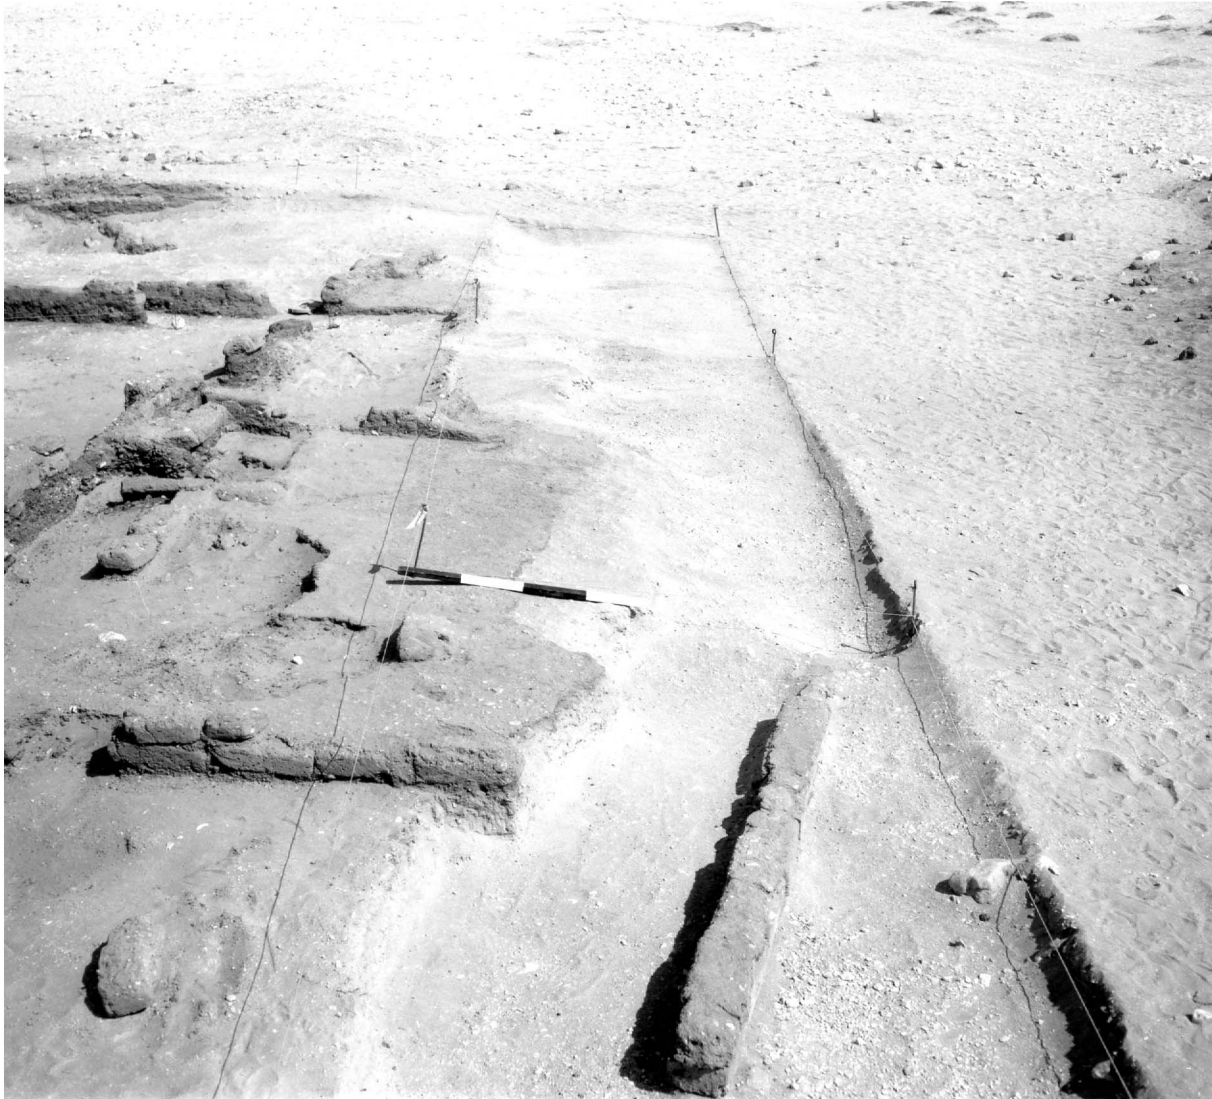
Figure 2.16. The southern part of the site, looking east. In the right foreground is the single line of foundation bricks from the enclosure wall [3146].

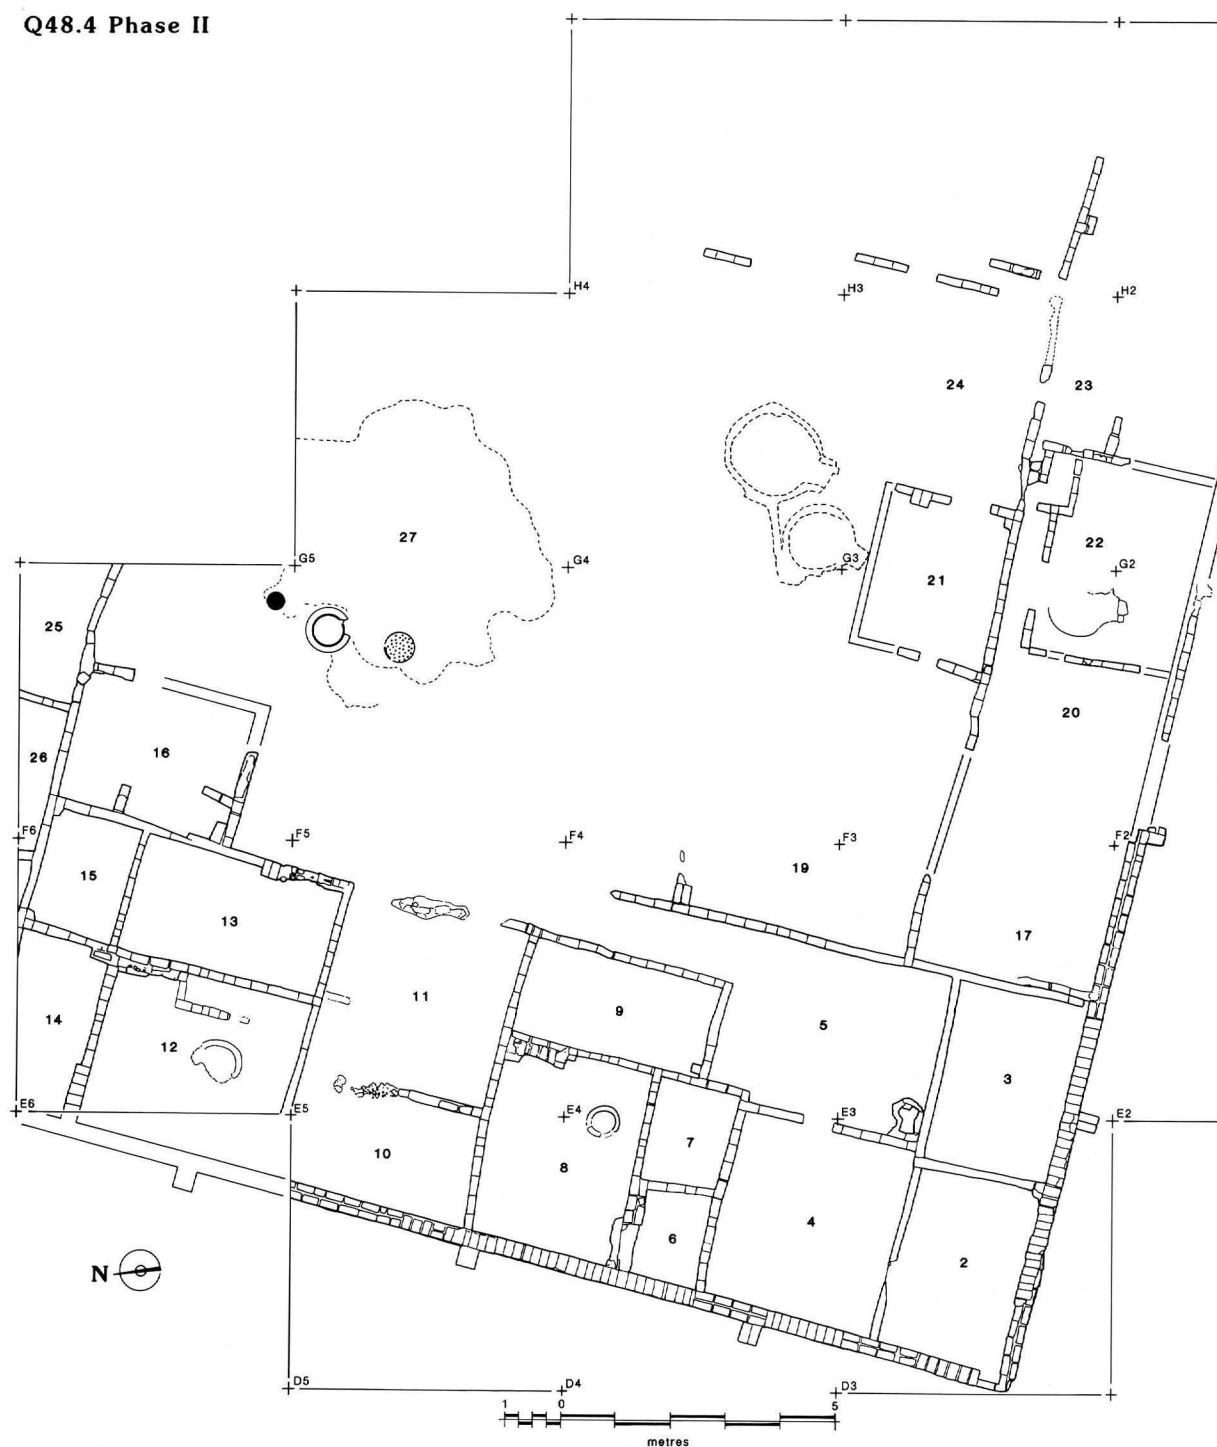
Figure 2.18. Overall plan of Phase II.

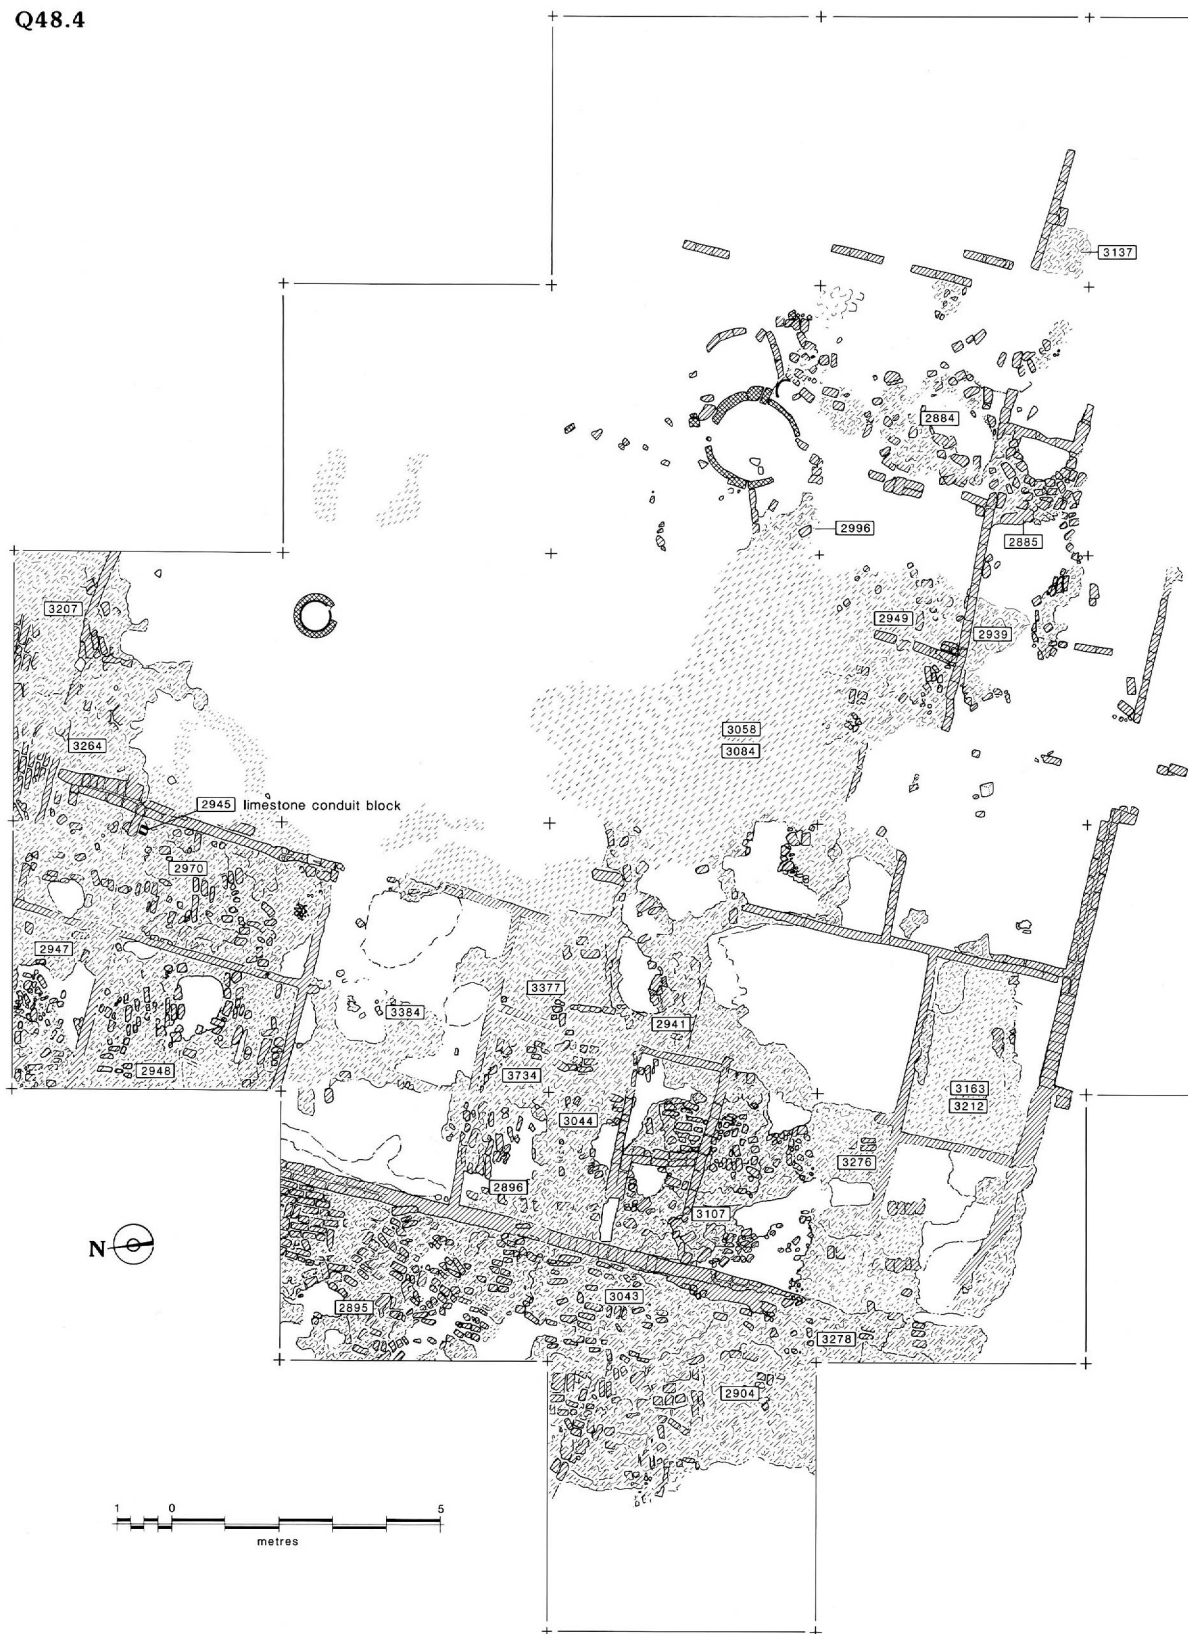
Figure 2.20. Overall plan showing rubble units (hatched), as exposed by removal of surface sand.

On the eastern fringes of this deposit it was overlaid by a thin cover of sandy debris which also contained a proportion of brick rubble broken into very small pieces. Its approximate limits are marked in Figure 2.20, with the relevant unit numbers. It really lies too far distant from the nearest walls to be considered as the rubble from the direct collapse of the Phase II walls after the final abandonment of the site and in any case probably spread southwards as well, over part
