## CHAPTER 4

REPORT ON THE 1984 EXCAVATIONS  
CHAPEL GROUP 528-531

Site supervisor: B.J. Kemp

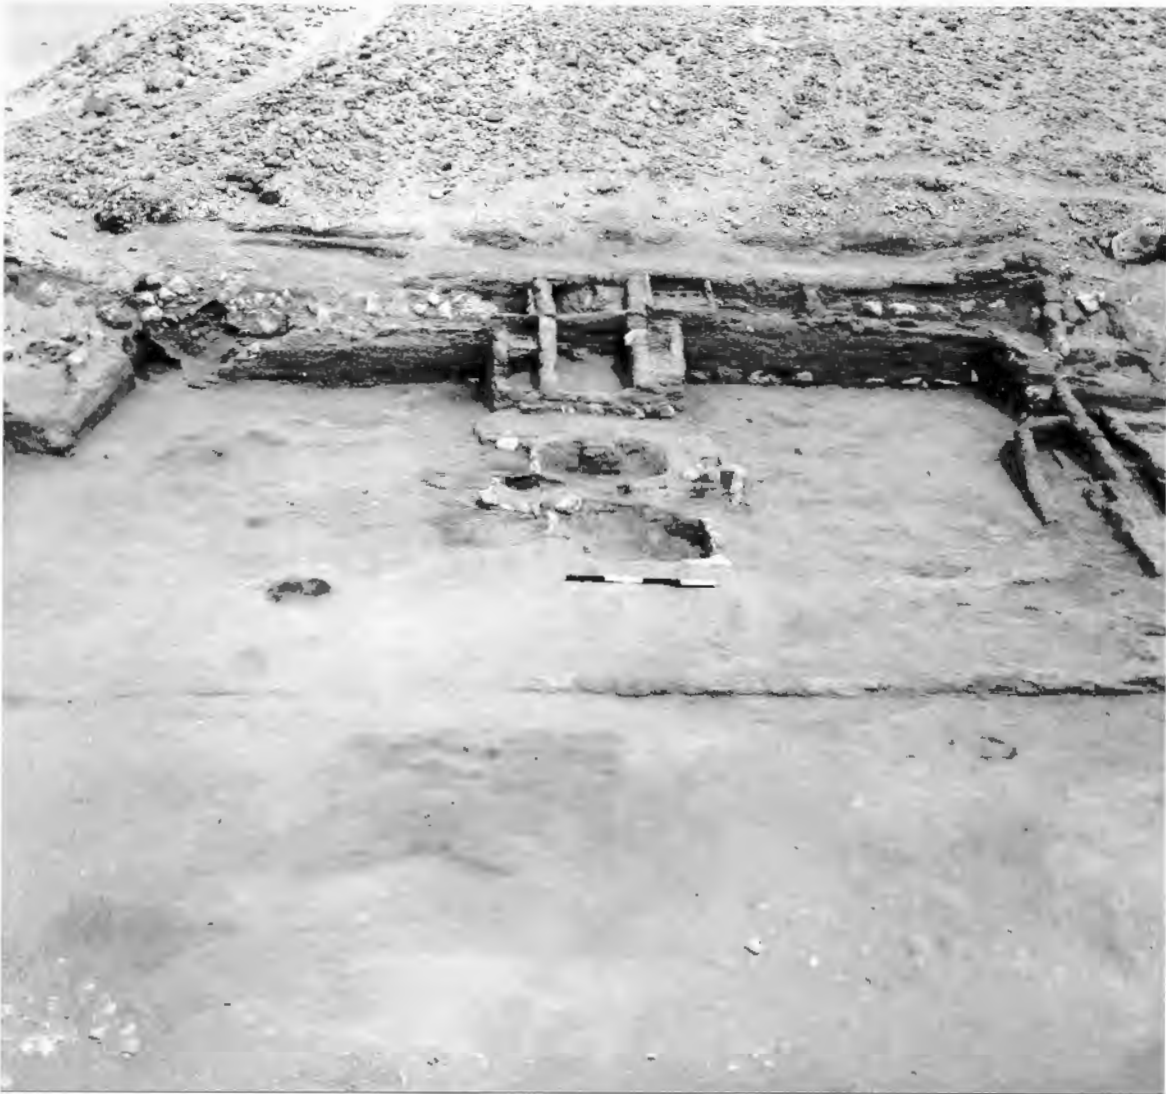
Figure 4.2. General view of Chapel 528, looking north.

The building stood within a courtyard, measuring about 8 x 7.50 metres (Figure 4.2). Of the south wall [1293] only a foundation course survived. Being of only a single course in thickness and without a buttress it may never have stood to any significant height, but served only as a boundary. The courtyard was entered from the west, over a brick threshold [1296] between jambs [1294, 1295]. A path had been laid to the gateway, but only a short portion of this was cleared. It consisted of narrow parallel walls of stones and mortar [1291, 1292], bordering a surface of packed marl [1290].

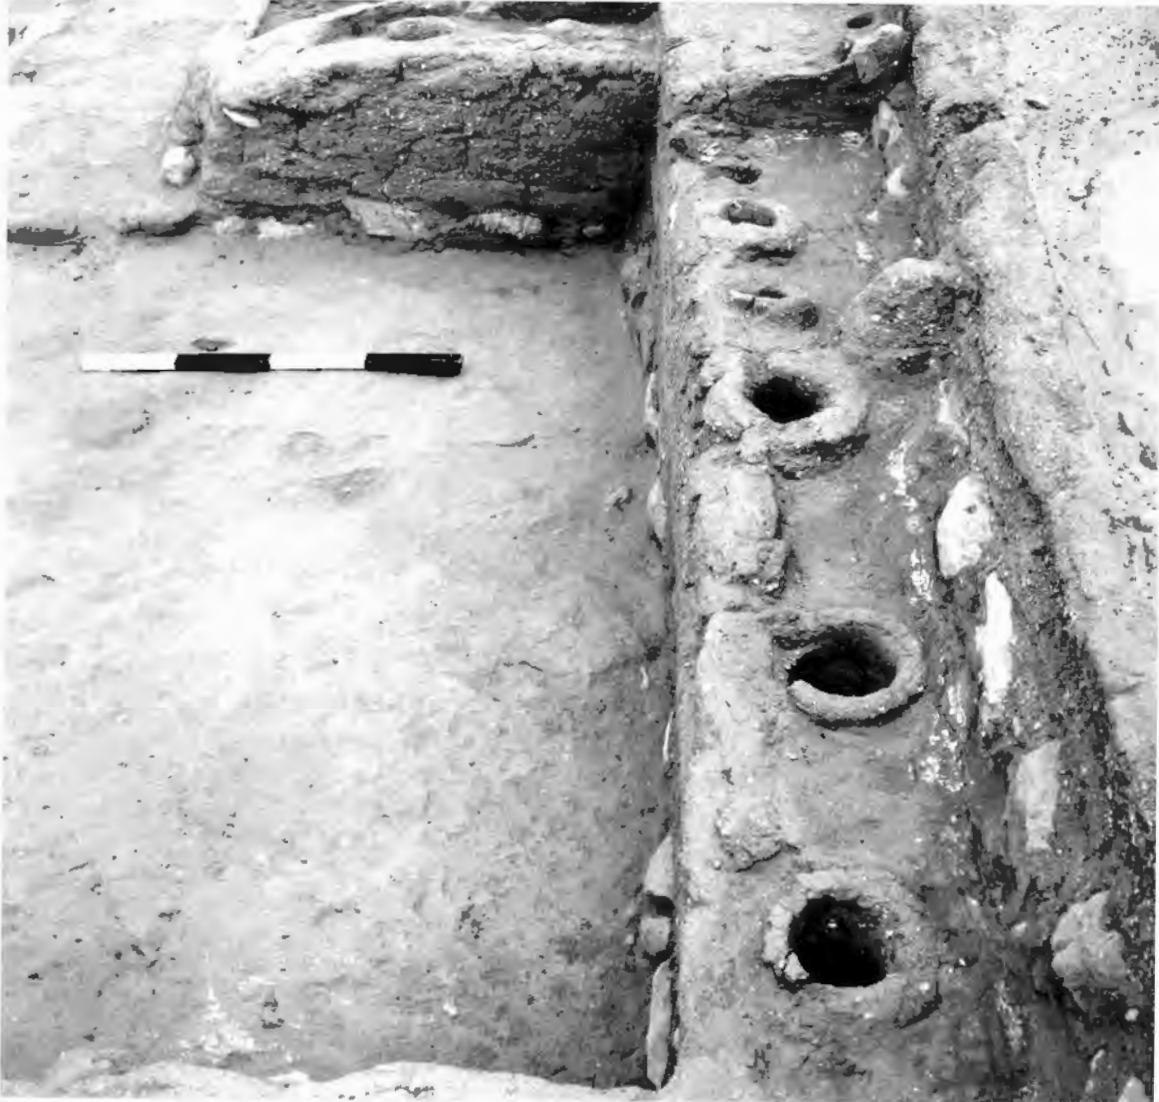
Figure 4.4. Bench with receptacles in the eastern part of Chapel 528, looking west.

The eastern set of benches is the better preserved (Figure 4.4). The main length of bench [1303] runs along most of the north side, and then continues for a short distance on the east. The fill of the bench had been covered first with a firm layer of marl mortar, this had then been plastered with a thin skim of Nile mud, and finally coated with gypsum. In the course of laying the surface

of the bench a series of circular receptacles had been fashioned from the marl mortar, each one provided with a raised rim. The rims and the interiors had, like the bench surface, been coated with Nile mud mortar and gypsum plaster. On this bench there were seven. Three [1317, 1085, 1090] were set closely together and were shallower than the others [1093, 1092, 1091, 1318]. On the west side of this area a short separate length of bench [1311] stood against the central projection, and probably supported two receptacles [1315, 1316], although the top of the bench was somewhat denuded. Lying in a corner against the rear wall [1304] and the central projection [1308] was a square, box-like construction [1314], 12 cms. above the bench level (Figure 4.5). It had its own narrow side walls [1319, 1320], constructed of small flat stones set upright in marl mortar. It reproduces in miniature the bench tops. At the back is a row of four tiny circular receptacles [1338-1341], probably originally with raised edges. The whole had been coated with Nile mud and gypsum plaster, although much of the original surface had been lost to erosion.

The principal feature of the building is a long narrow bench [1302, 1303], occupying the whole of the northern side (Figure 4.4). Its preserved height
