CHAPTER 2

REPORT ON THE 1983 EXCAVATIONS CHAPEL 561/450 (THE "MAIN CHAPEL")

Site supervisor: Ann Bomann

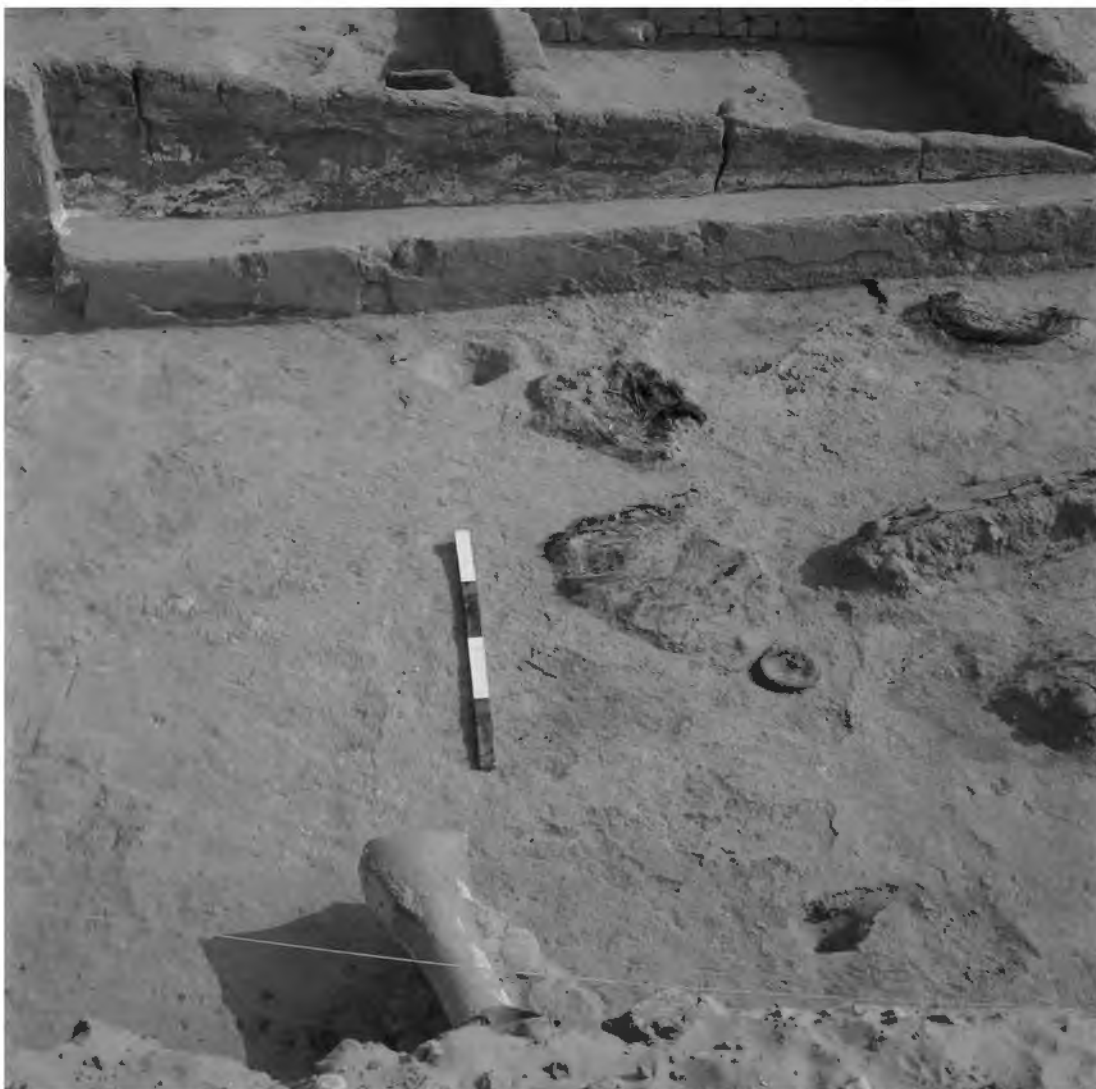
Figure 2.6. Main Chapel: view of the Outer Hall, looking south.

The hall measures 4.40 by 6.10 metres. Brick benches, about 30 cms. high, ran along the north and south walls (Figure 2.6). The western end of the northern bench [863] has been destroyed by digging. Its other end still lies beneath the unexcavated debris of the next square, but at the very end of the work it became apparent that it is broken near the north-east corner by another doorway opening to the north. The southern bench [866] is intact, and starts beside the entrance from Annexe 450.

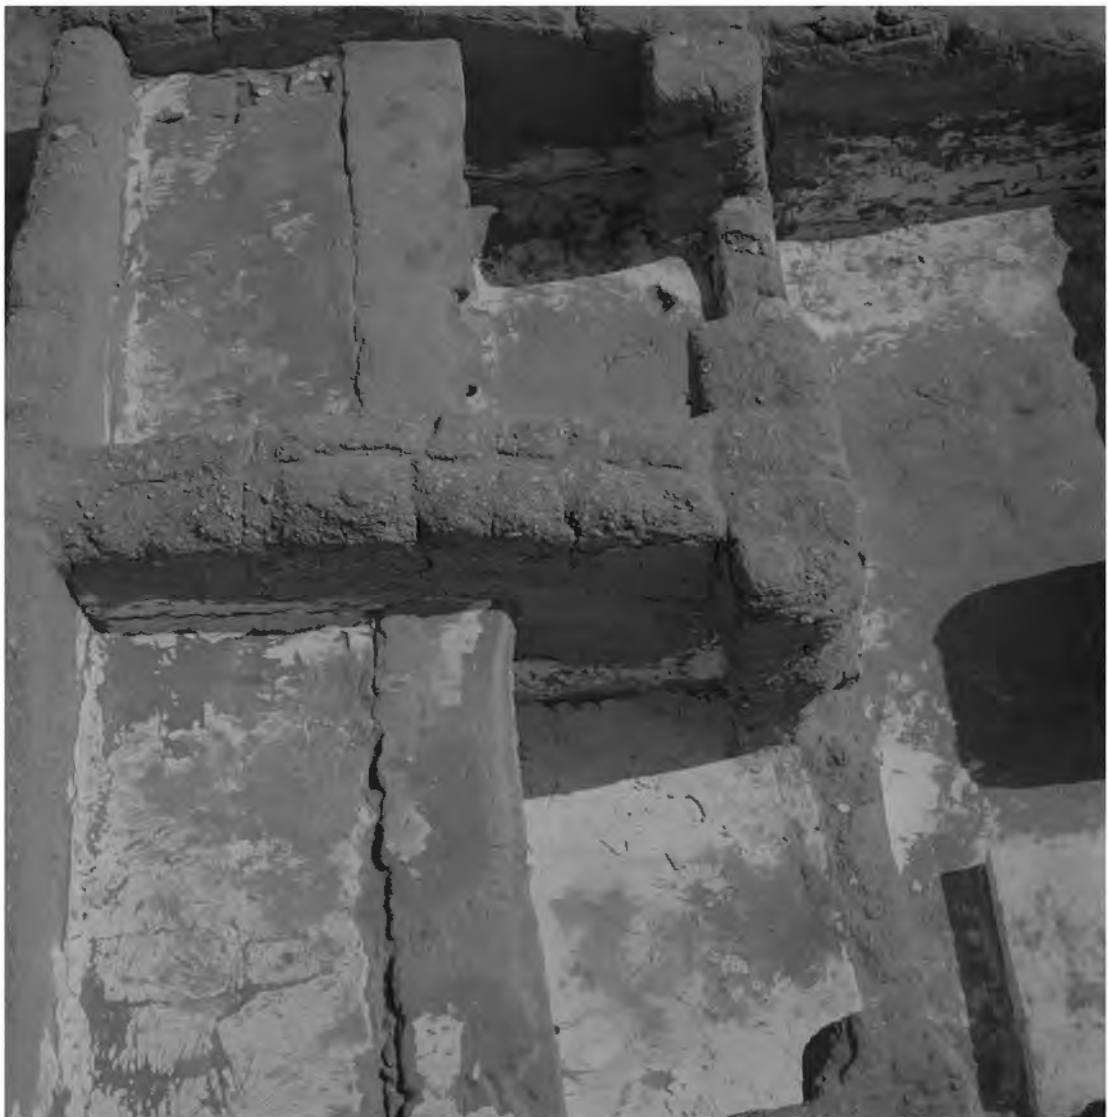
Figure 2.7. Main Chapel: the Sanctuary, looking south.

Nearly a third still lies unexcavated, but sufficient is clear for a description (Figures 2.7, 2.8). It is divided into two parts, a corridor and a group of three adjacent shrine chambers. The corridor was entered from the Inner Hall between a similar pair of brick piers [778, 781] and flanking screen walls [780] as occur between the Outer and Inner Halls.

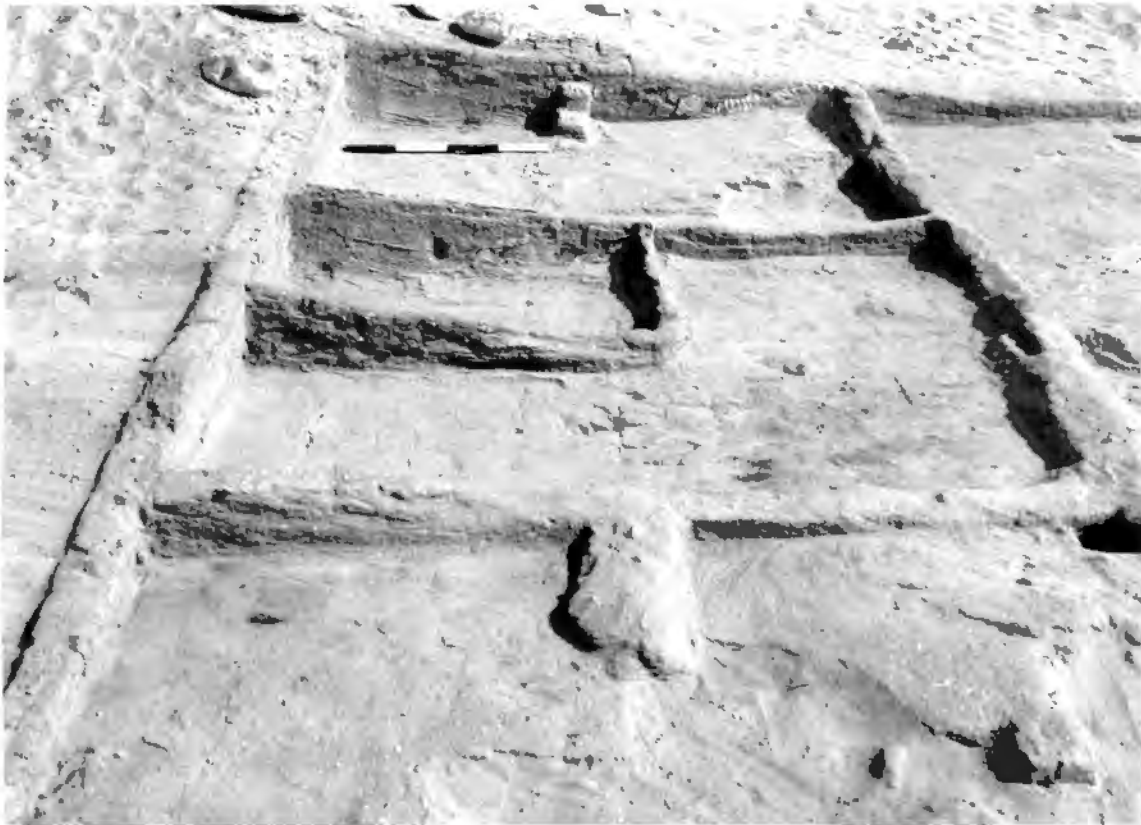
Figure 2.9. Building ("Chapel") 523, looking east.

The dismissive description reflects the fact that it is clearly not a chapel. It possesses nothing that resembles a shrine, nor the axial arrangement that

one would expect in a religious building of the period. Peet left these buildings exposed. Since his day sand and dried vegetation have blown in and protected the floors and the lower courses of brickwork, but the upper courses have decayed or collapsed. Nevertheless, the structural loss has been relatively slight.

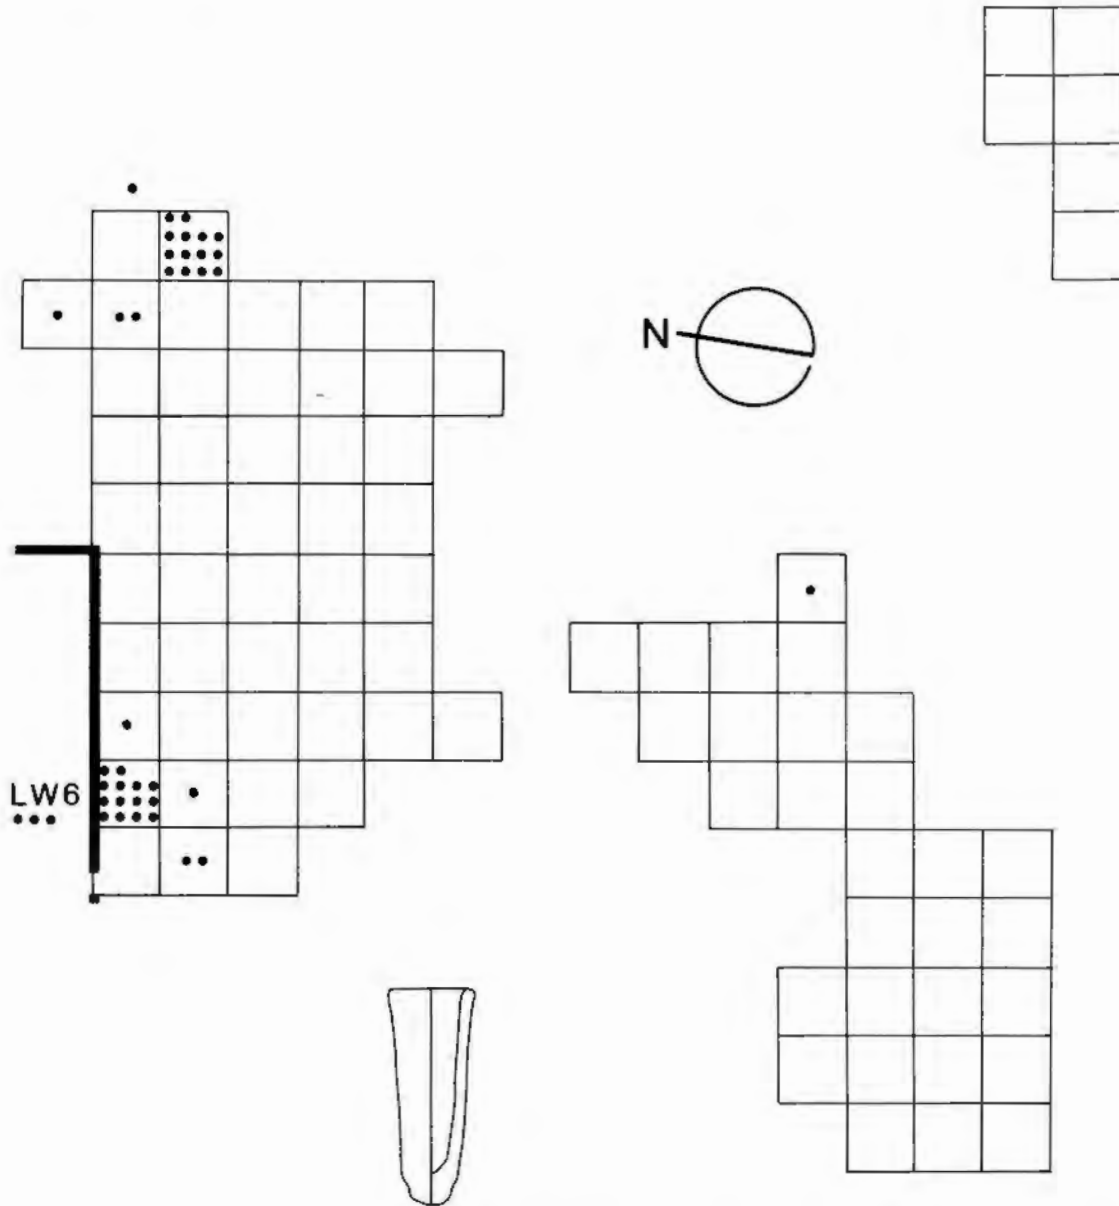
Figure 2.13. Distribution of sherds from pottery bread moulds at the Workmen's Village. "LW6" = house Long Wall Street 6, excavated in 1979.

Village, centred on square K19, was found in a thick deposit of wind-blown sand that had accumulated between the desertion of the village and the outward collapse of the village enclosure wall. They may not, therefore, reflect behaviour contemporary with the village's occupation. The other group, at the east end of the Main Chapel and concentrated in square S18, comes entirely from the dump from Peet's 1922 excavation of the chapels behind. From their position in the dumps we can judge that they were found most likely in building 523, which is where the solitary specimen recorded by Peet himself was found.
