# Great Aten Temple Spring 2012 Season

## Preliminary Report

October 2012

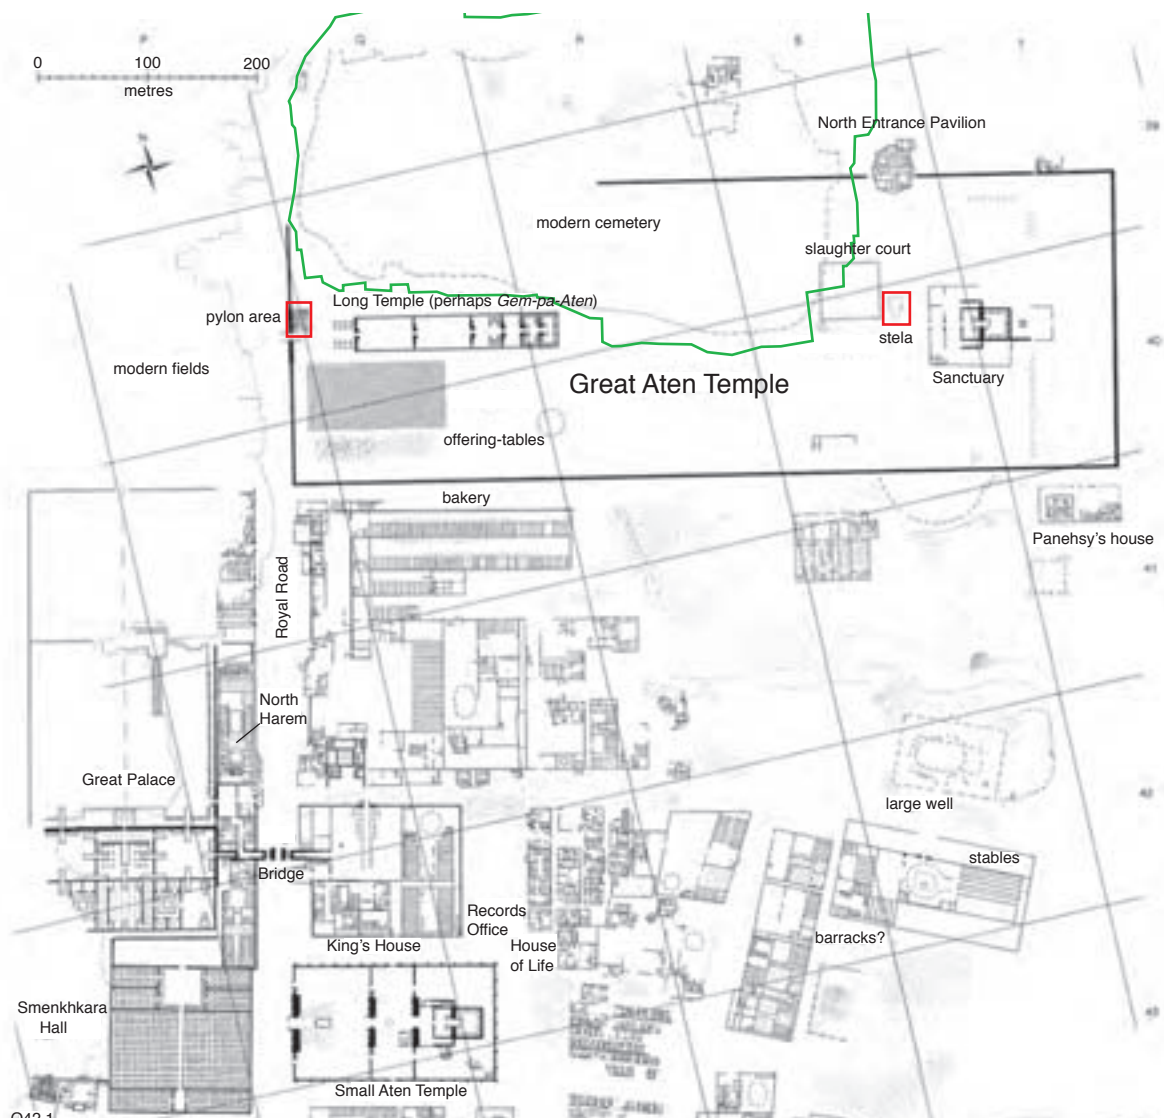
**Figure 1.** Plan of the Central City of Amarna. The two areas outlined in red are the locations of the recent fieldwork. The green line marks the edge of the modern cemetery as surveyed by Helen Fenwick in April 2009. Map based on Kemp and Garfi 1993, sheets 4 and 5.

It is not a single building but a collection of structures spread across a huge area of flat open desert, measuring 800 x 300 m, and surrounded by a mud-brick enclosure wall (Figure 1). The largest single building was situated towards the front, along the central axis of the temple enclosure. It might have had a separate ancient name, Gempa-aten ('The finding of the Aten'), but here it is referred to as the Long Temple (Pendlebury 1951: 191–7 is Fairman's summary of the evidence for the ancient names of parts of the temple). Much further back but on the same axis stood the Sanctuary. Both had been constructed very largely from stone blocks but these had been methodically removed after the Amarna Period ended and transported to other sites, many to Hermopolis/El-Ashmunein across the river. In front of the Sanctuary and to one side (the north) came a group of lesser structures that included what was probably the pedestal for a large stela.

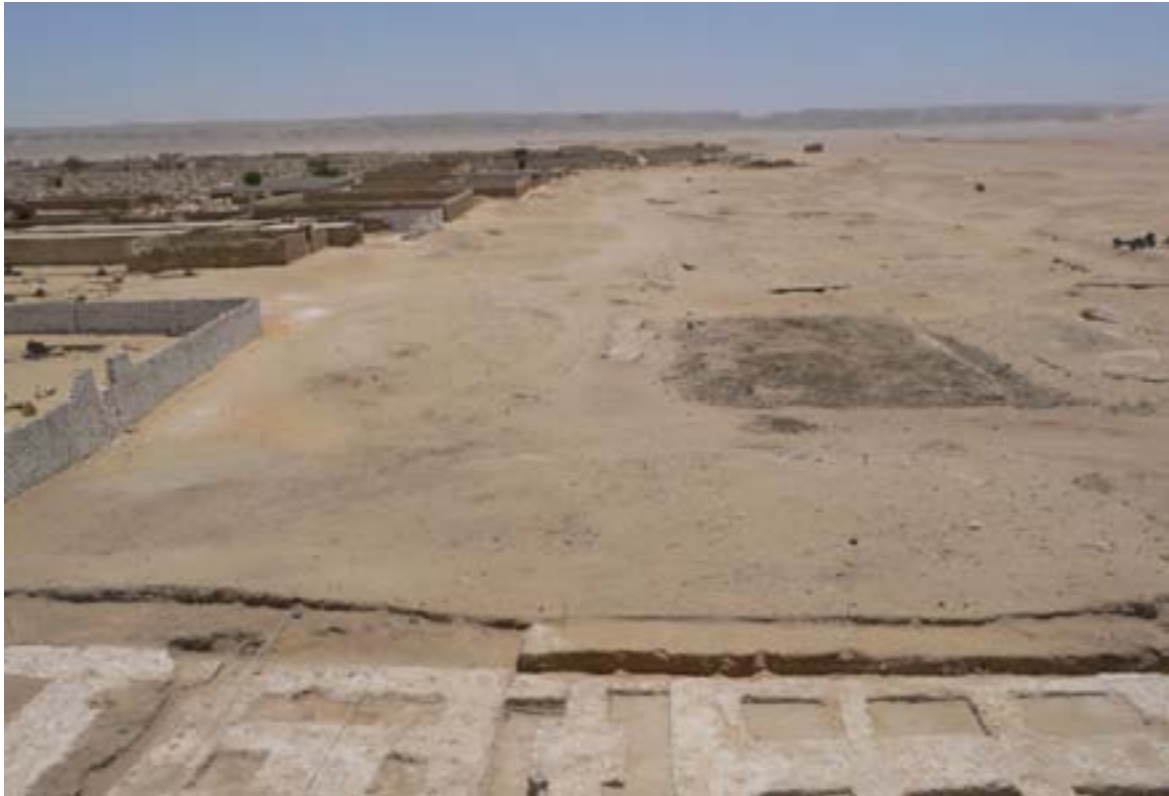
*Figure 2. View eastwards along the axis of the Great Aten Temple from a point slightly north of the axis.*

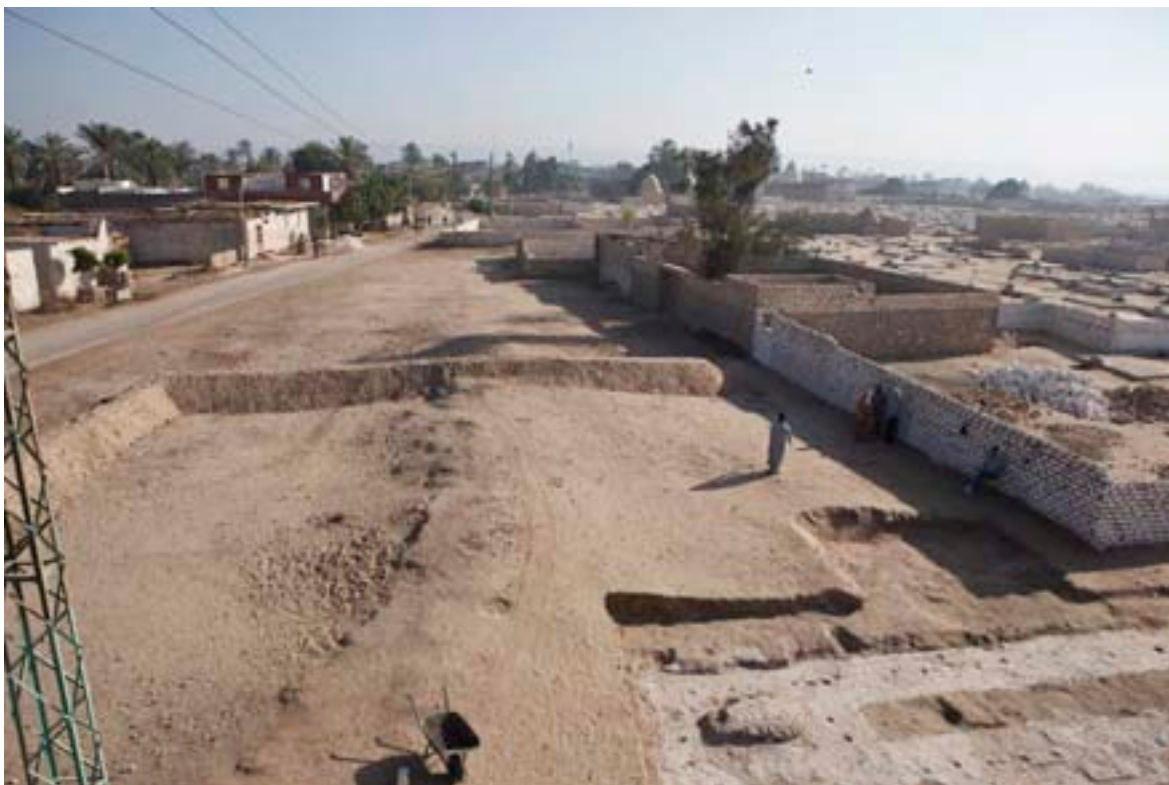
*Figure 3. View northwards from the front of the Great Aten Temple. In the bottom right of the picture the edge of the gypsum concrete foundations for the Platform Building of the Amarna Period is visible, very close to a recent addition to the private tomb enclosures that belong to the cemetery of the village of El-Till. The wheelbarrow stands on the line of the mud-brick enclosure wall of the temple.*

entrance itself had been left open and had gradually been buried in compacted dust. The foundations of the stone building and half of the entrance area were steadily excavated so that, by the end, the original ancient surfaces had been reached. The Pendlebury spoil heap, by contrast, was removed in layers but comprised such a volume of material that, by the end, approximately half of it remained for a future season. All earth that was removed was passed through sieves, producing a significant quantity of material, some of it recent but much of it ancient architectural fragments and pieces of stone and faience inlay and some pieces of statuary. The sieved debris was then piled into a linear embankment as a way of delimiting the site and separating it from the adjacent asphalt road, whilst leaving a gap to allow village access to the cemetery (Figure 3).

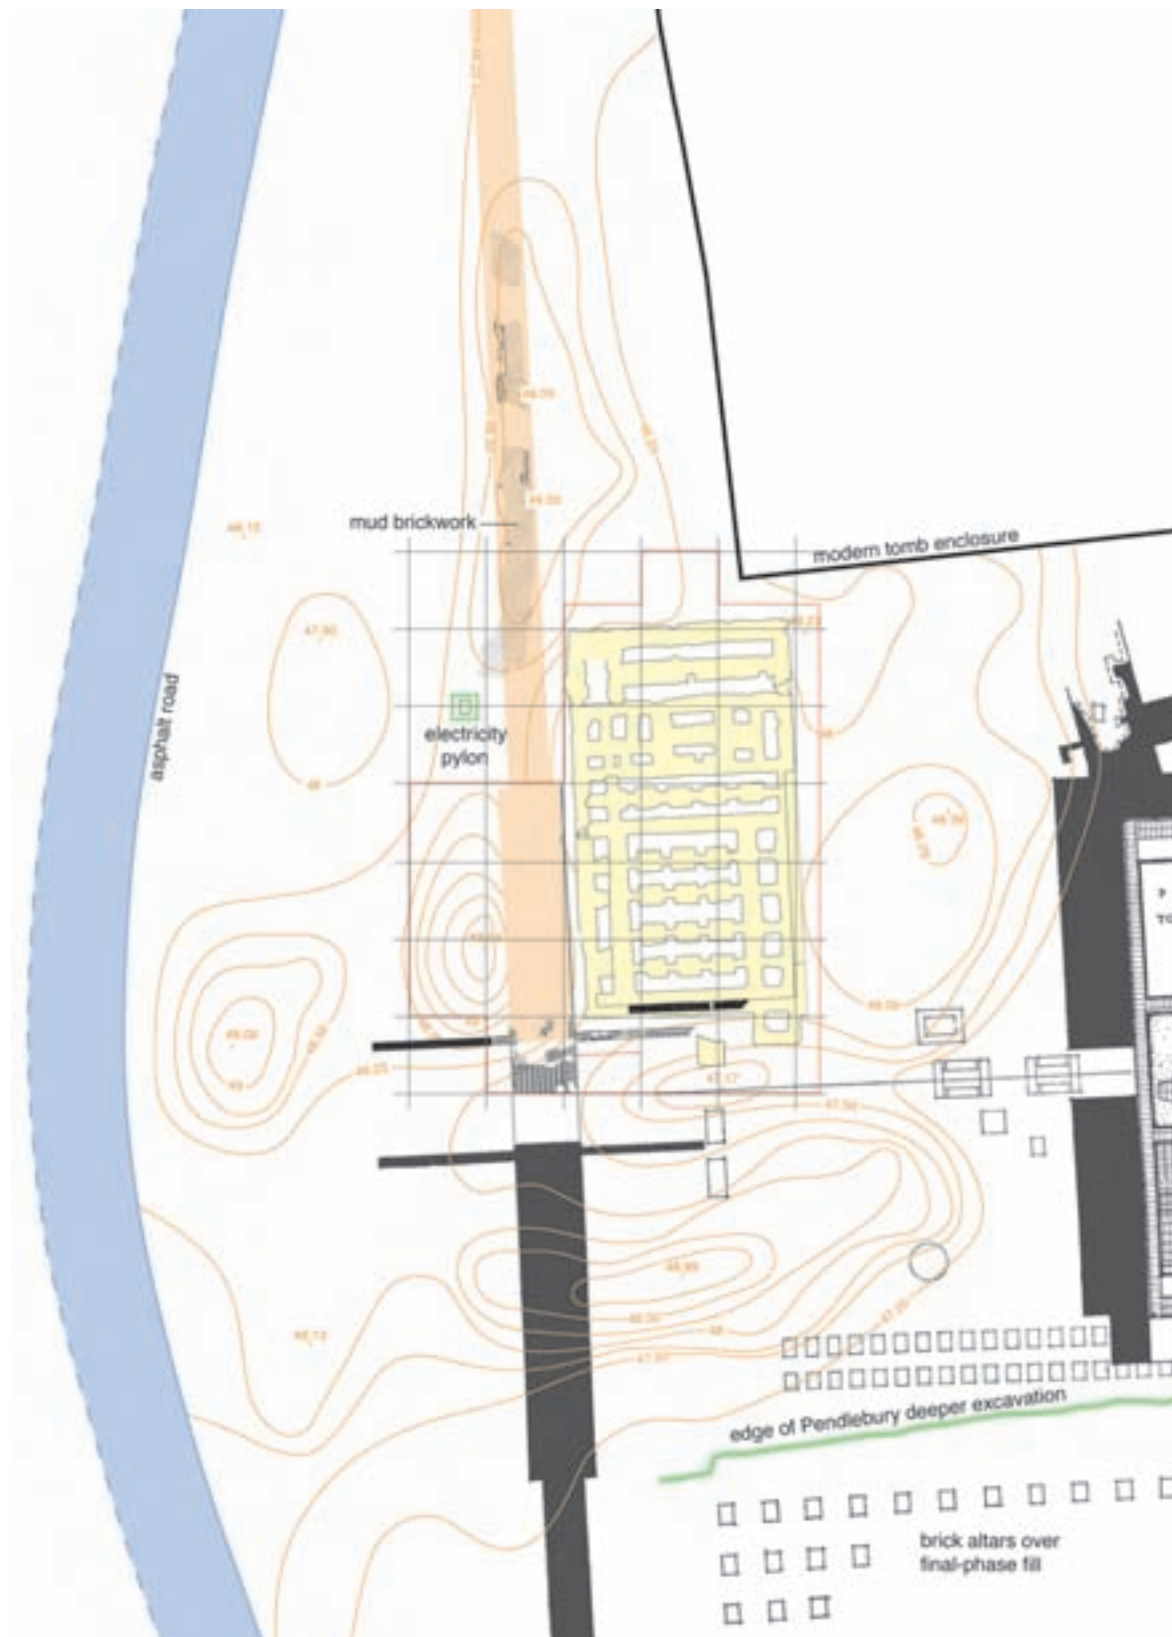
**Figure 4.** Plan of the front part of the Great Aten Temple, combining the results of the 2012 season with the Pendlebury plan of 1932.

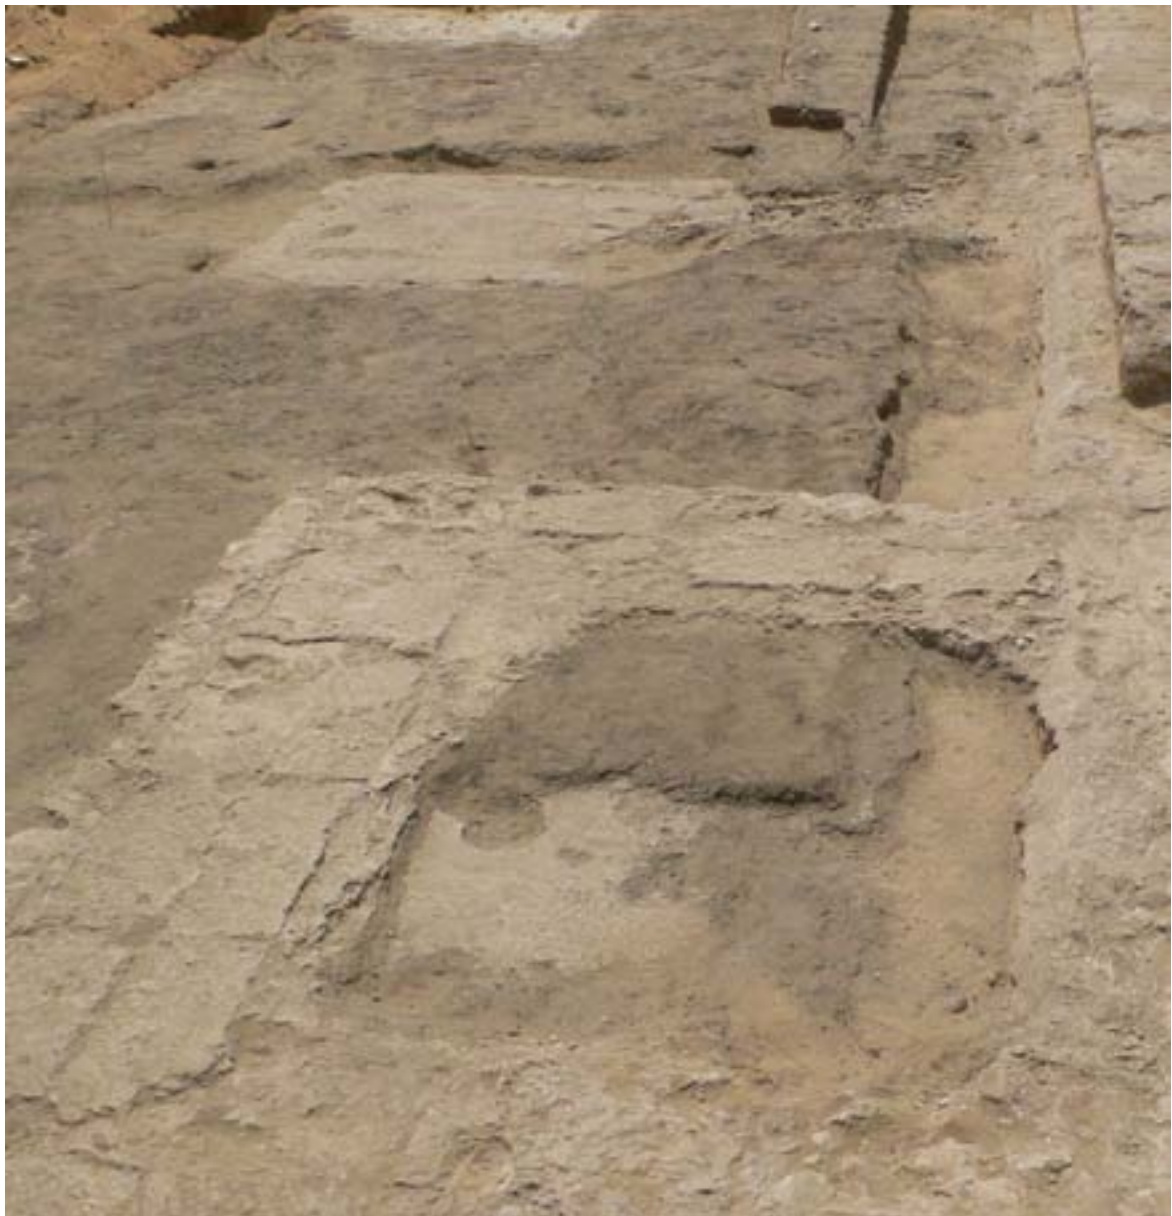
**Figure 5.** View westwards across the area of the entrance ramp. On the right is the southern edge of the gypsum concrete foundations for the Platform Building (with limestone blocks [13901] still in place), and in the foreground the square extension attached to its south-east corner [13920]. Beyond this is the rectangular gypsum foundation belonging to Phase I [13865], and beyond that the end of the mud-brick wall that marked the northern edge of the ramp of Phase III [13791].

south-western part of H31 (visible in the background to Figure 5 and in Figure 6). Its roughly square outline suggests that something had lain over and protected it. The first and second layers of mud-floors and gypsum whitewash covering can be observed across the excavation area in those places where the layers above have been damaged.

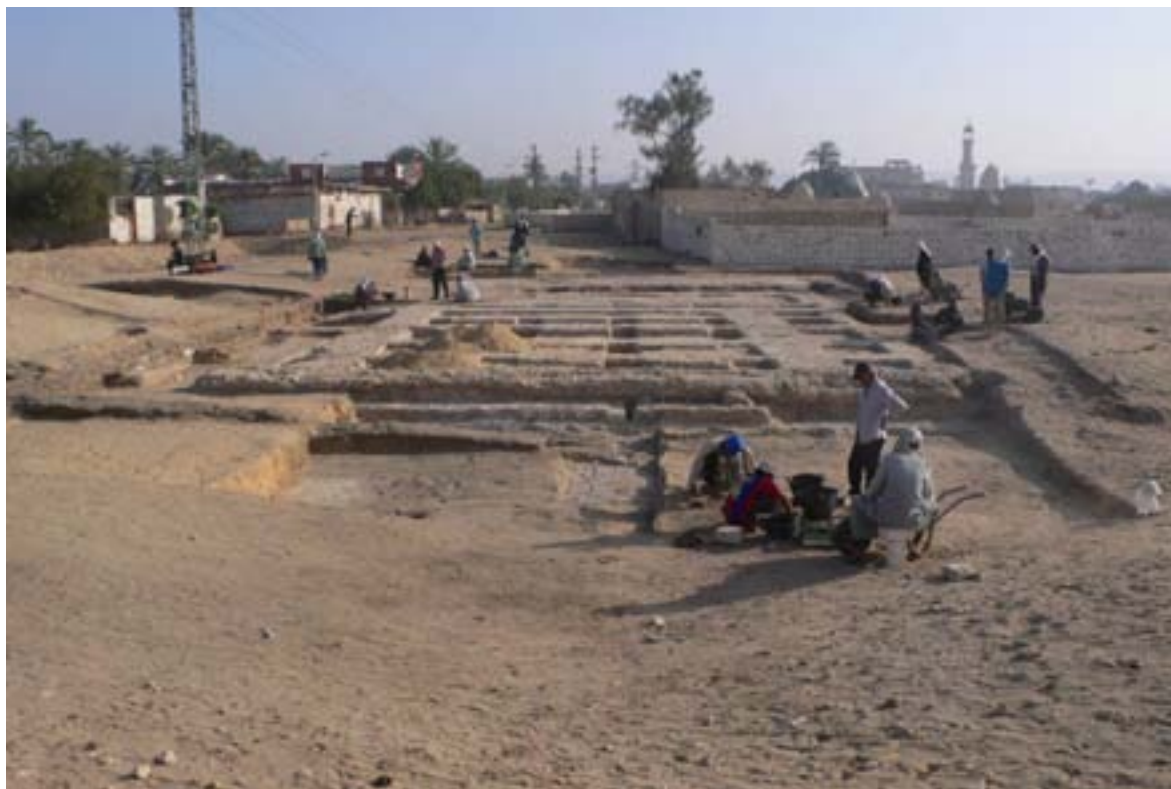
*Figure 6. Northwards view of the excavations, with the brick pylon at the left and, occupying the centre ground, the gypsum-concrete foundations for a stone building constructed during Phase IV. In the foreground the brick ramp of Phase III, east of the pylon threshold, is beginning to appear.*

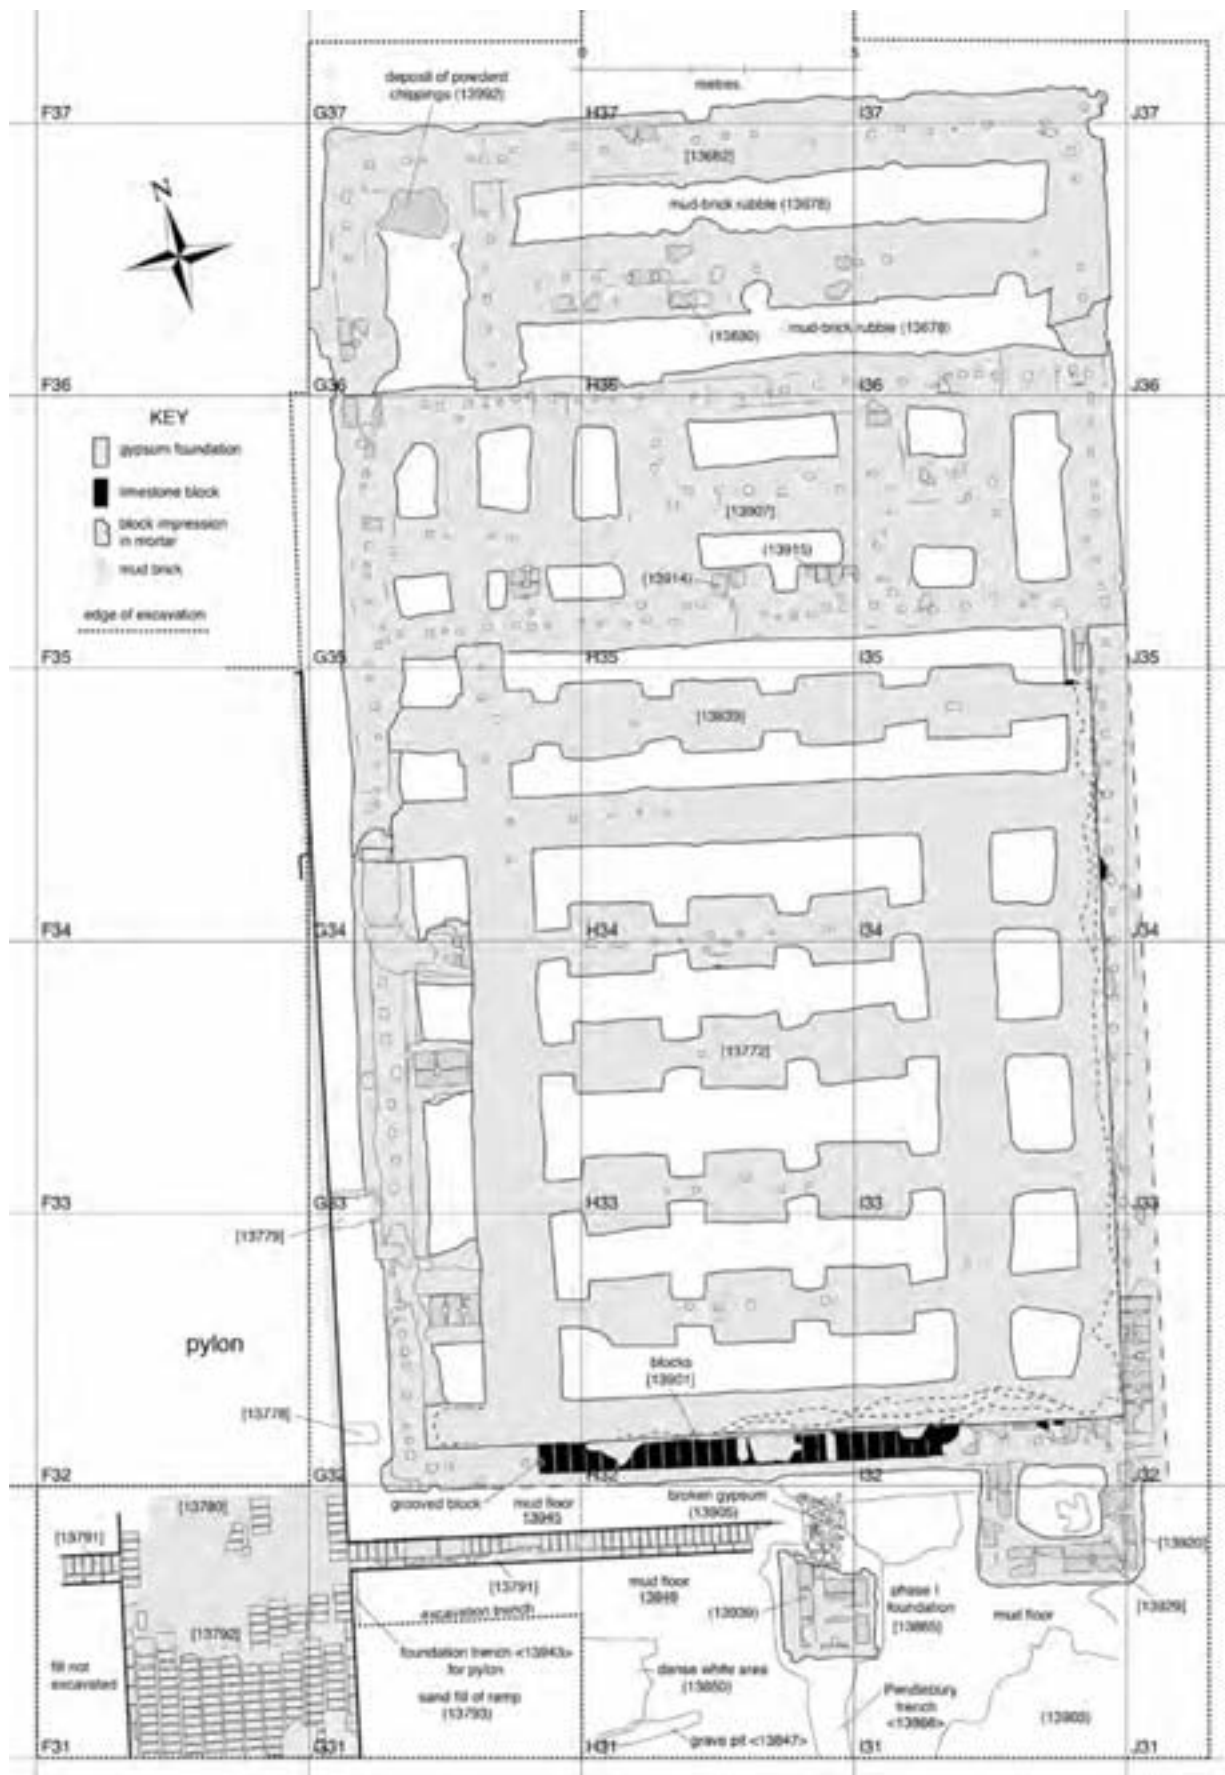
Figure 7. Plan of the excavations (based on originals by M. Bertram, D. Driaux, A. Hodgkinson and B.Kemp).

The foundations cover a rectangular area, of c. 25 x 14.25 m, to which an almost square extension [13920], of 3.0 x 2.3 m, was added to the south-east corner (Figure 7). It should be noted that Pendlebury did not expose the foundations entirely, stopping 5 m short of the northern edge (the part that lies in squares G36–I36). From its general appearance, it has three parts (not counting the small extension in the south-east corner). The southern part, roughly square, was largely made from a series of long, narrow, flat-topped ridges of gypsum concrete that had been built up from the natural ground to the intended new ground level [13772]. For the middle section [13907], that runs across grid squares G35–I35, the final level dropped by 20 cm, or a little more, and the gypsum was spread as a single layer that had a depth of around 10 cm.

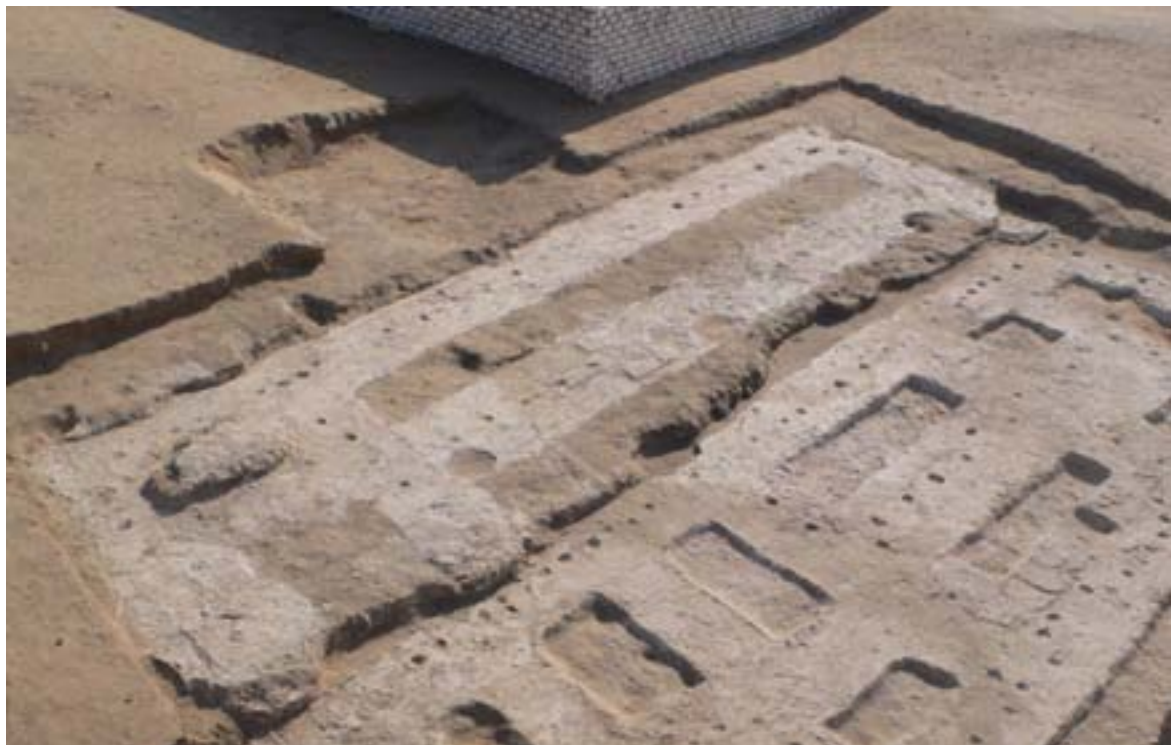
**Figure 8.** Northern end of the gypsum-concrete platform, sections [13907] and [13682]. The stone tomb enclosure that stands adjacent to it was built in January 2012. The holes in the gypsum were made to help lever up the limestone blocks during their removal after the end of the Amarna Period.

For the northern part [13682], the builders left in place a layer of mud-brick debris (13678), perhaps rubble from a demolished building (Figure 8). Aiming for a surface that was close to that of the southern section, they dug trenches into it, to a depth of about 20 cm, and filled them with gypsum concrete. In this way, the middle section was lower than the sections on either side, but this is unlikely to represent a final floor level that was lower.

Other than this, the site saw the partial excavation by Pendlebury in 1932, and its subsequent covering by wind-blown sand and dust and by village debris that included a thick layer of compacted animal manure in the hollow in grid square I31. In January 2012, a new stone enclosure brought the edge of the village cemetery to within 2.5 m of the foundations of the Platform Building (Figure 8).

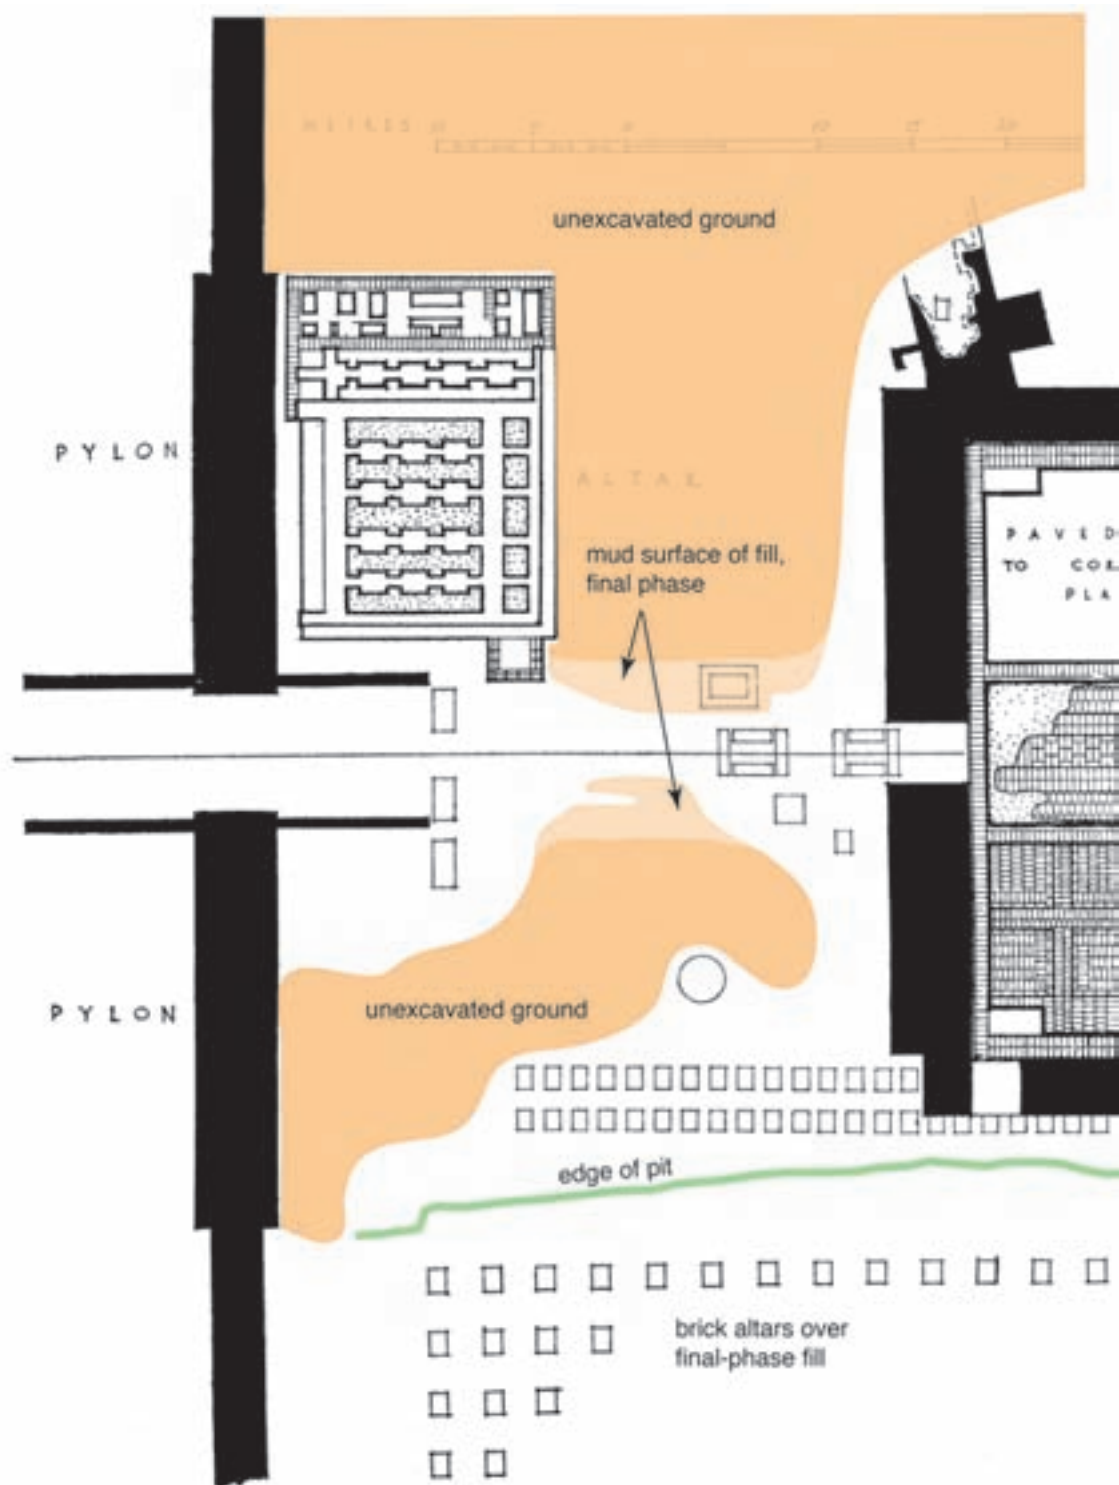
*Figure 9. Part of the plan made by Ralph Lavers of the Pendlebury excavations at the front of the Great Aten Temple. The shaded additions are a reconstruction of where Pendlebury's trenches ran.*

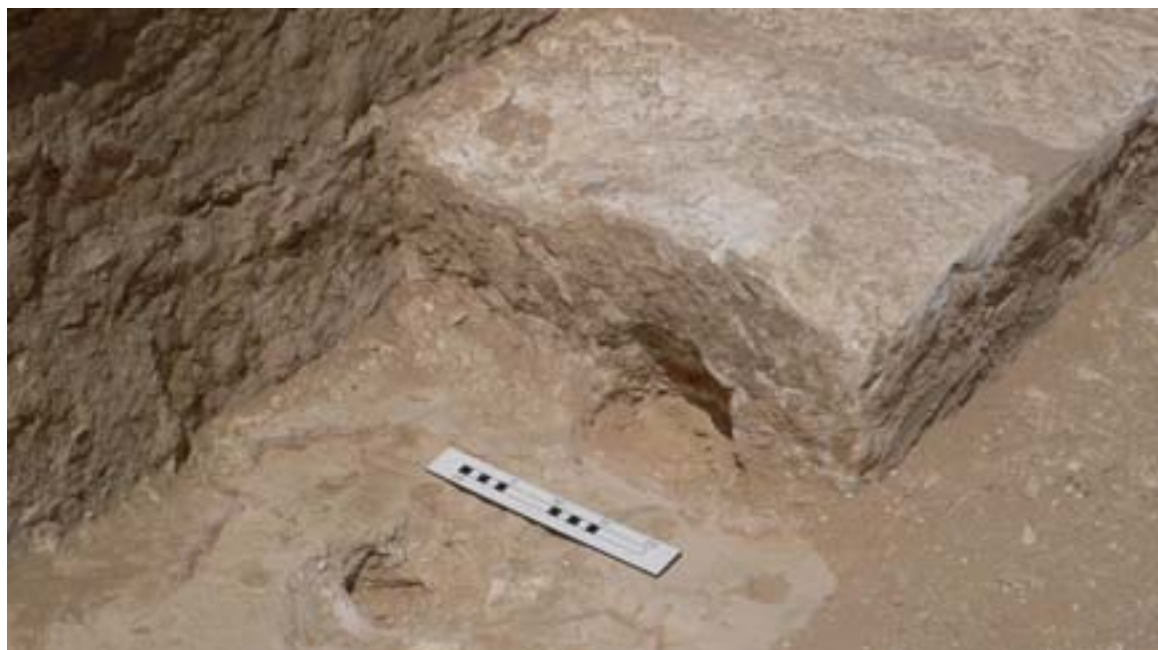
**Figure 10.** Original limestone block still in position at the south end of the gypsum concrete platform [13901]. It shows how the holes in the foundations were made, to assist in the removal of the lowest course of blocks.

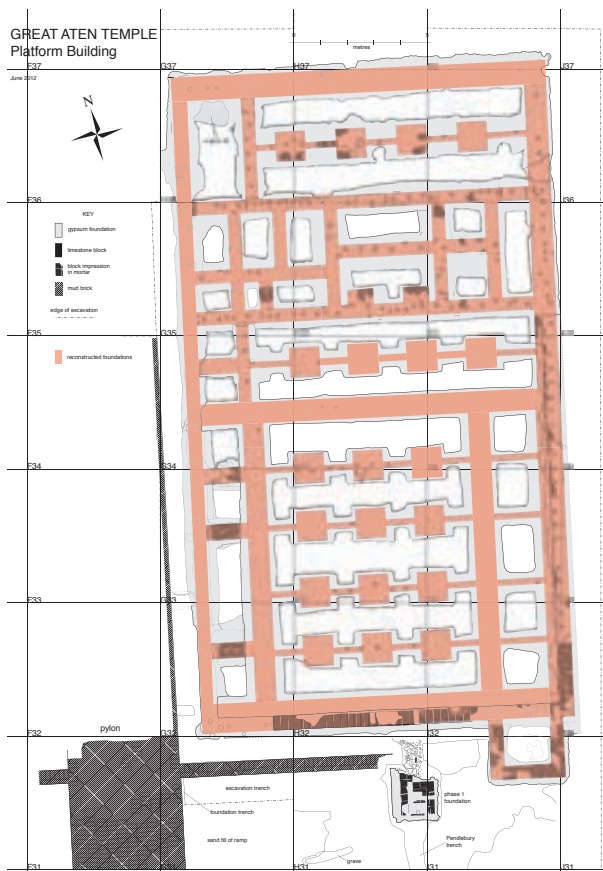
**Figure 11.** Reconstruction of the foundation course of limestone blocks of the Platform Building.

There is sufficient evidence, therefore, to reconstruct the plan of the building over most of its floor area (Figures 11 and 12). Starting in the south, we see that its main feature was a hall of columns, comprising four rows of three columns each, the axis of the building running east to west. Its internal space must have measured c. 7.7 x 14.7 m. It is likely, therefore, to have been entered in the middle of the east side, from what was probably a long corridor, probably c. 1.75 m wide. The square addition at the corner might then have served as an entrance vestibule, of the kind familiar from Amarna houses, its entrance on the west side. On the west side, thus at the rear of the columned hall, ran a second long corridor, c. 1.5 m wide.

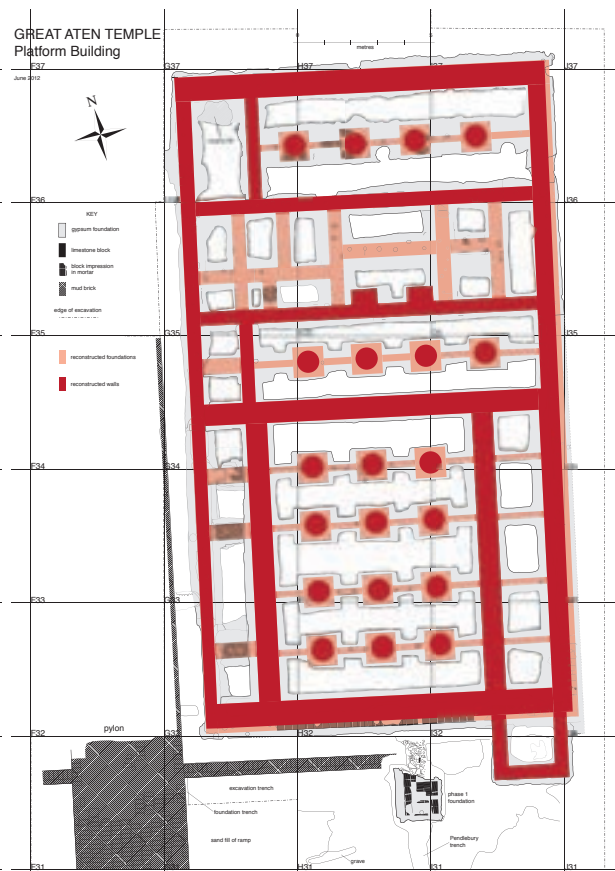
**Figure 12.** Reconstruction of the lowest course of stones and of column bases of the Platform Building. No attempt has been made to reconstruct the position of doorways.

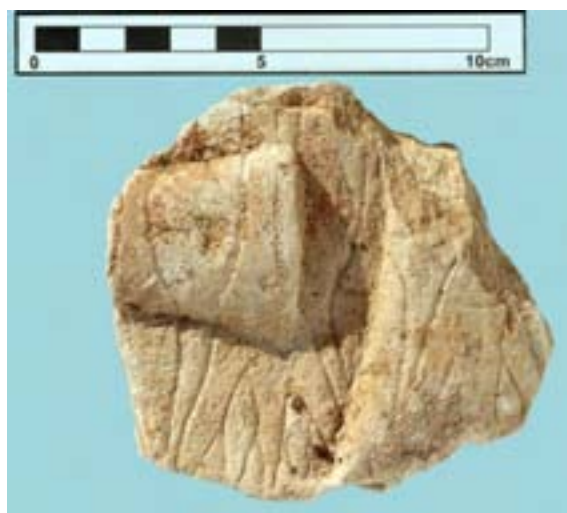
**Figure 13.** Fragment of limestone column, from G36 (13857), that has been carved with pendant ducks, all surfaces then covered with a lightly incised plant decoration.

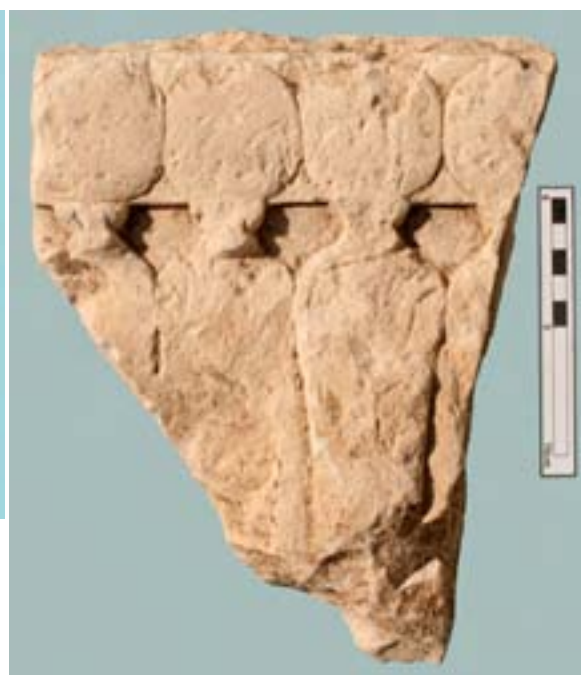
**Figure 14 (right).** Fragment of a limestone frieze carved with cobras, from E31 (13782).

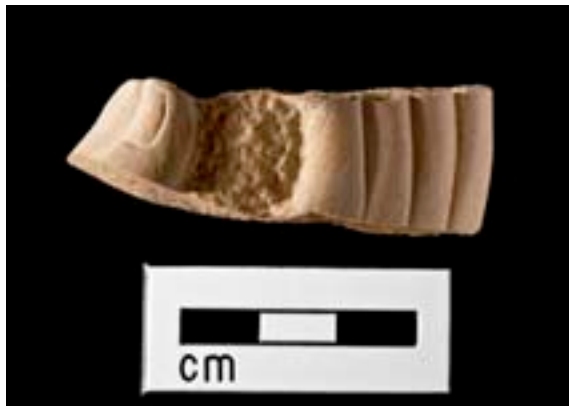
**Figure 15.** Fragment of quartzite inlay (S7531) depicting fingers and thumb, either from a human figure or from the end of an Aten ray. The rough space between fingers and thumb was perhaps filled by a separate inlay, presumably of faience. Photo by G. Owen

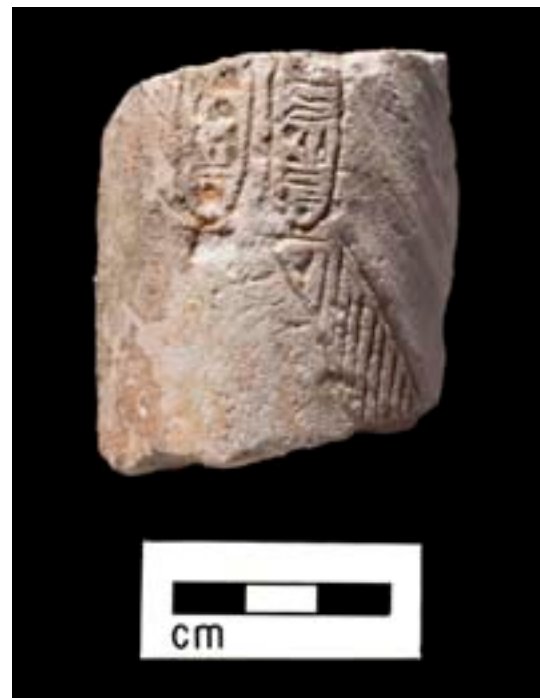
**Figure 16 (right).** Fragment from the arm of a royal statue, from G34 (13928), on which the Aten's cartouches have been carved. Photo by G. Owen.

The removal of the loose covering material and of part of the Pendlebury dump over the north pylon produced a collection of stone and faience fragments that are likely to derive from the Platform Building and to which can be added the list of finds from the Pendlebury excavations themselves (Pendlebury 1951: 17–20, presumably those found inside and outside the ‘West Entrance to the Temenos’, though some, particularly the fragment of sphinx, 32/20, will more likely have belonged to Phase I, before the Platform Building was constructed). The new fragments include two from columns decorated with the carved pendant ducks that were a common motif on columns at Amarna (Figure 13) and pieces of limestone frieze decorated with cobras (Figure 14). What particularly stands out is the variety of inlays that must have been used to decorate the stone surfaces. Some were in hard stones, including black granite, quartzite (Figure 15) and a fine-grained green stone that might be the same as the ‘metamorphosed green limestone’ of pieces from Amarna in the Petrie Museum (e.g. UC 46426, see <<http://www.accessingvirtualegypt.ucl.ac.uk/COVES/index.php>>). Others were in faience. Several pieces of faience tile were also found, depicting marsh and pond scenes. Were they set into a floor in the columned hall? Fragments were also found from relatively small statues in limestone and quartzite, two of them decorated with tiny carved Aten cartouches (Figure 16).

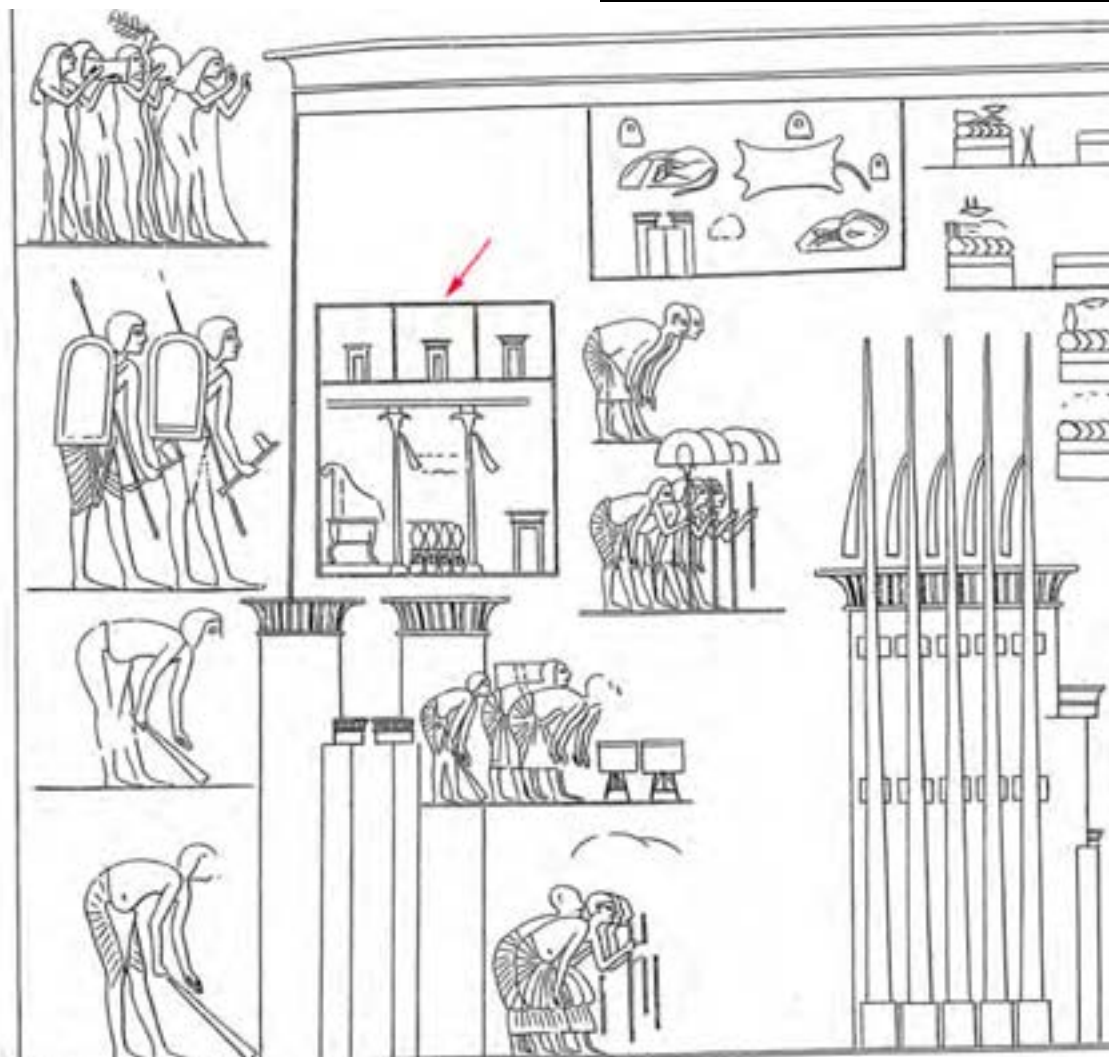
**Figure 17.** Part of the depiction of the 'House of the Aten' in the tomb of the high-priest Panehsy at Amarna (tomb no. 6). The red arrow points to a building that might be the Platform Building. After Davies 1905: Pl. XVIII.

As to the purpose of the building, in three of the pictures of the House of the Aten in tombs at Amarna (two in the tomb of Meryra, one in the tomb of Panehsy, Figure 17), seemingly just inside the outer entrance to the temple stands a separate building (shown duplicated in the case of one of the Meryra scenes). The details differ in each case. The Panehsy version gives prominence to a throne, whilst one of the Meryra versions includes a Window of Appearance. The building could therefore be classed as a small palace. It was also one of the few buildings in the temple enclosure that was roofed and offered safe storage for valuable objects.

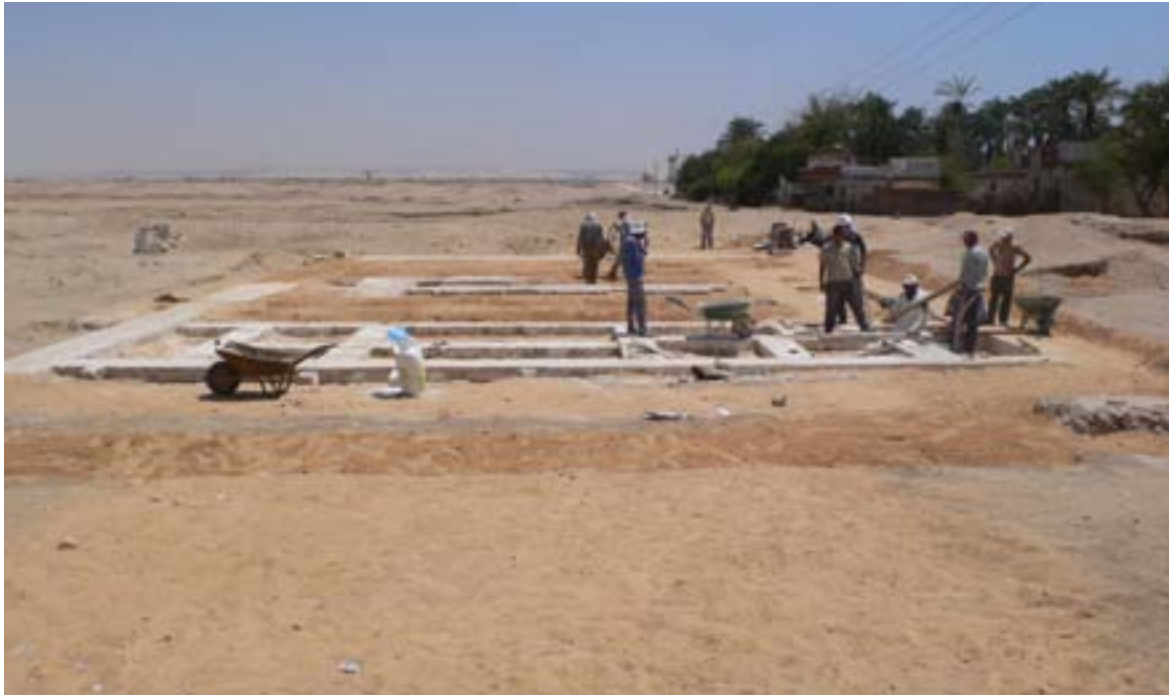
**Figure 18.** *The Platform Building, viewed to the south near the end of the season. The building team from El-Till, headed by Shahata Fahmy, lays a new foundation layer of stones and mortar over a bed of sand on top of the ancient foundations. This is, in turn, covered with sand pending the completion of the work in a future season.*

By this time it was necessary to stop the work (Figure 18). All exposed ancient surfaces were protected with sand. The final step (planned for 2013) will be to lay a single course of new stones over all wall lines, and to recreate the column foundation pattern. All intervening spaces will then be filled with sand, leaving a low platform, one block in height, over which the plan of the building will be unobtrusively visible.

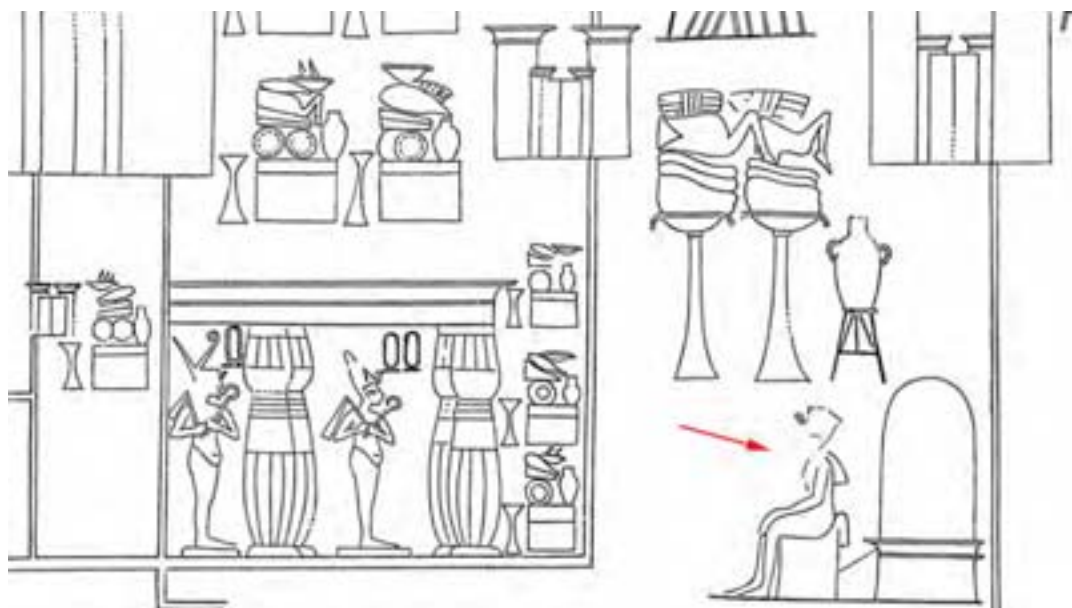
**Figure 19.** Round-topped stela and royal statue shown in the tomb of the high-priest Meryra as part of a composition depicting the Great Aten Temple. After Davies 1903: Pl. XXXIII.

The stela site stands in front of the Sanctuary of the Great Aten Temple in the eastern half of the temple enclosure (Figure 1). The modern cemetery lies to the north and west, extending into the centre of the enclosure and approaching to within 35 m of the stela site. The site was excavated in the 1933–4 season by the Egypt Exploration Society under John Pendlebury, who found a large T-shaped depression to the north-west of the entrance to the sanctuary (Pendlebury 1951: 11–12). The EES expedition excavated within this depression down to gypsum plaster foundations about 50cm below the surface level. The area around the depression was only examined at the surface, without excavation. It was concluded that this was the foundation for a stone platform, which held a large round-topped stela and possibly a seated statue of the king, both depicted in Amarna tomb scenes (Figure 19).

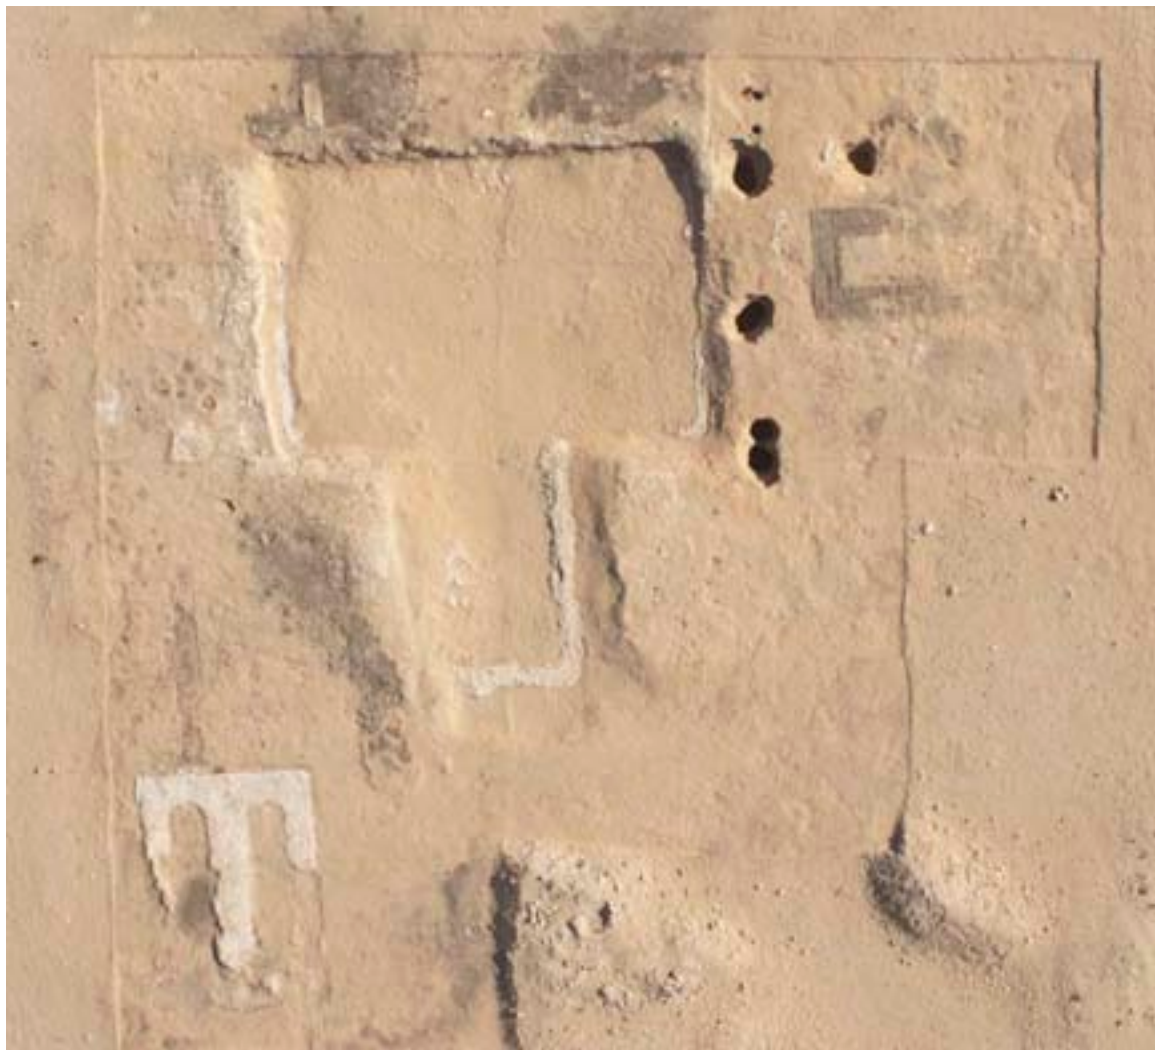
**Figure 20.** The stela site from the air after excavation. (The full northern extent of mud-brick paving was not exposed at this point.) Photo by Gwil Owen.

Excavation proceeded in 5 x 5 m squares, initially along the northern edge of the depression, then continuing south down both sides until a 5 m strip had been cleared on all sides. The surface deposit was removed down to the archaeological deposits and then each area was carefully cleaned. As part of this process, the slopes of the depression were also cleared back to the archaeological deposits. The centre of the depression was then excavated down to the gypsum foundations and the area of excavation was extended northward and eastward to follow the archaeological features initially exposed. The features exposed by surface cleaning were excavated as they were found, although time constraints left a few hollow features unexcavated at the end of the season (Figure 20).

The stela depression remained much as it was described by Pendlebury (1951: 11). The sides were somewhat irregular and seem to have suffered considerable erosion since they were exposed in the 1930s (Figure 20). The heavily fragmented gypsum plaster (or concrete) foundations remained at the bottom of the cut in thin strips along the east and west sides of the main rectangular section. In the southern extension — the upright of the T shape — the foundation was better preserved, possibly because it was originally thicker than the main section or perhaps because the gypsum plaster here seems to have been mixed with more limestone fragments. In any case, the foundation material in the southern extension appears to be slightly different from that of the main section, suggesting the two parts may not have been built quite at the same time.
