# Great Aten Temple Spring 2012 Season

## Preliminary Report

October 2012

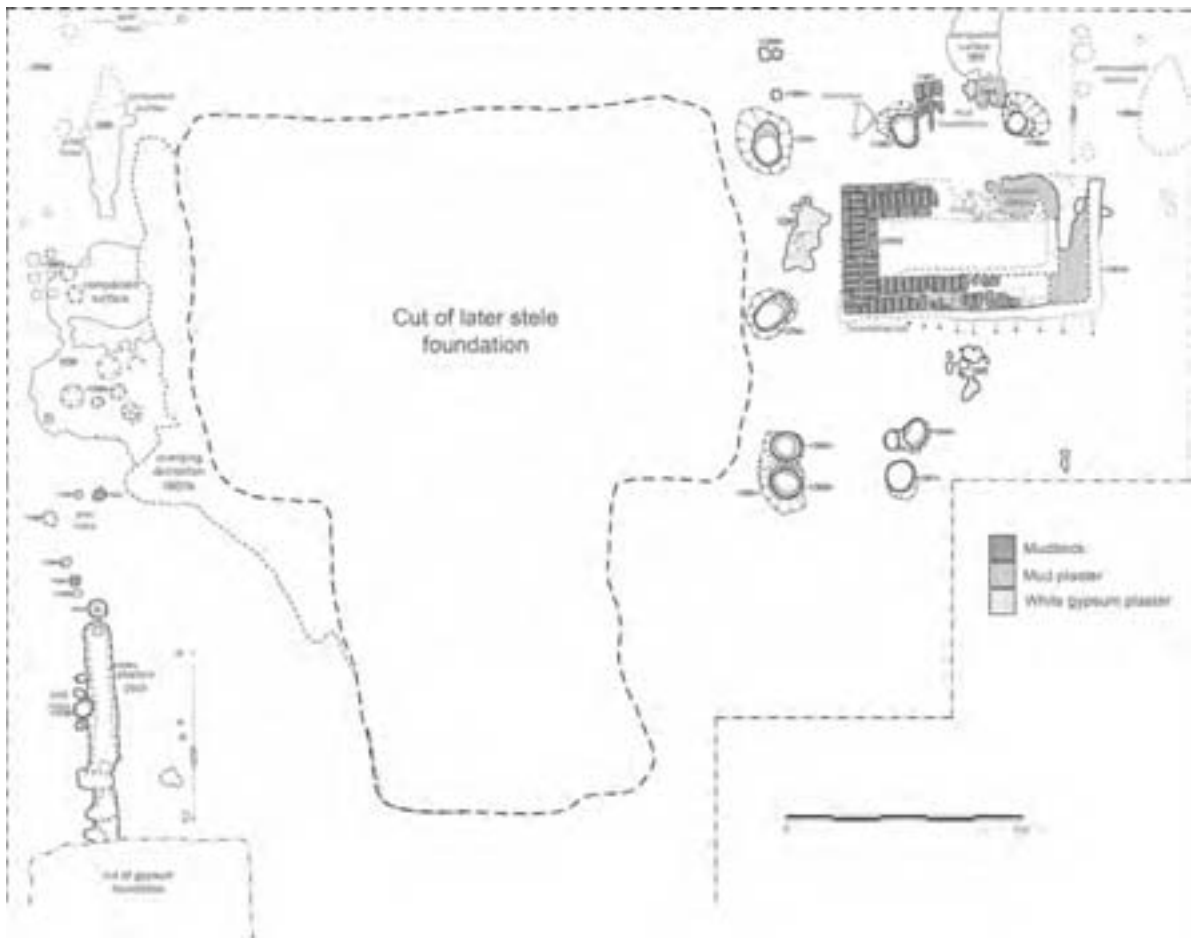
Figure 21. Plan of the Phase I features at the stela site, by Mary Shepperson.

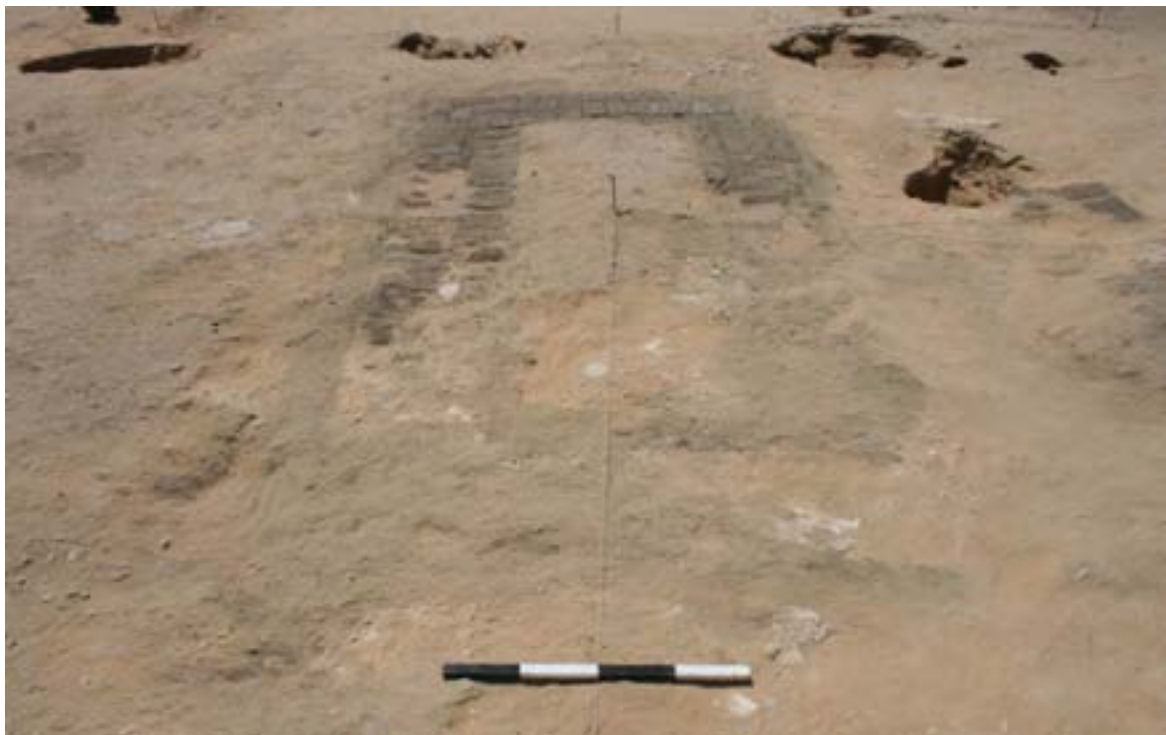
Figure 22. The Phase I mud-brick platform, viewed to the west.

A rectangular mud-brick foundation (6.30 x 4.50 m) lay on the eastern side of the stela depression, preserved at its western end as a single course of bricks [13695] and at the east end as just a foundation cut (Figure 22). This mud-brick structure had been noted, although not fully excavated, by Pendlebury, who interpreted it as the base for a ramp leading up to the stela platform from the east (1951: 11). This is clearly not the case, as the structure does not reach the edge of the stela foundation but stops more than 2 m short. Instead, this appears to be the foundation of a free-standing mud-brick platform. The remains of a pair of mud-brick bases [13697], [13813] mid-way along the long north side might belong to the ends of a ramp or steps approaching the platform from this side, with a hard-packed floor surface 13816 preserved at the foot of this.

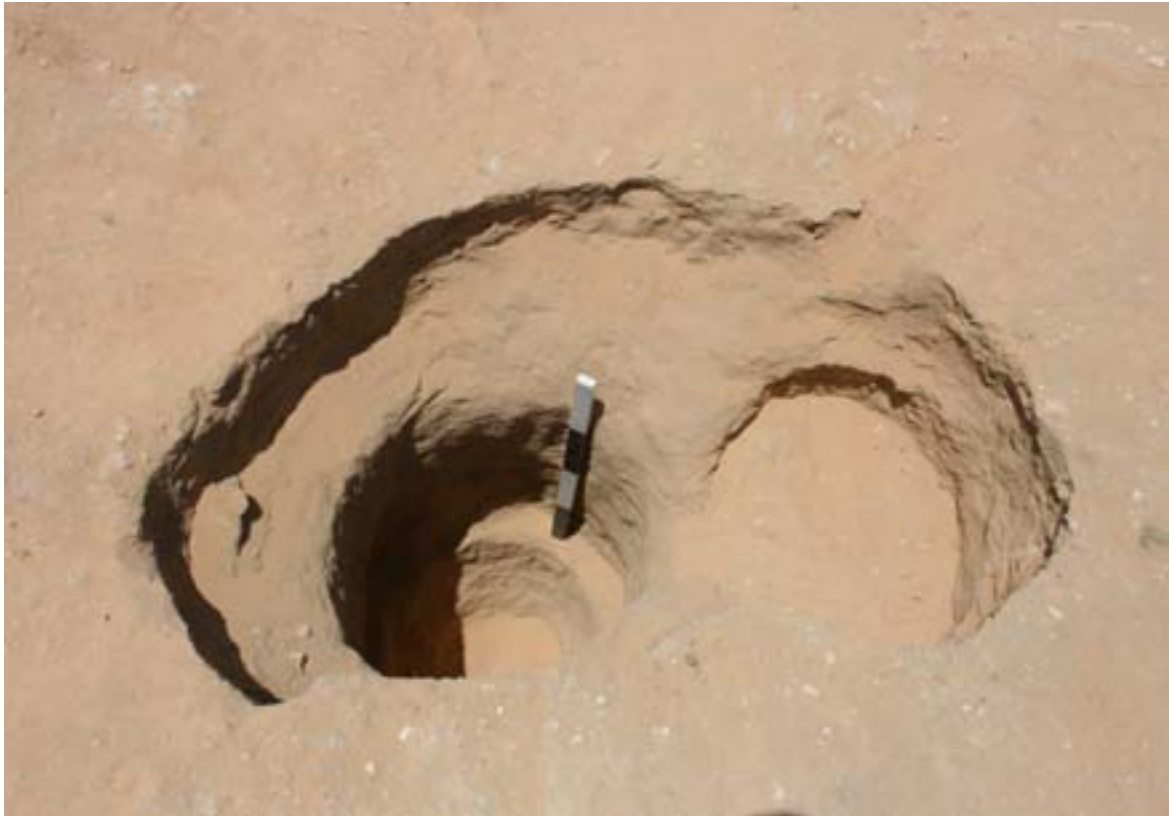
*Figure 23. One of the Phase I pits, this one showing two attempts to cut it into the desert. The scale is 1 m long.*

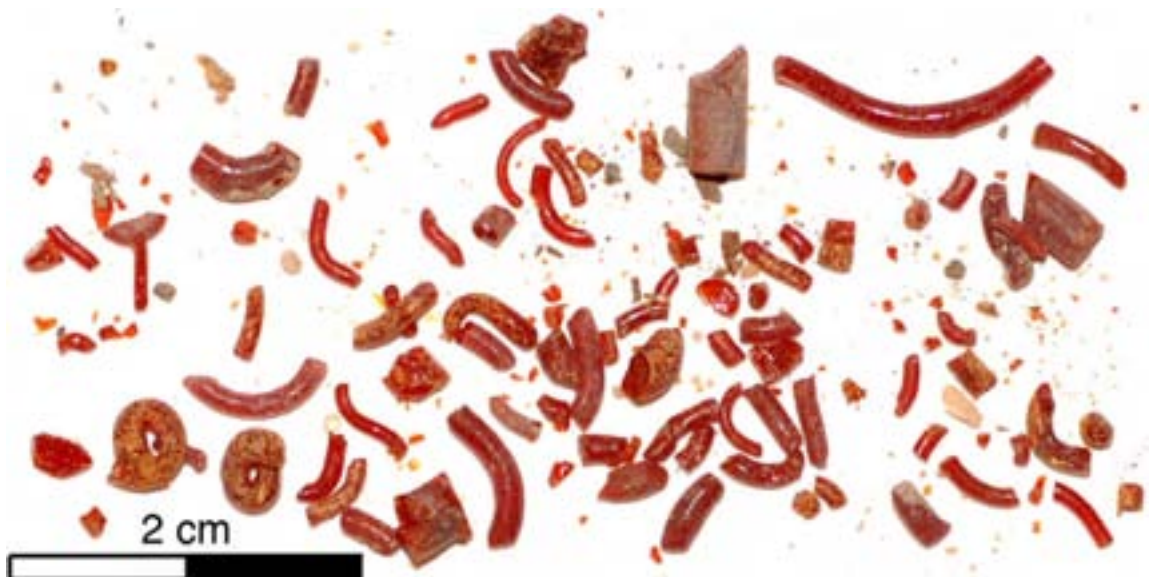
*Figure 24. Fragments of incense recovered from one of the deep pits at the site of the stela in the rear part of the Great Aten Temple. The filament shapes probably resulted from pouring viscous incense through a strainer (an explanation provided by Margaret Serpico). Photo by Teresa Wilson.*

Incense was a common find on site, and fragments were found in almost all the ditches, pits and postholes of Phase I. Some was in a raw form as lumps, but it was more commonly found in a processed form as tiny curving rods or filaments resembling red glass (Figure 24). To produce this shape, the incense had probably been passed through a strainer (an idea suggested by Margaret Serpico). In general, very few finds of any kind were recovered from the excavated material, indicating that the stela area of the temple was largely kept clear of rubbish and debris. The fact that the stela area had already been excavated by the EES and probably earlier by Carter probably also reduced the number of finds remaining on the site.

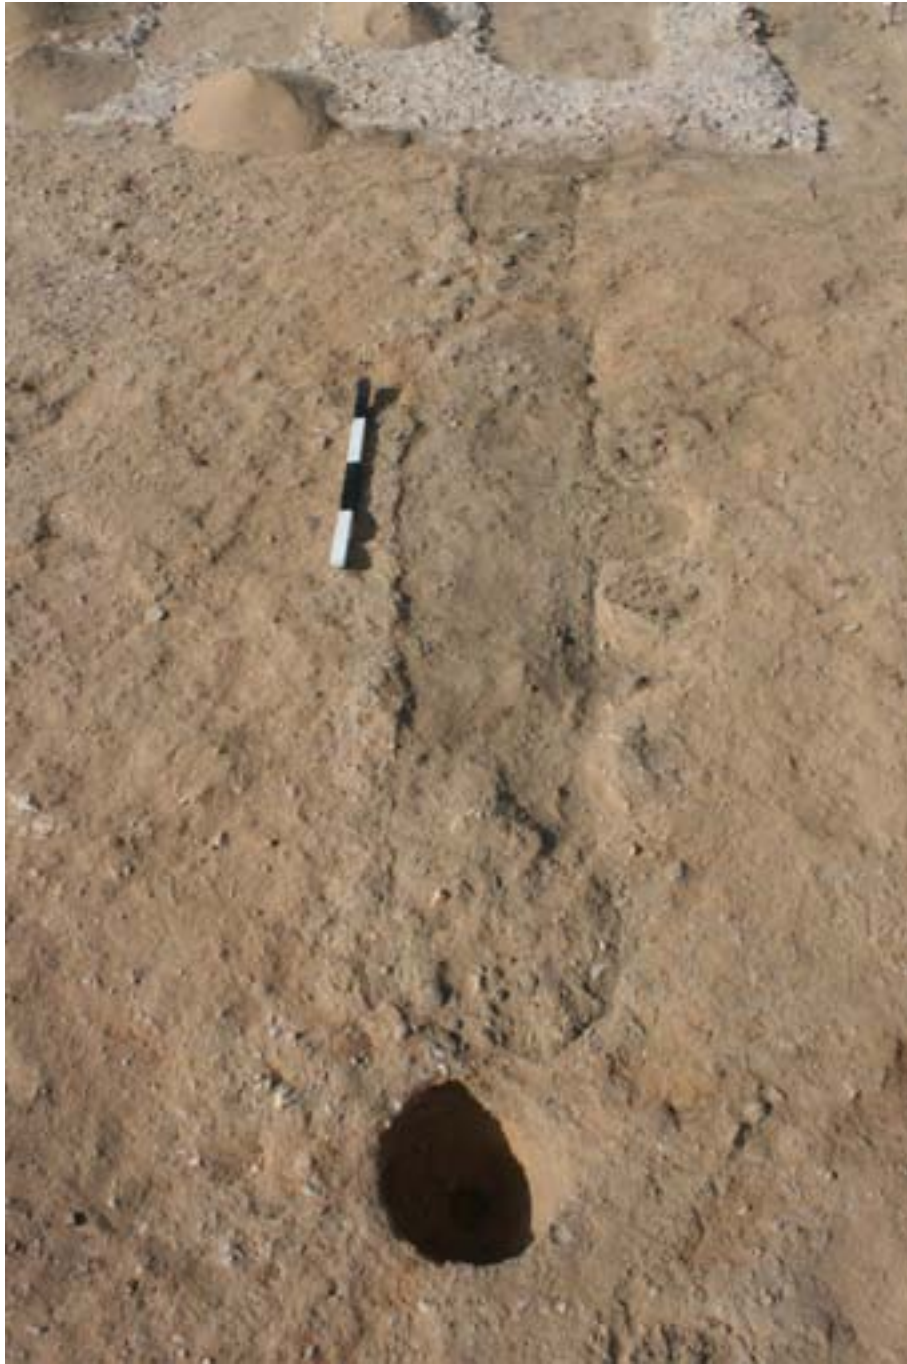
*Figure 25. Phase I ditch before excavation, looking south.*

On the west side of the stela depression, a compacted surface was uncovered into which numerous circular depressions and a long shallow ditch <13741> had been cut (Figure 25). This surface and its features certainly predated the main stone stela platform as it was overlaid by limestone debris from the platform's construction. Efforts then seem to have been made to level these features — some had been packed with lumps of mud brick — before the Phase II mud plaster and gypsum floor was laid above. The north–south running ditch was cut at its southern end by the foundation cut for the Phase II rectangular gypsum base, suggesting it was out of use by the time this base was built. The ditch at least can be tentatively linked to the deep pits described above, as the ditch fill was more or less identical to that of the pits.

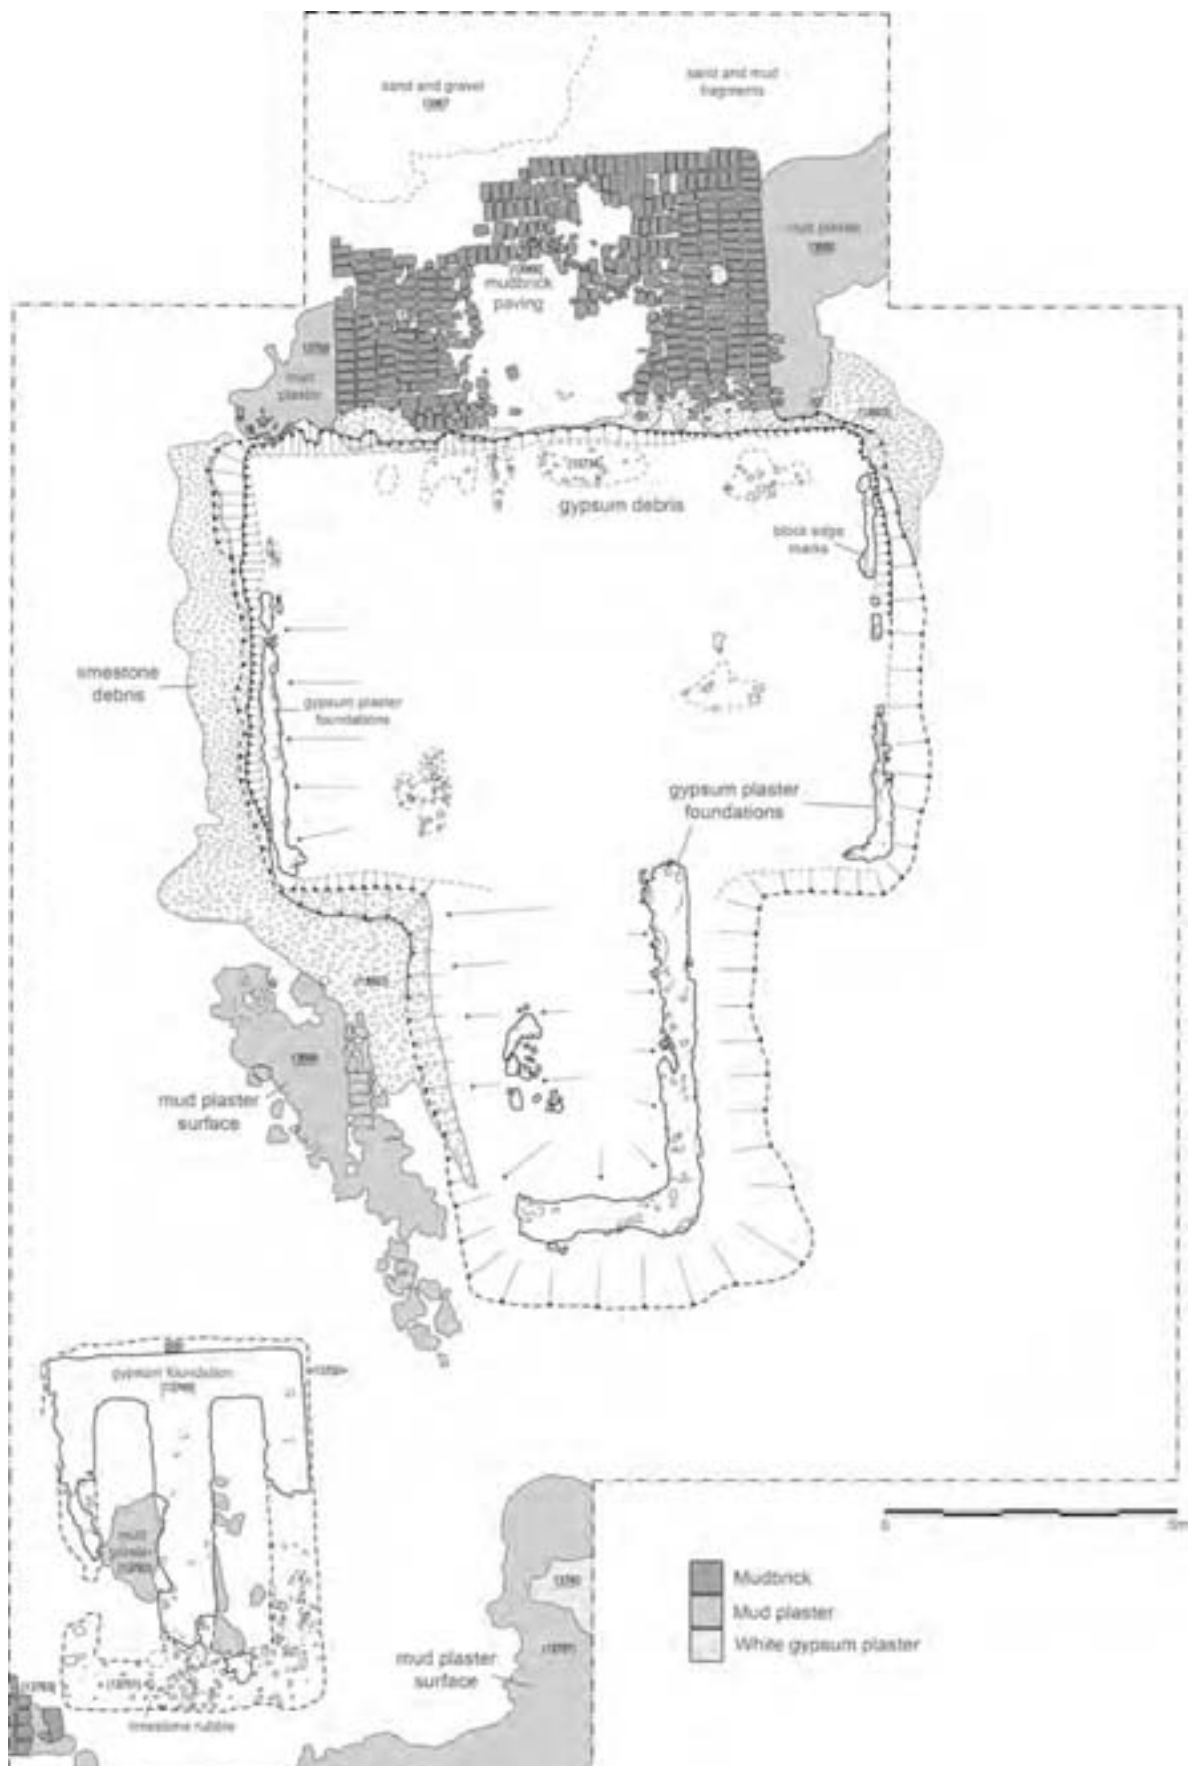
Figure 26. Plan of the Phase II features at the stela site, by Mary Shepperson.

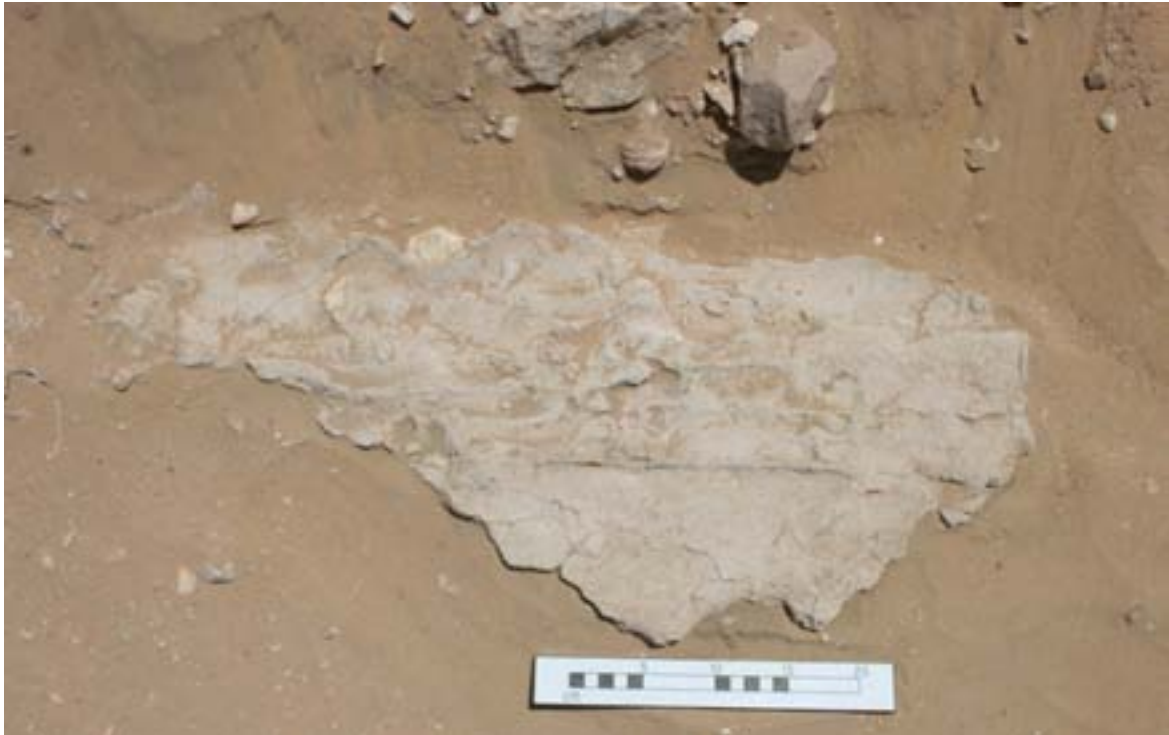
*Figure 27. The Phase II stela site: the impression of part of a limestone block is preserved in the layer of mortar laid over the bed of gypsum concrete. On the far side of the ridge that marks the edge of the block is the surplus mortar that has been worked with fingers.*

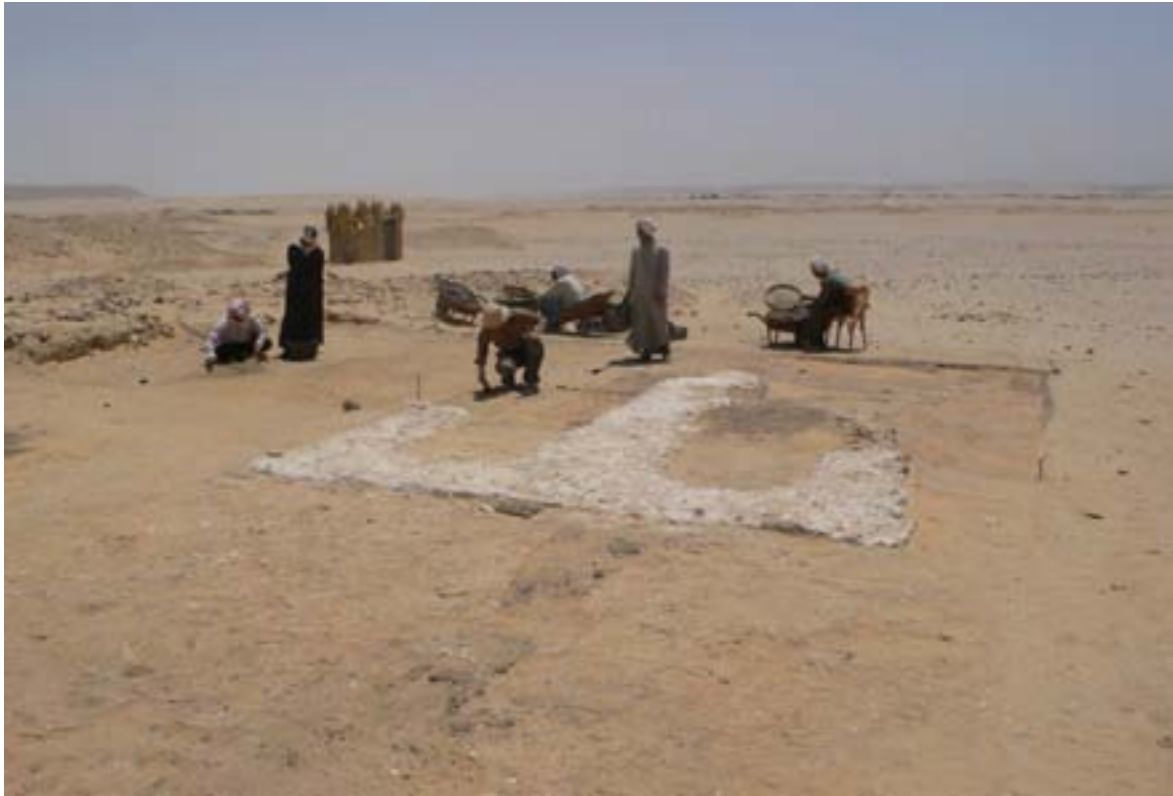
*Figure 28. The rectangular gypsum foundation in the process of being cleaned, viewed to the south.*

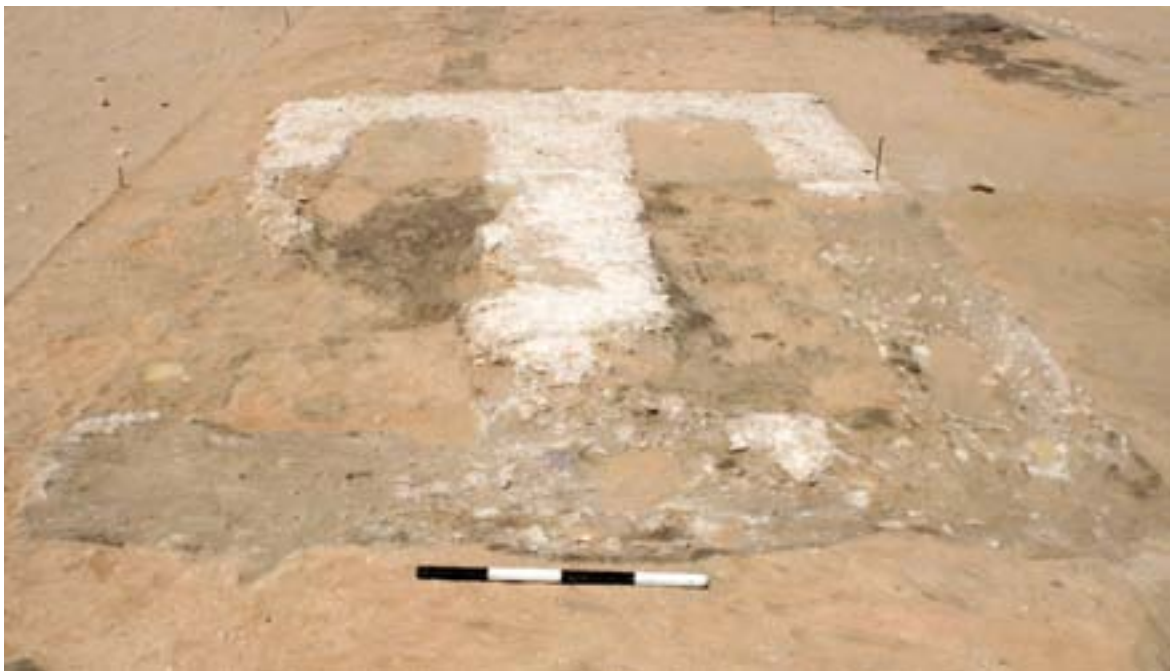
*Figure 29. The rectangular gypsum foundation, viewed to the north.*

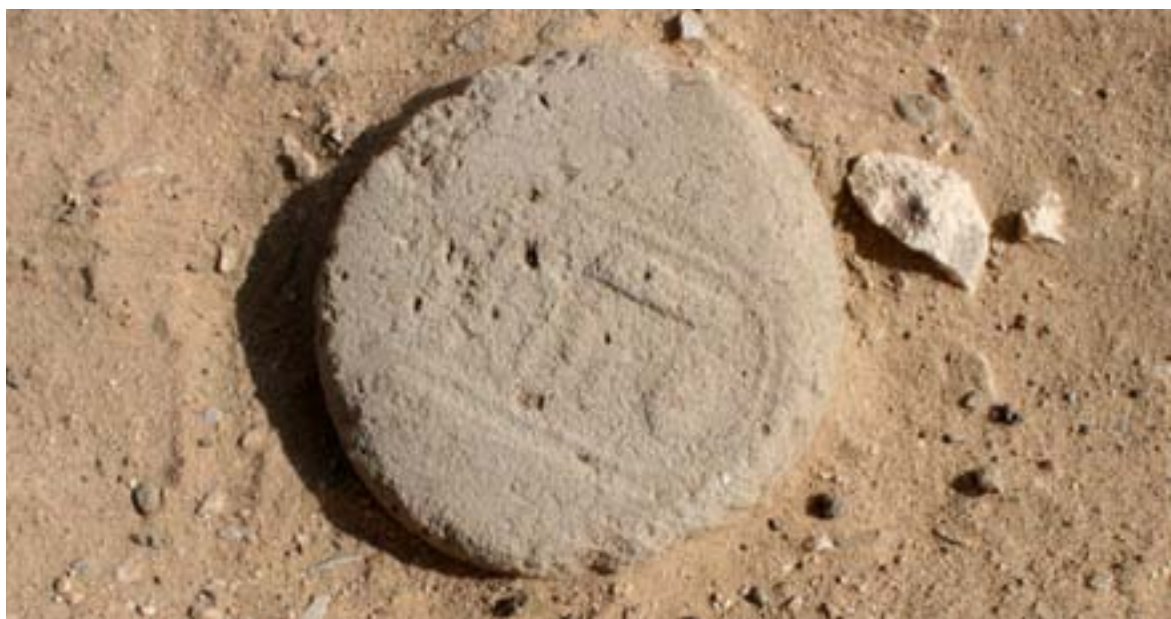
*Figure 30. Mud jar stopper, as found at the stela site.*

Two clay jar stoppers were recovered. The larger was stamped with a label identifying the jar contents as wine, and was found just below the surface above a deep Phase I pit (Figure 30). The smaller stopper, which retained some of its fabric covering, was jammed into a Phase I pot emplacement as part of the levelling material laid down before the construction of Phase II.

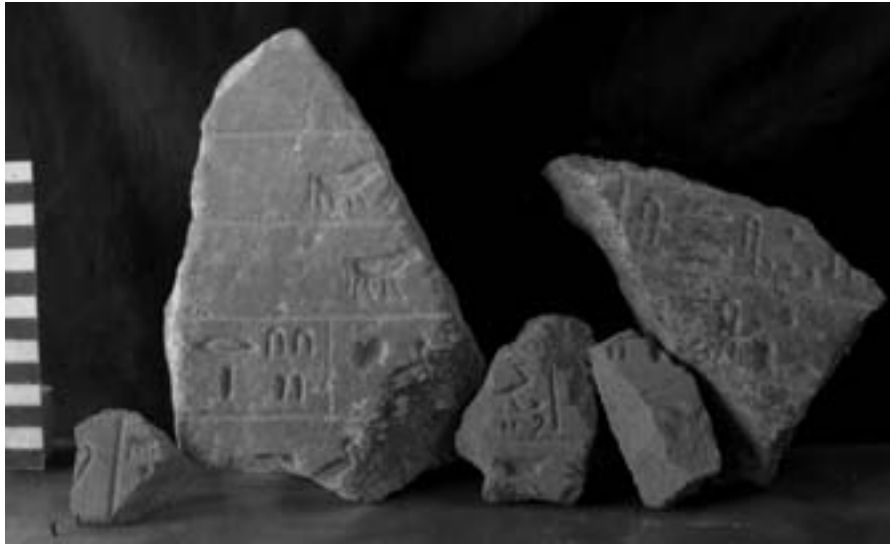
Figure 31. Fragments of stela from the Great Aten Temple discovered in 1933/4. EES archive photograph 1933/4, no. O 74.

A single photograph in the EES archive (Figure 31) depicts five fragments of this offering list (current whereabouts unknown), but their distinctive character is enough to associate them with fragments of the same type in the Metropolitan Museum of Art (Figure 32) that derive from the 1891–2 work that the teenage Howard Carter undertook (as Petrie's assistant and Lord Amherst's representative) in the areas of the Sanctuary of the Great Aten Temple and the dump just south of it (outside the temenos). Pendlebury's remark about prior excavation suggests that he actually saw traces of Carter's work and thus that the New York fragments were actually retrieved in the platform area.

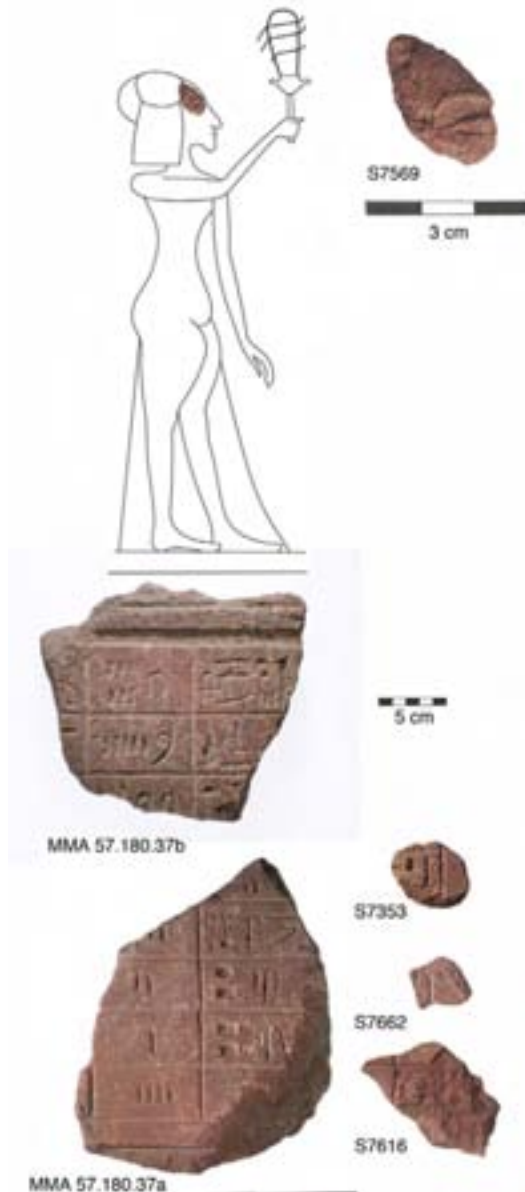
Figure 32. Lower left: two fragments of quartzite stela in the Metropolitan Museum of Art, Harrris Brisbane Dick Fund. Photographs by William Barrette. Right: three small fragments from the 2012 excavations. Photographs by Marsha Hill. Top: fragment (S7569), from the 2012 season, that seems to be part of a face, perhaps of a princess. On the left it has been placed within the outline of one of the princesses depicted on Boundary Stela S.
