## CHAPTER 1

REPORT ON THE 1987 EXCAVATIONS  
A LARGE WELL BESIDE BUILDING Q48.4

## Q48.4: well

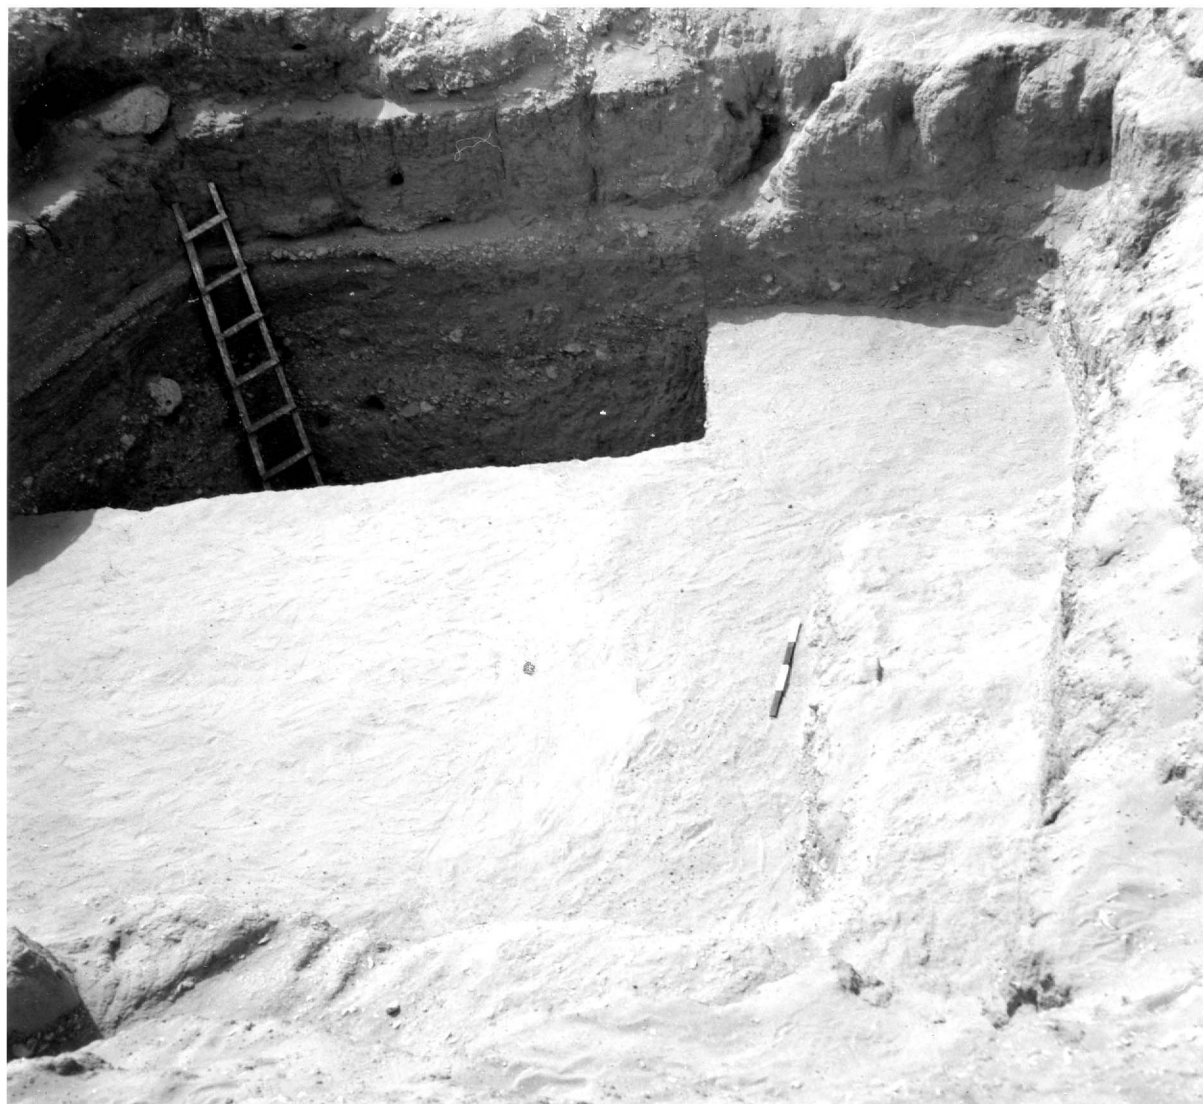
**Figure 1.2.** The well at the end of the 1987 season, looking west. The ladder descends at the south-west corner of the stratigraphic pit. The metre scale runs beside the descending ramp [3826].

On the south and west sides true ancient faces are first encountered in the form of a narrow horizontal shelf [3825] running along the top of the precipitous sides of the well shaft. That on the south is about 60–70 cms wide, just adequate to form a pathway; on the west it narrows to almost nothing. In the south-west corner a prominent natural boulder projects across it. The east and north sides provided the means of access, principally a ramp cut into bedrock, which really begins more than half way along the east side. It is here more or less horizontal and 3 m wide and so looks more like a platform [3829], but, as it turns to run westwards along the north face of the shaft, it begins a gentle descent [3826] (Figure 1.2). Where it disappears beneath the unexcavated deposits a step seems to be present, and, indeed, in order to make the descent into the lower parts of the well a staircase must have developed here which was very steep. The outer

edge of the ramp had been protected by a brick wall, now represented by a single brick [3828] and a bed of mortar [3827], both *in situ*. Two more bricks [3830] lie on the floor of the platform, but their derivation is uncertain. Access to the platform from outside was by means of a narrow sloping gully [3831] that enters at an angle from the south-east. Its upper part is outside the excavation limits, but its course may to some extent be marked by the sand-filled erosion channel which appears on the general site map, Figure 2.1, although, if it ran far in this direction, it would have had to change direction slightly, more towards the east. The floor of the gully is narrow and concave. It was partly filled with a thick layer of gravel washed in after abandonment. It is thus possible that the water action involved also scoured the gully making its floor narrower than when in original use.

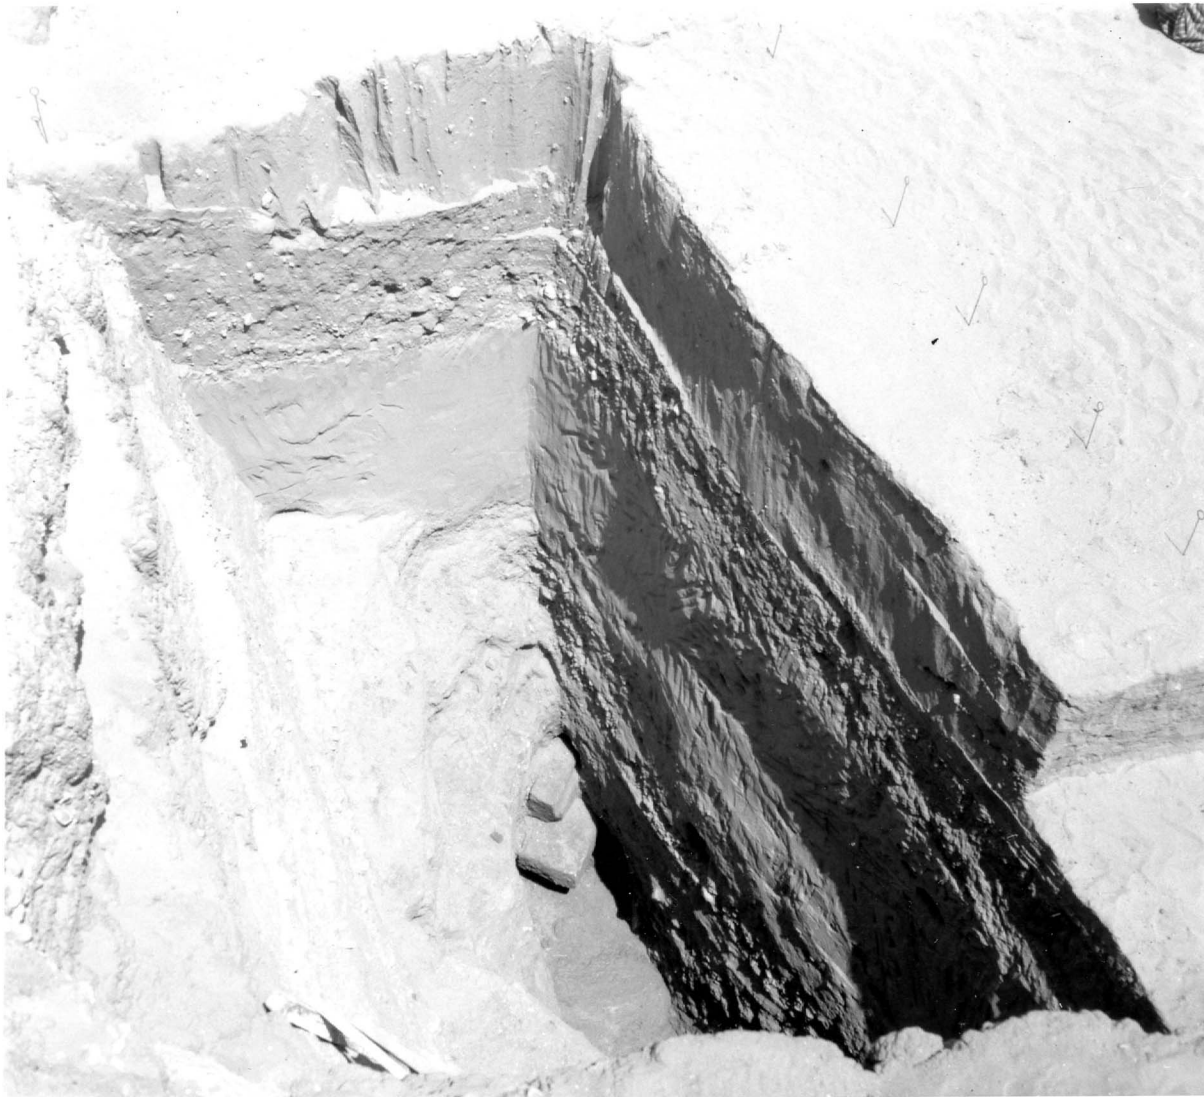
**Figure 1.4.** View of the stratification pit in the well fill, looking north.

On the north side, in both the plan and the section, limestone blocks are visible (Figure 1.4). The two largest [3833] are still partly within the section wall. The upper stone is a reused door jamb, to judge from its profile. It is tempting to regard them as crude steps, continuing the now stepped access ramp which had followed the north face of the well down presumably to the level of the shelf which separates the two stages of the shaft. In the restricted space available they would represent a stepped turning towards the well centre, built into the side of the bowl-like lower part of the well composed of the earthy packing layer. If this were so, it would imply that the original bottom of the well is not far below the level reached by this year's excavation. This touches on the difficult question of how far the level of the ancient water table differed from the modern one. The water level must reflect two factors: back pressure from the Nile, causing in ancient times a rise and fall as the Nile rose and fell, and a slow inflow from the desert wadi-

**Layer 5.** This layer (part of unit [2876]) shows rapid alternation of sand and fine gravels of an orange colour but is wedged-out to the southern edge of the section. The drawn section is not fully representative of its shape, however, for the wedging out also occurred from west to east (Figure 1.4). Thus the maximum thickness lay against the west wall of the well. Interpretation: the sequence is similar to Layer 4, but, because of the cracking and plant growth of the surface of Layer 4 on which it stands, it is considered that Layer 5 was deposited at least one wet season later. A considerable amount of coarse material occurs, which is thicker to the north and to the west. The directions of slope show clearly how the deposit (and Layer 6 above) had entered the well, i.e. as a cascade of water and debris from a gully in the north-west corner of the well, and the composition of the deposit suggests a fresh supply of coarse material.

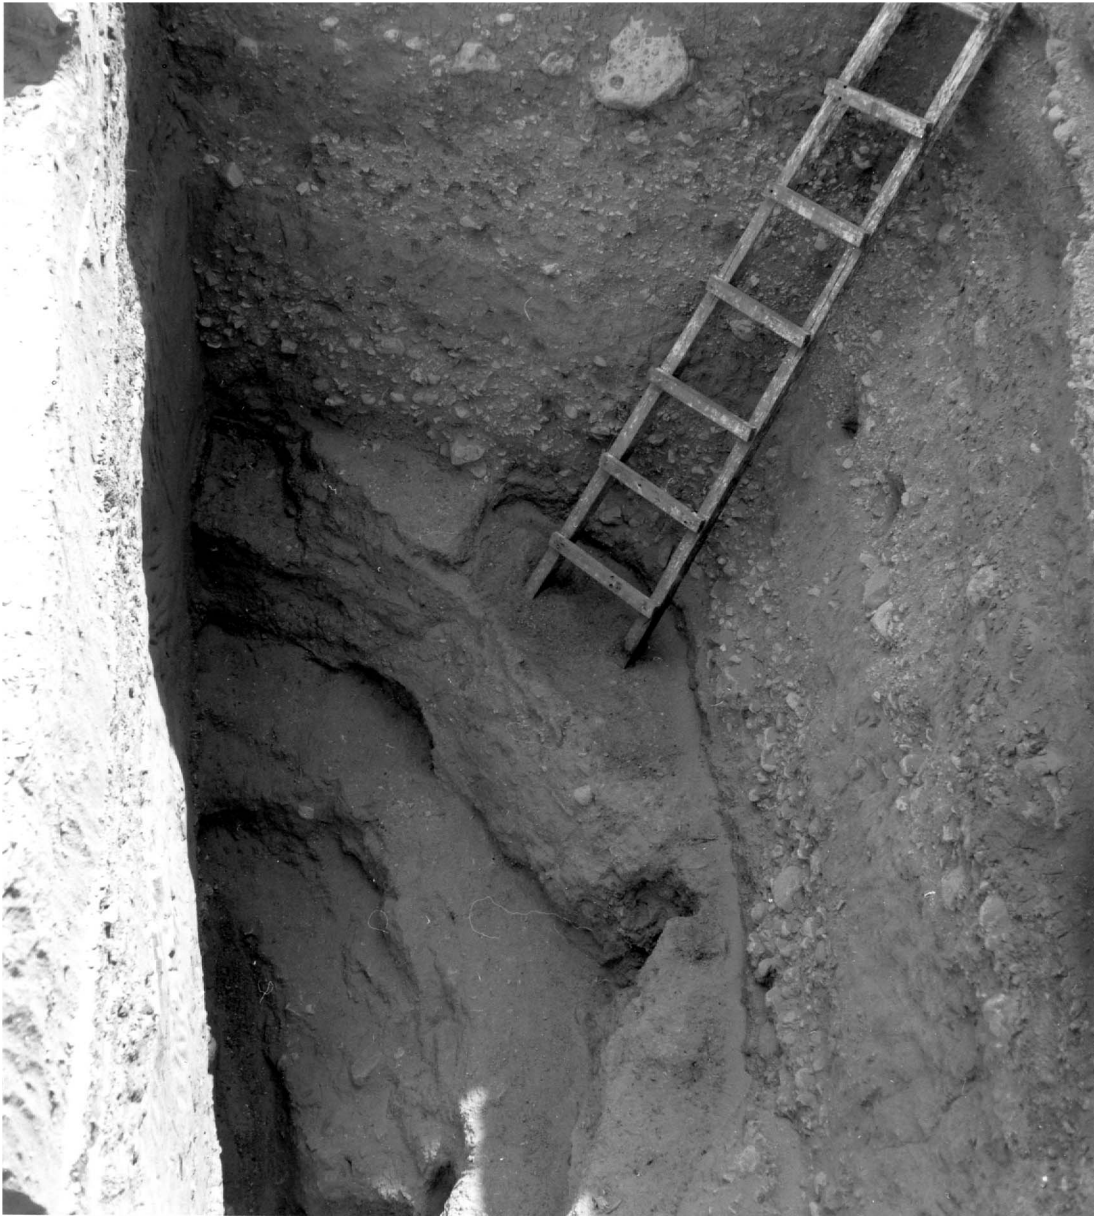
**Figure 1.5.** View of the stratification pit, looking south. The wooden ladder stands on the shelf, unit [3832].
